Natural Terrain Hazard Study

Application for Permission under Section 16 of The Town Planning Ordinance (Cap. 131)

Minor Relaxation of Building Height Restriction
from 2 Storeys to 4 Storeys for
Proposed 4-Storey Columbarium
at Part of Inland Lot No. 7755 RP and
Government Land sandwiched between
Inland Lot No. 7755 RP and Inland Lot No. 7713,
Cape Collinson Road, Chai Wan

Philip So & Associates Limited

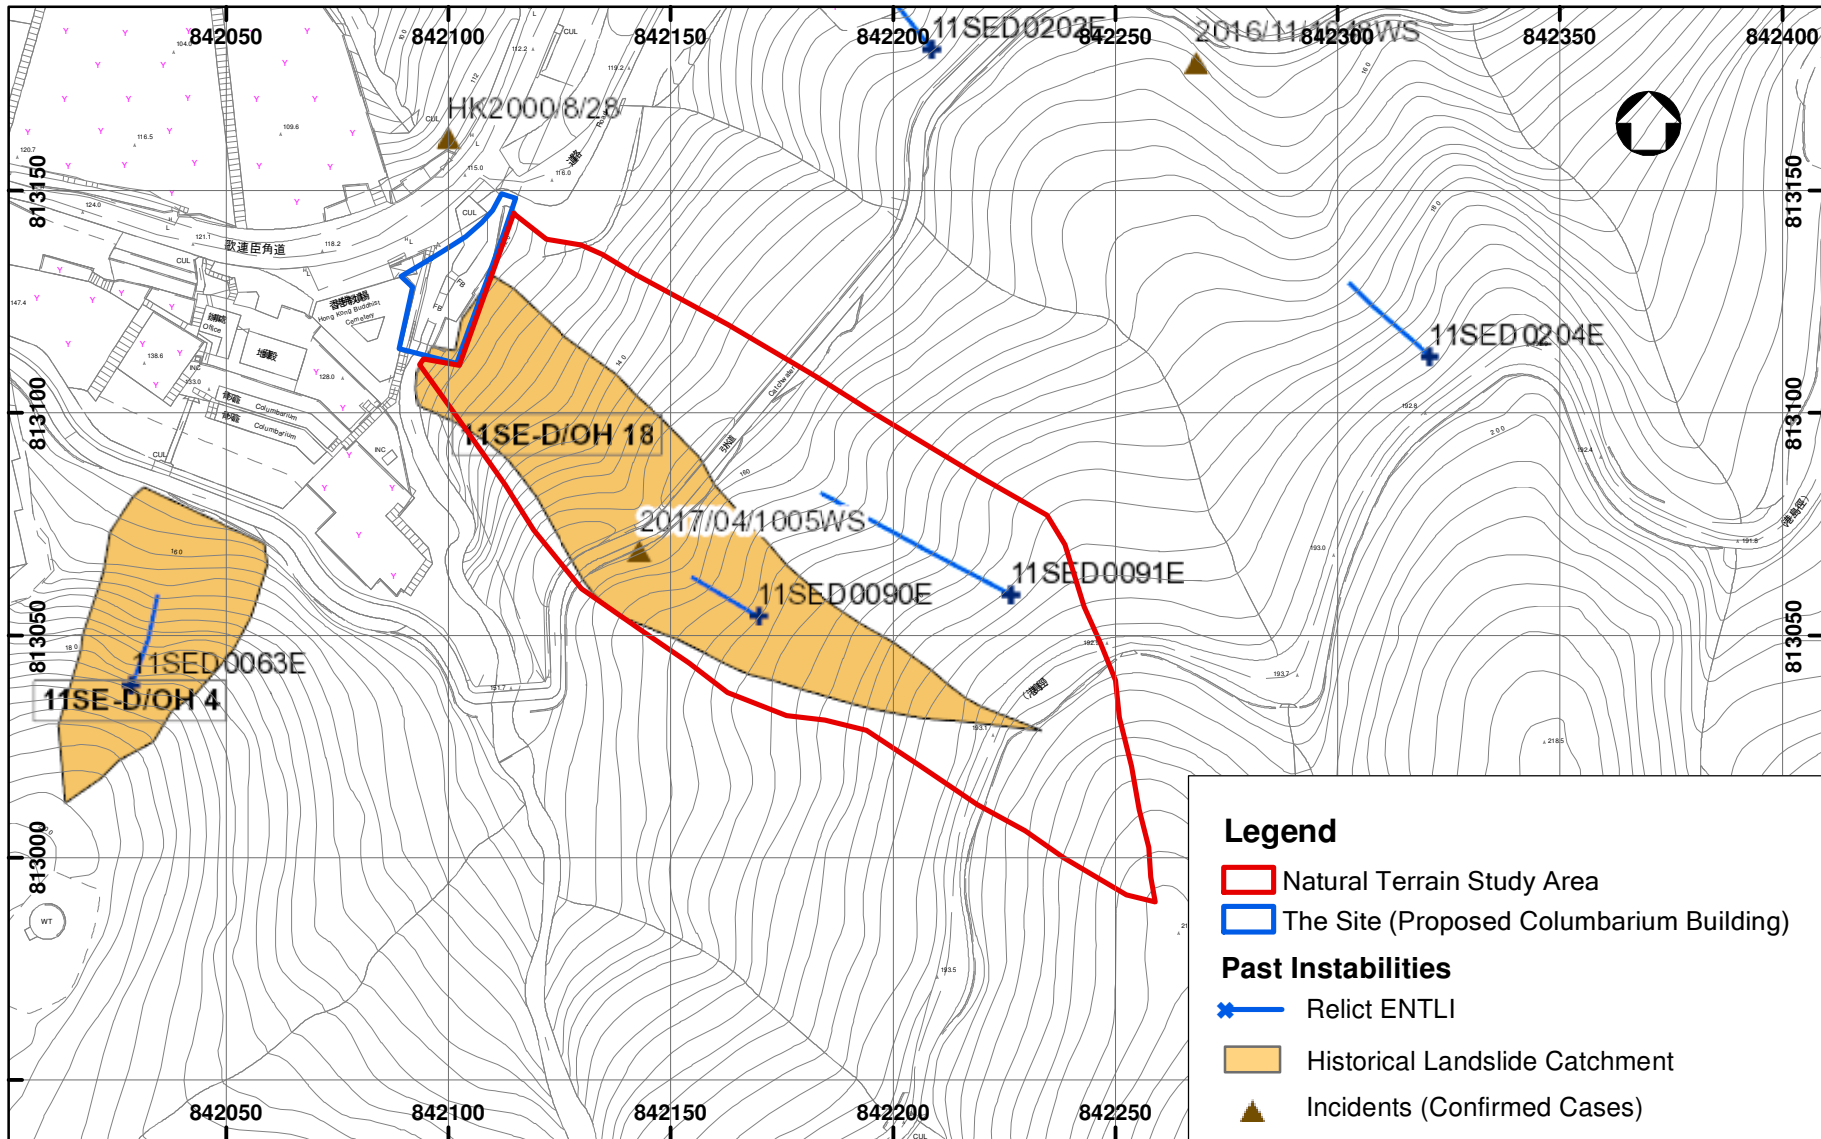
TITLE: Recorded Past Instabilities	SCALE: 1 : 1700	Philip So & Associates Limited In associaton with	FIGURE NO : FIGURE 5
---	---------------------------	--	---------------------------------------

The GEO landslide incident database has recorded one small scale failure within the NTSA. Incident no. 2017/04/1005WS was recorded in the middle portion of the NTSA on the man-made cut slope Feature No. 11SE-D/CR350 (**Figure 5**). It is a minor soil cut washout with failure volume of 0.8m³.

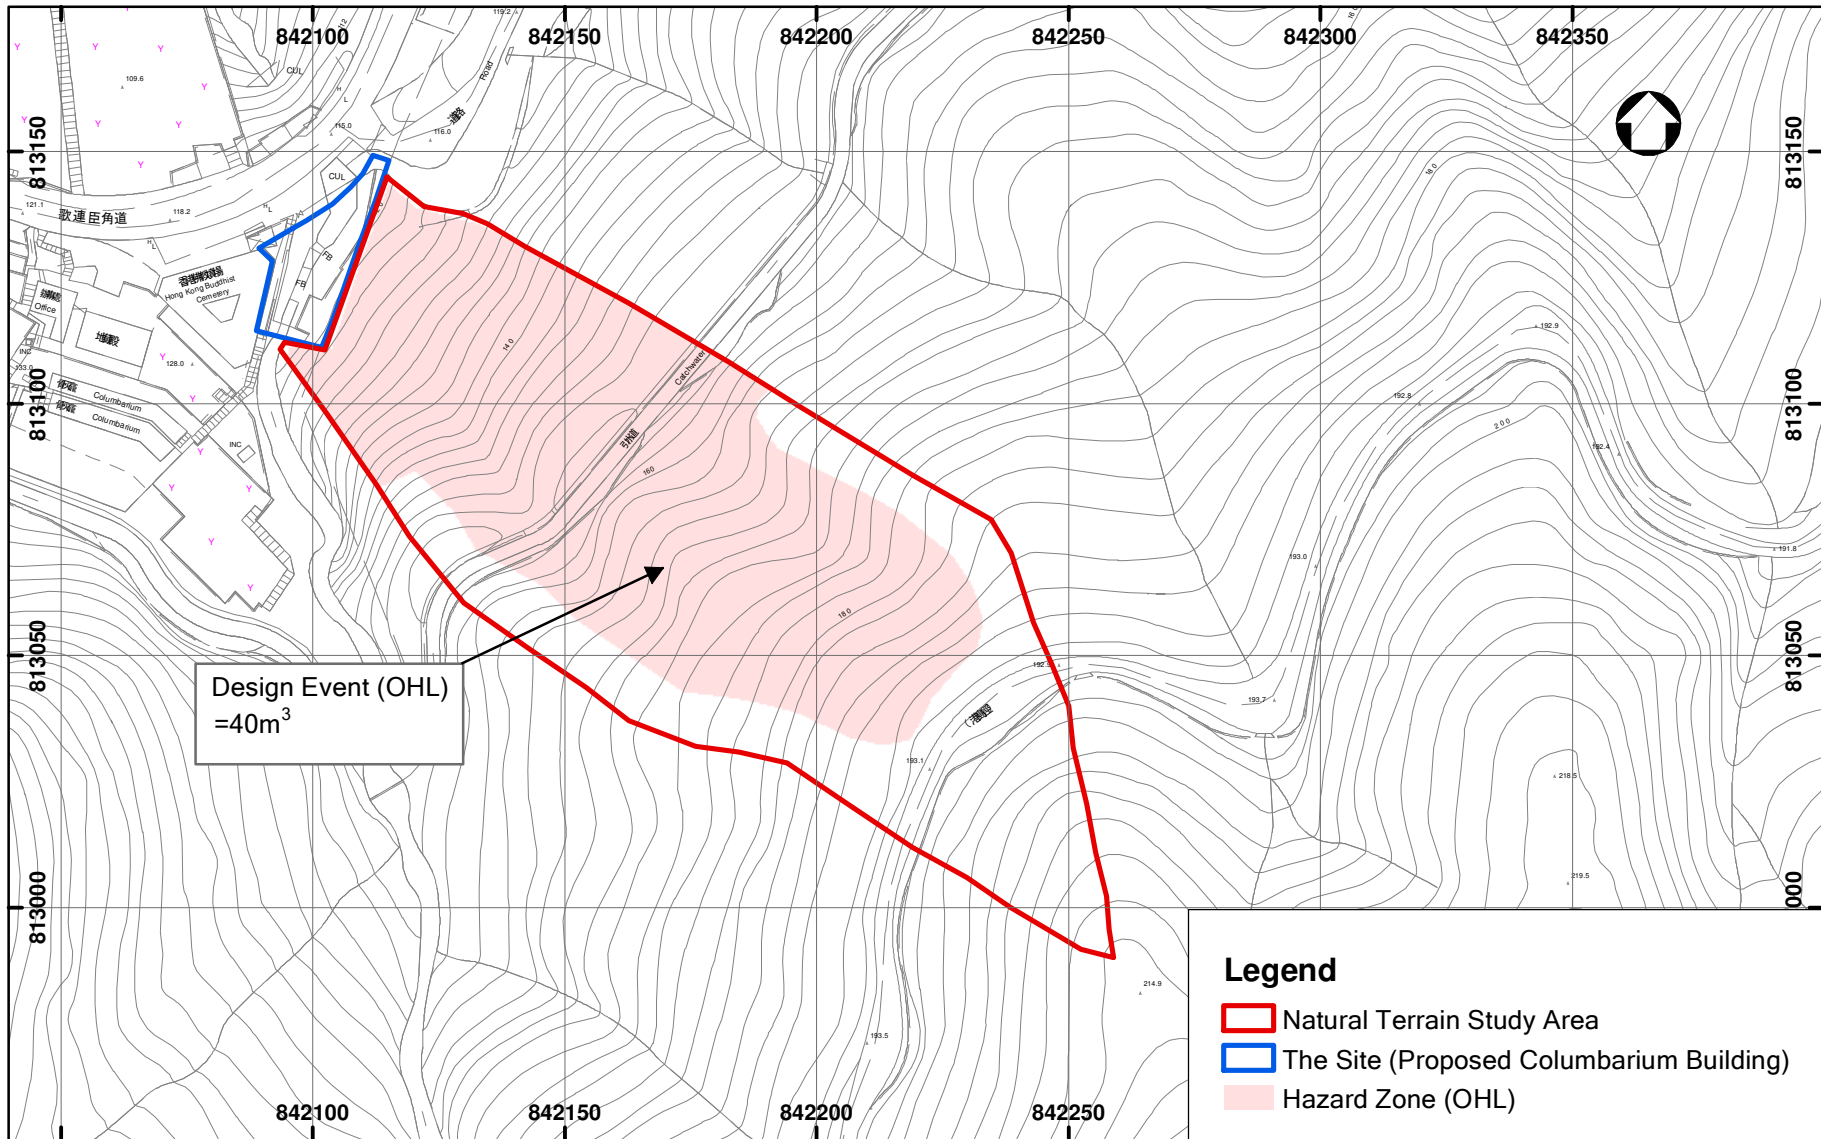
FIGURE NO :
FIGURE 11

The NTSA also contain transportational middle slope terrain. The middle slope terrain lies between +120 mPD and +190 mPD where slope gradients range between 25-35°. Although, there is no significant water concentrate towards the NTSA, evidence of previous landslides are discerned on the relatively steeper hillslopes within the transportational middle slope terrain. Failure mechanism of the landslides are likely due to the development of transient perched water table at the interfaces between hillslope colluvium and decomposed rock materials during prolong of heavy rainfall. OHL is considered a viable hazard within the middle slope terrain unit. The potential landslide area within the NTSA is shown in the natural terrain hazard map (**Figure 11**).

Based on the assessment of the design event requirements of middle slope terrain units within the NTSA, adoption of 40m³ as a credible design event for the NTSA is considered appropriate. The potential landslide source area within the NTSA is shown in the natural terrain hazard map (**Figure 11**).

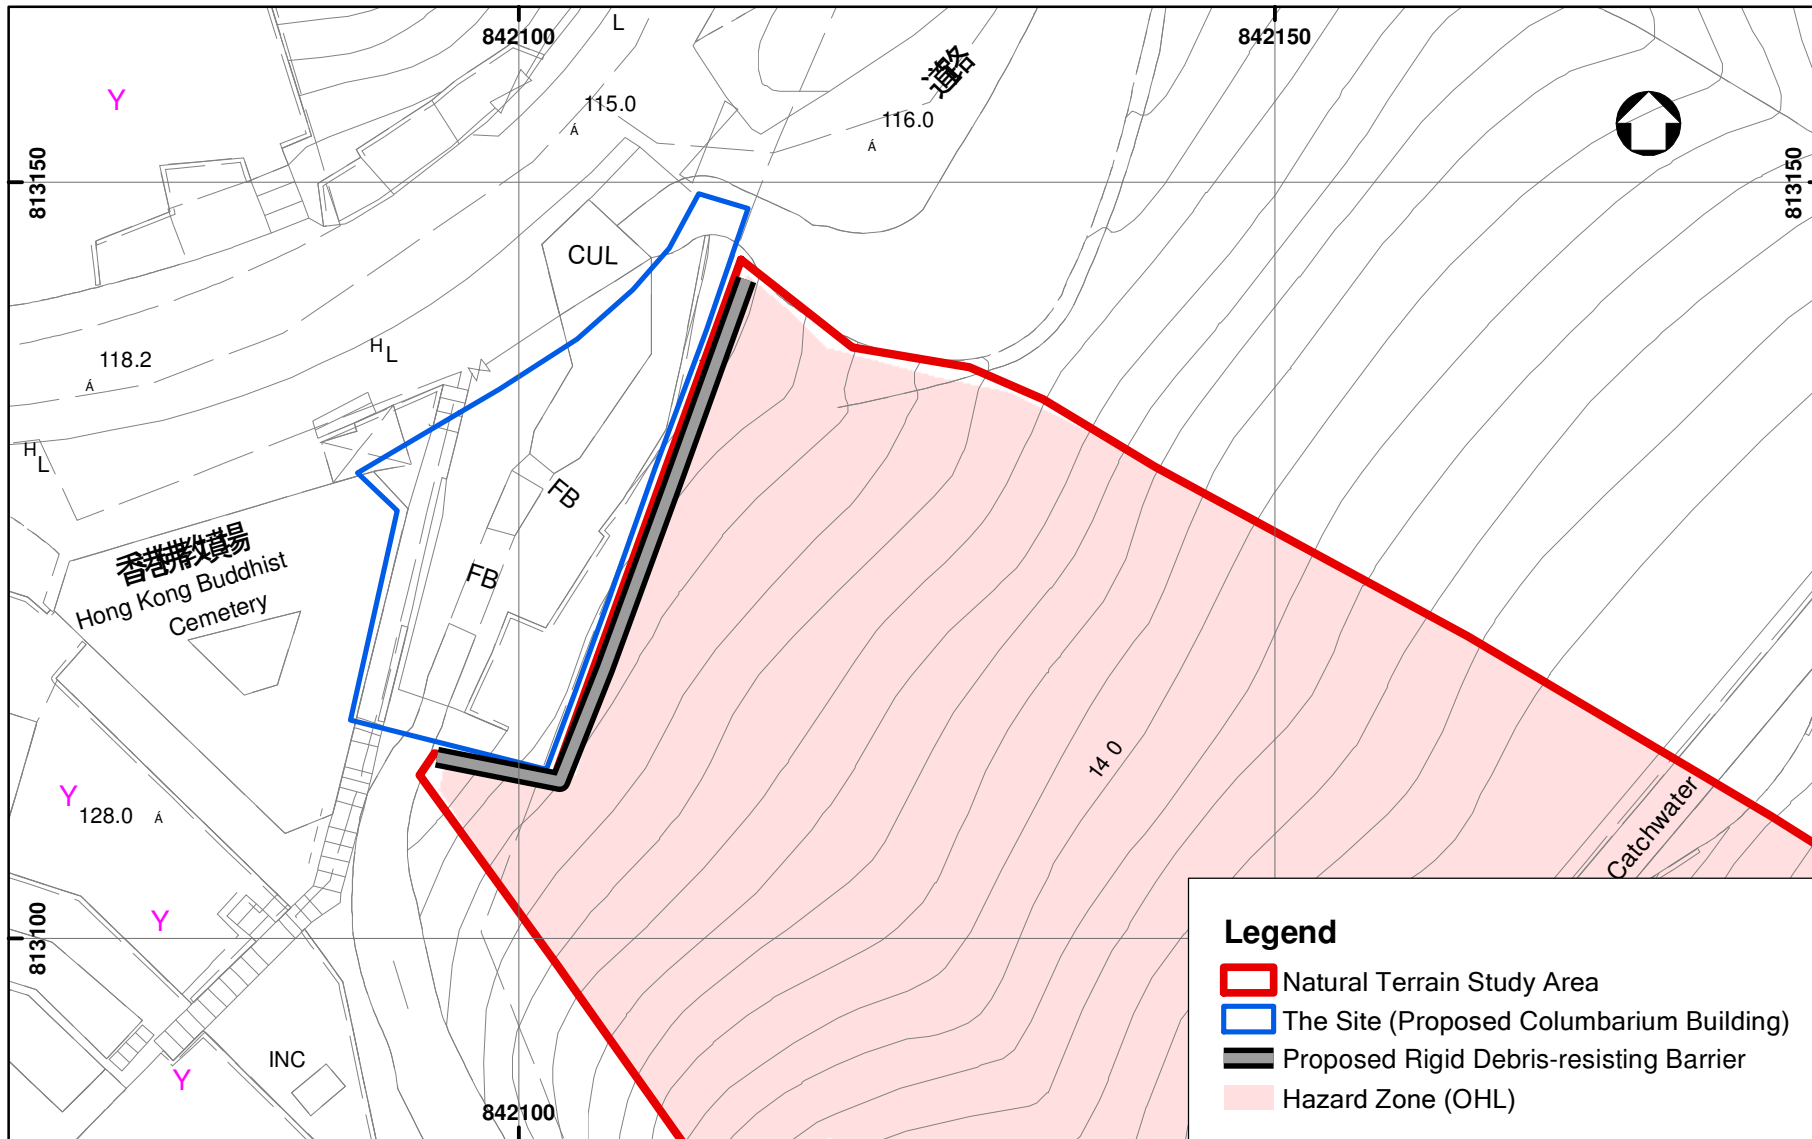
TITLE: Natural Terrain Hazard Mitigation Measures	SCALE: 1 : 500	Philip So & Associates Limited In associaton with	FIGURE NO : FIGURE 12
--	--------------------------	---	--

Following the review of the landslide hazards on the NTSA, debris mobility model for the NTSA have been simulated to assess whether a failure volume of 40m³ from the NTSA could pose hazard to the Site. The results revealed that the debris for Cases on both critical flow paths RP1 and RP2 at the upper portion of the NTSA will not reach the site boundary. However, debris for both cases on the flow paths RP1 and RP2 below the Catchwater will reach the Site boundary. Therefore, mitigation measure is considered necessary. To mitigate

the landslide hazards, erection of a rigid debris-resisting barrier at the toe of the NTSA is recommended. It will be more cost-effective to integrate the debris-resisting barrier with the ELS/Site formation designs. An elevated retaining walls/bored-pile walls can be acted as a debris-resisting barrier. The detailed design of the mitigation measures will be under separate submission in the later stage, i.e. site formation design. The location of the recommended rigid debris barrier is illustrated in **Figure 12**.

Debris mobility modelling has been carried out to simulate the potential design event of 40m³. The results revealed that the debris will reach the Site boundary. Following the result from the assessment, mitigation works for the potential natural terrain hazard is considered necessary for the proposed development. A rigid debris-resisting barrier integrated with the ELS/Site Formation designs is recommended to be constructed along the toe of the NTSA.

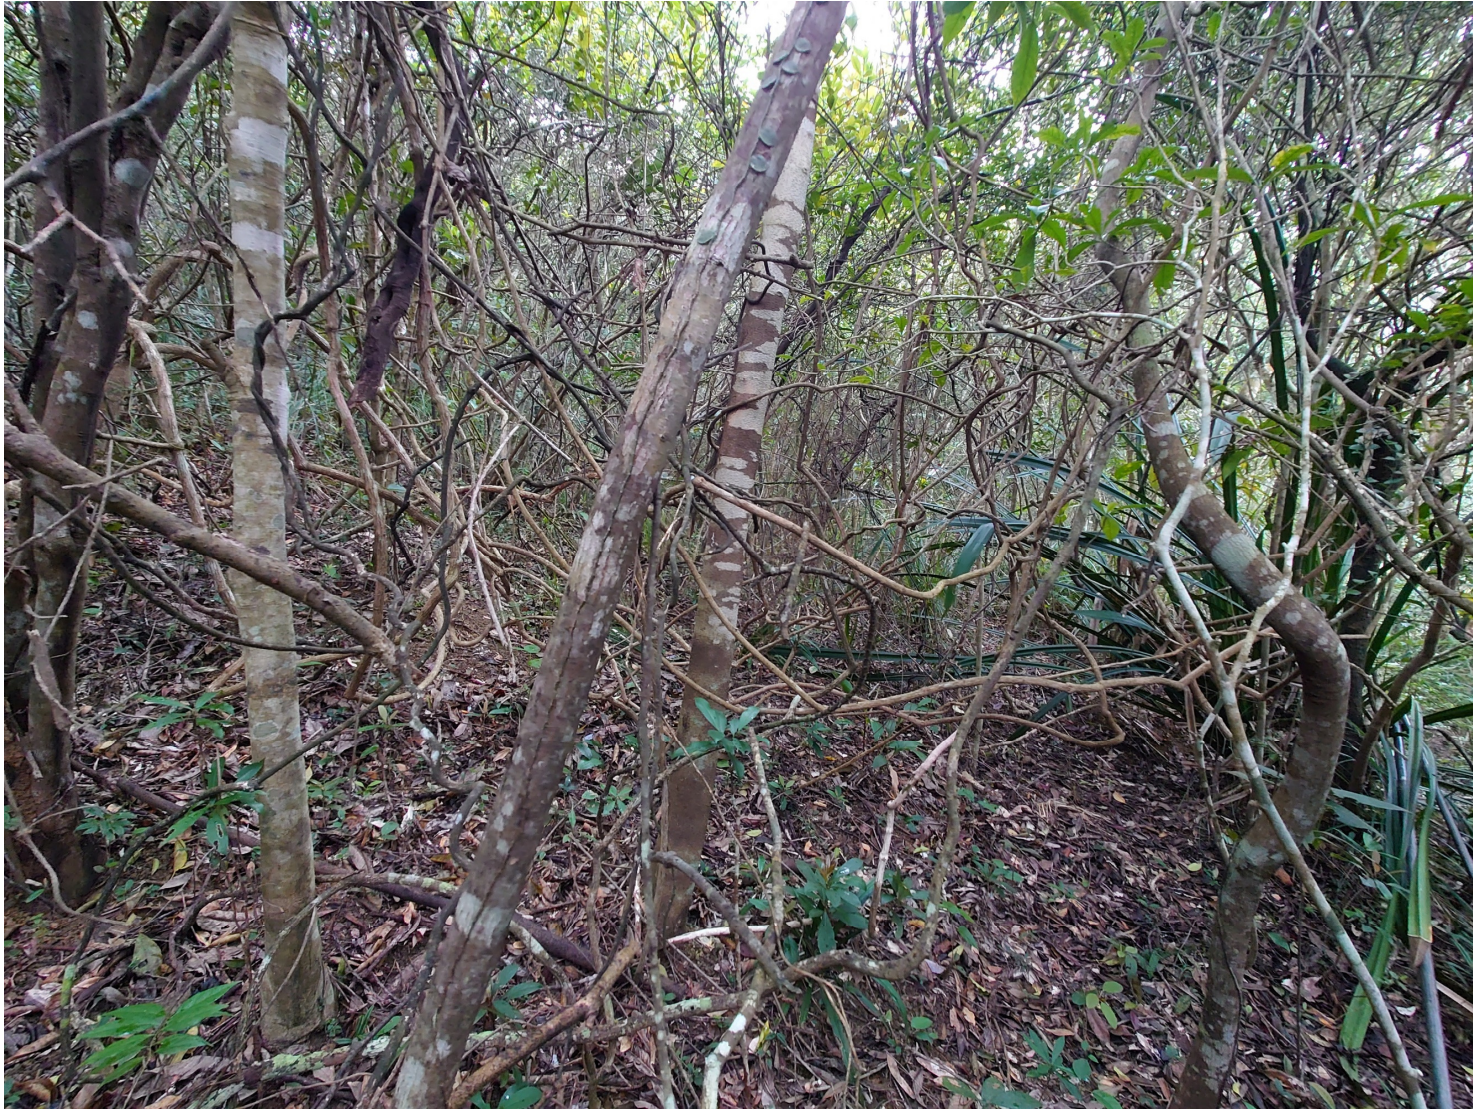
Plate 11 General view of the natural terrain at the upper portion of the NTSA

General slope gradient at the upper portion of the NTSA is about 15° and covered with dense vegetation and rattans.

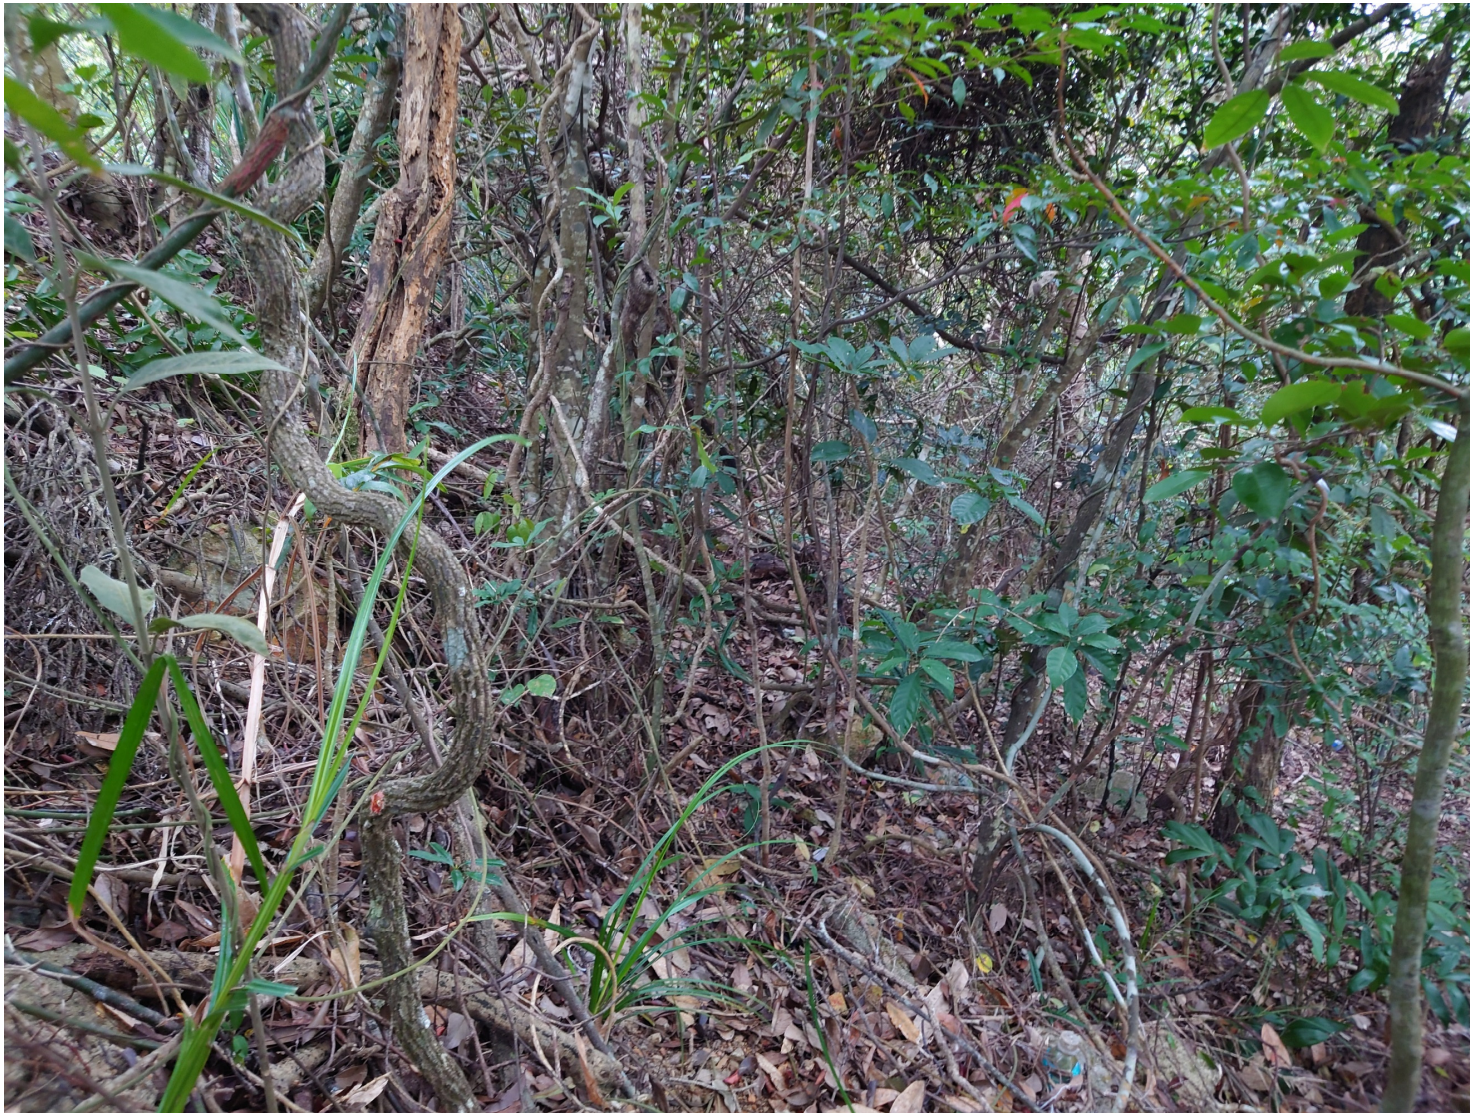
Plate 12 General view of the natural terrain at the middle portion of the NTSA

General slope gradient at the upper portion of the NTSA is between 25° and 30° . It is also covered with dense vegetation and rattans.

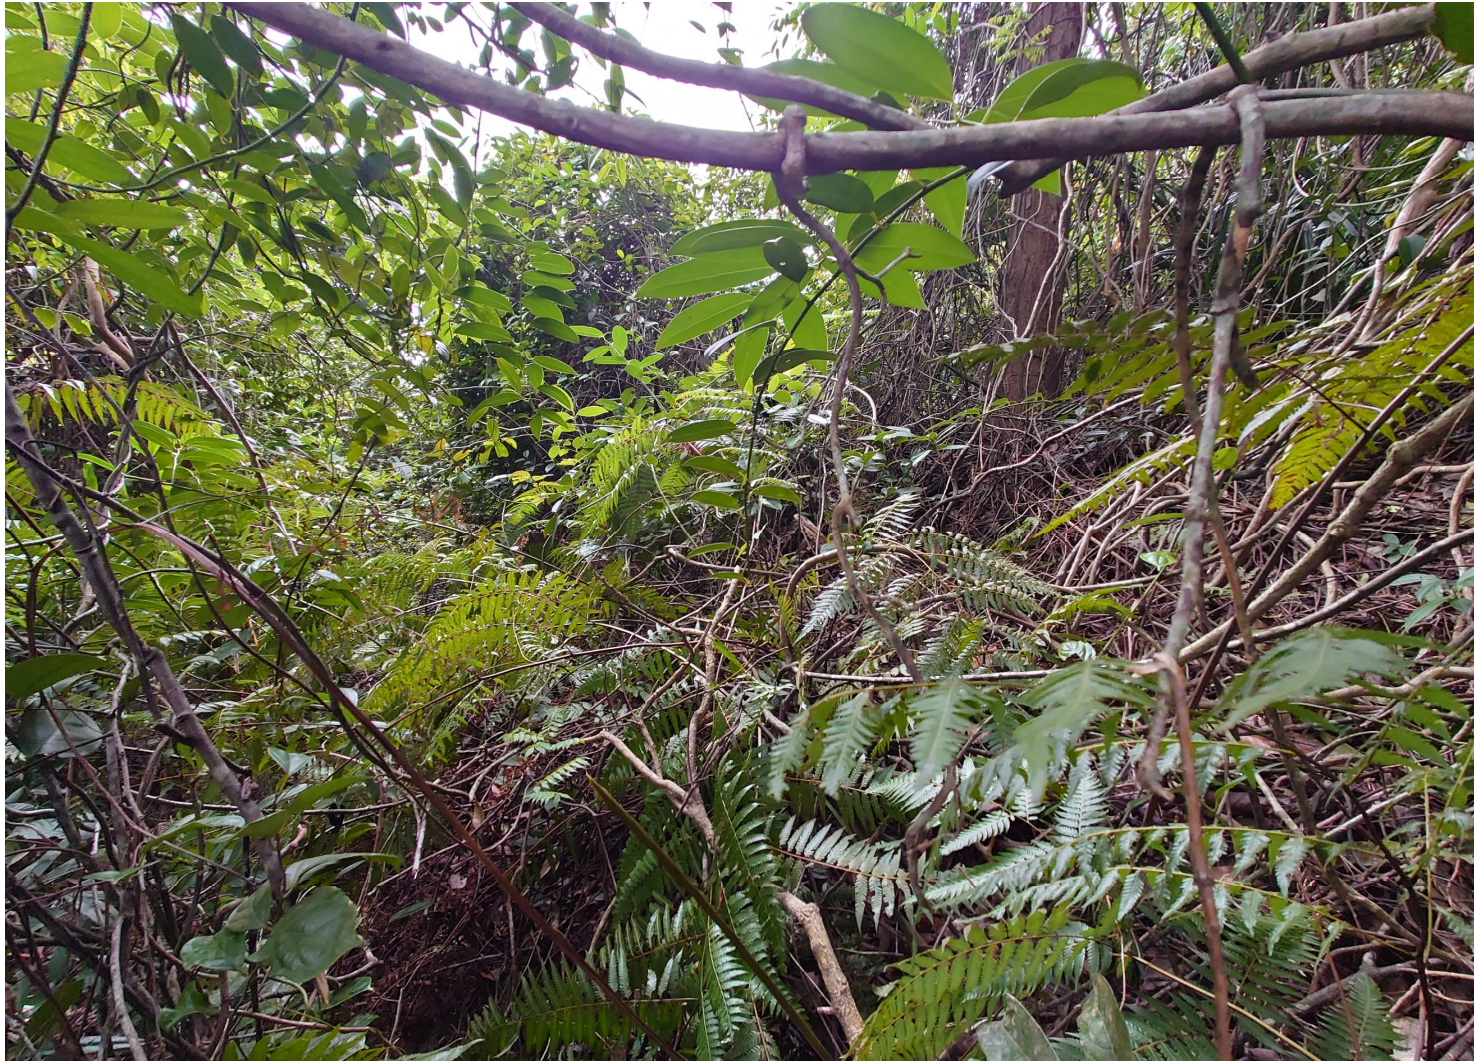
Plate 13 General view of the natural terrain at the lower portion of the NTSA

General slope gradient at the upper portion of the NTSA is about 30° , locally 35° . It is covered with denser vegetation than the upper and middle portions of the NTSA.

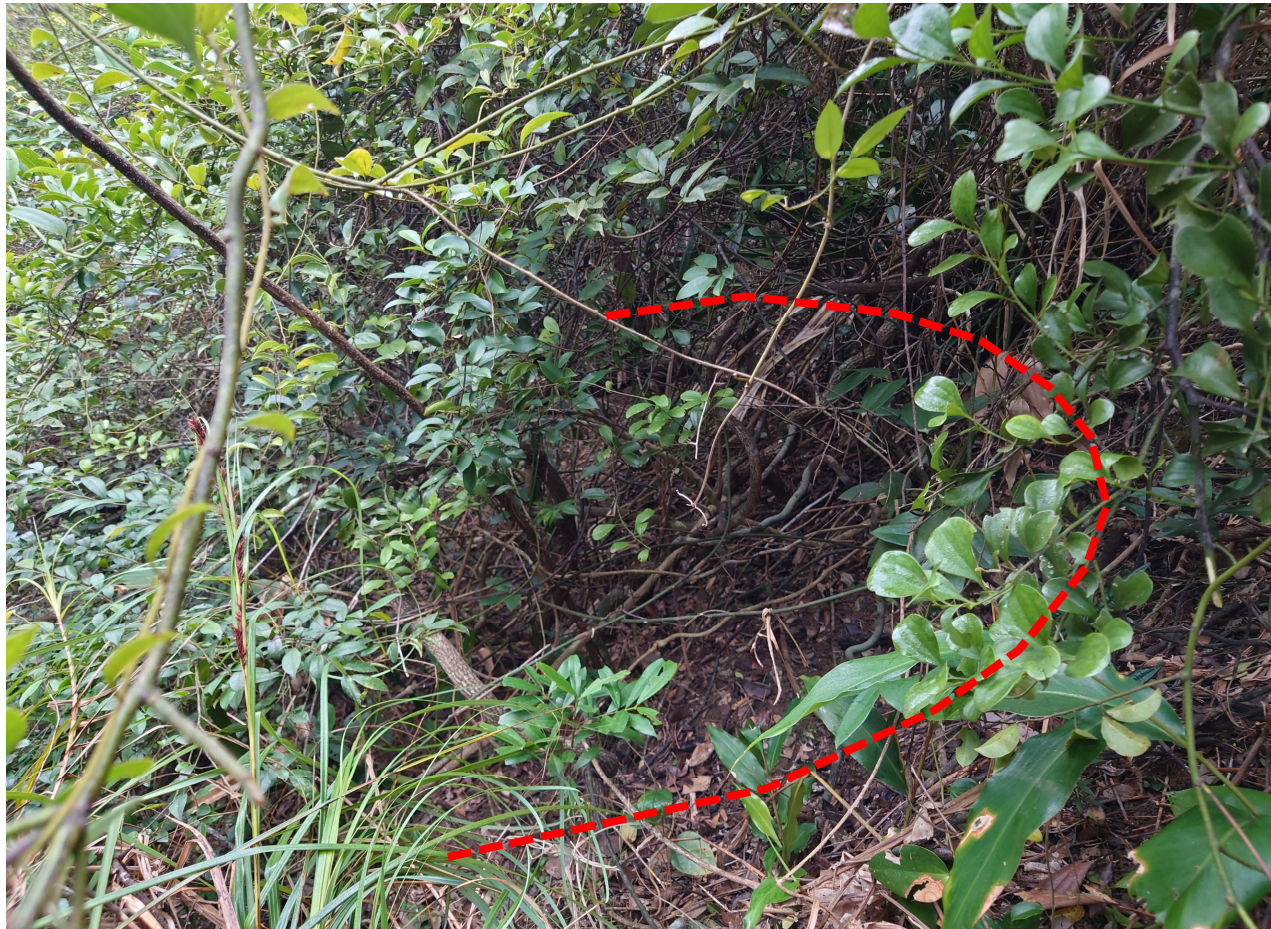
Plate 14 Relict landslide scar, RL1 (ENTLI No. 11SED0090E) at about +171 mPD

Two minor concave depressions appear as darker tone which are located at the middle portion of the NTSA, they are probably represent as two relict landslide scars (RL1 and RL2). The landslide scarp of RL1 appeared as a concave depression with a relatively distinctive change of slope. The landslide scarp of RL2 appears as rounded and broad depression. This degraded feature indicates the landslide could be happened a very long time ago before 1945. The failure of RL1 and RL2 probably due to the transient build-up of perched water table between the thin colluvium and the insitu materials. RL1 and RL2 have an estimated landslide volume of 33m³ and 40m³ respectively (need to verify during the field mapping, please refer to Section 5.2.4). These locations were probably registered in the ENTLI as the record nos. 11SED0090E and 11SED0091E respectively.

Relict landslide, RL1 (ENTLI No. 11SED0090E) was identified at about +171 mPD near the southern spur within the NTSA. RL1 appears to be a distinctive concave depression with a rounded scarp of discernable change of slopes. No noticeable debris lobe can be recognised below the landslide scar, probably the landslide could be occurred for a long time ago and most of the landslide debris had been eroded leaving a shallow depression with depth of about 0.7m. The measured width and length of landslide source is about 11.7m and 8.7m respectively.

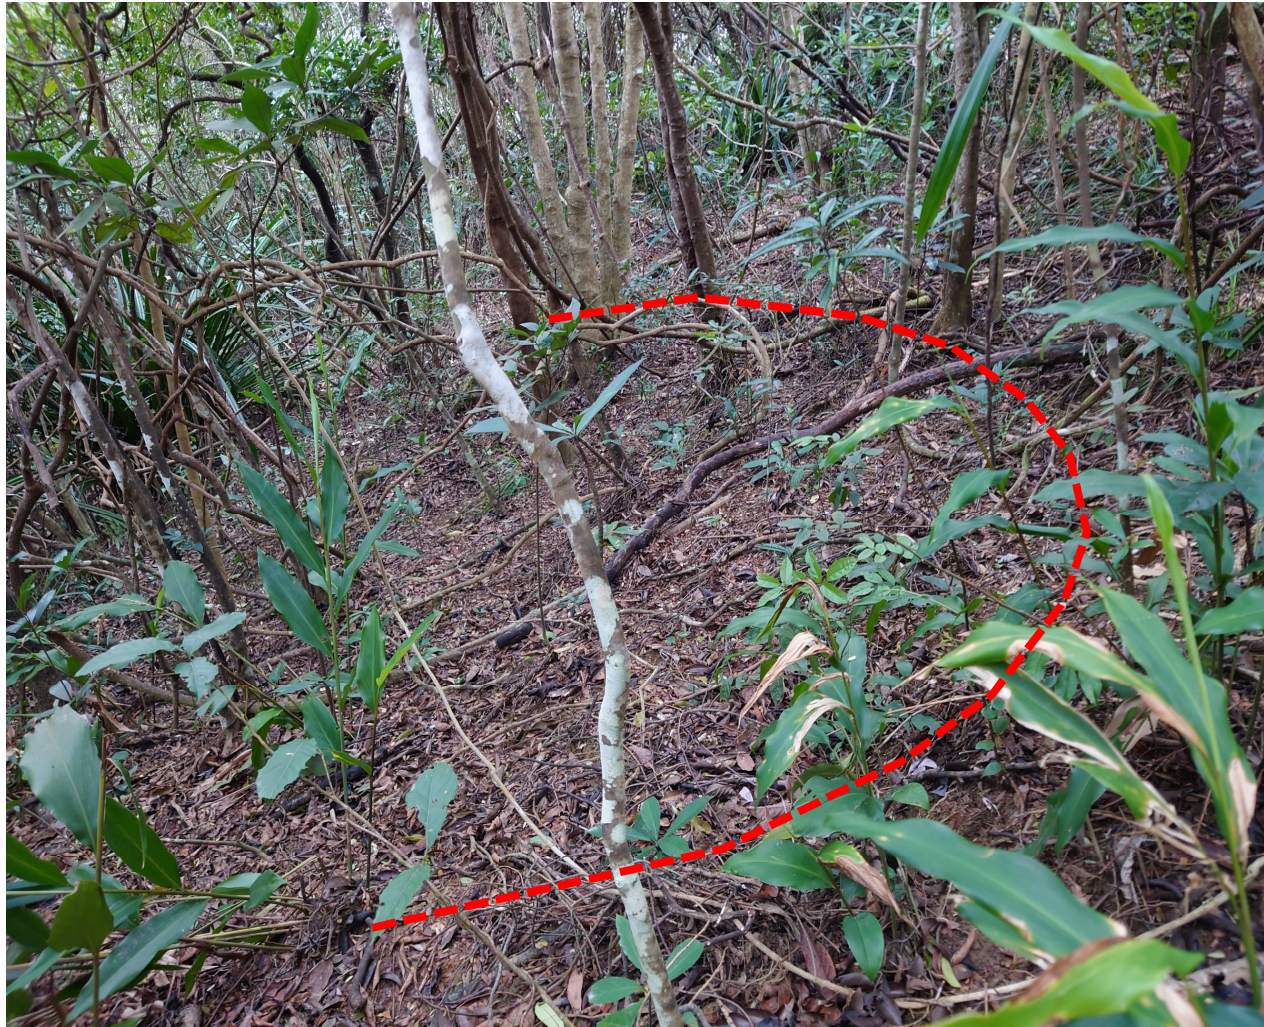
Plate 15 Relict landslide scar, RL2 (ENTLI No. 11SED0091E) at about +186 mPD

Another relict landslide (RL2) was registered as ENTLI record no. 11SED0091E which is located at about +186 mPD below the convex change of slope between the upper slope terrain and middle slope terrain (**Plate 15**). It appears to be a broad, subtle and shallow depression with a rounded scarp, probably older than the RL1. This failure probably part of the hillside retreat process. The estimated failure volume of RL2 is 31.4m³ with measured width, length and depth of the landslide source as 10.6m³, 11.3m³ and 0.5m respectively.

Relict landslide (RL2) was registered as ENTLI record no. 11SED0091E which is located at about +186 mPD below the convex change of slope between the upper slope terrain and middle slope terrain (**Plate 15**). It appears to be a broad, subtle and shallow depression with a rounded scarp, probably older than the RL1.

The estimated failure volume of RL2 is 31.4m^3 with measured width, length and depth of the landslide source as 10.6m^3 , 11.3m^3 and 0.5m respectively.

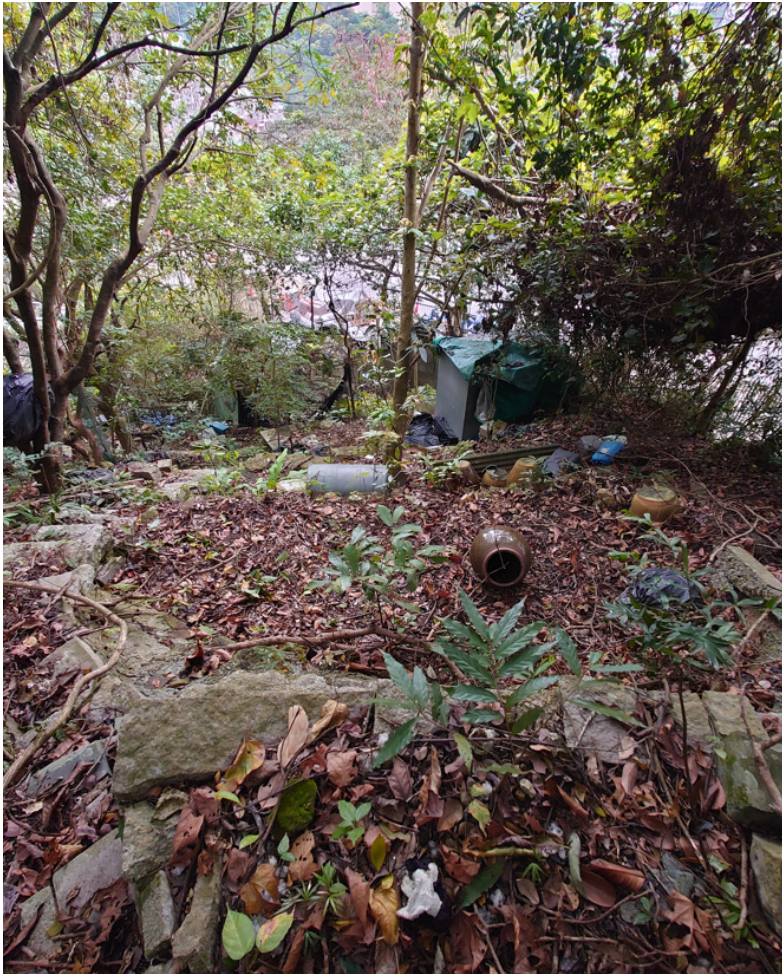
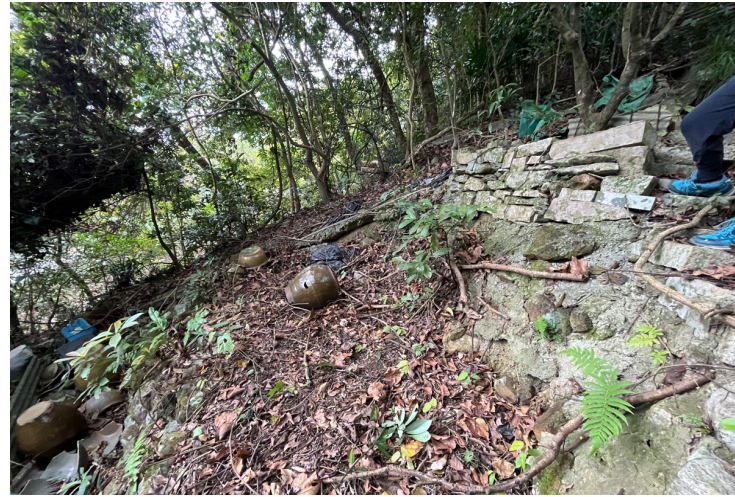
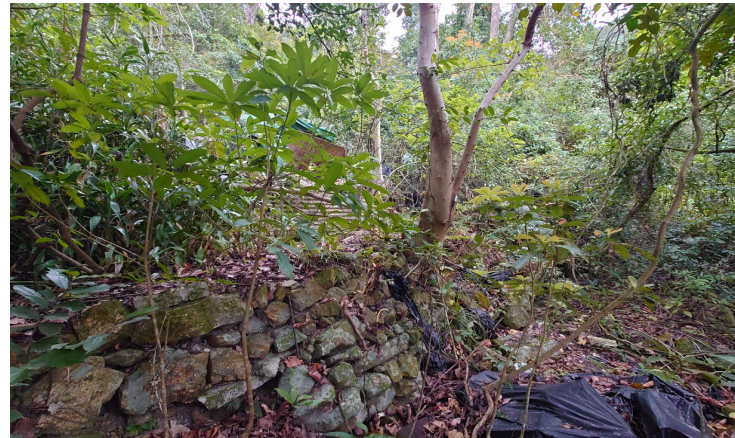
Plate 19 Abandoned small terraces (probably for urns placement during 1980s) near the northern toe of the NTSA

Minor anthropogenic features also include abandoned terraces located at the toe of the NTSA (**Plate 19**). The height of the terraces are generally less than 0.7m with rubble facings and about 1.2m wide within an overall hillslope gradient less than 25 degrees. The terraces were probably used for placement of urns in the 1980s (observed from aerial photographs)

and left abandoned since the completion of the Hong Kong Buddhist Cemetery which was located at the western side adjacent to the Site in 1991. No obvious significant fill bodies and no sign of distress or failure can be discerned within and in the vicinity of the terraces both from aerial photographs and during field mapping. These small terraces are considered to have no significant impact to the proposed development.

The height of the terraces are generally less than 0.7m with rubble facings and about 1.2m wide within an overall hillslope gradient less than 25 degrees. The terraces were probably used for placement of urns in the 1980s (observed from aerial photographs) and left abandoned since the completion of the Hong Kong Buddhist Cemetery which was located at the western side adjacent to the Site in 1991.

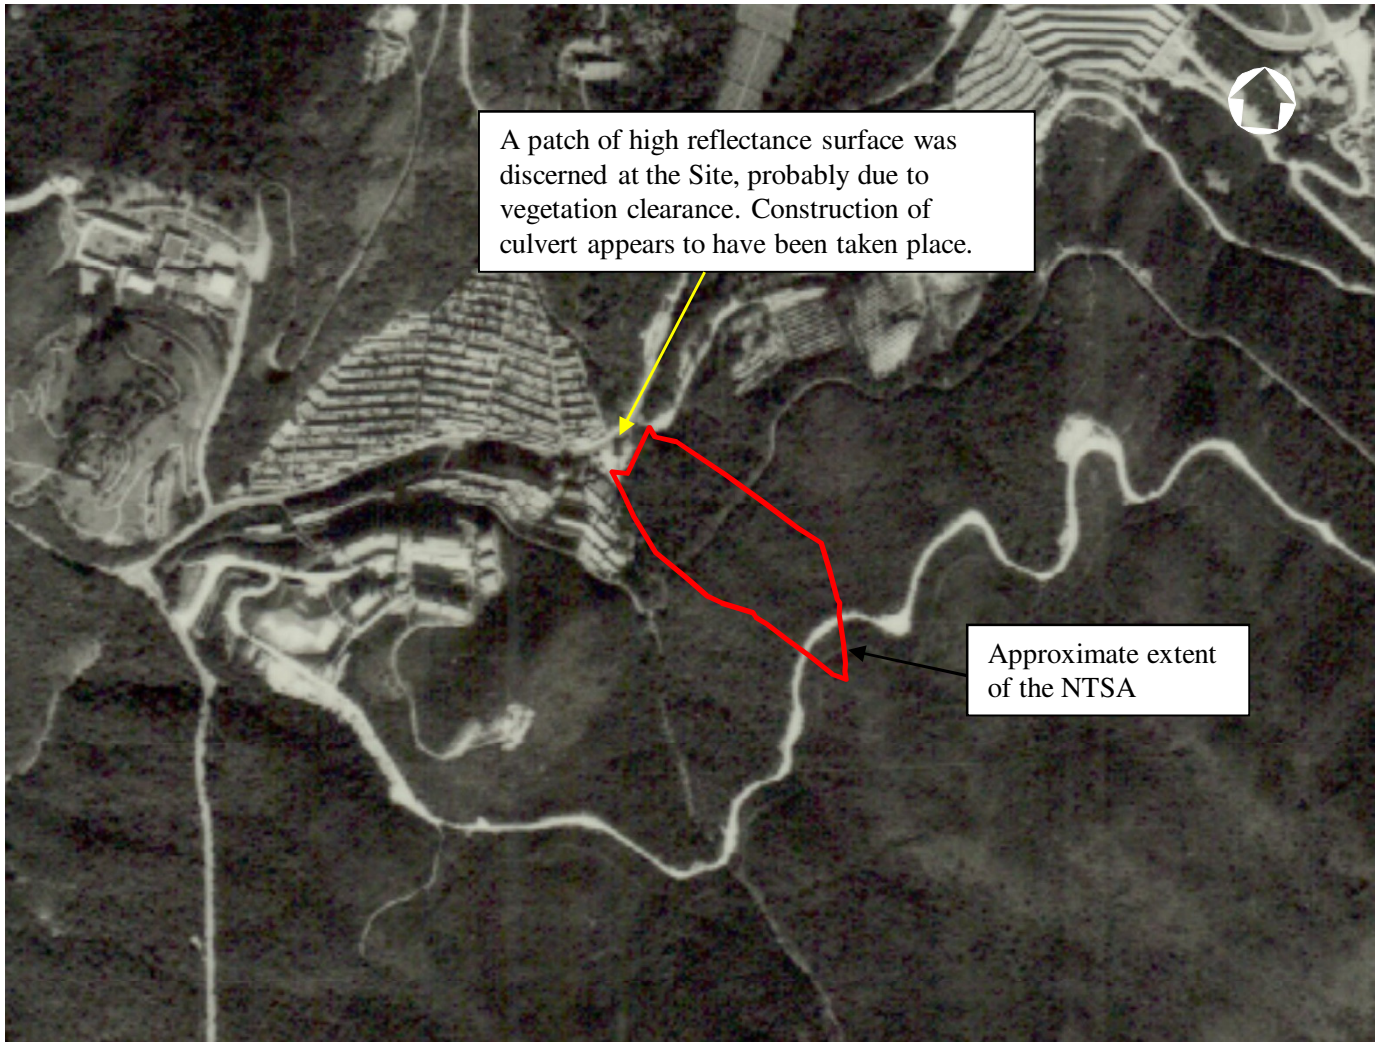
A patch of high reflectance surface was discerned at the Site, probably due to vegetation clearance. Construction of culvert appears to have been taken place.

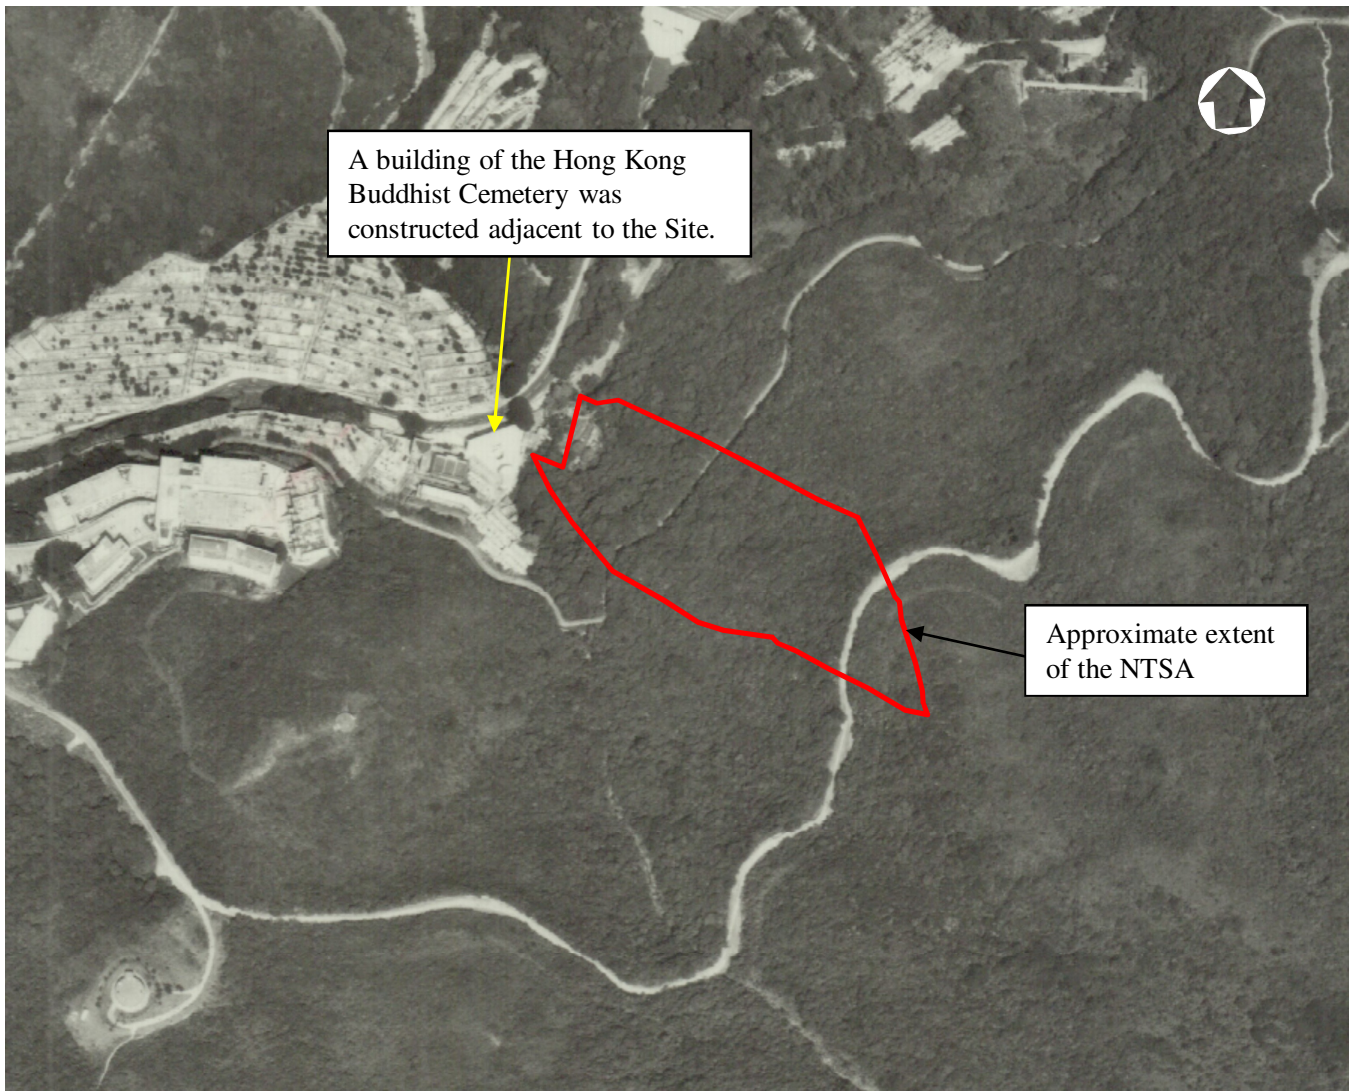
A building of the Hong Kong Buddhist Cemetery was constructed adjacent to the Site.
