Geotechnical Planning Review Report

Section 16 planning application for
proposed columbarium
at Lot NKIL 6071 (Portion) &
STT KX1603 (Portion),
Ching Cheung Road

June 2024

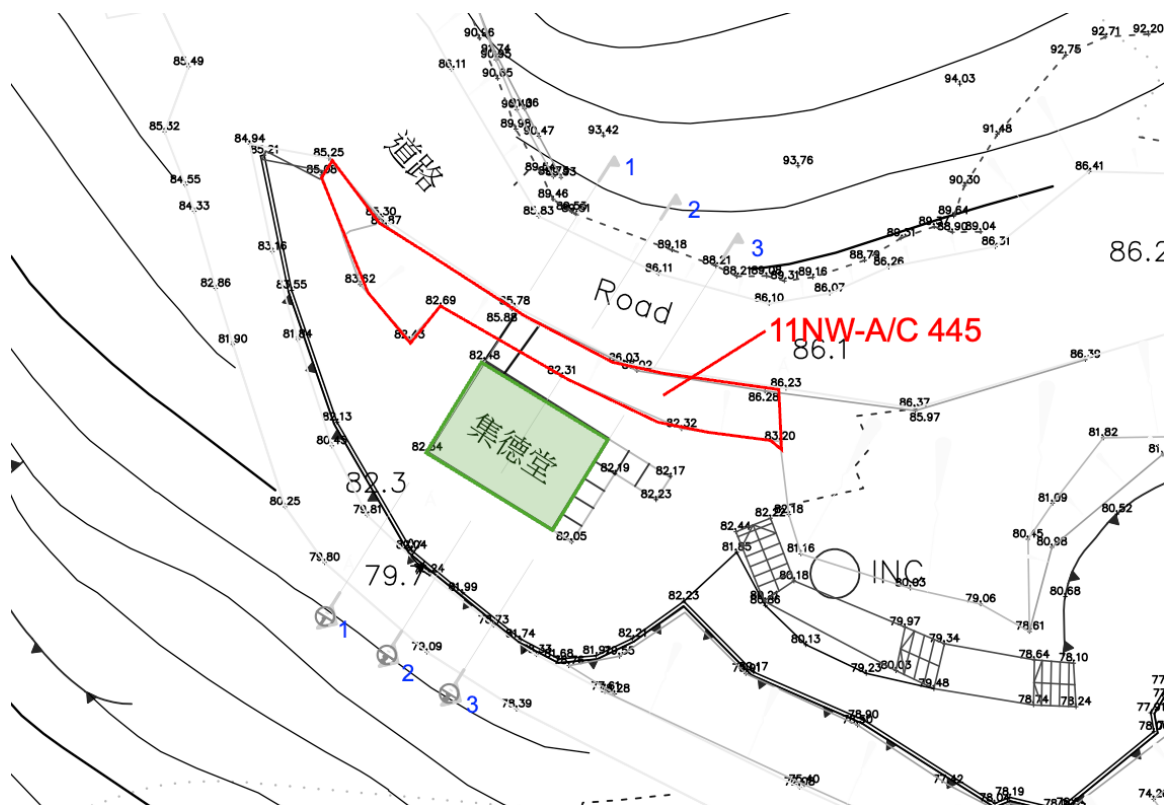
A registered geotechnical feature no. 11NW-A/C 445 is identified at the north of the building. It is a 4m high cut slope with average angle of 70 degree and length of 35m. The facility at crest is a Road/footpath with low traffic density. The information from slope information system, CEDD and Slope Maintenance Responsibility Information System, LandsD are attached in [Appendix B](#).

The stability of aforesaid feature will be assessed, soil nails will be installed if necessary as per the tentative scheme as shown in sections 1, 2 and 3 below:

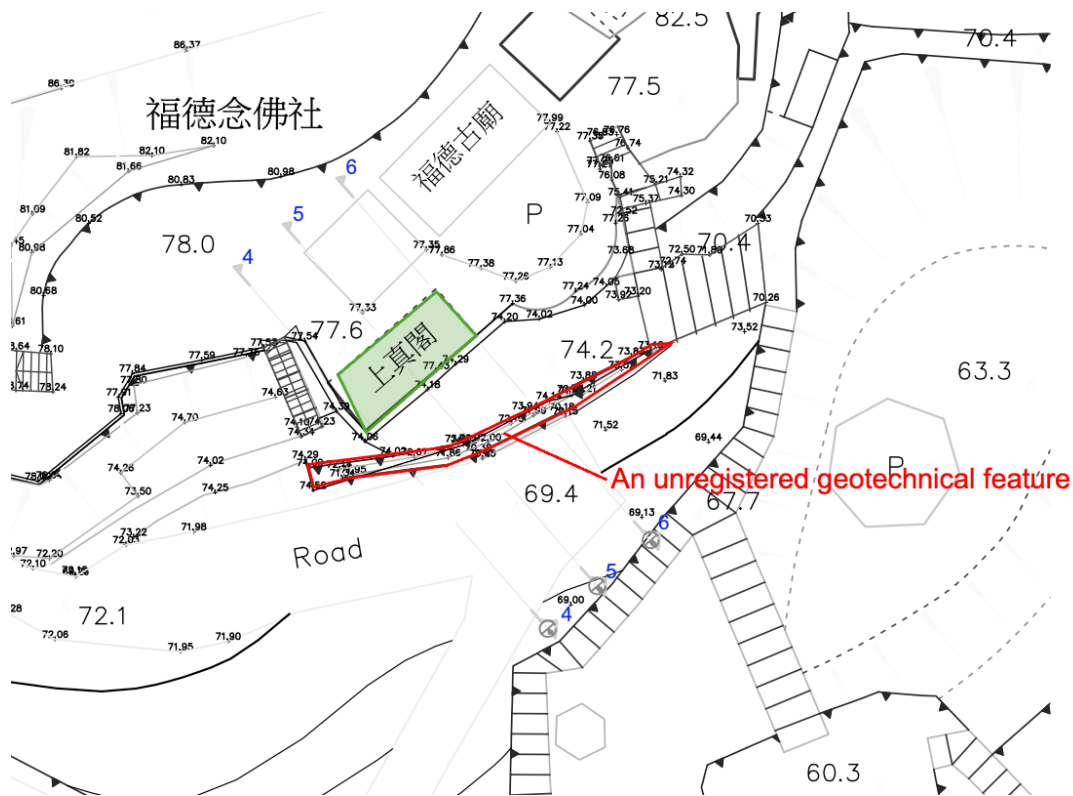
An non-registered geotechnical feature is identified at the south of the building. It is a 4m high cut slope with toe wall with average angle of 80 degree and length of 25m. The facility at toe is a Road/footpath with low traffic density.

The stability of aforesaid feature will be assessed, L-shaped wall with soil nails will be installed if necessary as per the tentative scheme as shown in sections 4, 5 and 6 below:

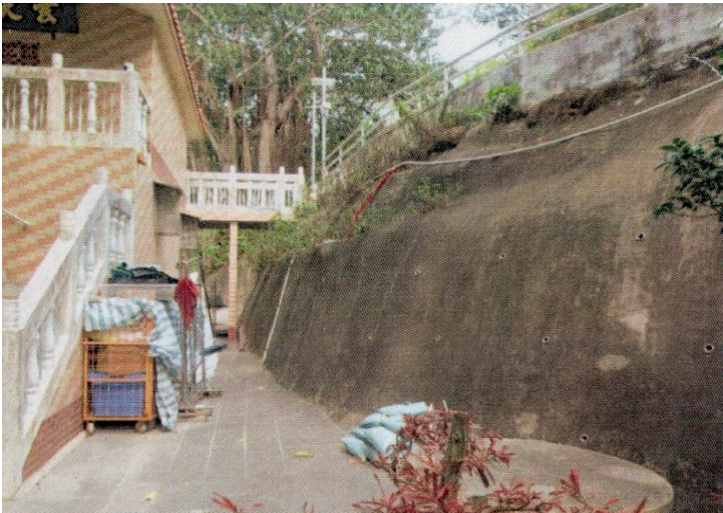
Visual inspection was carried out on 25th June 2024 for both registered and non-registered features. There was no sign of distress and water seepage during the site inspection. Having reviewed the current condition, no immediate danger for both registered and non-registered features was identified.

A photograph showing a geotechnical feature. On the left, there is a building with a tiled roof and a white balcony. A paved walkway runs alongside a slope. The slope is covered with a dark, textured mesh reinforcement. A person in a red shirt is visible near the building. In the foreground, there are some red plants and a blue cart.	<p>Photo No: 1 Date Taken: 25-Jun-2024</p> <p><u>Description:</u> A registered geotechnical feature no. 11NW-A/C 445 is identified at the north of Chap Tak Hall (集德堂)</p>

Detailed geotechnical assessment and necessary upgrading works will be carried out for both registered and non-registered features as mentioned above.

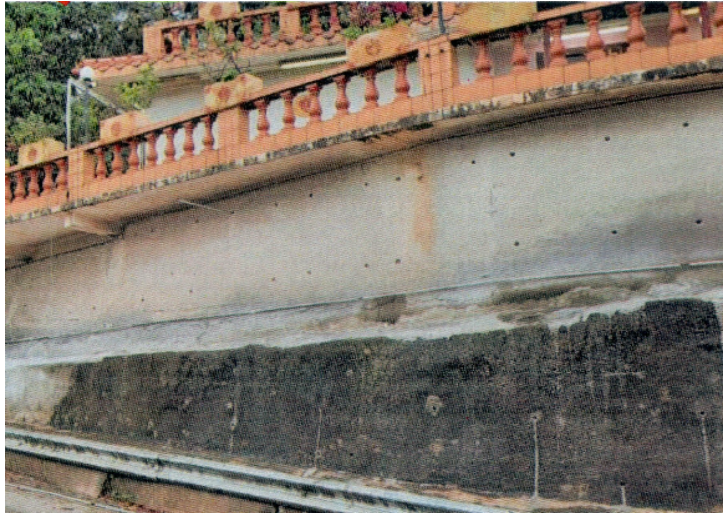
A photograph of a concrete retaining wall. The wall is light-colored and has a decorative railing on top with orange-brown balusters. The wall appears to be on a slope. The bottom part of the wall shows some dark, textured material, possibly soil or a different layer of the wall.	<p>Photo No: 2 Date Taken: 25-Jun-2024</p> <p><u>Description:</u> An non-registered geotechnical feature is identified at the south of Sheung Tsang Hall (上真閣)</p>

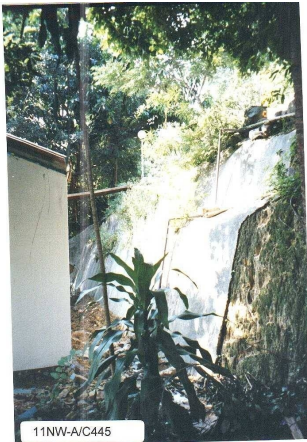
11NW-A/C445

View of the critical section, looking northwest.

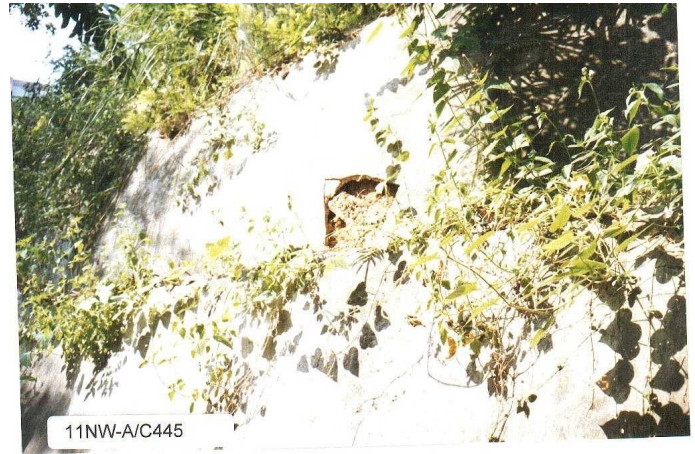
11NW-A/C445

Missing chunam above the beam.

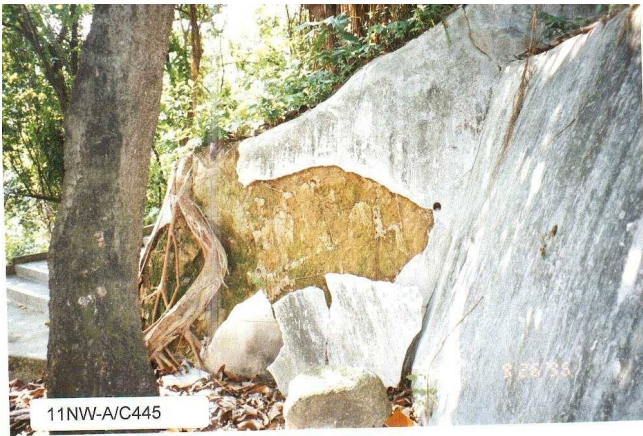
11NW-A/C445

Missing chunam near the western end of the feature.
