TREE GROUP INSPECTION REPORT FOR

LOT NOS. 515RP & 524S.B IN D.D. 90

Ms. Lee Hiu Wa

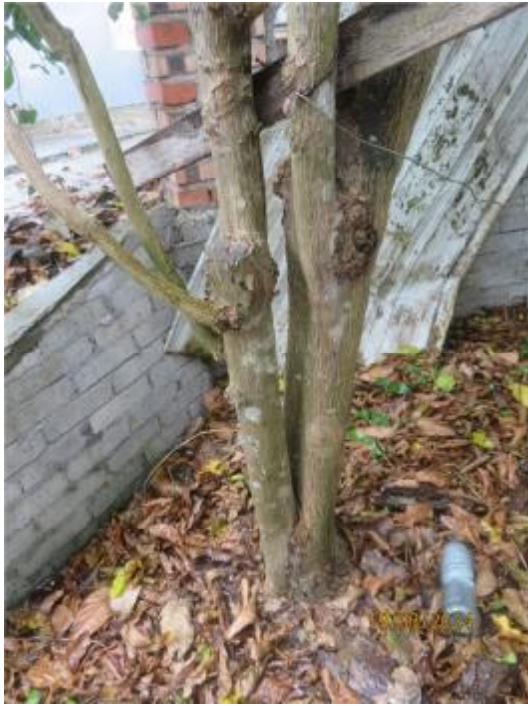
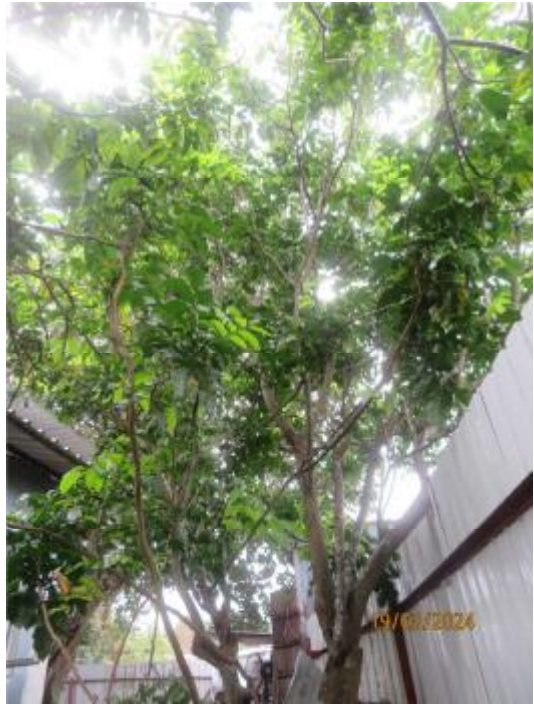
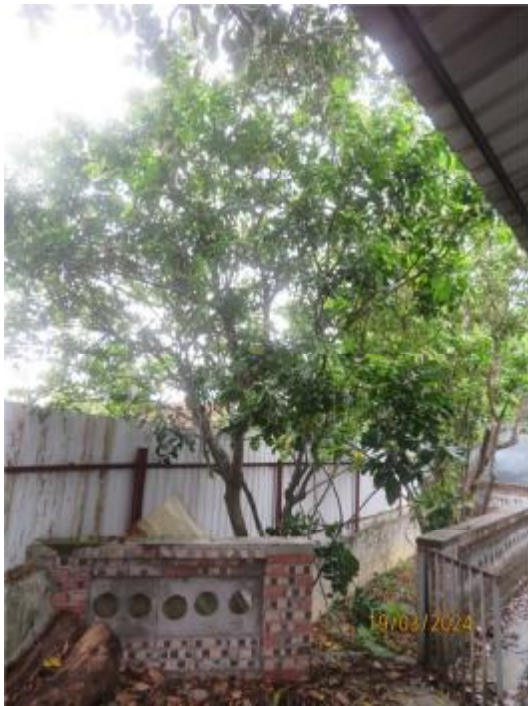
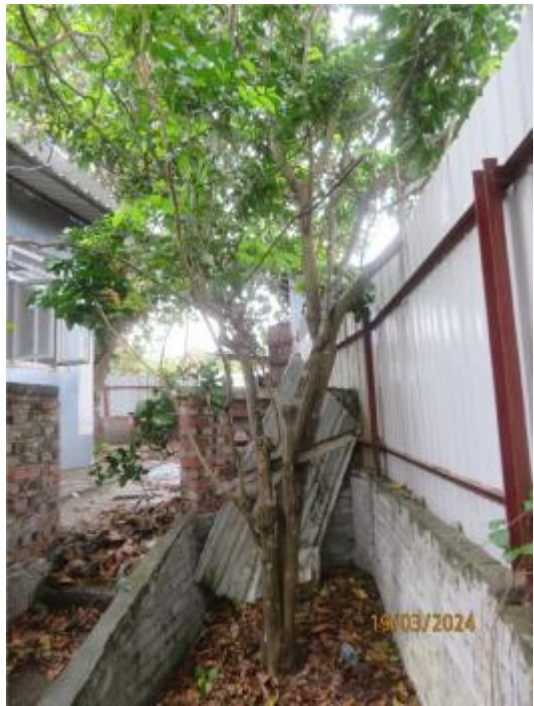
Tree No.	Tree Species		Tree Size Measurement			Amenity Value (High / Medium /Low)	Form (Good/ Fair/ Poor)	Health Condition (Good / Fair / Poor /Dead)	Structural Condition (Good/ Fair/ Poor)	Suitability for Transplanting	Origin	Recommendation	Remarks
	Scientific Name	Chinese Name	DBH(mm)	Overall Height (m)	Crown Spread (m)					(High/ Medium/ Low)		(Retain/ Transplant/ Fell)	
T1	<i>Dimocarpus longan</i>	龍眼	314	10	7	Low	Fair	Fair	Fair	Low	Exotic	Fell	multi-trunks
T2	<i>Litchi chinensis</i>	荔枝	294	11	8	Low	Fair	Fair	Fair	Low	Exotic	Fell	codominant trunks, included bark, wound (trunk)
T3	<i>Clausena lansium</i>	黄皮	294	10	4	Low	Fair	Fair	Fair	Low	Exotic	Fell	codominant trunks, included bark, near the electric wire
T4	<i>Artocarpus heterophyllus</i>	菠蘿蜜	430	12	8	Low	Fair	Fair	Fair	Low	Exotic	Fell	codominant trunks, wound (trunk), dead branches
T5	<i>Clausena lansium</i>	黄皮	145	7	3	Low	Fair	Fair	Fair	Low	Exotic	Retain	multi-trunks, included bark

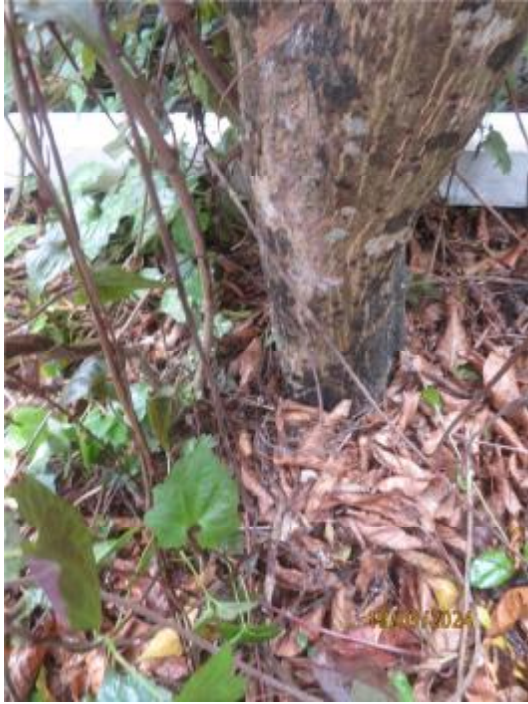
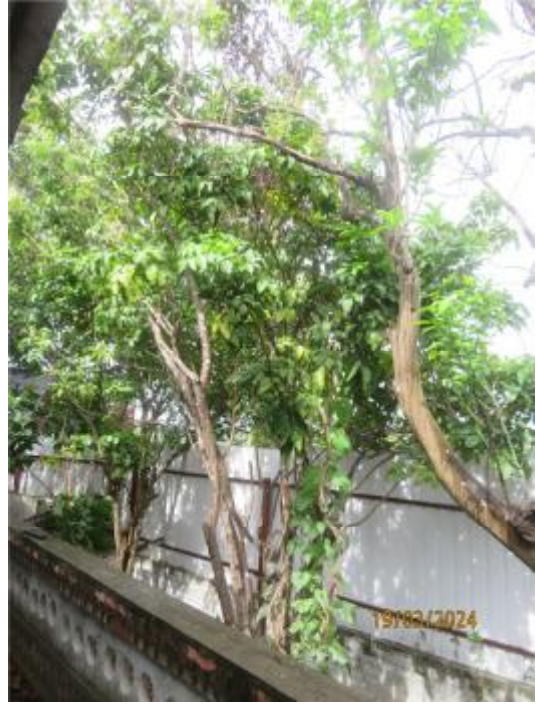
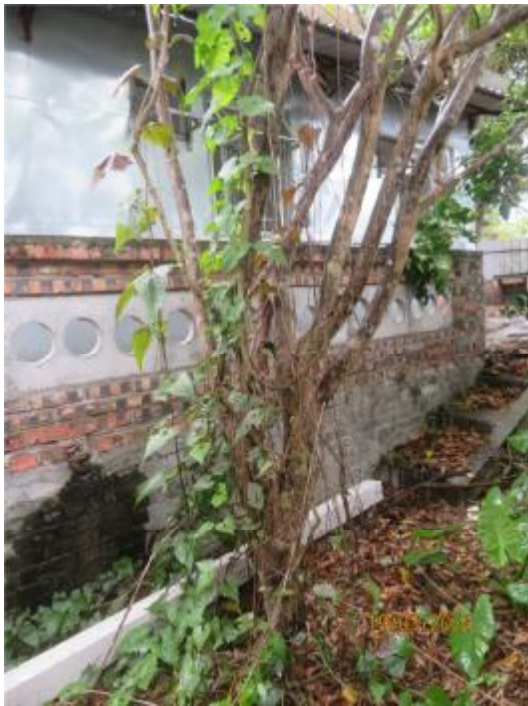
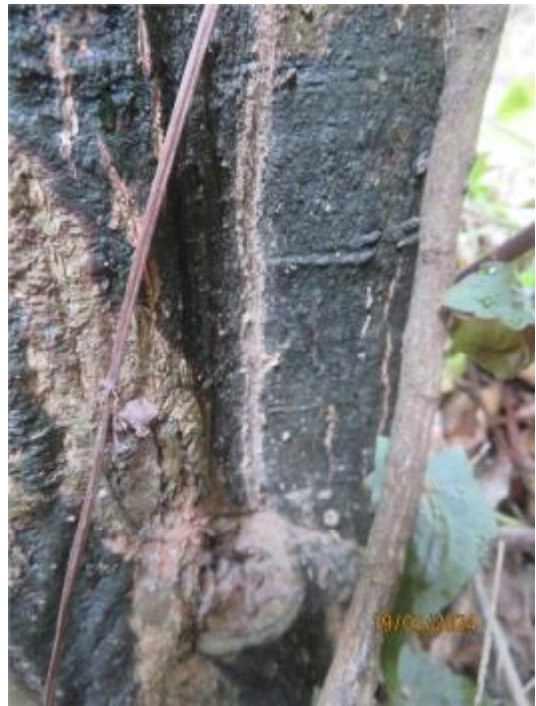
T6	<i>Clausena lansium</i>	黄皮	173	5	3	Low	Fair	Fair	Fair	Low	Exotic	Retain	multi-trunks ,vine, termites
T7	<i>Citrus maxima</i>	柚	380	5	3	Low	Fair	Fair	Fair	Low	Exotic	Retain	multi-trunks, vine, included bark, sparse, dead branches
T8	<i>Clausena lansium</i>	黄皮	230	6	4	Low	Fair	Fair	Fair	Low	Exotic	Retain	vine
T9	<i>Dimocarpus longan</i>	龍眼	363	10	6	Low	Fair	Fair	Fair	Low	Exotic	Fell	multi-trunks, root restriction
T10	<i>Psidium guaiava</i>	番石榴	166	5	4	Low	Fair	Fair	Fair	Low	Exotic	Fell	multi-trunks, vine
T11	<i>Psidium guaiava</i>	番石榴	161	5	4	Low	Poor	Fair	Poor	Low	Exotic	Fell	multi-trunks, vine
