TREE GROUP INSPECTION REPORT FOR

LOT NO. 478 S.A. RP, 479, 487, 484 & 482 IN

D.D. 90

Proposed Temporary Warehouse for Storage of Food Provisions for a Period of 3 Years and Filling of Land at Lot 478 S.A RP, 482 (Part), 484 & 487 (Part) in D.D. 90, Lin Ma Hang Road, Ta Kwu Ling, NT

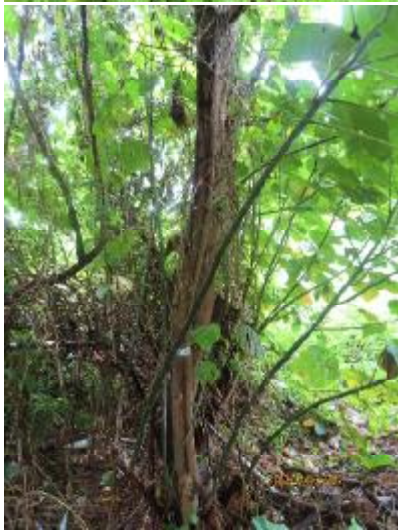
T15	<i>Macaranga tanarius</i> var. <i>tomentosa</i>	血桐	280	6	9	Low	Poor	Fair	Poor	Low	Native	wound (trunk), lean, exposed root
T16	<i>Macaranga tanarius</i> var. <i>tomentosa</i>	血桐	140 + 120 + 90	7	7	Low	Poor	Fair	Poor	Low	Native	wound (trunk), multi-trunks, vine
T17	<i>Ficus hispida</i>	對葉榕	90 + 80+ 170 + 80	3	5	Low	Poor	Poor	Poor	Low	Native	wound (trunk), much dead branches, multi-trunks
T18	<i>Ficus hispida</i>	對葉榕	260+ 220 + 370 + 140 + 200	5	5	Low	Poor	Poor	Poor	Low	Native	wound (trunk), exposed dead wood
T19	<i>Ficus hispida</i>	對葉榕	100 + 80+ 110 + 130	5	4	Low	Fair	Fair	Fair	Low	Native	wound (trunk), multi-trunks
T20	<i>Ficus hispida</i>	對葉榕	370	5	6	Low	Fair	Fair	Fair	Low	Native	wound (trunk), multi-trunks
T21	<i>Ficus hispida</i>	對葉榕	120 + 130	5	5	Low	Fair	Fair	Fair	Low	Native	included bark , multi-trunks, vine
T22	<i>Macaranga tanarius</i> var. <i>tomentosa</i>	血桐	15	4	4	Low	Fair	Fair	Fair	Low	Native	vine

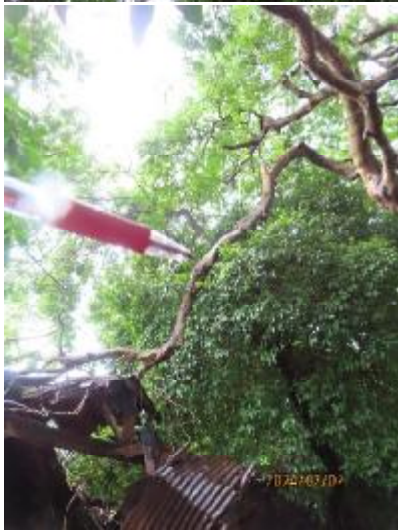
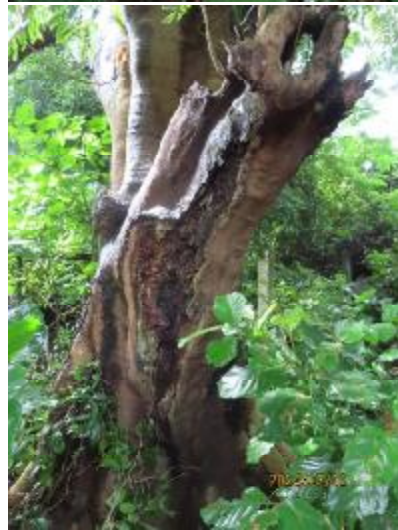
T44	<i>Dimocarpus longan</i>	龍眼	290	8	6	Low	Fair	Fair	Fair	Low	Exotic	
T45	<i>Delonix regia</i>	鳳凰木	900	11	14	Low	Poor	Fair	Poor	Low	Exotic	large wound (trunk), decay, vine,
T46	<i>Dimocarpus longan</i>	龍眼	100	6	4	Low	Fair	Fair	Fair	Low	Exotic	vine

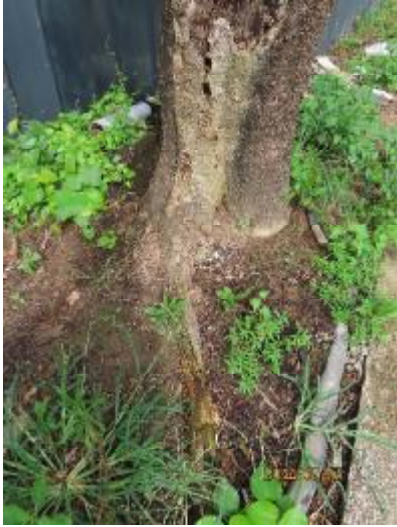
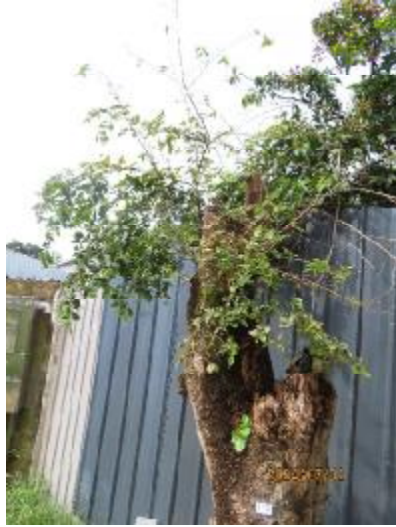
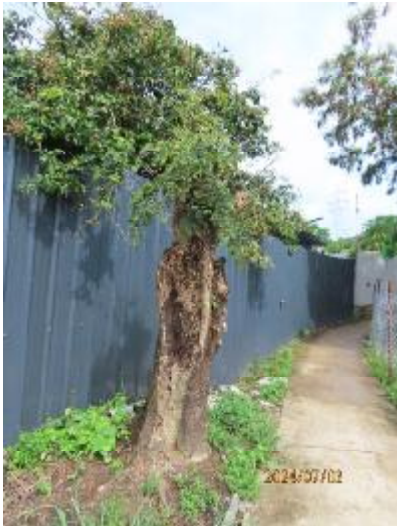
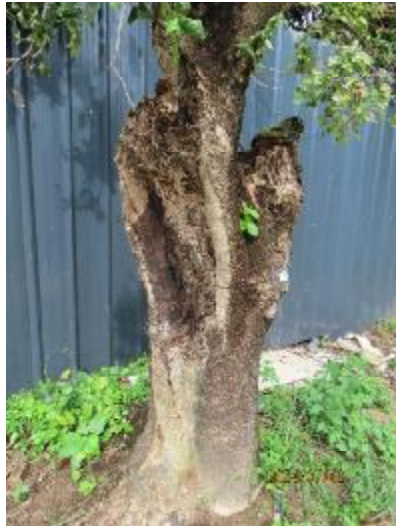
Tree No.	Tree Species		Tree Size Measurement			Amenity Value (High / Medium /Low)	Form (Good/ Fair/ Poor)	Health Condition (Good / Fair / Poor /Dead)	Structural Condition (Good/ Fair/ Poor)	Suitability for Transplanting (High/ Medium/ Low)	Origin	Remarks
	Scientific Name	Chinese Name	DBH(mm)	Overall Height (m)	Crown Spread (m)							
T47	<i>Aporosa dioica</i>	銀柴	500	8	8	Low	Fair	Fair	Fair	Low	Native	vine
T48	<i>Sterculia lanceolata</i>	假蘋婆	240 + 200 + 310	8	8	Low	Fair	Fair	Fair	Low	Native	
T49	<i>Dimocarpus longan</i>	龍眼	170 + 230 + 240	8	7	Low	Fair	Fair	Fair	Low	Exotic	dead branches
T50	<i>Celtis sinensis</i>	朴樹	500	2	1	Low	Poor	Poor	Poor	Low	Native	epicormics.,decay, exposed dead wood
