Drainage proposal

Reference: A/NE-YTT/2
Our Ref: SMT/Drainage/01
Date: 4 May 2022

**Proposed Ancillary Vehicle Park for a Period of 3 years
Lot 70(part) in DD 27 and Adjoining Government Land
Yim Tin Tsai, Tai Po, NT
Drainage Proposal**

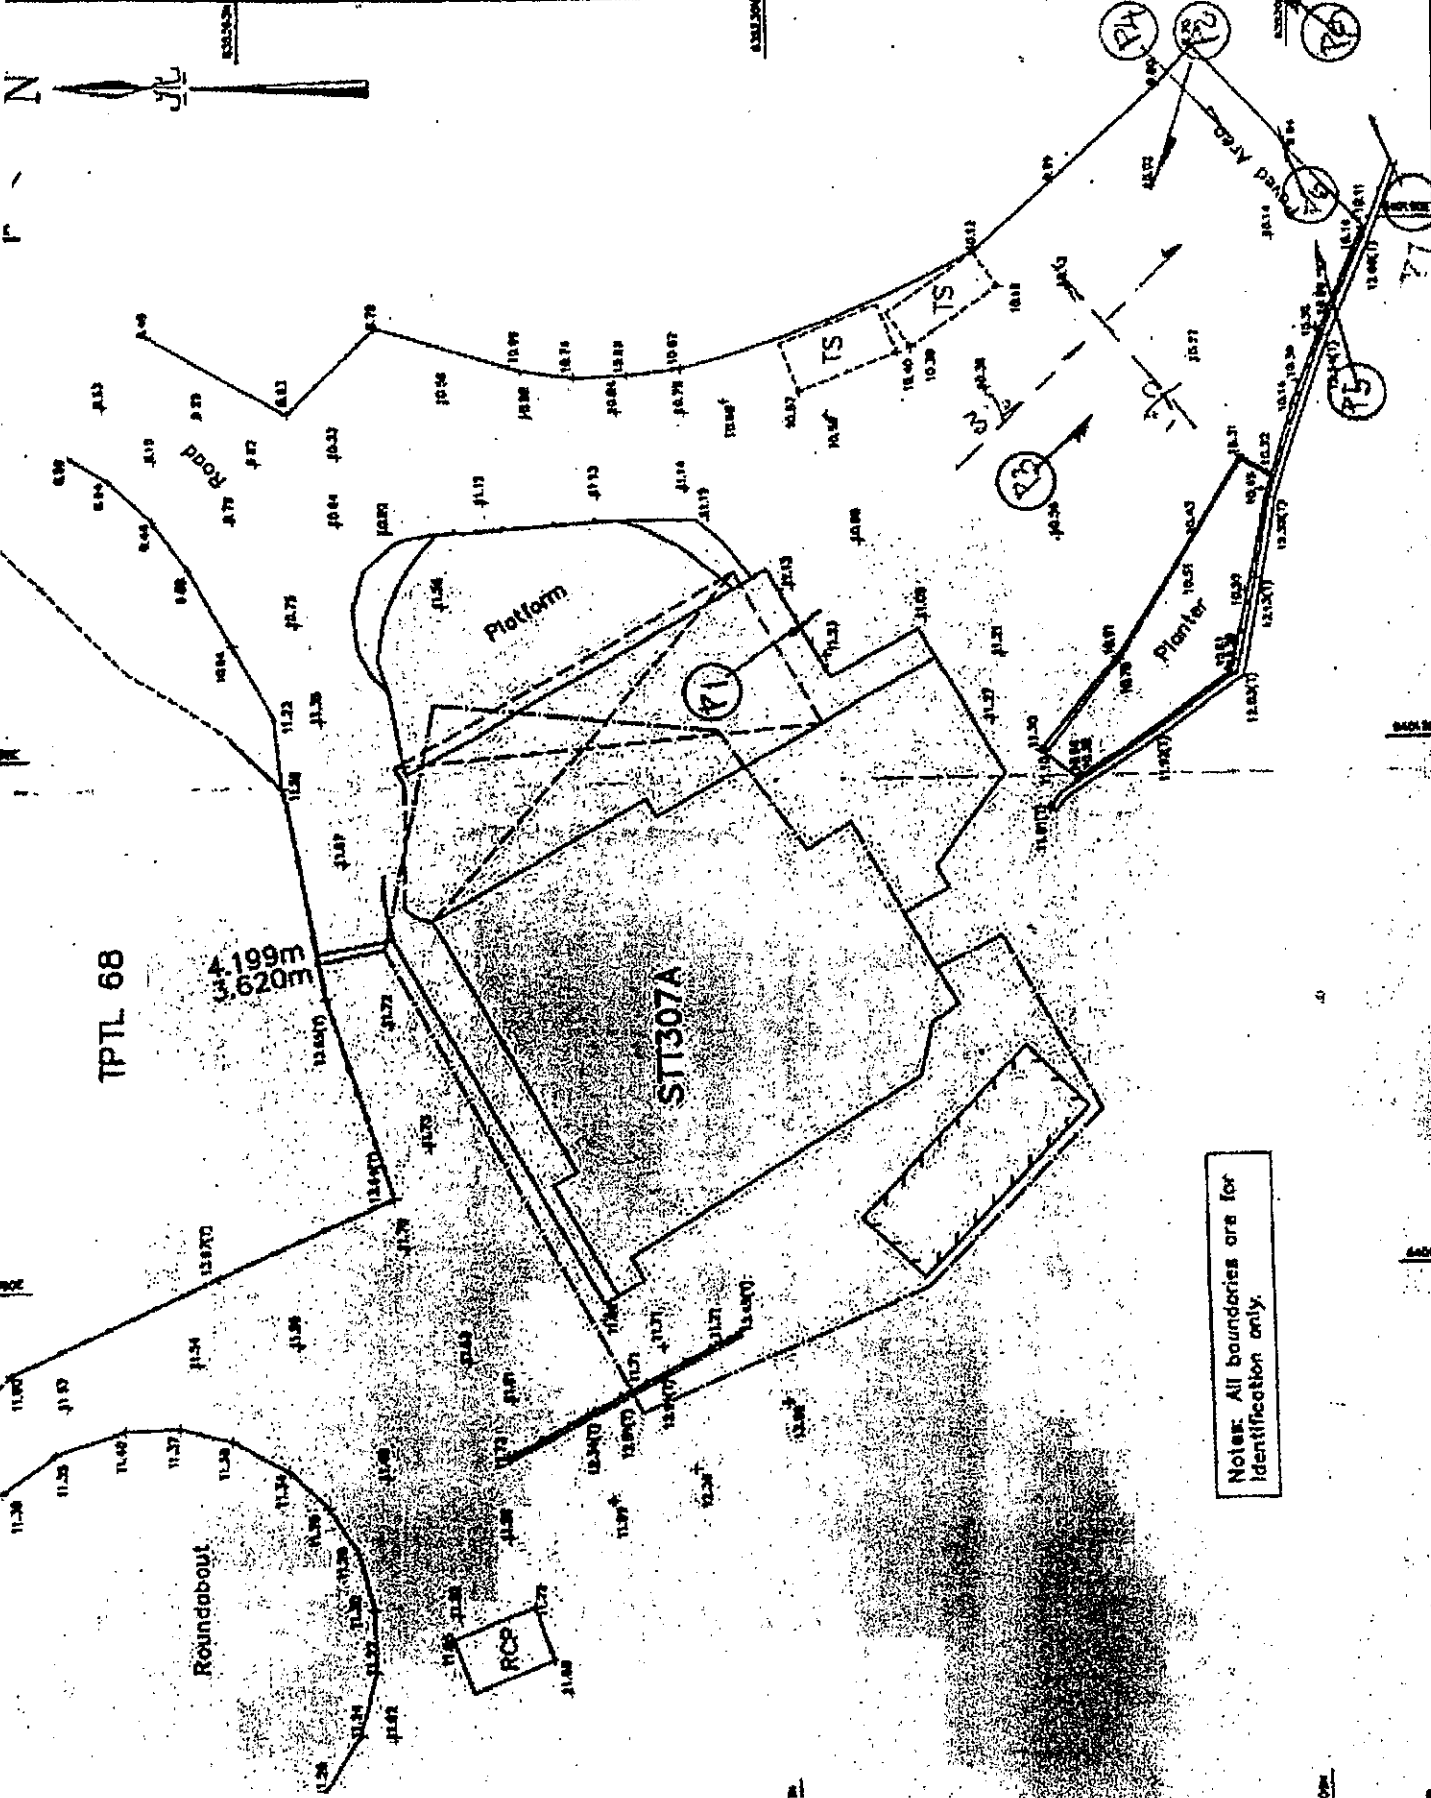
From the site survey and site inspections, vehicle park area is paved, the gradient of the car park in the south-east direction is about 3% and that along the other direction toward the gentle nature slope is about 1%. The surface water would be evenly drained toward the end of the car park along a 15 meters strip of relatively level ground. The paved area would effectively act as a 15 to 20 meters wide flat channel. With the 3% gradient, no ponding of surface water would occur, and the surface runoff shall cease shortly after rain stops. The drainage condition was observed during a rainy day as indicated in the photos. It appears that mother nature is exercising her natural ability to take care of the surface water.
