**CLP Outline Agreement No. 460009419**

## **Tree Treatment Report at Hing Keng Shek near House No. 58A, Sai Kung**

**Prepared by Melofield Nursery & Landscape Contractor Ltd.**

Client:	CLP
Prepared by:	HO Sik Yan  (Registered Arborist TM429739, under The Registration Scheme for Tree Management Personnel, Development Bureau)
Date of Survey:	2 October 2024

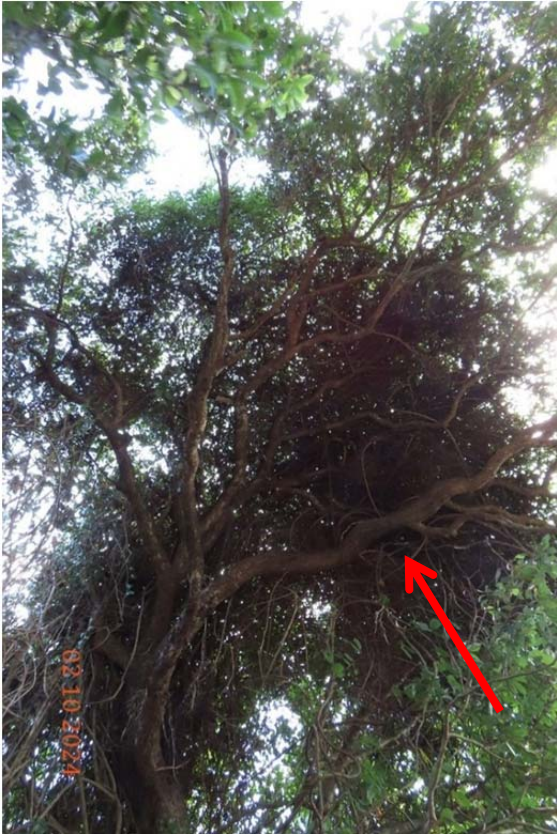
T1 Crown with dense vine coverage

<b>Tree No. (Tree Species)</b>	<b>Observations</b>	<b>Preventative Crown Pruning Recommended</b>
T1 ( <i>Machilus chekiangensis</i> )	<ul style="list-style-type: none"> <li>- Imbalanced crown;</li> <li>- Climbers on crown;</li> <li>- A dead branch and a dead stub will be close to and protrude over the future overhead line.</li> </ul>	<ul style="list-style-type: none"> <li>- Crown cleaning as for better tree growth and also to eliminate the conflict between the trees and the future overhead line. Removing the dead branch and the dead stub, and also climbers.</li> </ul>
T5 ( <i>Ficus hispida</i> )	<ul style="list-style-type: none"> <li>- Slope tree with an imbalanced crown;</li> <li>- Some branches will be close to the future overhead line.</li> </ul>	<ul style="list-style-type: none"> <li>- Crown reduction as for better tree growth and also to eliminate the conflict between the trees and the future overhead line. Shortening over-extended, drooping branches.</li> </ul>

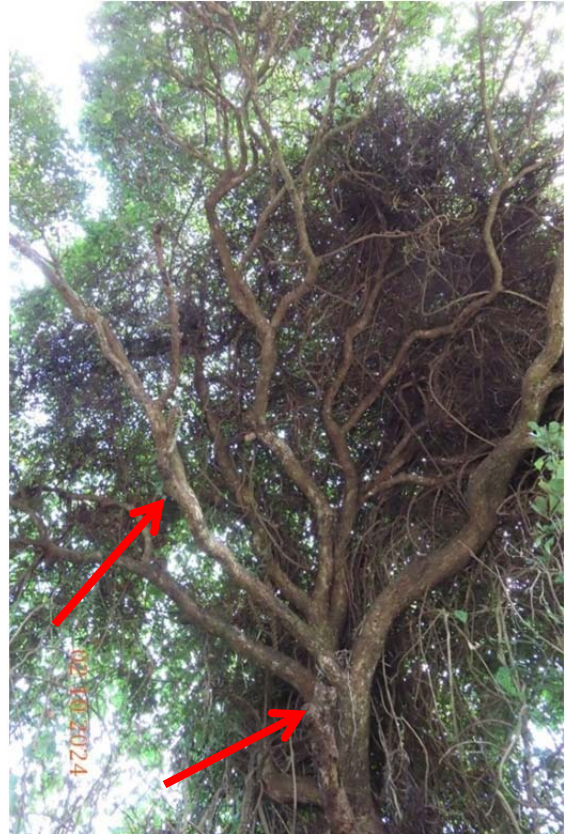
T1 A dead branch and a dead stub will be close to and protrude over the future overhead line

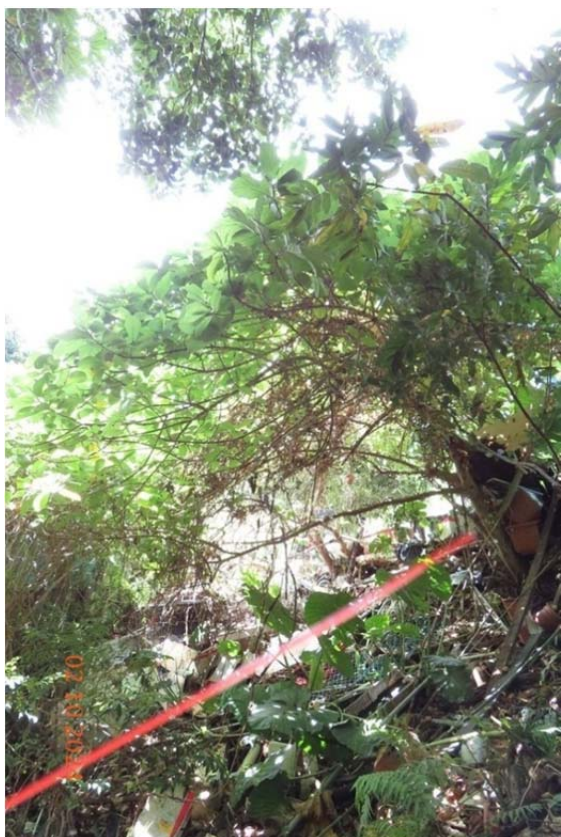
T5 Imbalanced crown. It is recommended to shorten over-extended, drooping branches.

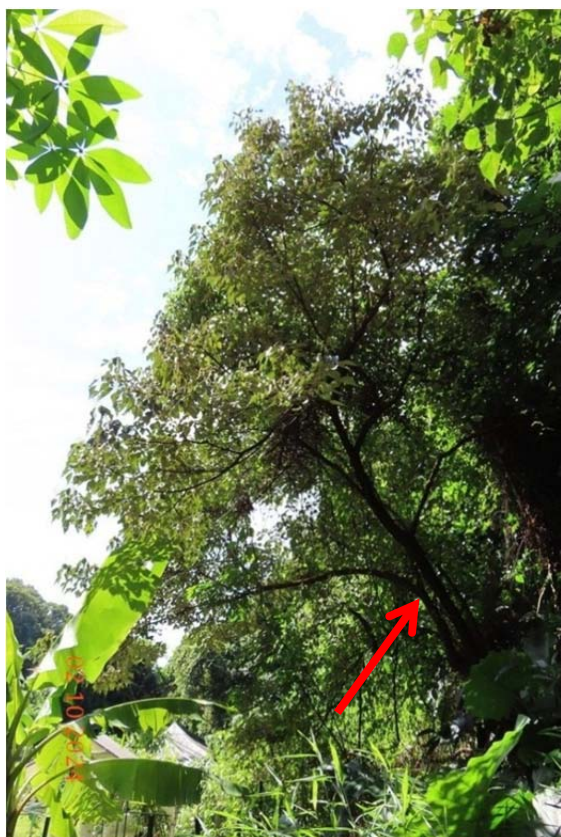
T8	<i>Mallotus paniculatus</i>	白楸	6.5	190	5	L	P	A	A	L	-	N	Retain & Prune	-	AFCD	AFCD	Slightly leaning; slightly imbalanced crown; on sloping ground.  Imbalanced crown with over-extended, drooping branches will be close to the future overhead line. Crown reduction is recommended to shorten over-extended, drooping branches.

T8 Slightly imbalanced crown. It is recommended to shorten some over-extended, drooping branches.
