**Geotechnical Planning Review Report for Proposed House
(New Territories Exempted House) Development**

**Lot No. 361 in D.D. 32,
Ha Wong Yi Au, Tai Po,
New Territories**

JDF Engineering Consultants Limited

March 2024

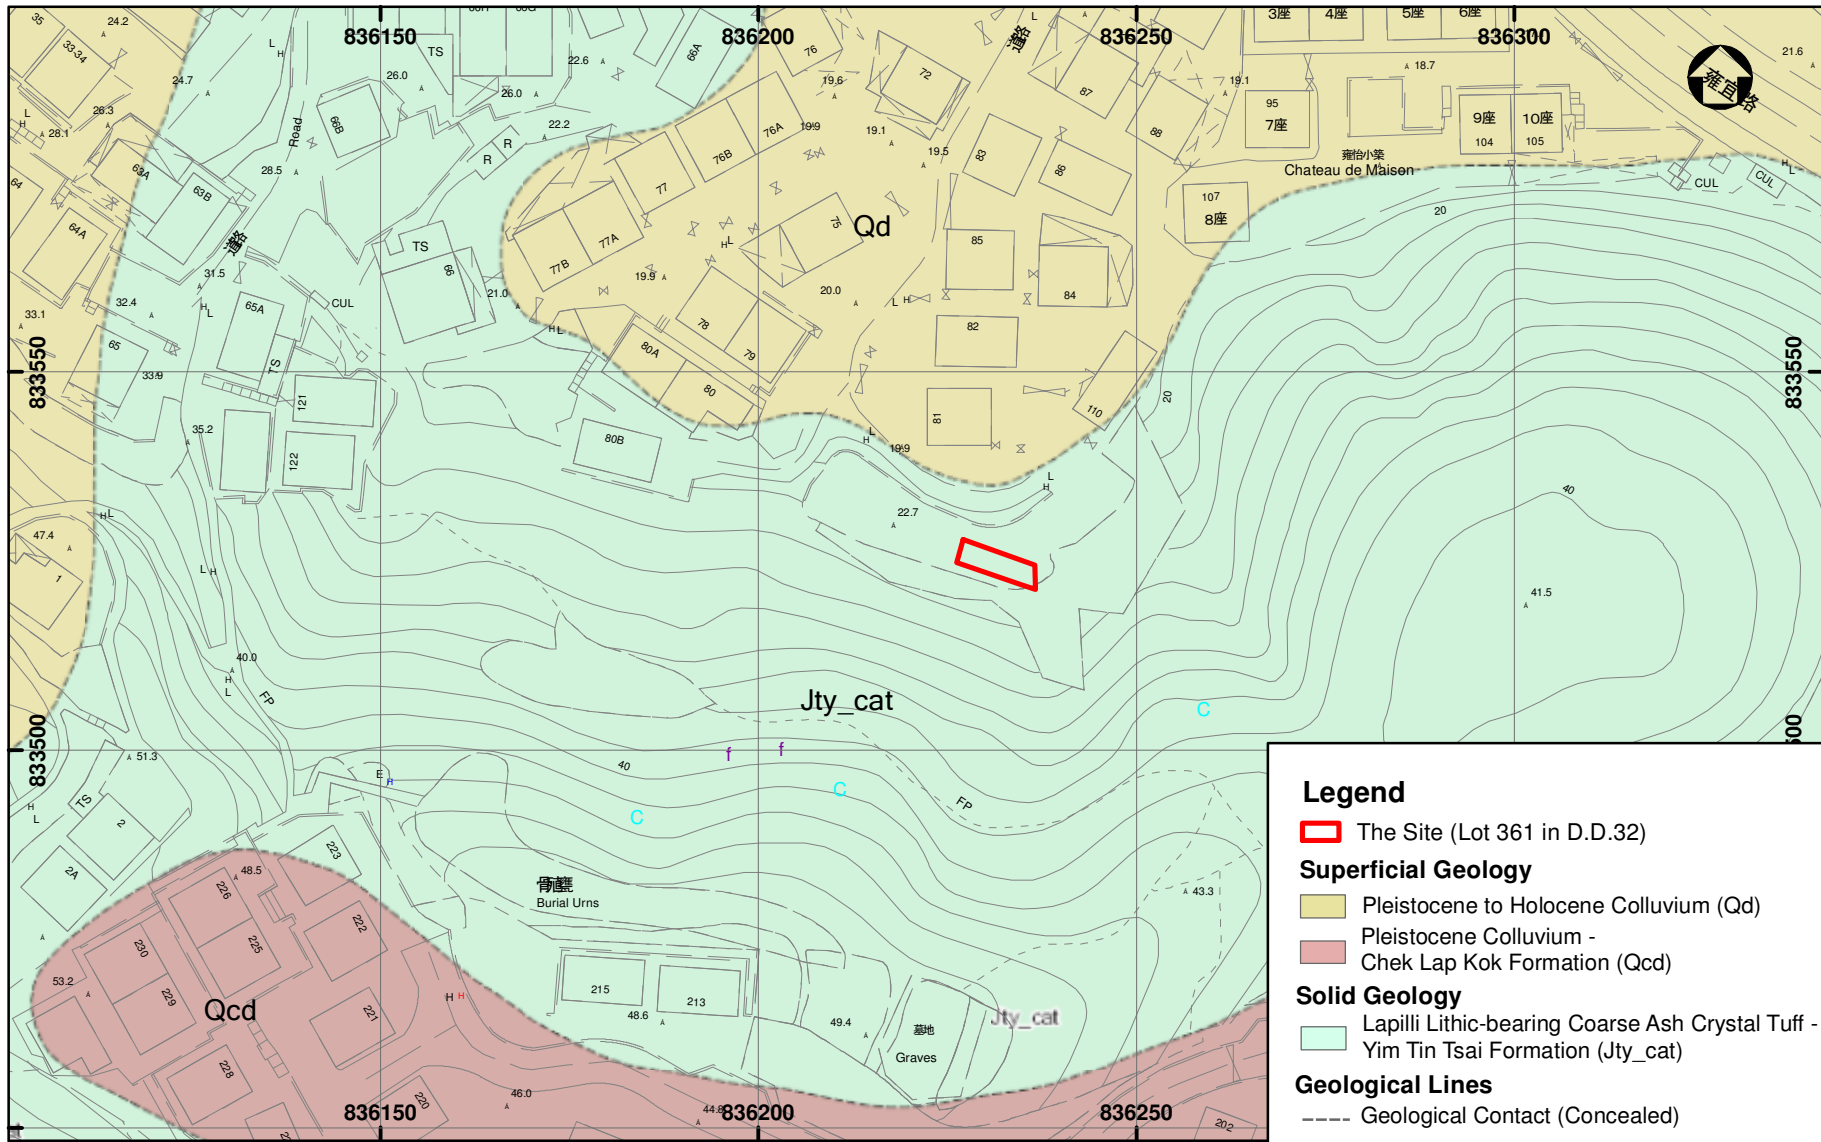
FIGURE NO :
FIGURE 2

The 1:20,000 scale geological map sheet 7 (HKGS, 2010, Second Edition) indicated that the Site is likely to be underlain by Lapilli Lithic-bearing Coarse Ash Crystal Tuff (Jty_cat) of the Yim Tin Tsai Formation under the Tsuen Wan Volcanic Group in Middle Jurassic.

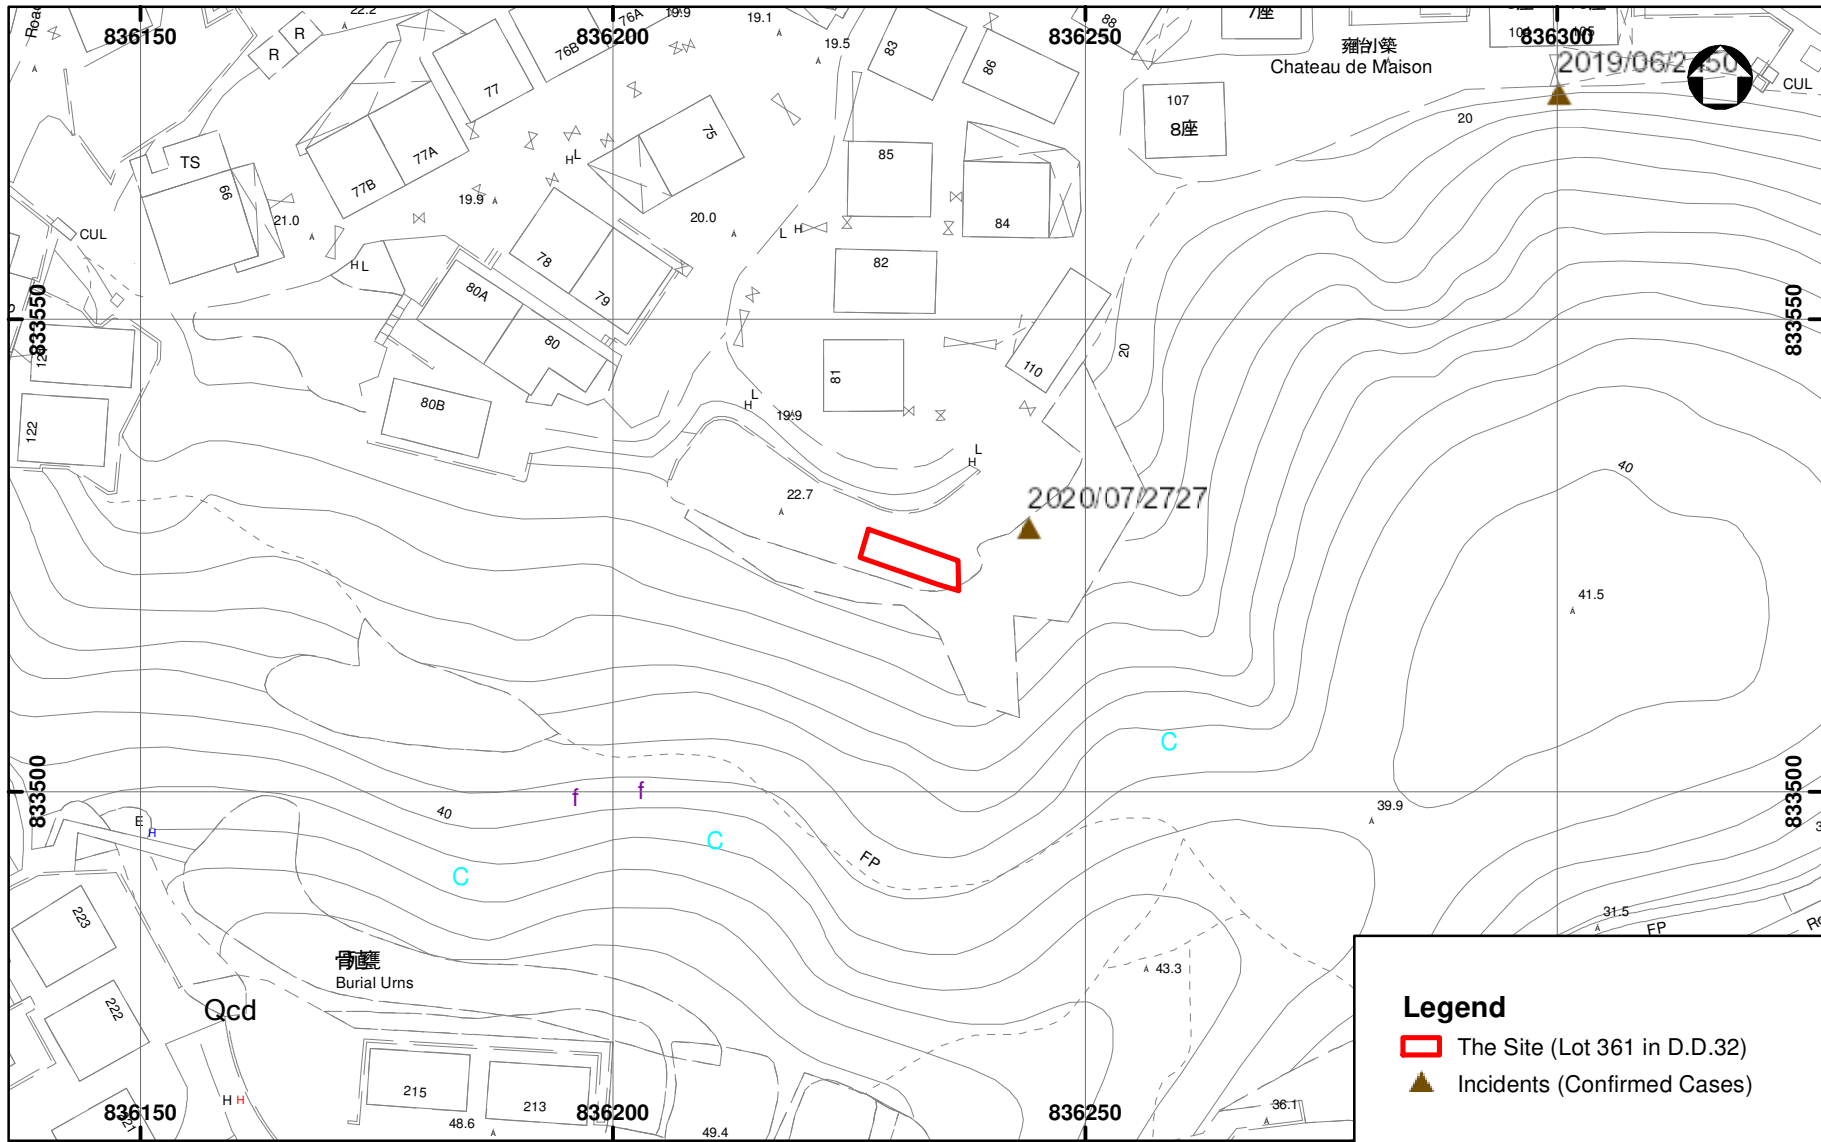
FIGURE NO :
FIGURE 3

The GEO landslide incidents database has indicated one incident record located at about 20m to the east of the Site (**Figure 3**). The incident was recorded as 2020/07/2727 and it involved a small slope failure (4m^3) within a disturbed terrain adjoining to an access road in July 2020. Detailed information of the feature extracted from SIS is presented in **Appendix A**.

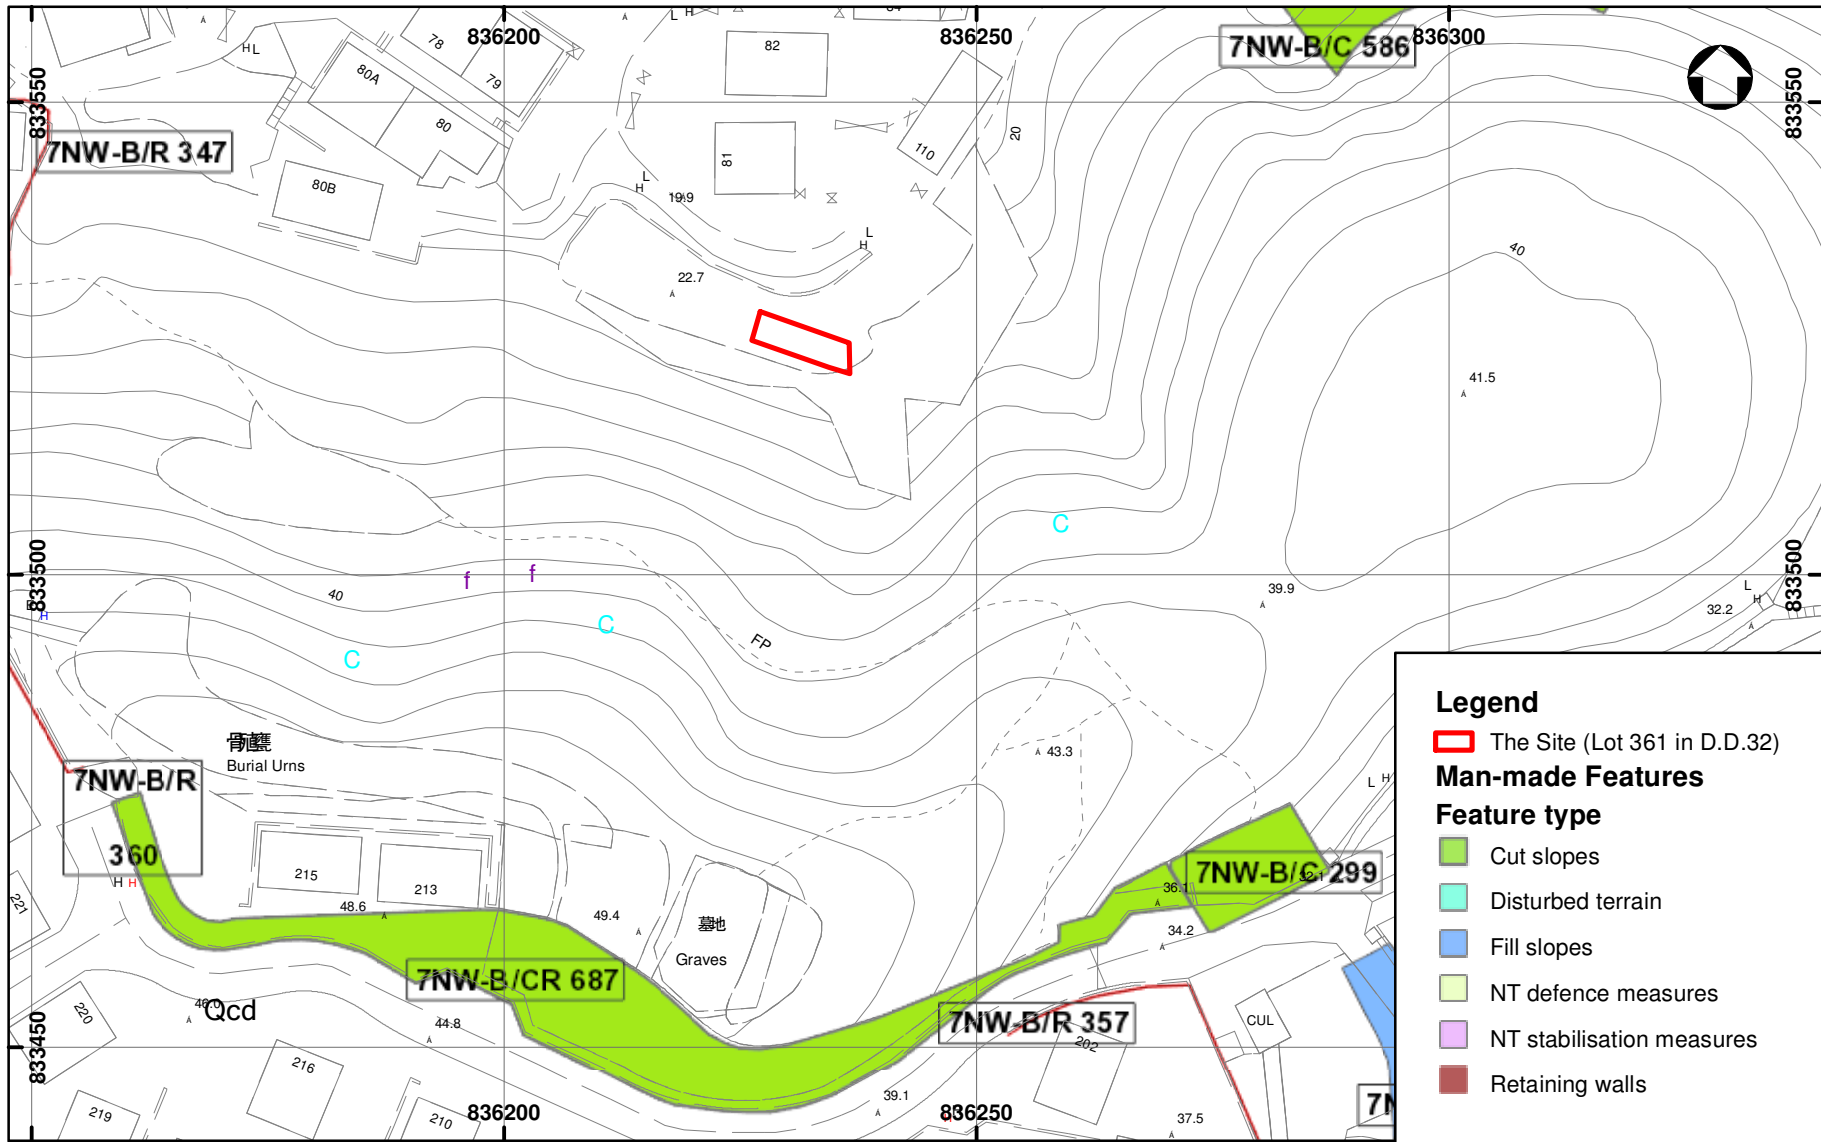
FIGURE NO :
FIGURE 4

No man-made feature has been registered within or in the vicinity of the Site, **Figure 4**.

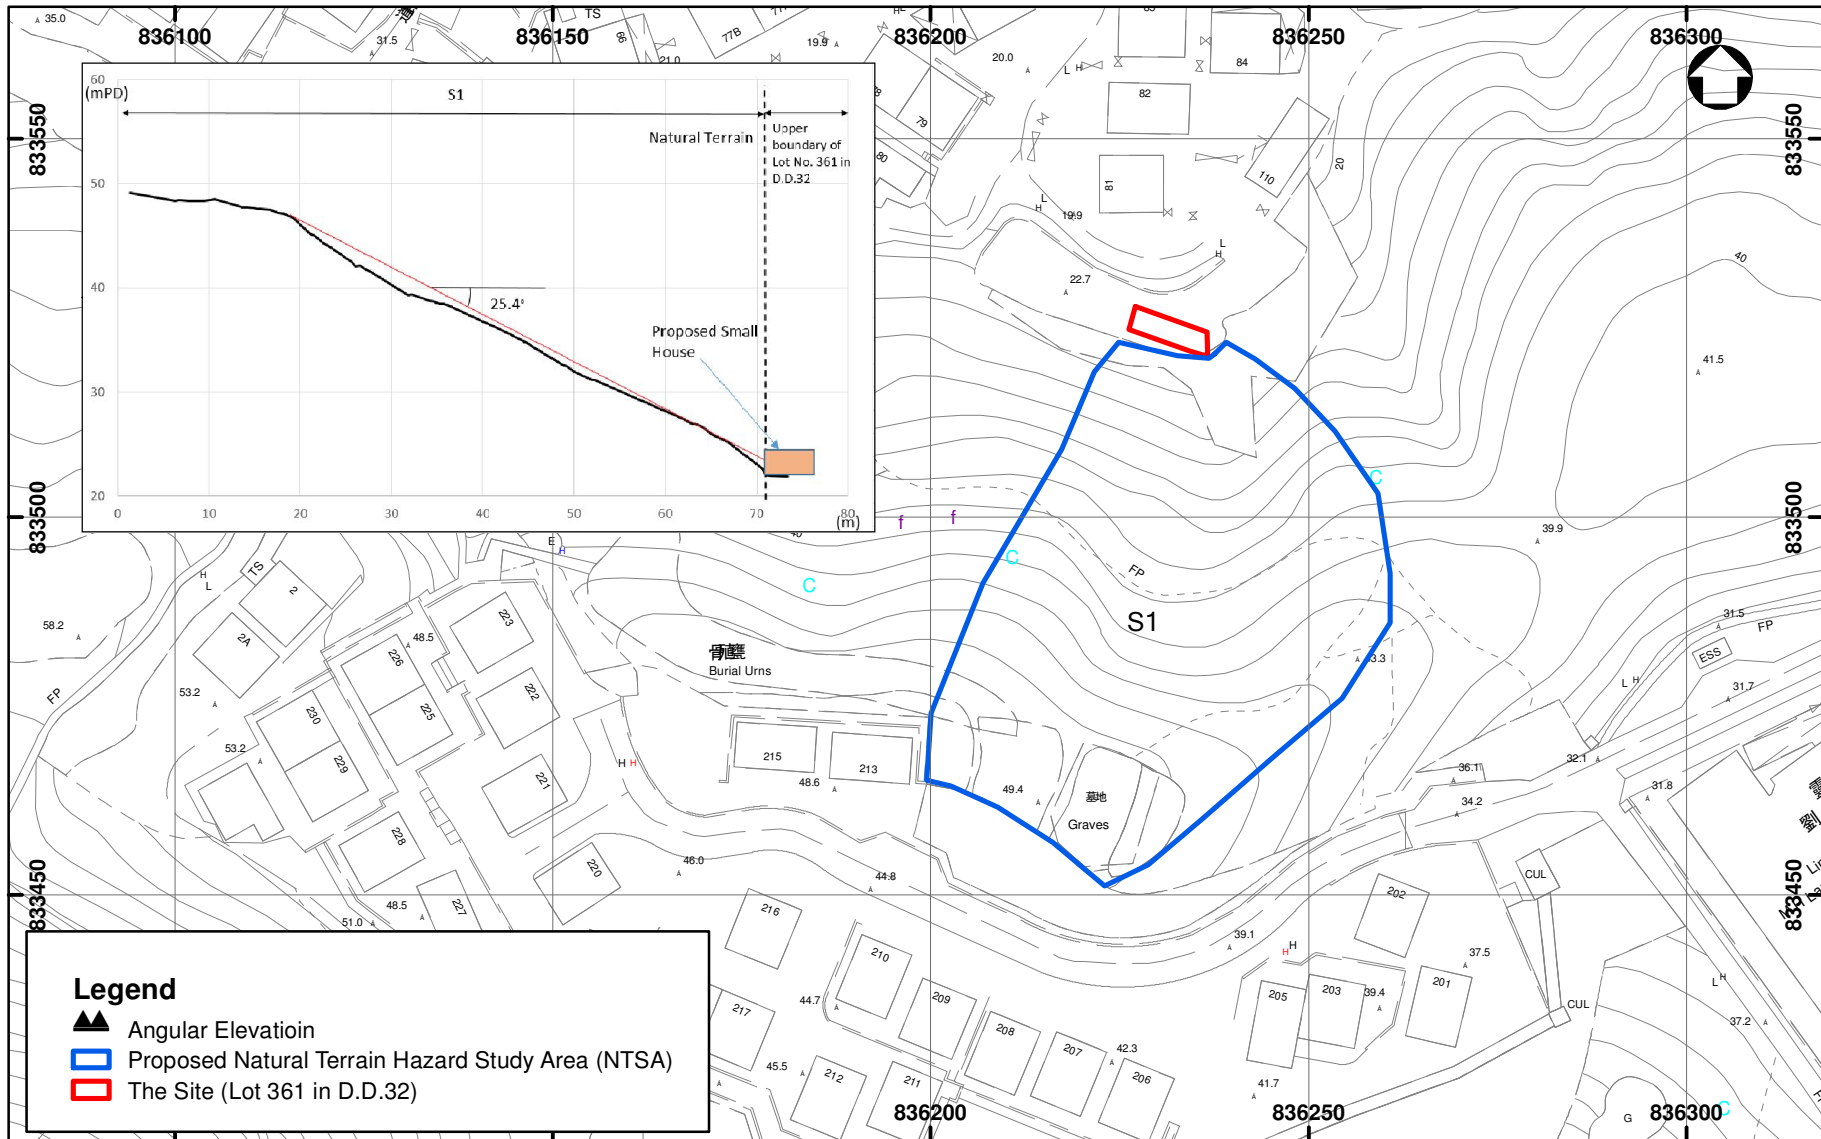
FIGURE 5

Based on the results of the review, the angular elevation from the natural terrain to the Site is 28.4°. According to GEO report No.138, the proposed development satisfied the “Alert Criteria” and therefore a further study of the natural terrain hazards posing to the proposed development is required. The proposed extent of the natural terrain hazards study is delineated in **Figure 5**. A proper natural terrain hazard mitigation measure shall be implemented, if found necessary, as part of the proposed development. Therefore, a natural terrain hazard study will be carried out in the next stage of the project.

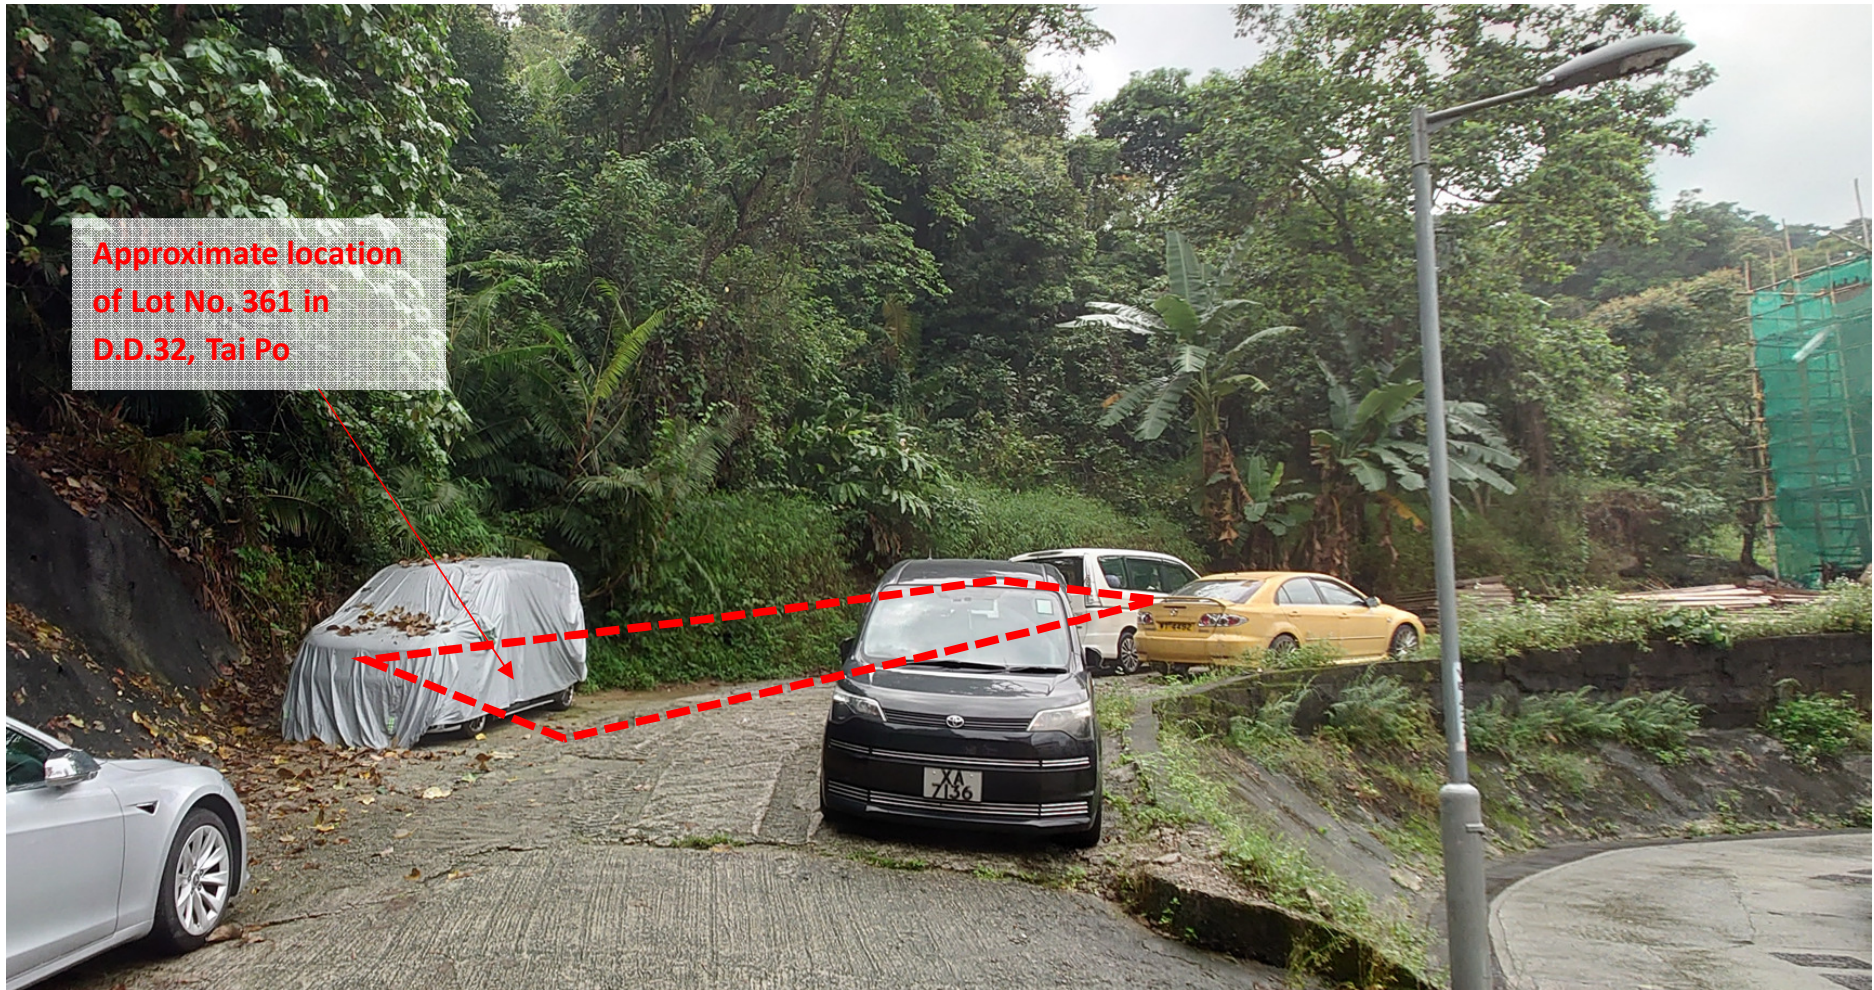
Plate 1 General View of the Site

The Site, where the proposed NTEH is to be constructed, is located on a platform at Ha Wong Yi Au, Tai Po (**Plate 1 and Plate 2**). The Site is covered by concrete surface and is retained by a small non-registered retaining wall with maximum high of about 0.7m and a small cut slope of about 1.0m high at its north-eastern side. The approximate location of the lot boundary is shown in **Figure 1**. A natural terrain overgrown with dense vegetation is overlooking the Site at the south-western direction (**Plate 3**). Further details on the discussion of these features are given in Section 4 and 5 below.

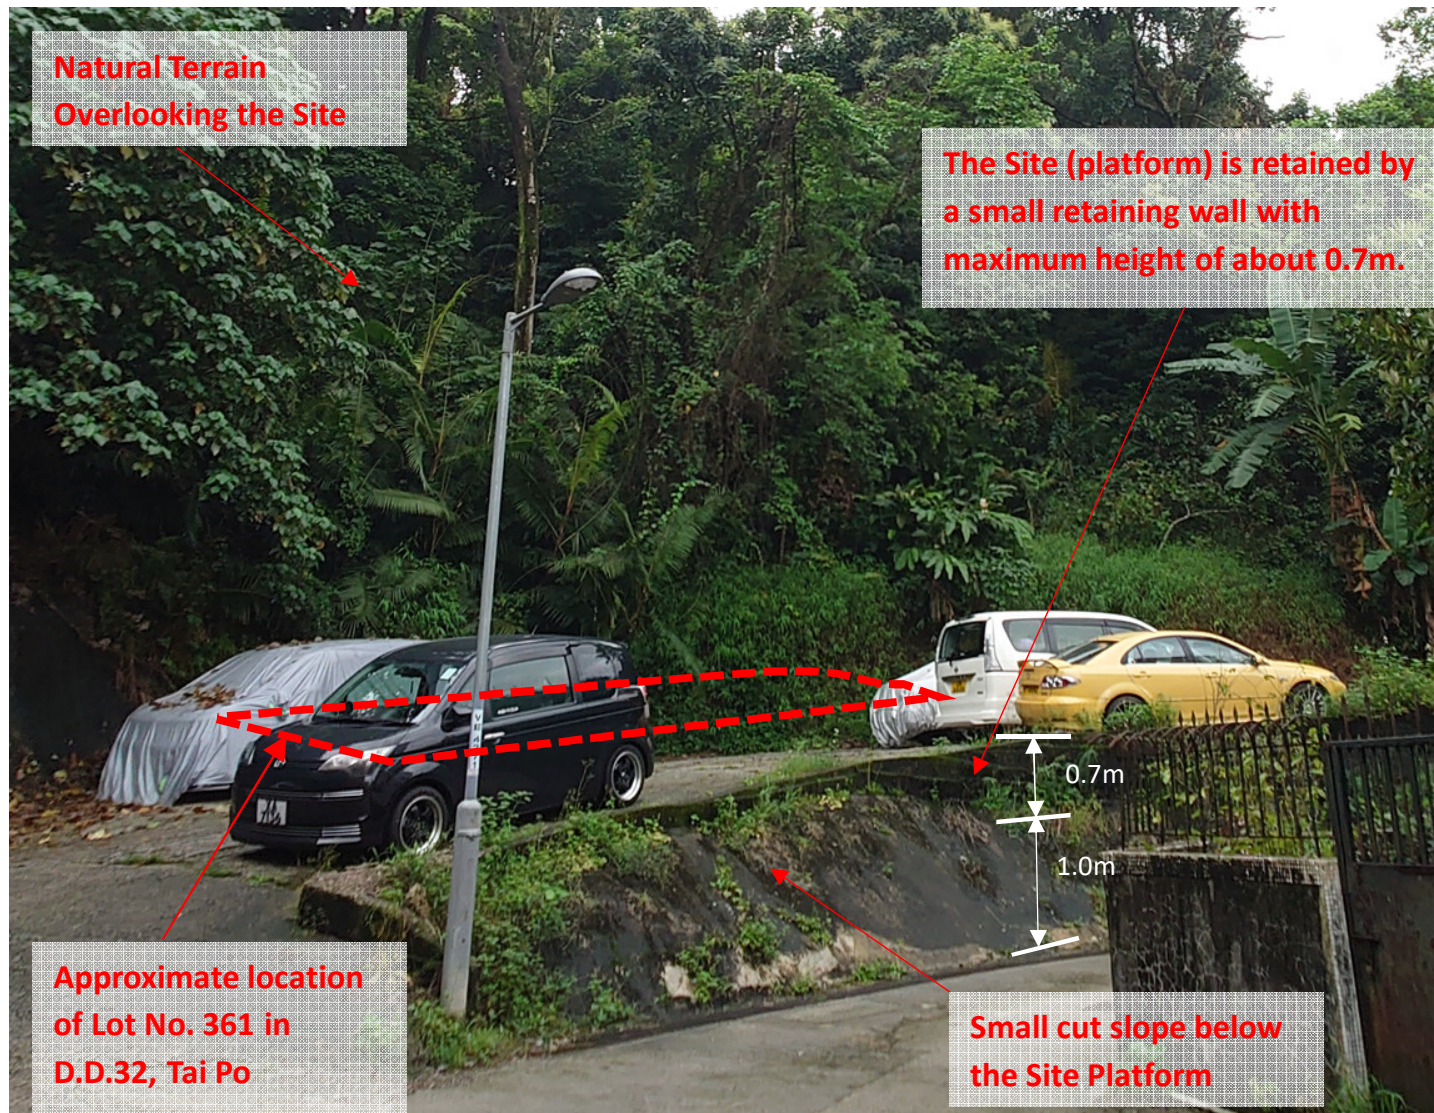
Plate 2 General View of the Site, the non-registered retaining wall and the cut slope

Although there is no man-made feature has been registered within or in the vicinity of the Site, the Site platform was retained by a retaining wall at its north-eastern side with a maximum height of about 0.7m (**Plate 2**). There is also a small cut slope (about 1.0m high) with chunam surface below the retaining wall. No major sign of distress can be identified at the retaining wall and the cut slope during the inspection. However, the stability of these retaining wall and cut slope have to be checked with respect to the proposed development based on the subsurface conditions and shear strength parameters of soil/rock obtained from a site specific ground investigation. If found necessary, appropriate improvement/upgrading works, including slope re-profiling, installation of soil nails, and thickening of the retaining wall shall be carried out so as to meet the current geotechnical standard.

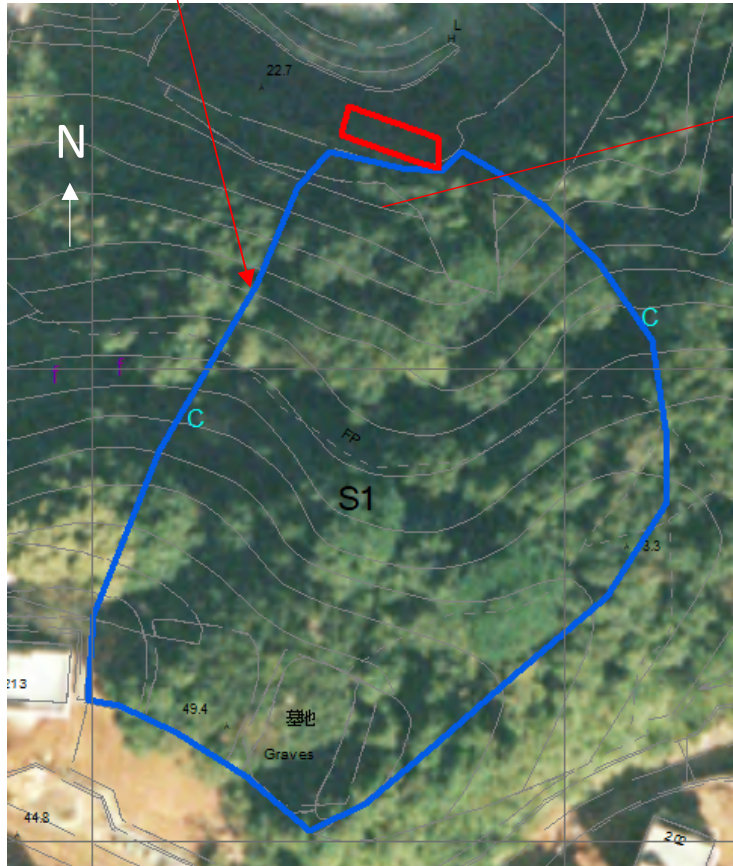
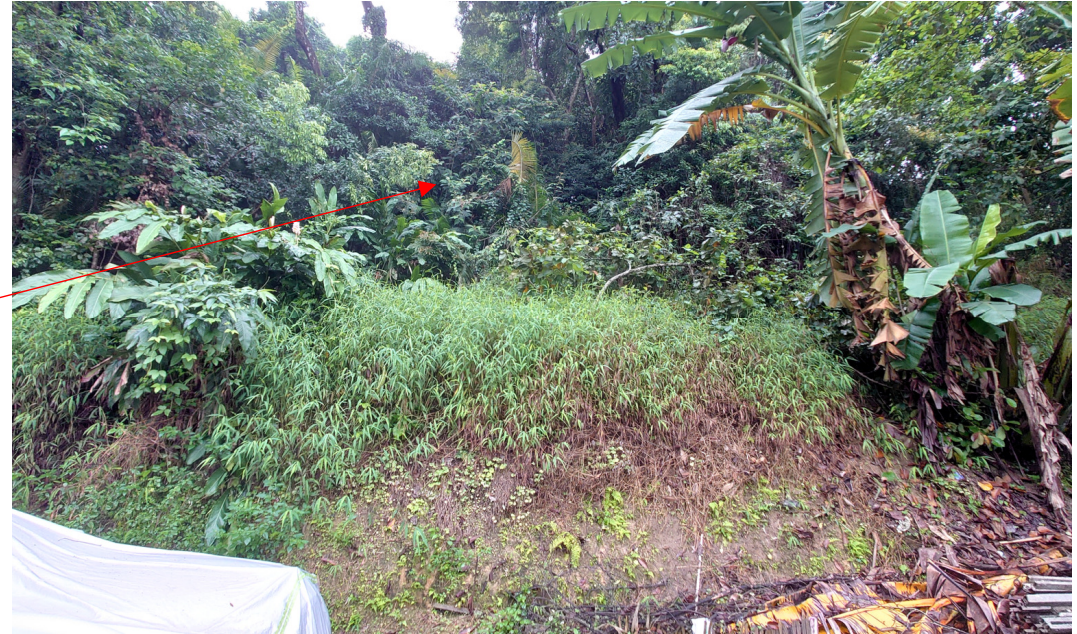
Plate 3 Natural Terrain Overlooking the Site

It is noted that the Site may be affected by natural hazard aroused from a natural terrain above the Site from the elevation of about +49mPD to +22mPD. An initial screening exercise has been carried out to assess whether the proposed development falls within the “In-principle Objection Criteria” or the “Alert Criteria” with respect to the concerned natural terrain according to the guideline given in GEO Report No. 138 Second Edition. The potential hillside catchment that may affect the proposed development has been delineated based on the 1:1000 topographic map and is presented in **Figure 5**. The measured angular elevation from the top of the natural terrain to the nearest boundary of Lot no. 361 is about 25.4° and therefore satisfied the “Alert Criteria” and therefore further study of the natural terrain hazards arouse from the natural terrain to the Site is required. If found necessary, natural terrain hazard mitigation measure shall be implemented.

General view of the Natural Terrain above the Site
