Tree Survey Report

Date of Survey: 15th October 2024

Lot 385 Rp (Part) In D.D. 128 And Adjoining Government Land, Ha Tsuen, Yuen Long, New Territories

Registered Arborist

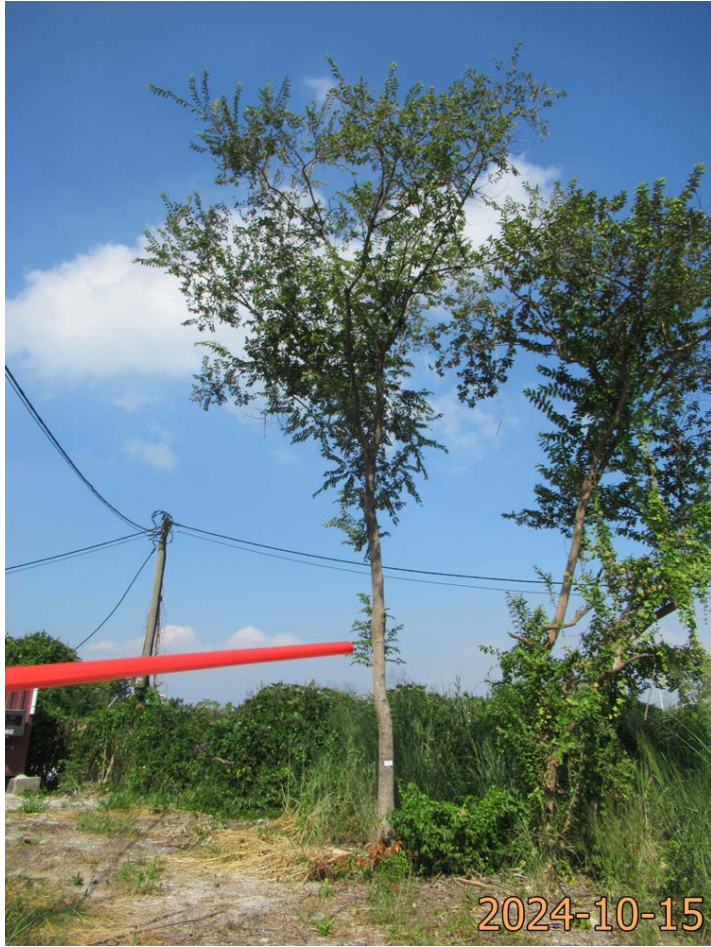
T9 (Overview)

Tree No.	Tree Species		Tree Size Measurements			Amenity Value	Form	Health Condition	Structural Condition	Suitability for Transplanting	Remarks
	Botanical Name	Chinese Name	Overall Height (m)	DBH (mm)	Average Crown Spread (m)	High /Med /Low	Good /Fair /Poor	Good /Fair /Poor /Dead	Good /Fair /Poor	High /Med /Low	
T1	<i>Acacia auriculiformis</i>	耳果相思(耳葉相思)	8.5	130	3.0	Low	Fair	Fair	Fair	Low	
T2	<i>Celtis sinensis</i>	朴樹	8.0	95	2.0	Low	Fair	Fair	Fair	Low	
T3	<i>Celtis sinensis</i>	朴樹	8.0	100	3.0	Low	Fair	Fair	Fair	Low	
T4	<i>Celtis sinensis</i>	朴樹	8.0	110	5.0	Low	Fair	Fair	Fair	Low	
T5	<i>Dimocarpus longan</i>	龍眼	7.0	160	8.0	Med	Fair	Fair	Fair	Low	
T6	<i>Dimocarpus longan</i>	龍眼	8.0	440	9.0	Med	Fair	Fair	Fair	Low	
T7	<i>Celtis sinensis</i>	朴樹	8.5	110	6.0	Low	Fair	Fair	Fair	Low	
T8	<i>Psidium guajava</i>	番石榴	9.0	190	6.0	Med	Fair	Fair	Fair	Low	
T9	<i>Celtis sinensis</i>	朴樹	9.5	130	5.0	Low	Poor	Poor	Poor	Low	cavity at trunk base

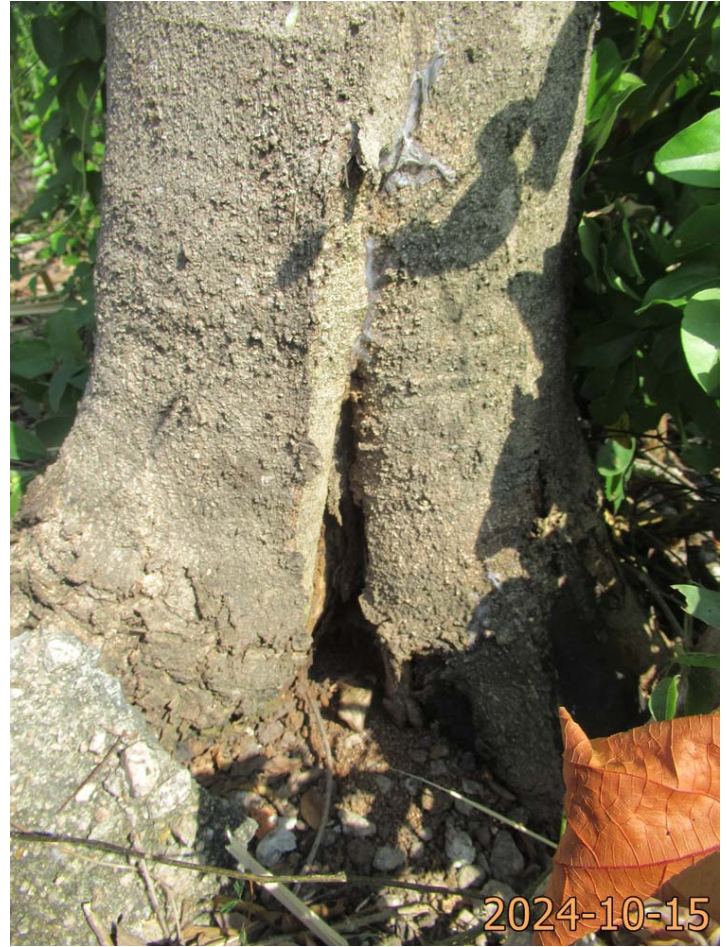
T9 Cavity at trunk base

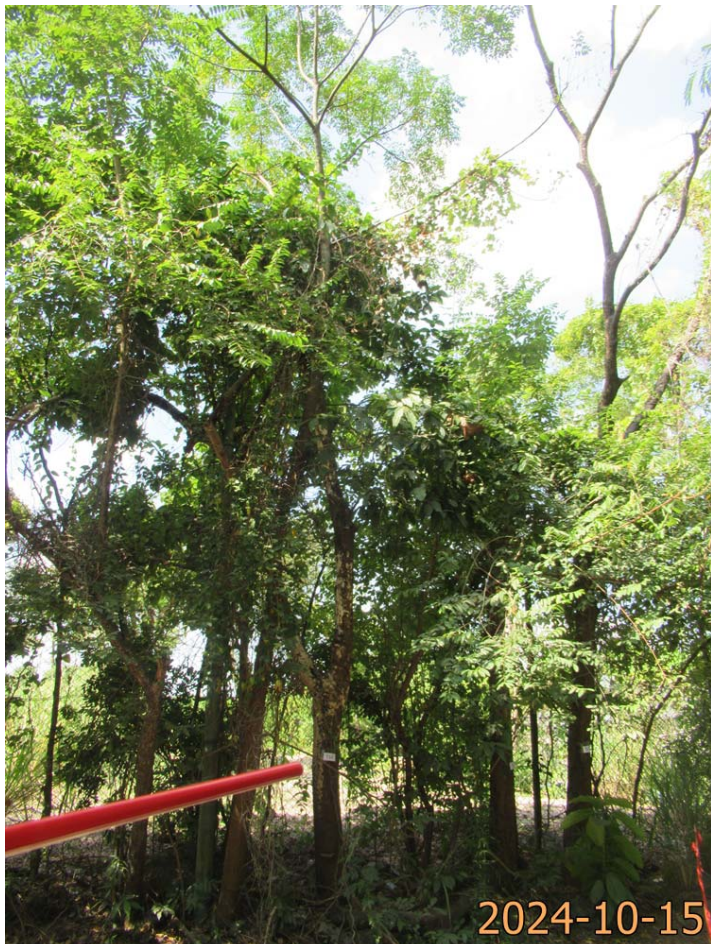
T14 (Overview)

T10	<i>Celtis sinensis</i>	朴樹	8.0	150	5.0	Low	Fair	Fair	Fair	Low	
T11	<i>Celtis sinensis</i>	朴樹	9.0	160	5.0	Low	Fair	Fair	Fair	Low	
T12	<i>Celtis sinensis</i>	朴樹	6.5	110	4.0	Low	Fair	Fair	Fair	Low	
T13	<i>Melia azedarach</i>	楝(苦楝)	7.0	95	4.0	Low	Fair	Fair	Fair	Low	
T14	Dead tree	死樹	6.5	150	1.0	-	-	Dead	-	-	dead tree
T15	Dead tree	死樹	5.0	150	1.0	-	-	Dead	-	-	dead tree
T16	Dead tree	死樹	5.0	150	1.0	-	-	Dead	-	-	dead tree
T17	<i>Celtis sinensis</i>	朴樹	8.0	160	5.0	Low	Fair	Fair	Poor	Low	crooked trunk
T18	<i>Celtis sinensis</i>	朴樹	8.0	190	7.0	Low	Poor	Poor	Poor	Low	co-dominant trunks with included bark, crack at trunk base

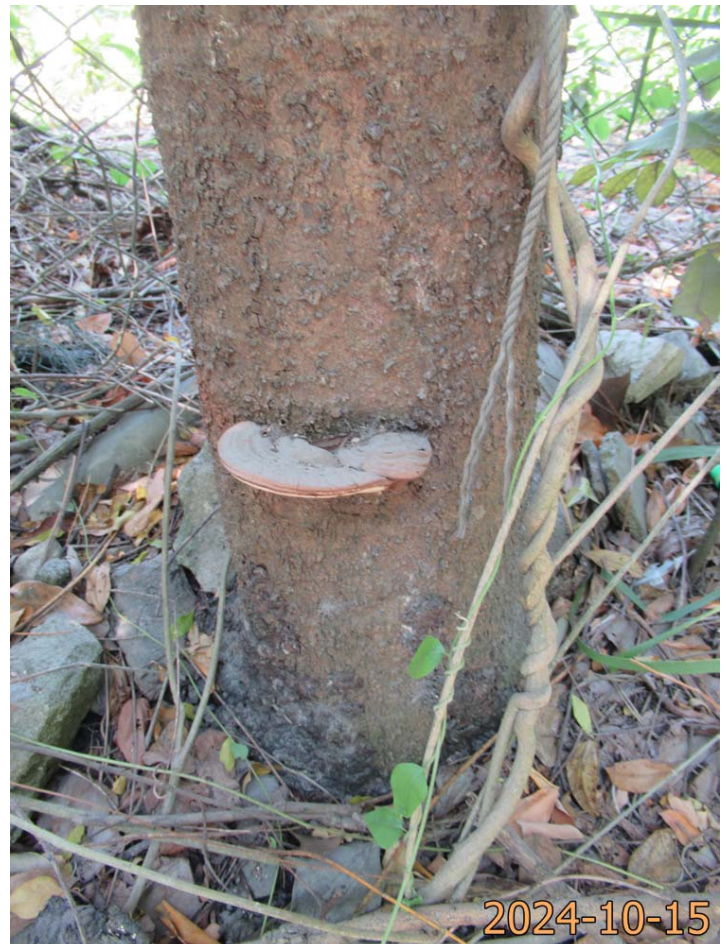
T14 Fungal fruiting bodies

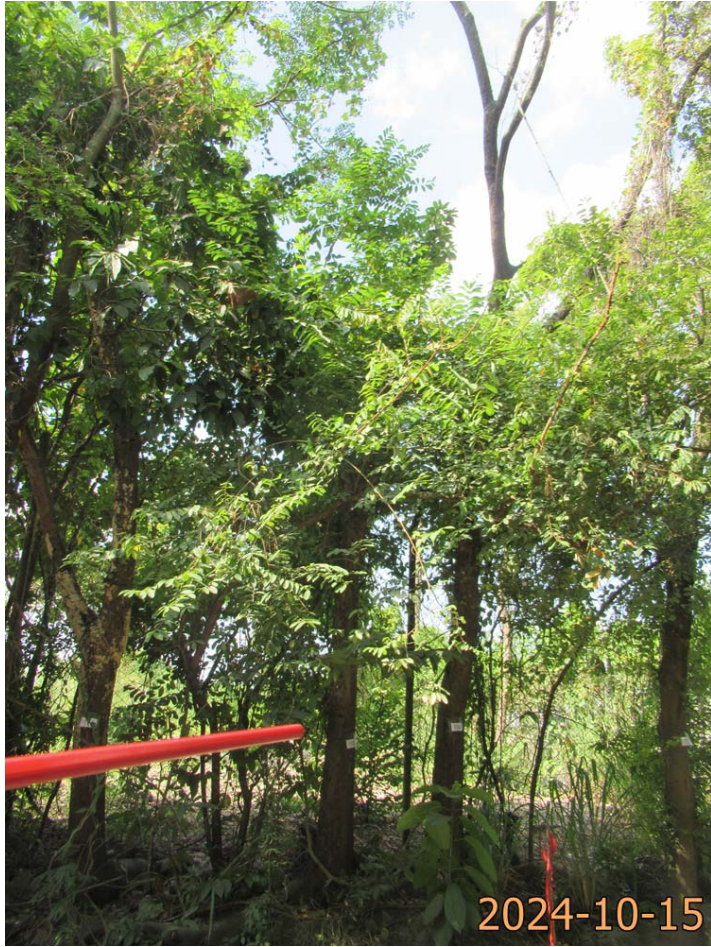
T15 (Overview)

At the time of inspection on 15th October 2024, **18 nos.** tree were found within the Site. **3** dead trees (T14, T15, and T16) were recorded in the surveyed area. Location of individual tree refers to Appendix I.

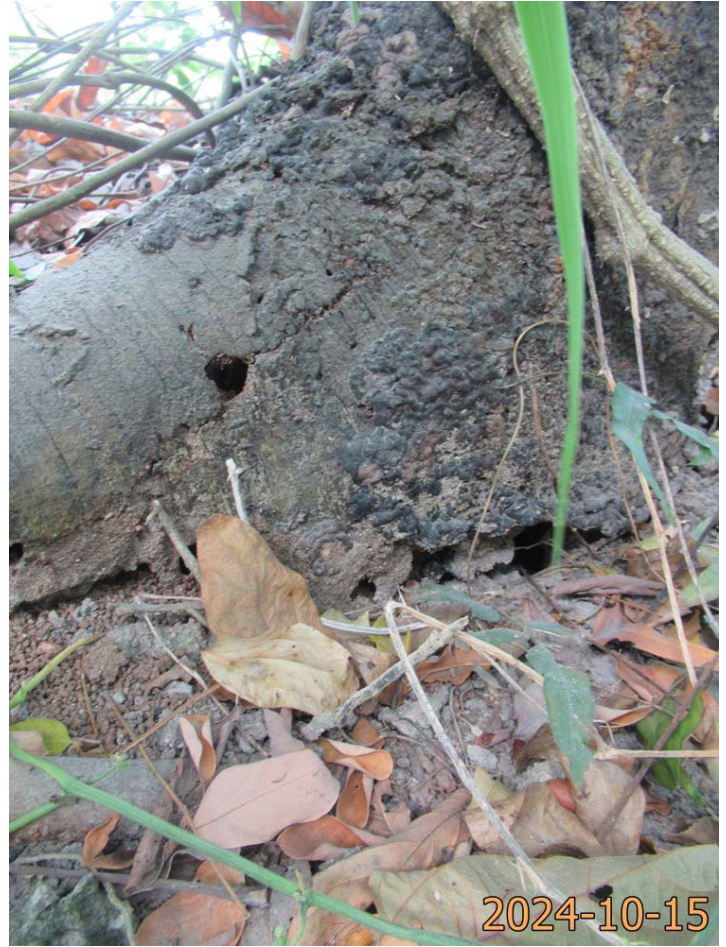
T15 Trace of termite

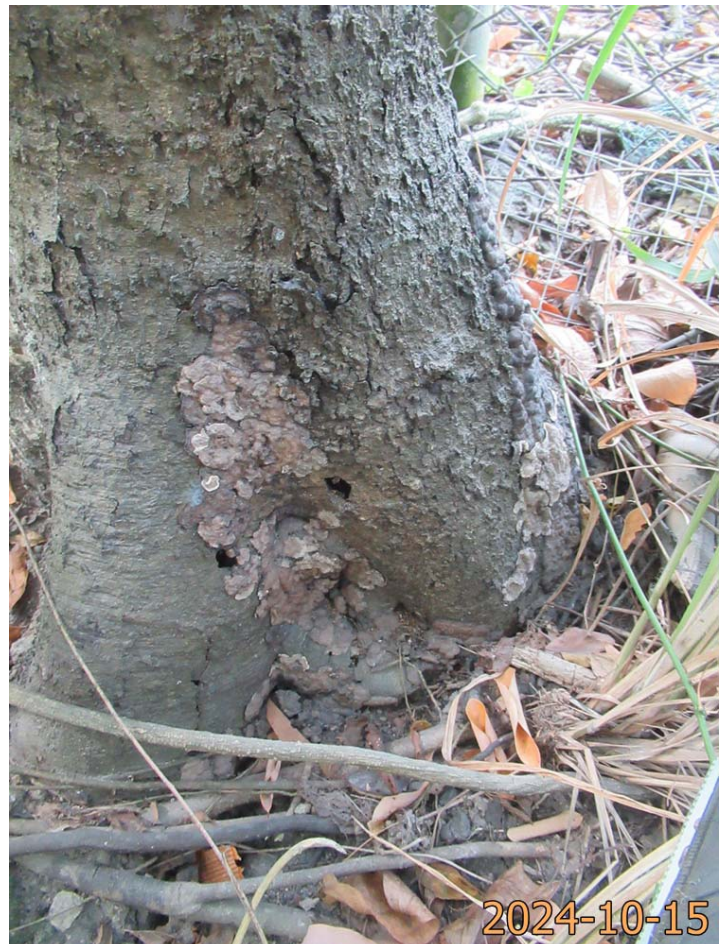
T16 Trace of termite

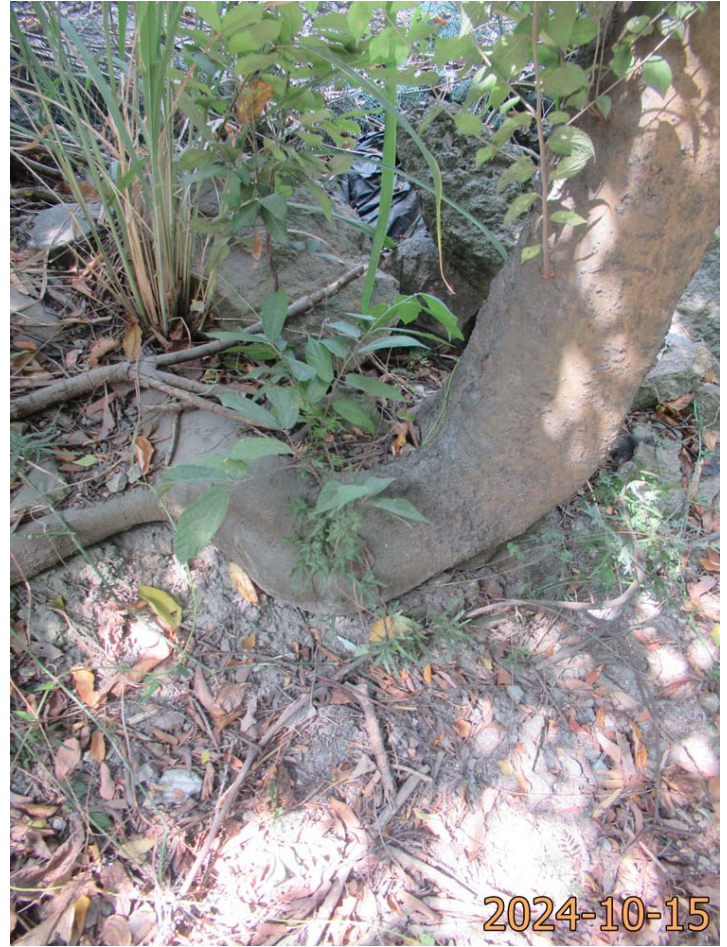
T17 Crooked trunk

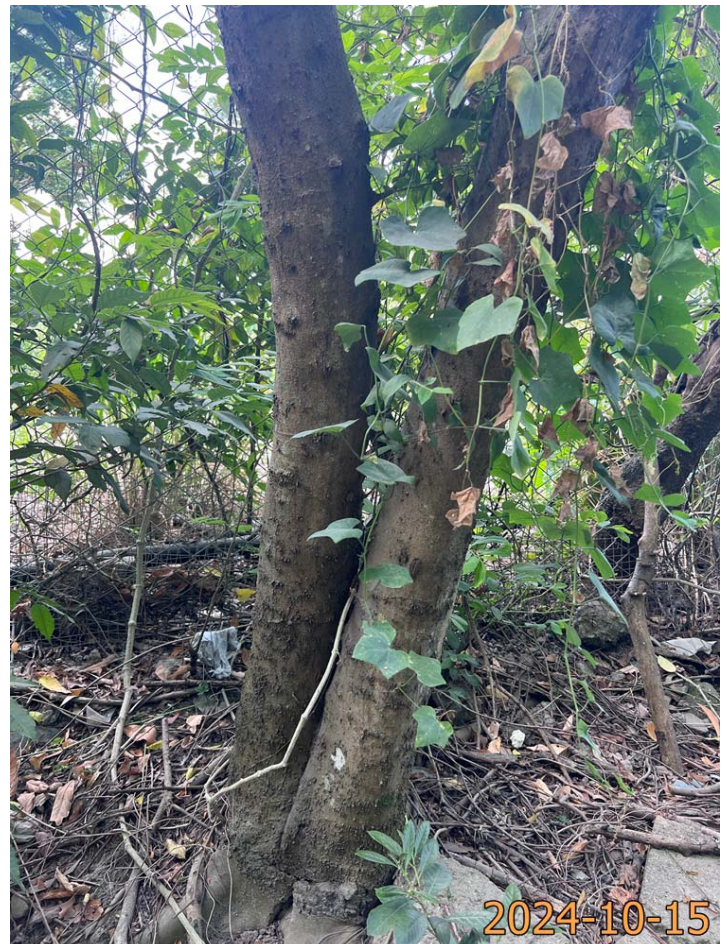
T18 Co-dominant trunks with included bark

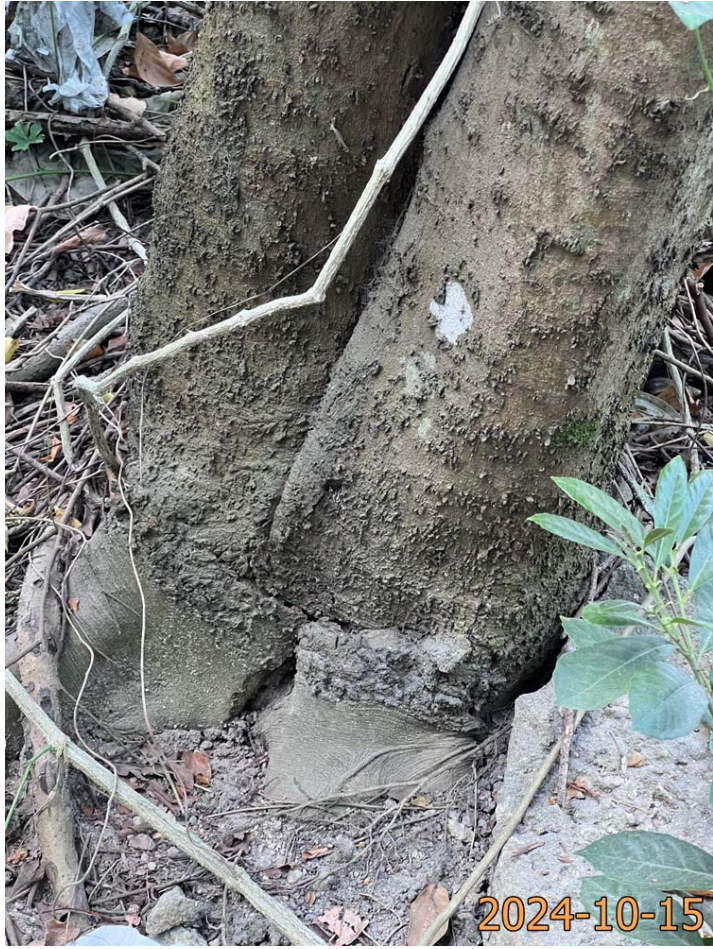
T18 Crack at trunk base
