## **Conservation Management Plan**

## Nam Koo Terrace at no. 55 Ship Street, Wan Chai, Hong Kong

## **Hopewell Holdings Limited / Yuba Company Limited**

October 2024

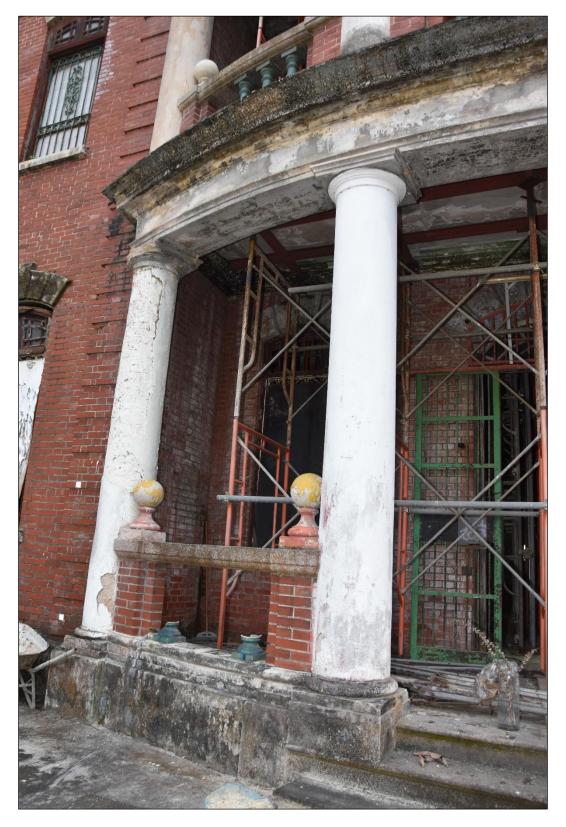
Photo B-11 – Main Building main façade ground floor east part of recess entrance porch, showing the Doric Ionic columns and the parapet wall in between, (the 4 nos. glazed ceramic bottle shape balusters are all broken), (8<sup>th</sup> October, 2024)

- Replace the broken balusters all four are broken at both bays on ground, and one broken at the east bay on first floor,
  - Check and clean the balusters on first floor (remaining three at east bay, five at the middle, and four at the west bay), and also replace the cracked balusters,

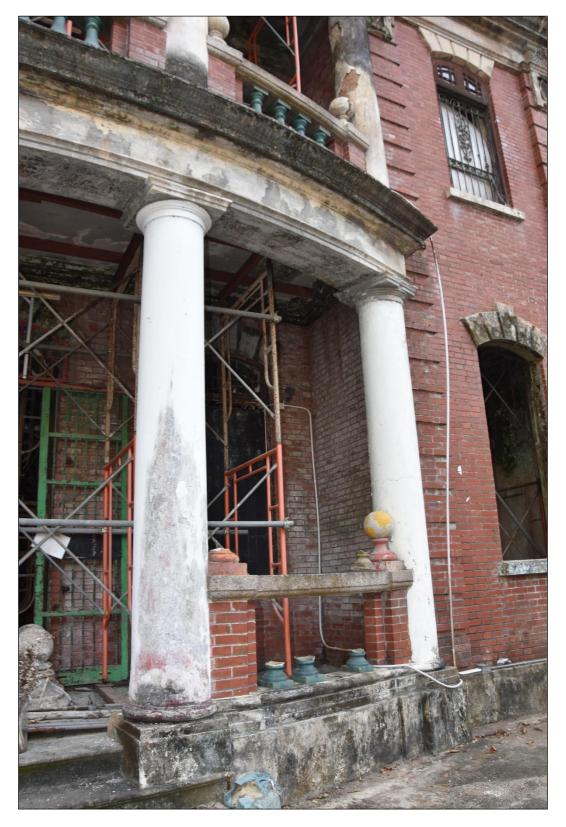
Photo B-12 – Main Building main façade ground floor west part of recess entrance porch, showing the Doric Ionic columns and the parapet wall in between, (the 4 nos. glazed ceramic bottle shape balusters are all broken), (8<sup>th</sup> October, 2024)

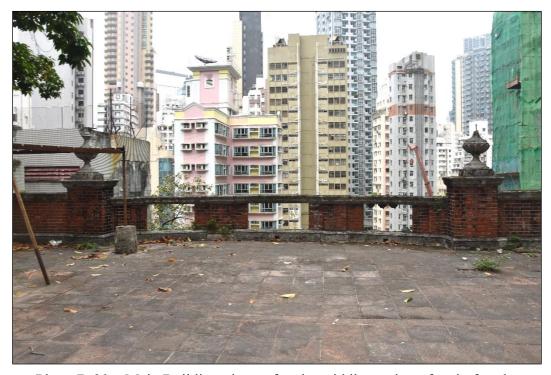
Photo B-20 – Main Building, the roof at the middle portion of main façade,

(all the glazed ceramic bottle shape balusters broken),

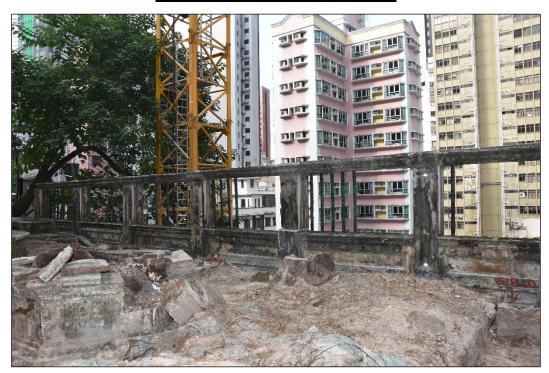
Photo B-61 – The boundary wall above the granite block retaining wall at north-east elevation (facing Queen's Road East), landscaped garden side, (nearly all the glazed ceramic bamboo shape fencing bars at the upper part have been broken), (8<sup>th</sup> October, 2024)

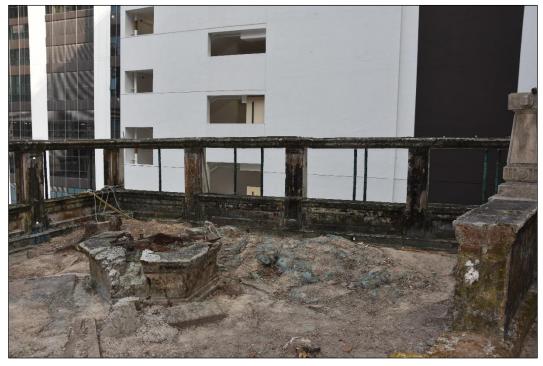
Photo B-62 – The boundary wall above the granite block retaining wall at south-east elevation (facing Ship Street), landscaped garden side, (nearly all the glazed ceramic bamboo shape fencing bars at the upper part have been broken), (8<sup>th</sup> October, 2024)

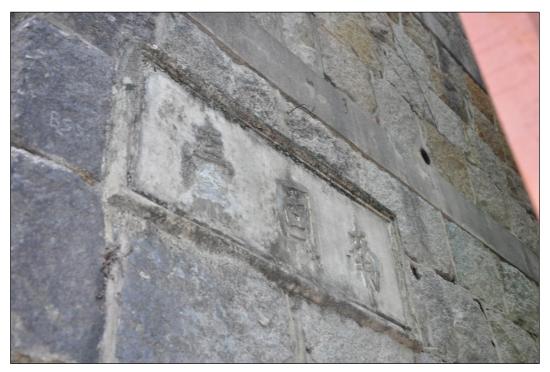
Photo C-01 – The street name plate at the north-east elevation (facing Queen's Road East), (east corner of the granite block retaining wall) with the Chinese characters "南 固 臺". (25<sup>th</sup> October, 2021)

- Both are covered by some tree roots.
  - These two street name plates will be repaired and preserved in-situ.
  - And the railing in front of the two street name plates will be modified, such that there will be no railing in front of the two street name plates. (subject to approval from Government Department)

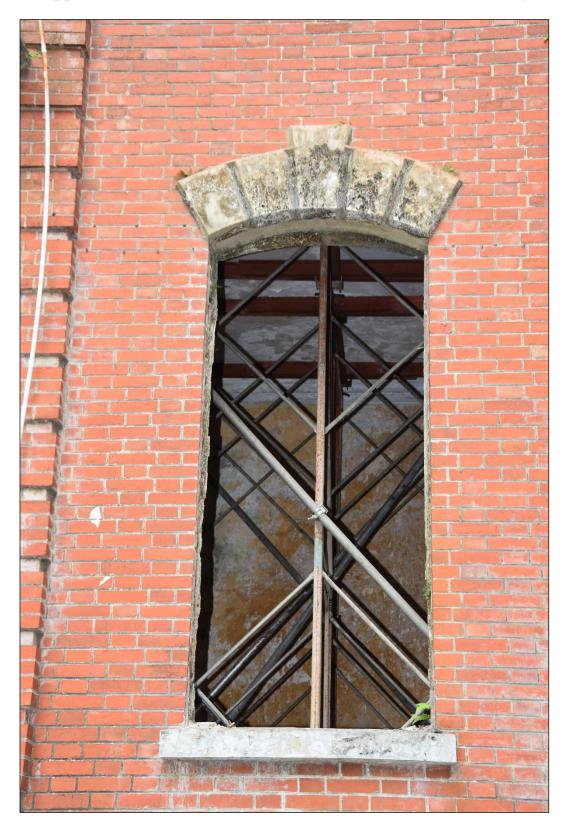
Photo App3-01 – North-east elevation (front elevation), ground floor, window Wdw-Gf01, external side, the window and window grille removed, the window opening covered with plywood panel, (21st March, 2023)

- (4) Supply and install new timber windows and frame in accordance with the cartographic survey drawings and ironmongery information.
- (5) Remove the paint and rust on the existing wrought iron window grille, and paint.

- (6) Replicate the wrought iron window grille (of different dimensions).
- (7) Replace the missing wrought iron window grille, and paint.
- (8) Repair the plaster at the voussoir arch on top of each window, and paint.

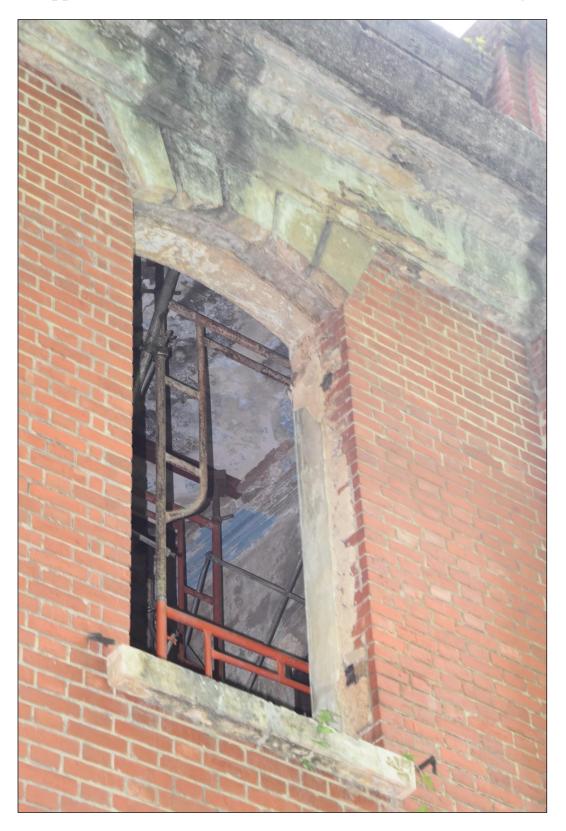
Photo App3-14 – South-east elevation (facing Ship Street), first floor, window Wdw-1f05, external side, the window and window grille removed, (21st March, 2023)
