**LOT NO. 63, 296 (PART), 331 RP (PART) &
393 RP (PART) IN DD185, SHEUNG WO CHE NO. 198
SAI LAM TEMPLE, SHATIN, NEW TERRITORIES**

GEOTECHNICAL PLANNING REVIEW REPORT

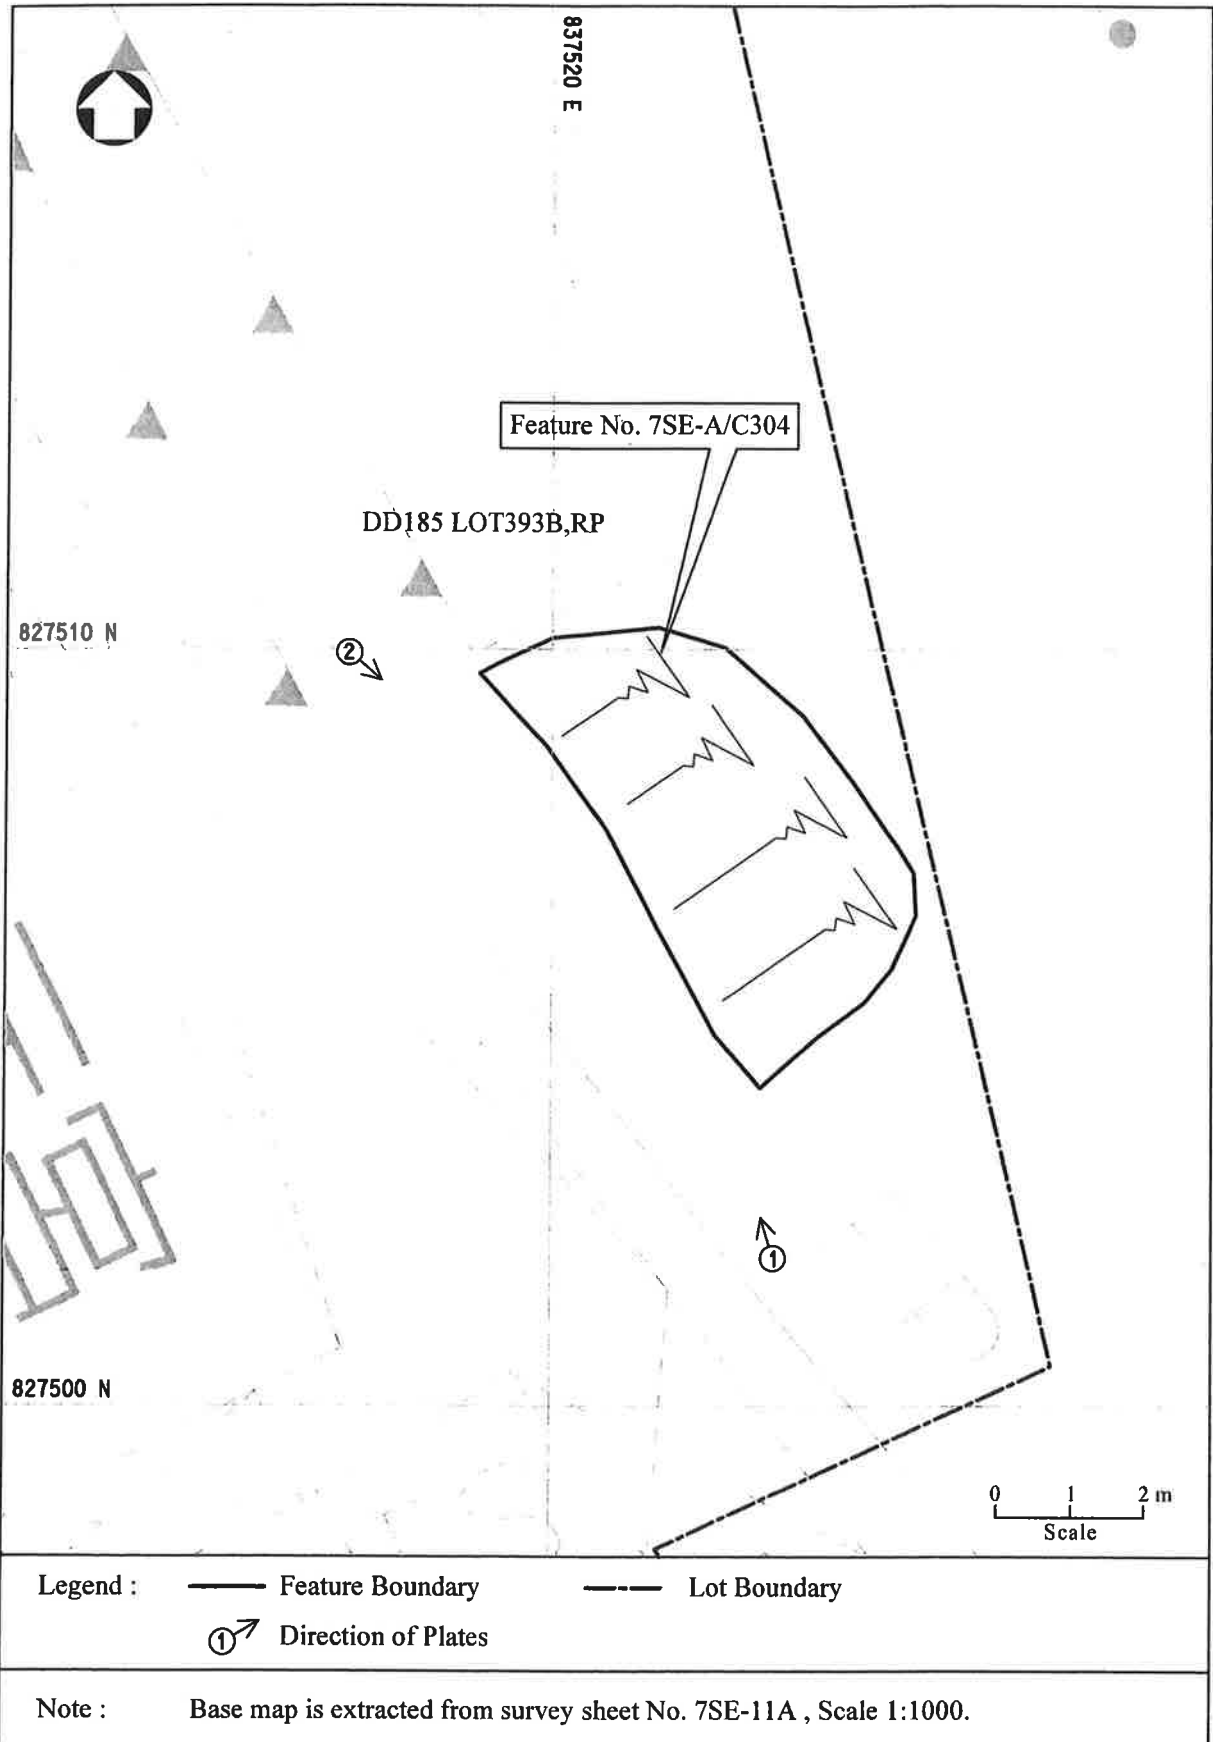
Figure 2.2 Site Observation Plan

Visual inspections on the study feature were carried out in April 2011 and July 2013 respectively. At the time of inspections, the feature was a 7.5m long soil cut slope and it was generally facing southwest (Plates 1 & 2). The maximum height of the feature was about 5.6m and the slope angle varied from about 35° to 53°. The slope surface was covered with erosion control mat at the northern portion whereas the southern portion was bare.

The area behind the crest of the study feature was an undeveloped greenbelt whereas a footpath and a temple were located at the toe of the feature. No signs of distress and seepage were observed during the site inspections.

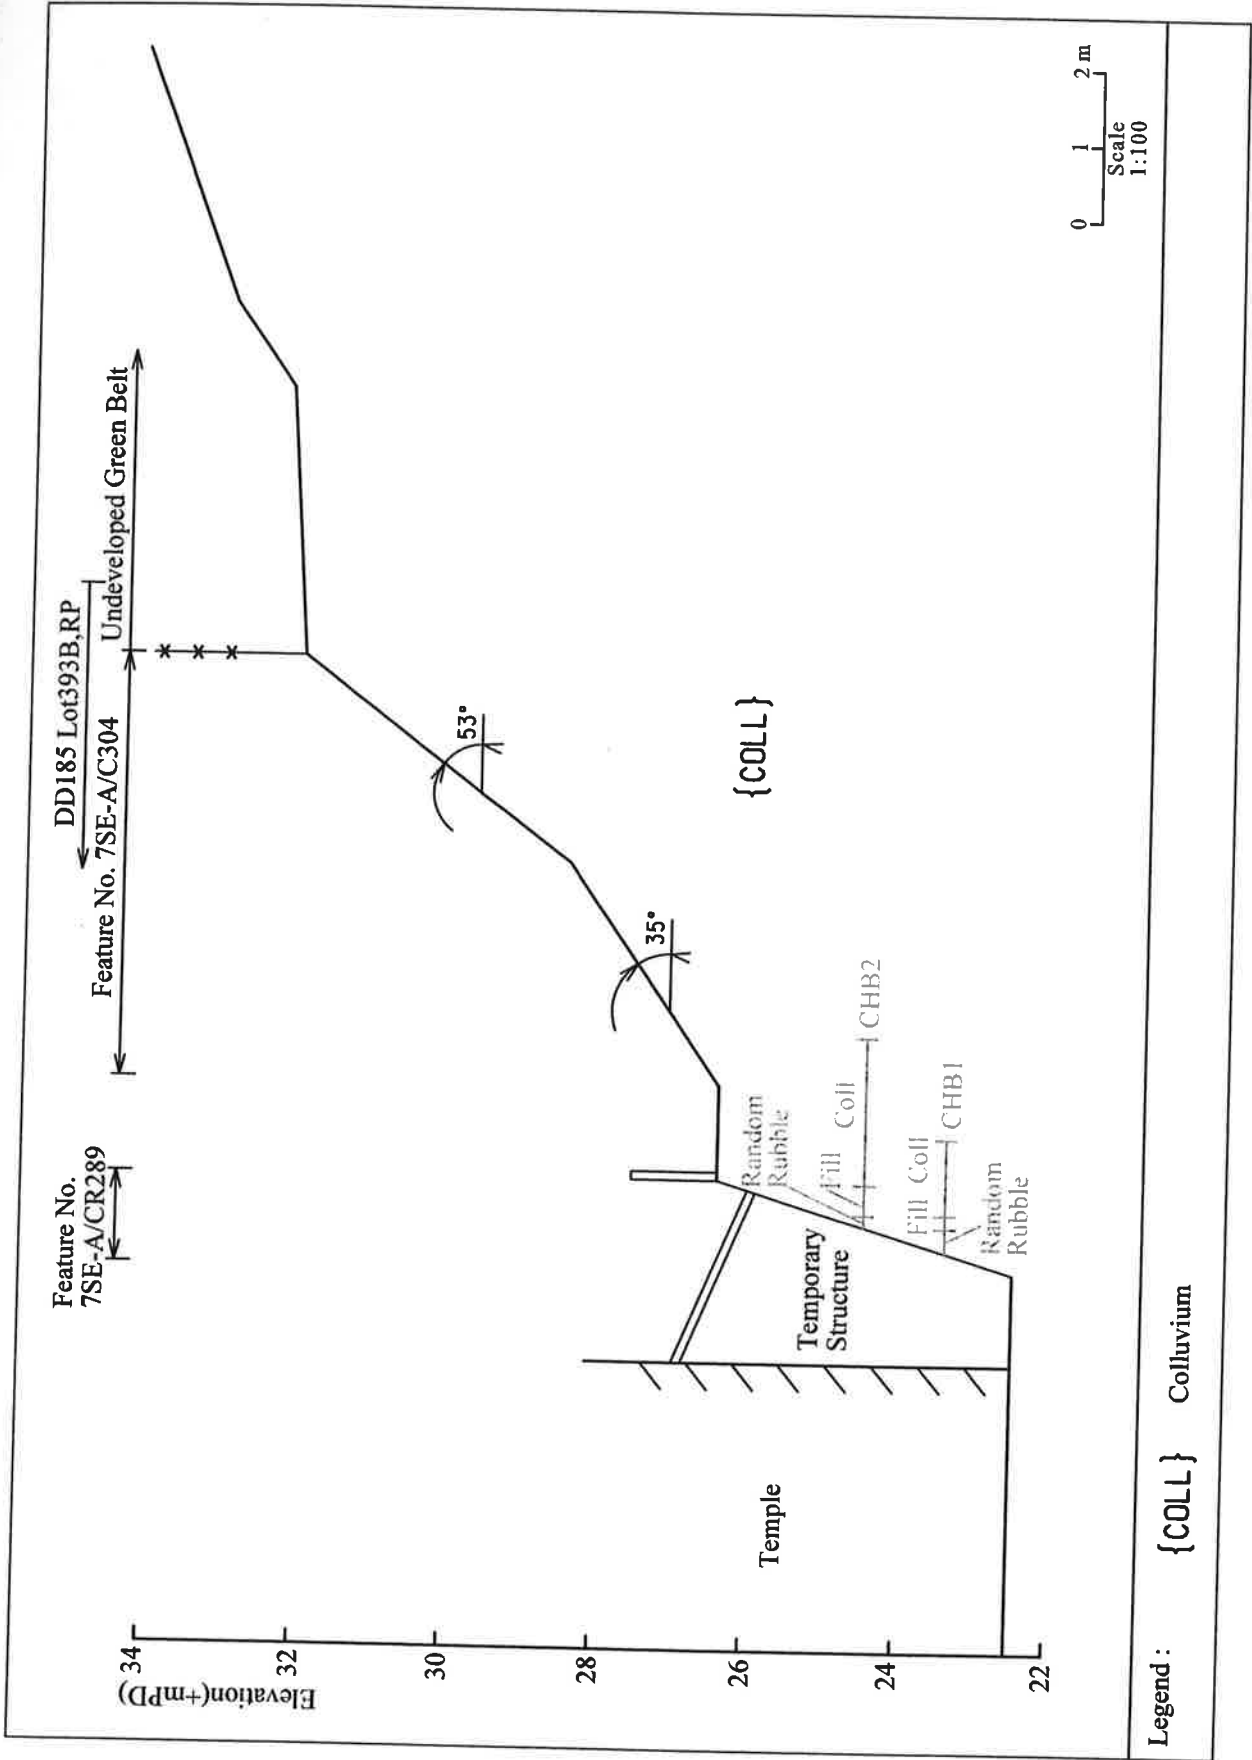
Figure 3.2 Geological Profile of Section 1-1

No groundwater monitoring records exist for the study feature and no signs of seepage were observed on site. However, the groundwater table for Sections 1-1 was assumed at one-third of the slope height to account for 1 in 10 year return period of rainfall.

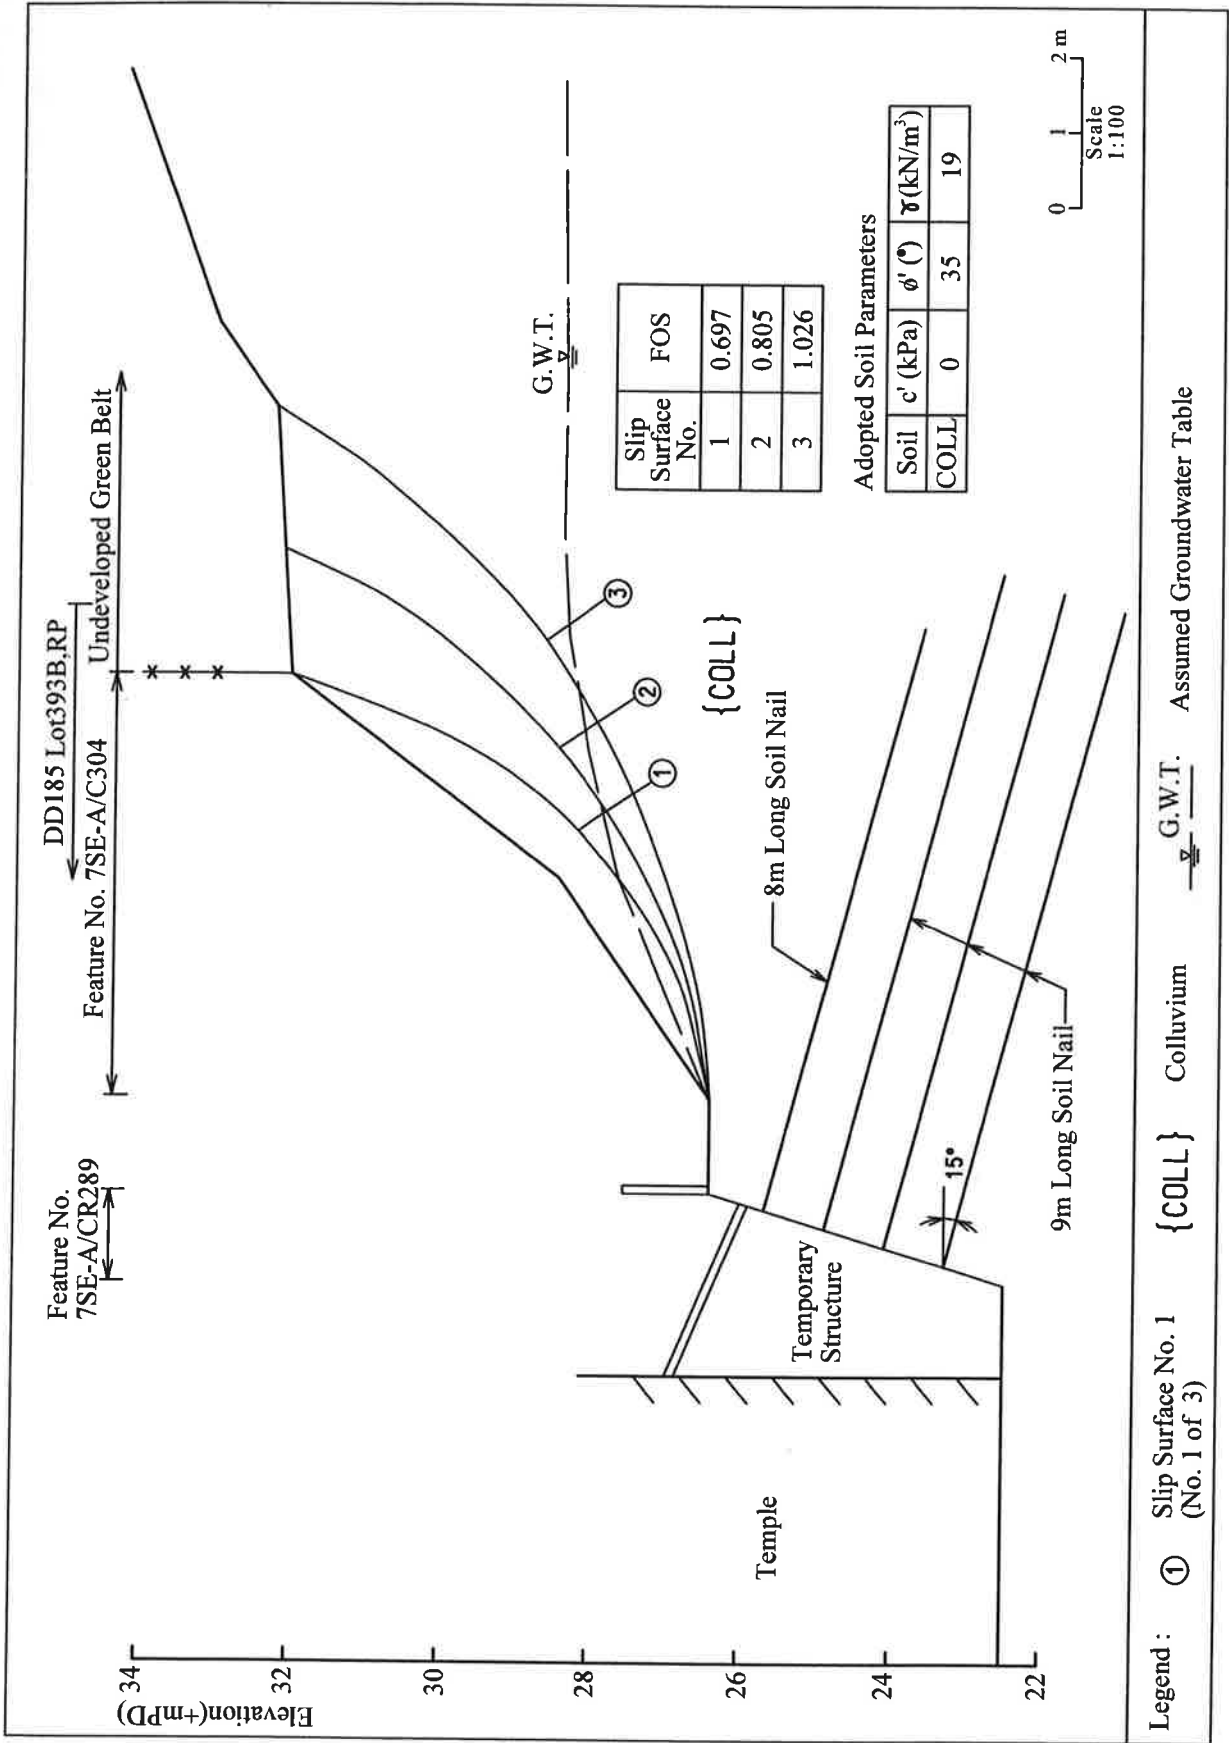
Figure 3.3 Stability Analysis of Section 1-1

Slope stability analysis was carried out for the Section 1-1 based on the inferred geological model, groundwater condition and shear strength parameters as discussed in Sections 3.2 to 3.4. The Morgenstern-Price Method in SLOPE/W Version 6.2 (BD reference No. G0138) was used for the stability analysis. The calculated Factor of Safety (FOS) are tabulated below:

Section	Slip Surface No.	FOS
1-1	1	0.697
	2	0.805
	3	1.026

The results of stability analysis are presented in Figure 3.3 and the computer outputs of the stability analysis are enclosed in Appendix G.

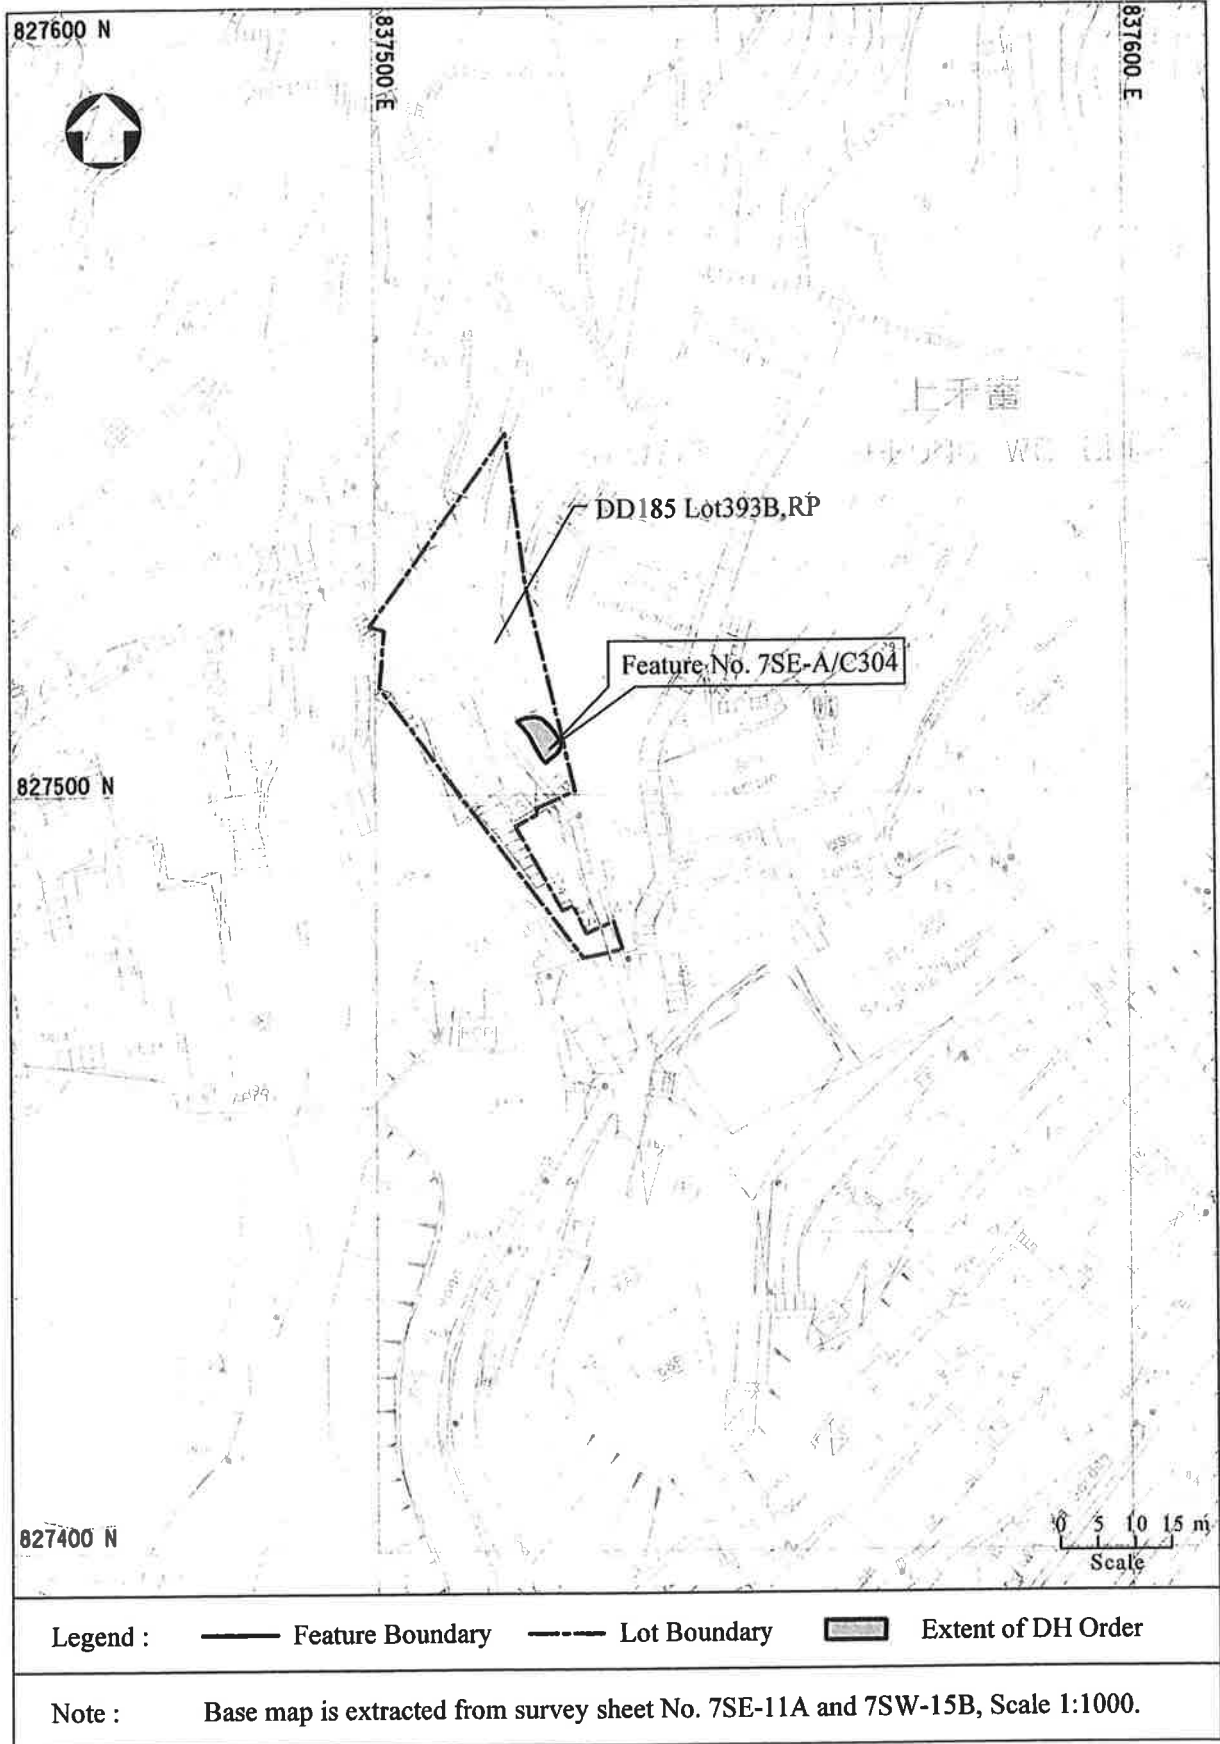
Figure 5.1 Action to be Taken

The extent of the feature subject to DH Order is coloured pink in Figure 5.1

Feature No. **7SE-A/C304** satisfies the requirements for the service of a Dangerous Hillside (DH) Order under Criterion F of GEO Circular No. 24. It is therefore recommended that a DH Order be served on the owners of DD185 Lot393B,RP with respect to the feature.

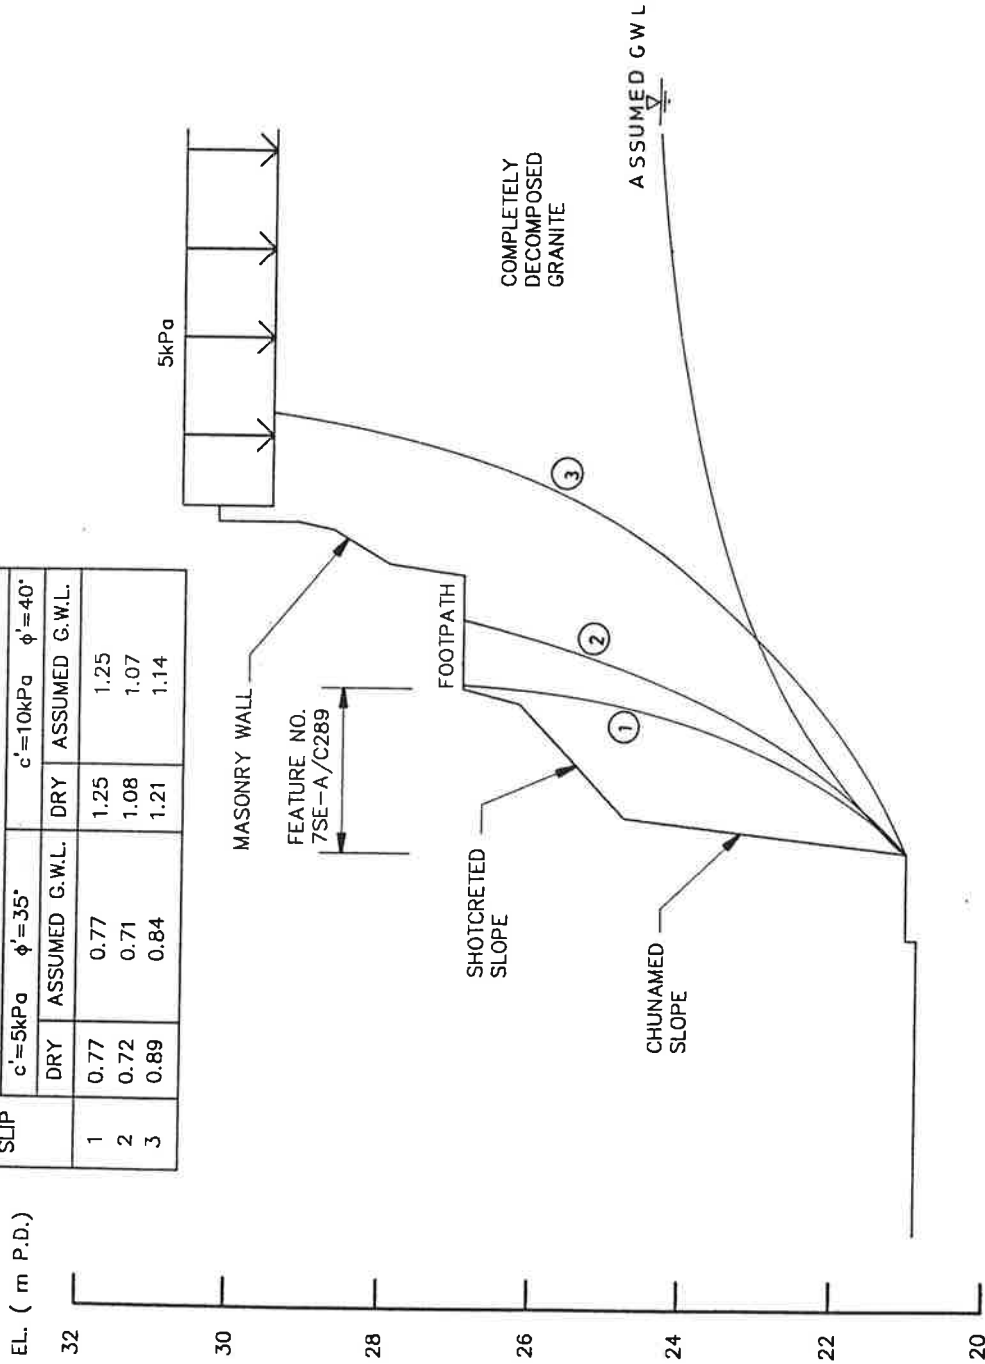
SLOPE STABILITY ANALYSIS AT SECTION 1-1

SLIP	CALCULATED FACTOR OF SAFETY		
	$c' = 5kPa$	$\phi' = 35^\circ$	$c' = 10kPa$ $\phi' = 40^\circ$
	DRY	ASSUMED G.W.L.	DRY
1	0.77	0.77	1.25
2	0.72	0.71	1.08
3	0.89	0.84	1.21
