Tree Survey Report

**Section 16 Planning Application for Proposed Public Utility
Installation (Submarine Cable and Landing System) on
Government Land near Rural Building Lot No. 1220 and 1221,
Chung Hom Kok, Hong Kong Island**

Tree Survey Report (Final Rev.1)

Document No. 004

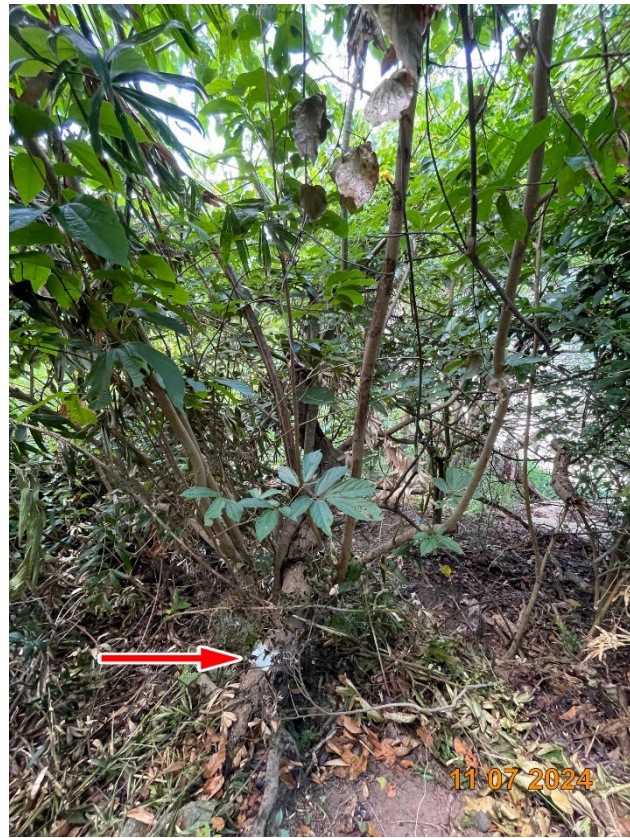
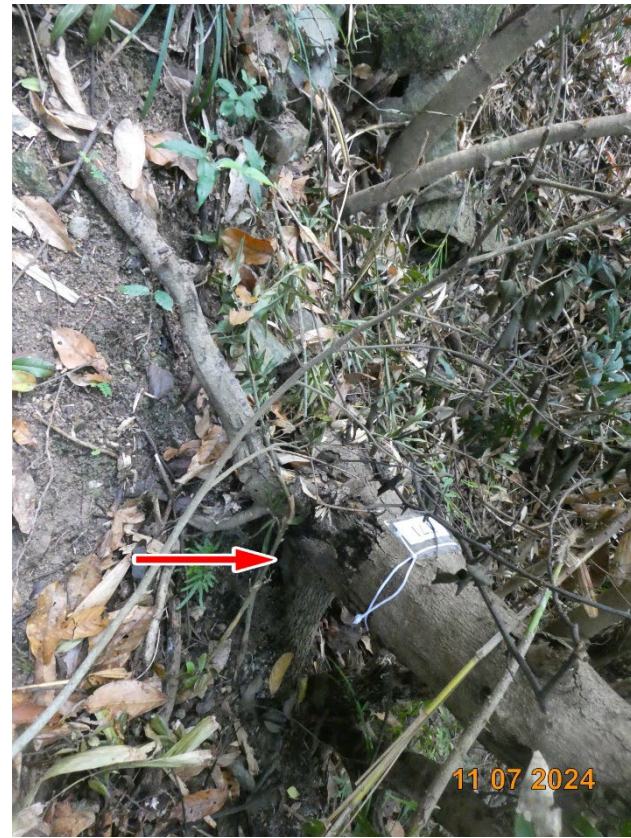
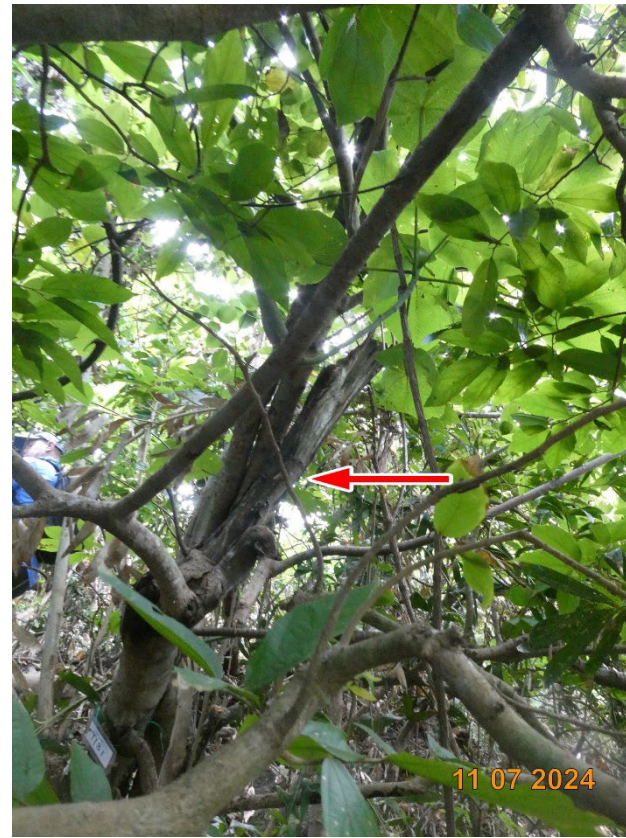
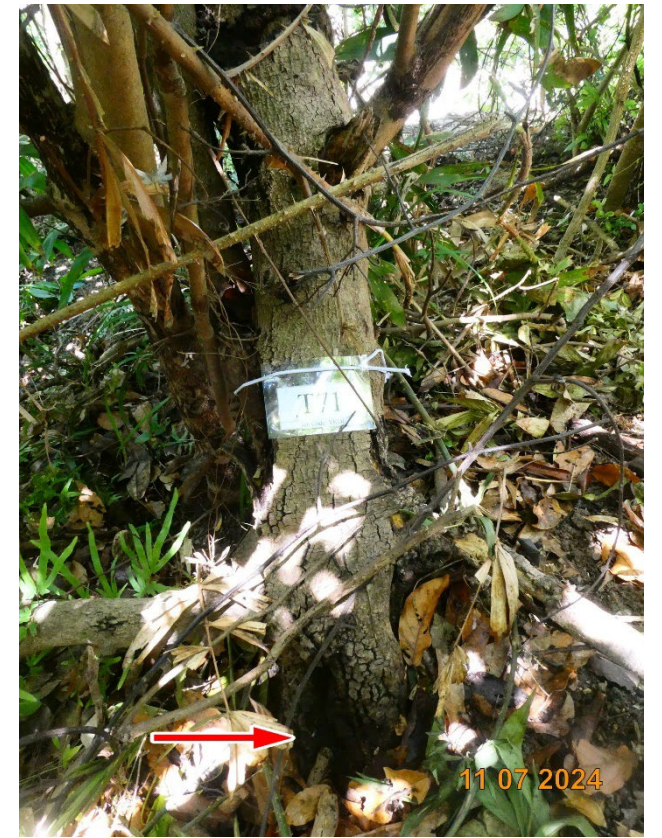
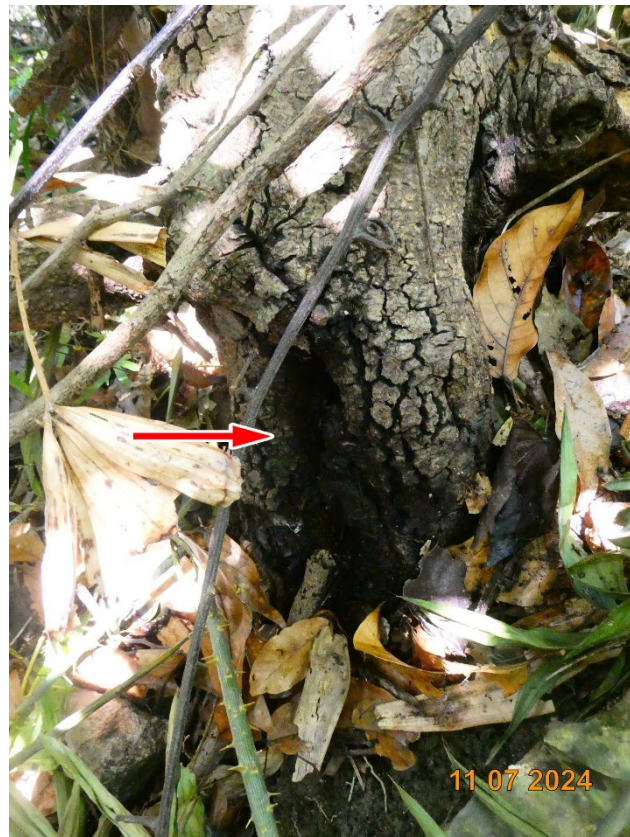
Tree No.	Photo No.	Species		Tree Size			Proposed Treatment (Retain/Transplant/Fell)	Remarks
		Scientific Name	Chinese Name	Height (m)	DBH (mm)	Crown Spread (m)		
T71	1 - 5	<i>Macaranga tanarius var. tomentosa</i>	血桐	4.0	140	6.0	Fell	Severe lean. Suppressed tree.
T72	6 - 7	<i>Sterculia lanceolata</i>	假蒴婆	5.0	100	3.0	Fell	Failed tree. Severe trunk wound.
T77	8 - 9	<i>Leucaena leucocephala</i>	銀合歡	7.0	120	7.0	Fell	Failed and regenerated. Invasive pest plant.
T78	10 - 12	<i>Leucaena leucocephala</i>	銀合歡	6.0	110	4.0	Fell	Failed and regenerated. Crown smothered with climber. Invasive pest plant.
T79	13 - 14	<i>Leucaena leucocephala</i>	銀合歡	4.0	120	9.0	Fell	Failed and regenerated. Invasive pest plant.
T80	15 - 16	<i>Macaranga tanarius var. tomentosa</i>	血桐	3.0	280	8.0	Fell	Asymmetrical crown shape.
T81	17 - 18	<i>Celtis sinensis</i>	朴樹	8.0	160	5.0	Fell	Narrow crown shape. Low foliage density and dieback.

Photo No. 1 | T71 (Fell)

Photo No. 2 | T71 (Fell)

Photo No. 3 | T71 (Fell)

Photo No. 4 | T71 (Fell)

Photo No. 5 | T71 (Fell)

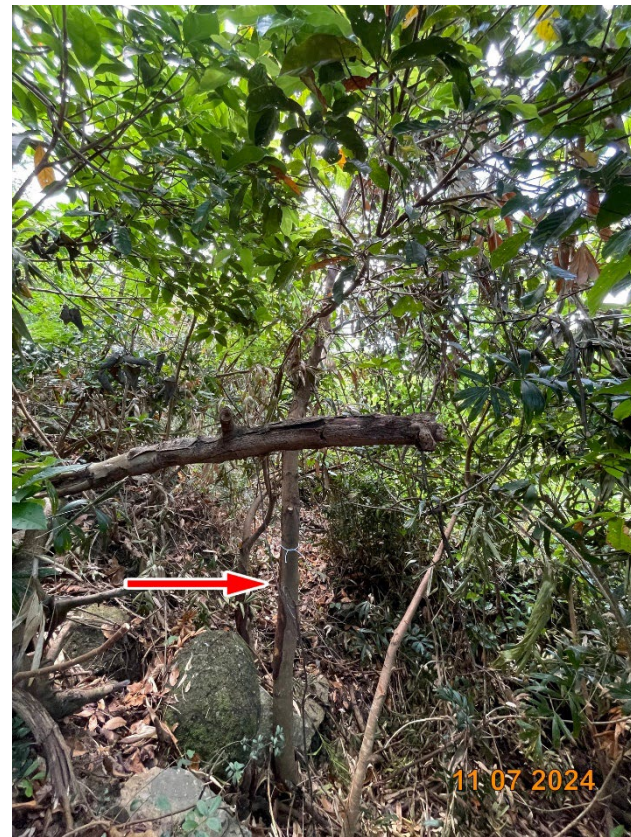
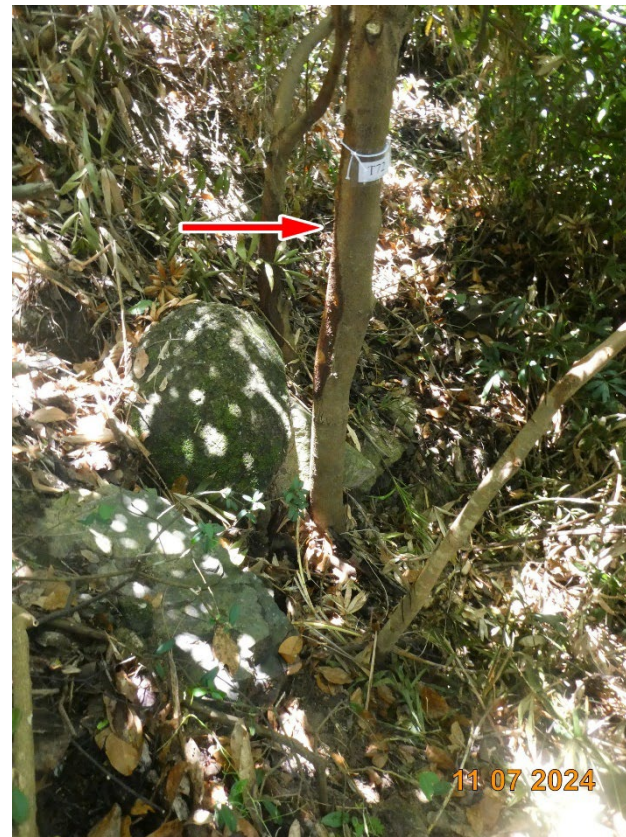
Photo No. 6 | T72 (Fell)

Photo No. 7 | T72 (Fell)

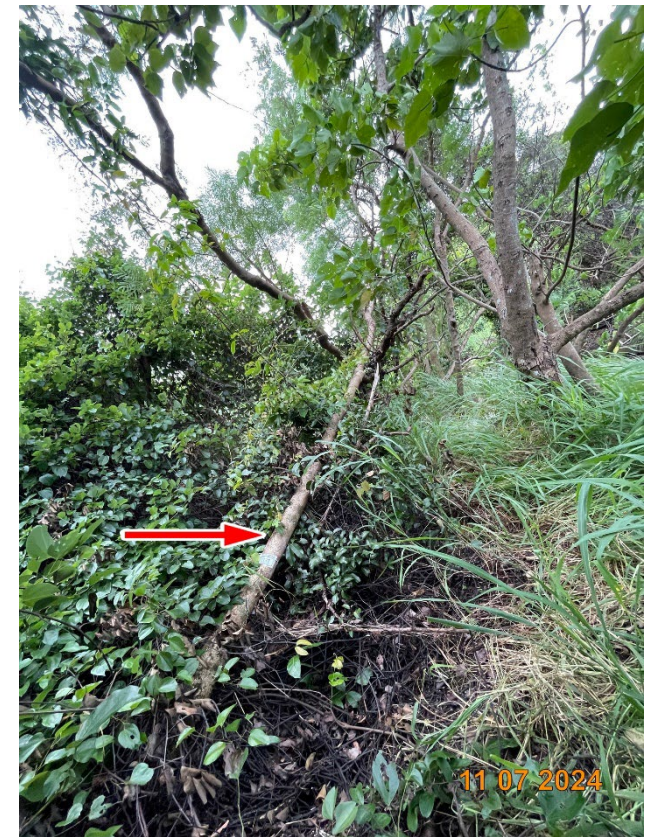
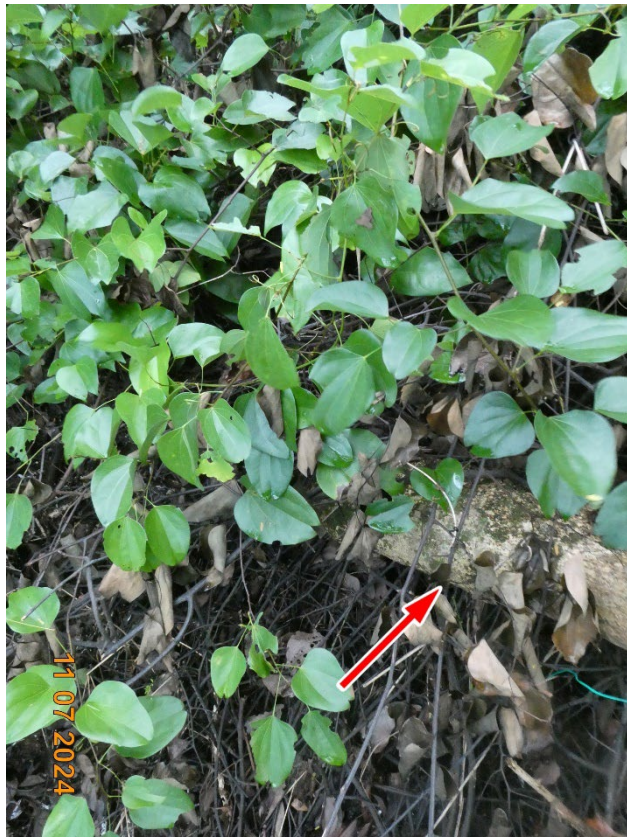
Photo No. 8 | T77 (Fell)

Photo No. 9 | T77 (Fell)

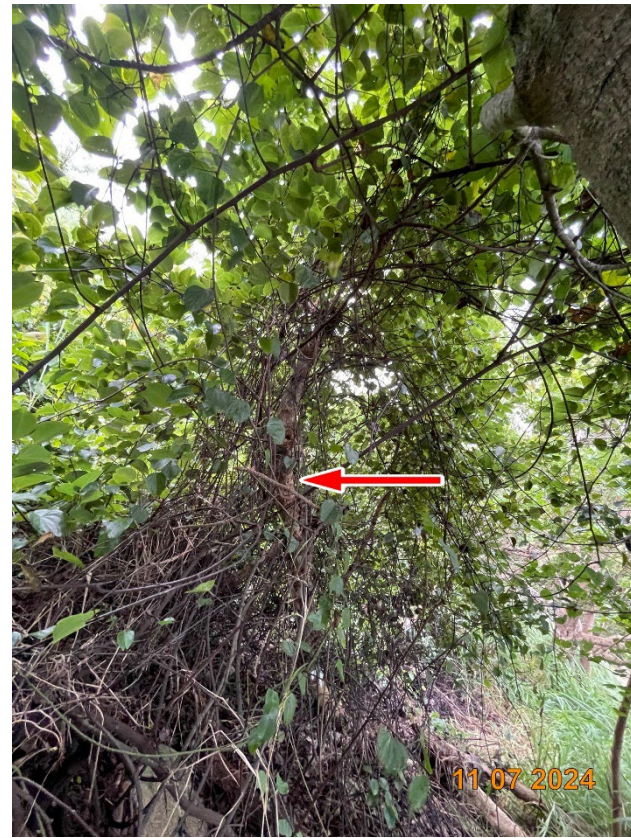
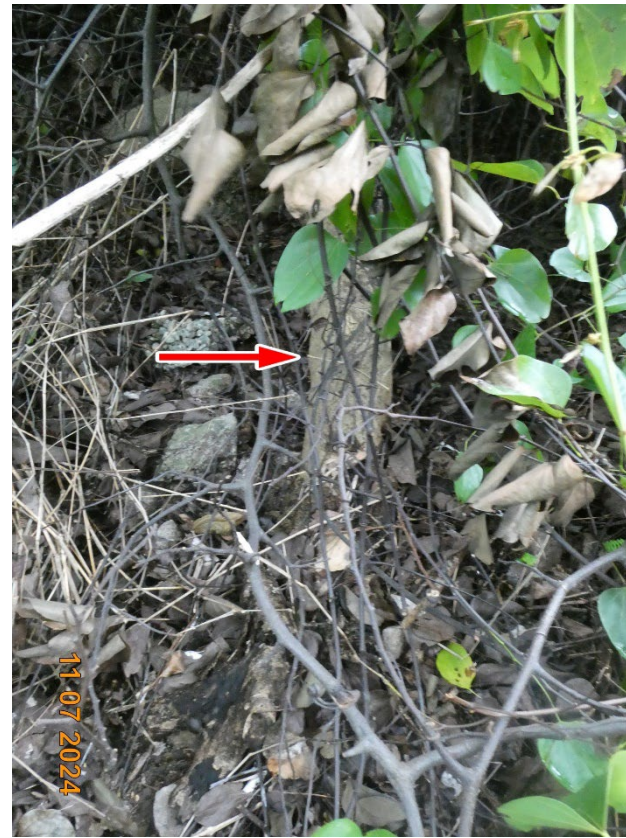
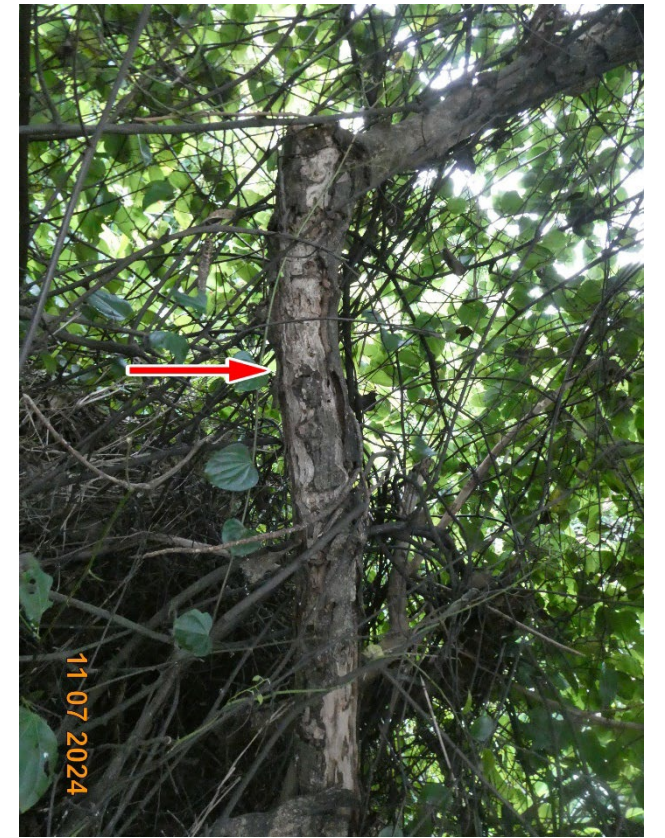
Photo No. 10 | T78 (Fell)

Photo No. 11 | T78 (Fell)

Photo No. 12 | T78 (Fell)

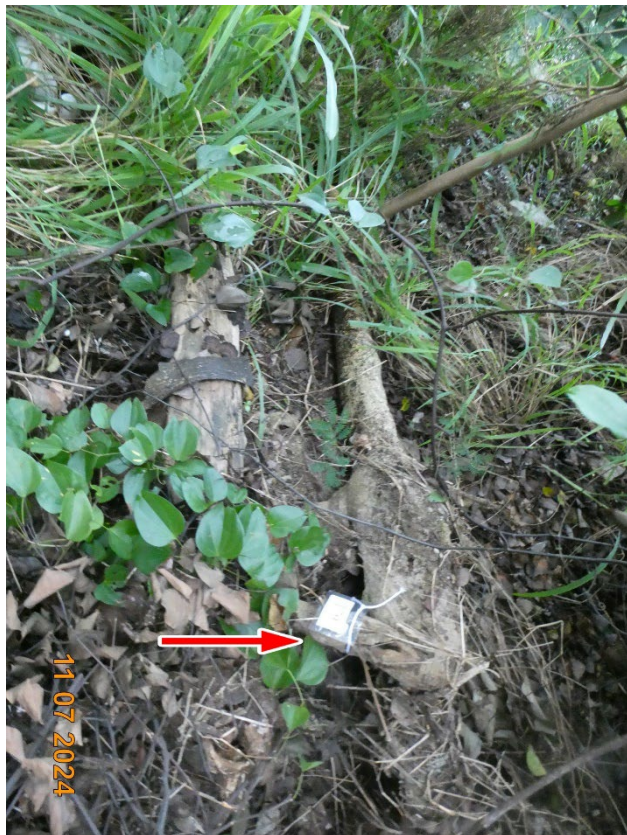
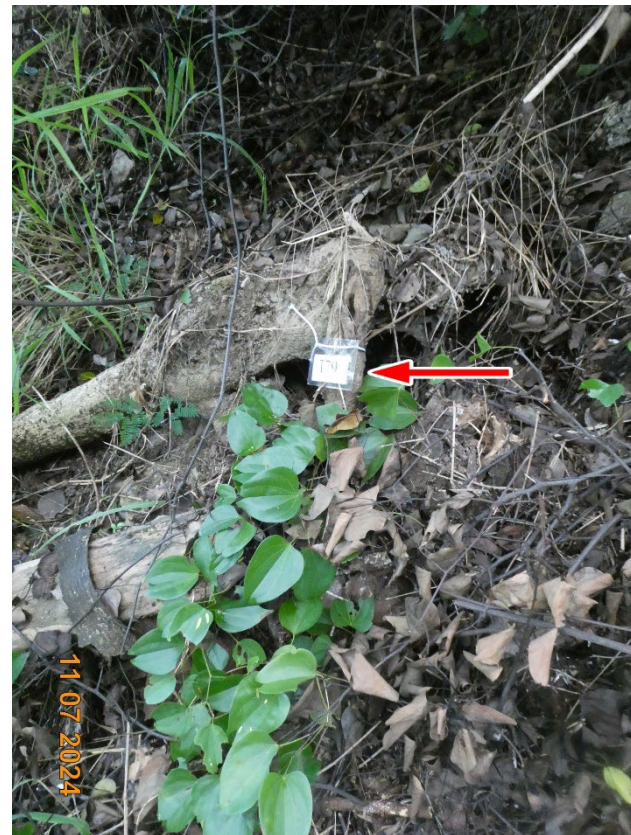
Photo No. 13 | T79 (Fell)

Photo No. 14 | T79 (Fell)

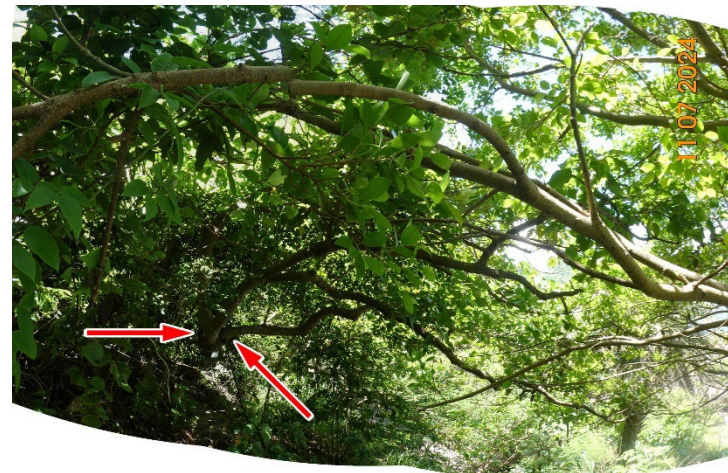
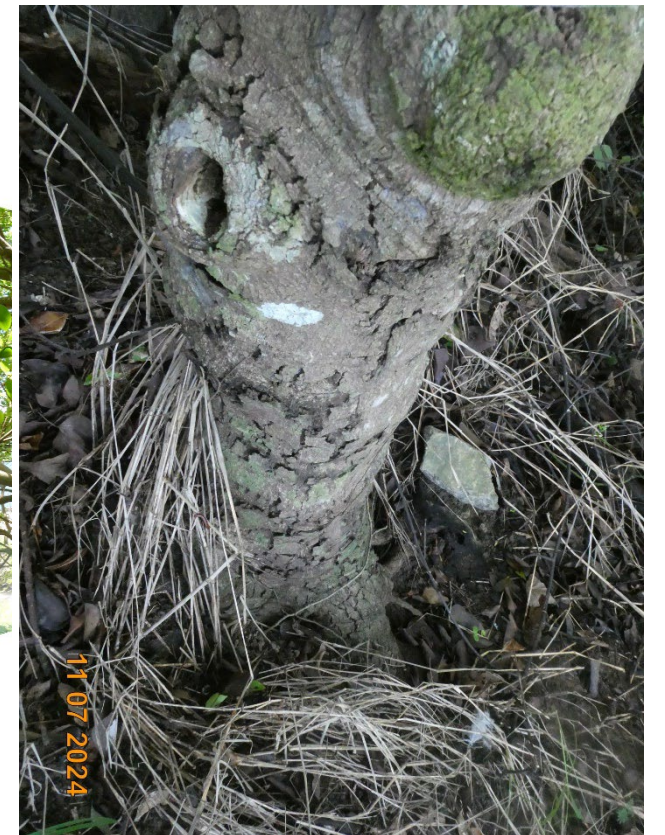
Photo No. 15 | T80 (Fell)

Photo No. 16 | T80 (Fell)

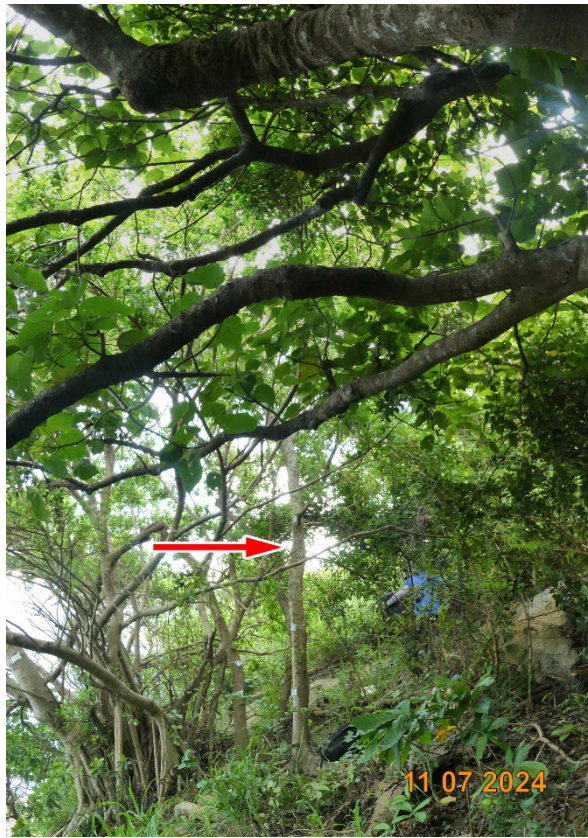
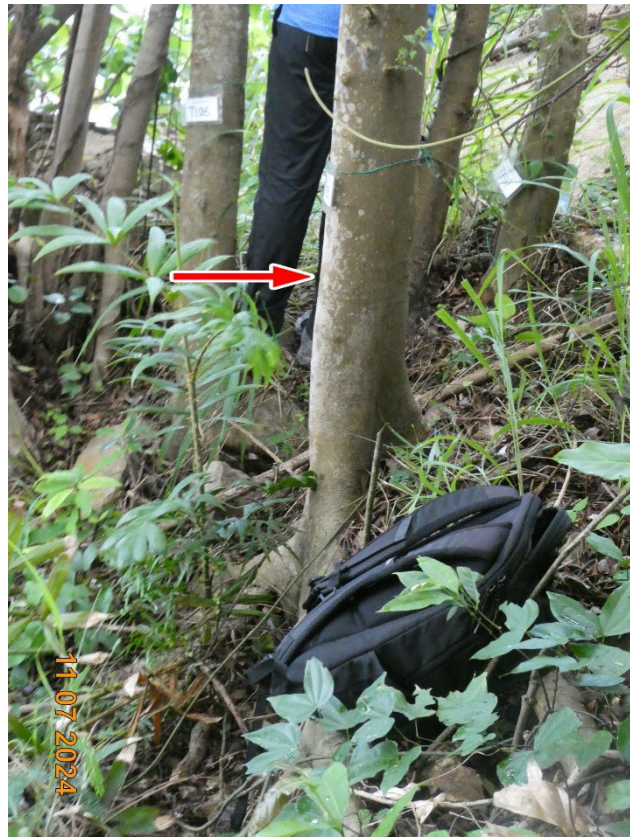
Photo No. 17 | T81 (Fell)

Photo No. 18 | T81 (Fell)

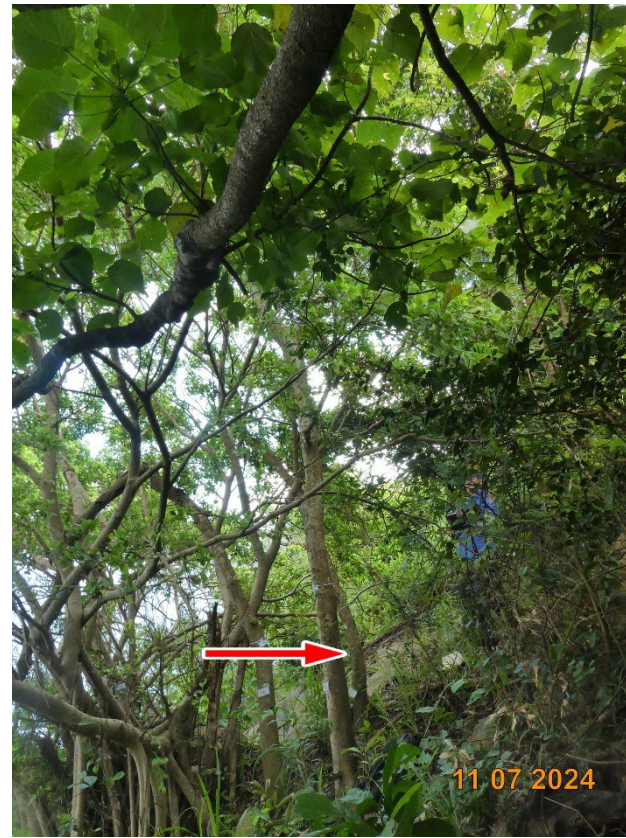
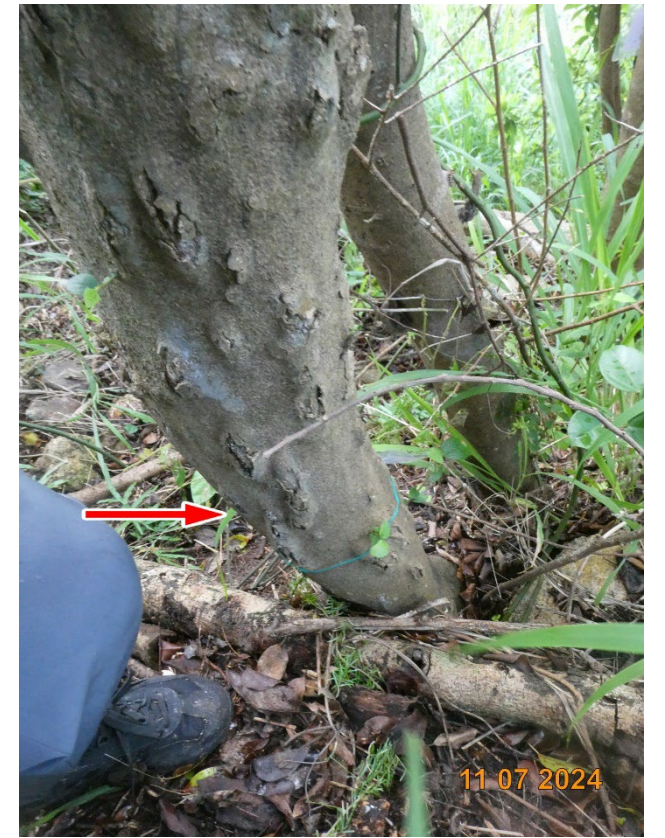
T82	19 - 20	<i>Celtis sinensis</i>	朴樹	7.0	130	5.0	Fell	Failed tree. Only a spar remains.
T83	21 - 22	<i>Celtis sinensis</i>	朴樹	3.0	140	1.0	Fell	Failed tree. Only a spar remains.
T84	23 - 25	<i>Ficus microcarpa</i>	細葉榕	14.0	700	16.0	Fell	Several trunks. Asymmetrical crown shape.
T85	26 - 28	<i>Leucaena leucocephala</i>	銀合歡	5.0	120	4.0	Fell	Failed and regenerated. Crown smothered with climber. Invasive pest plant.
T86	29 - 30	<i>Macaranga tanarius var. tomentosa</i>	血桐	3.0	110	6.0	Fell	Minor crown asymmetry.

Photo No. 19 | T82 (Fell)

Photo No. 20 | T82 (Fell)

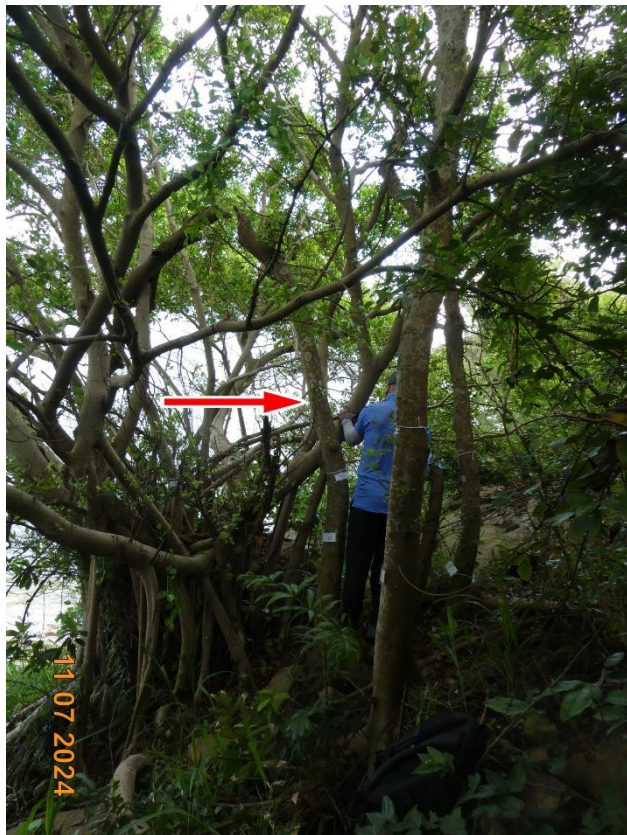
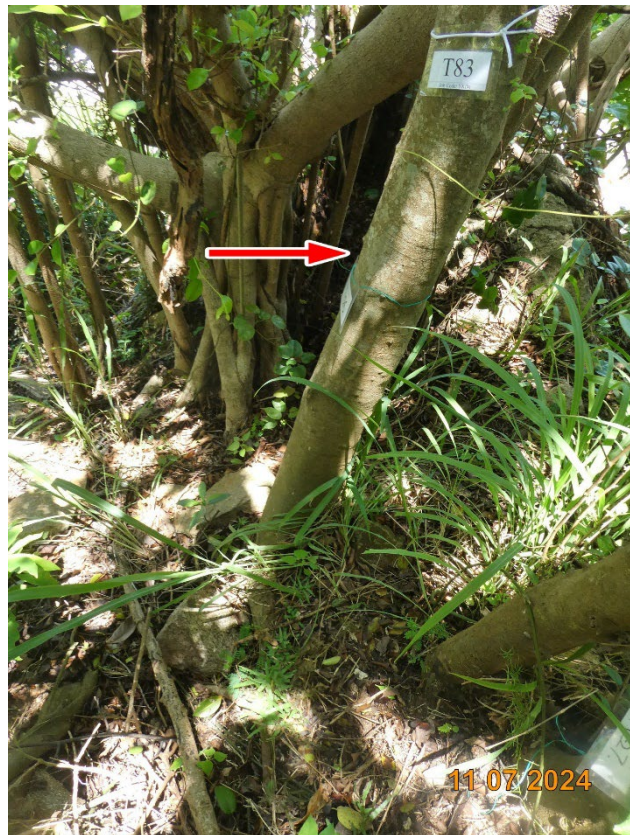
Photo No. 21 | T83 (Fell)

Photo No. 22 | T83 (Fell)

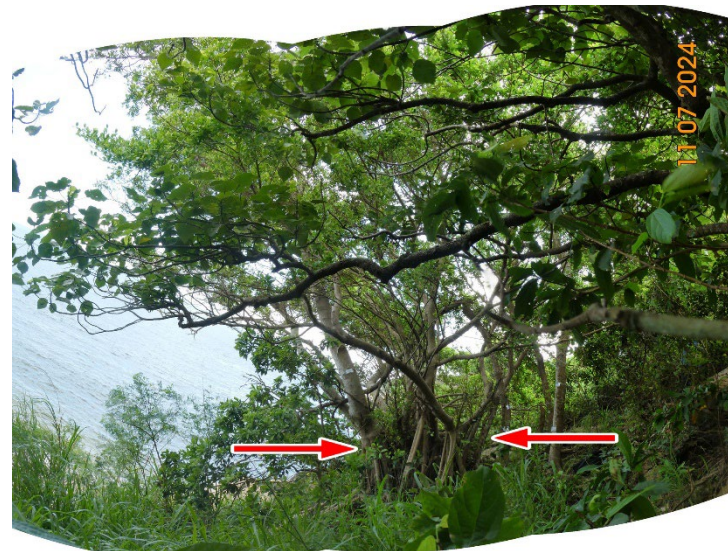
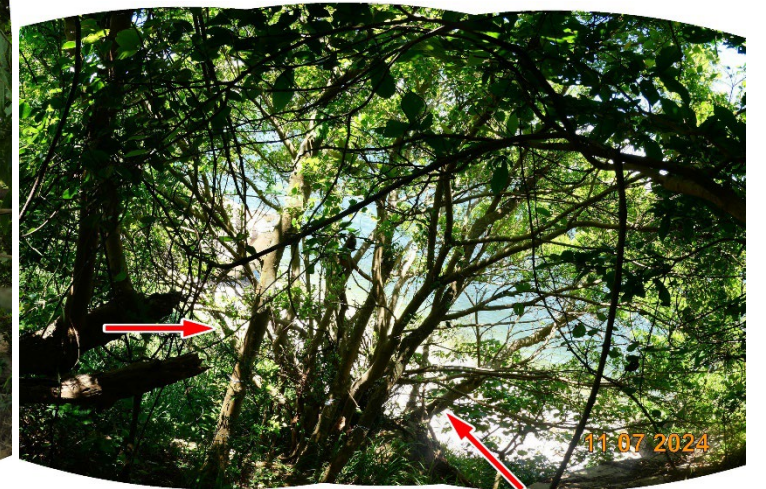
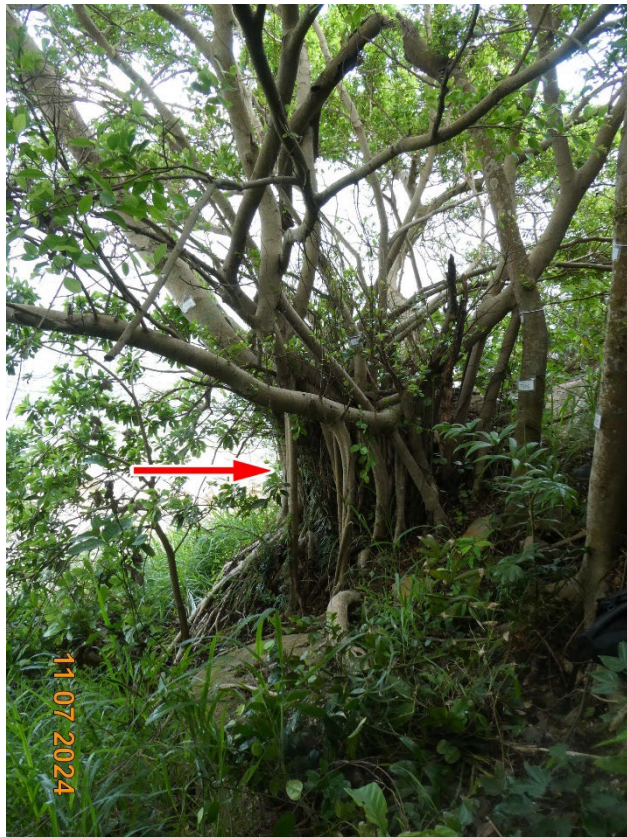
Photo No. 23 | T84 (Fell)

Photo No. 24 | T84 (Fell)

Photo No. 25 | T84 (Fell)

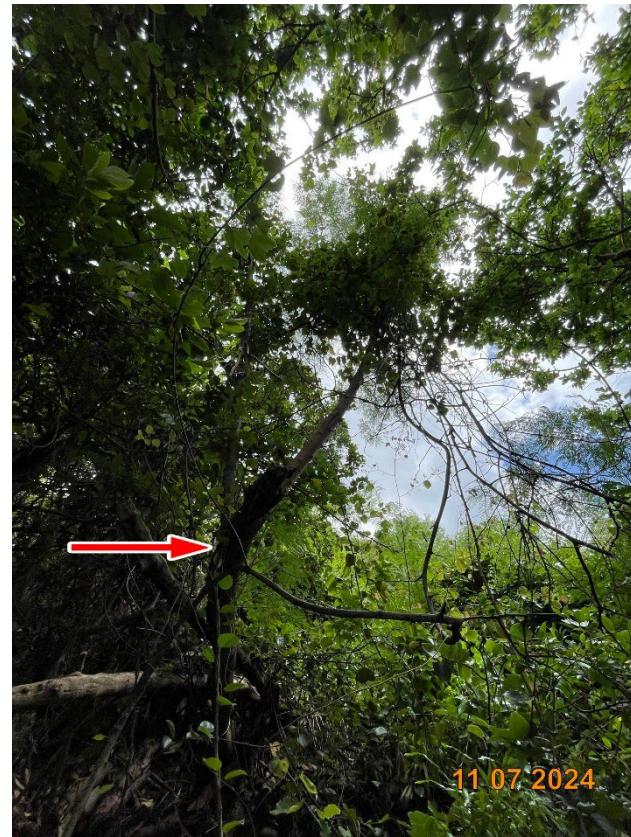
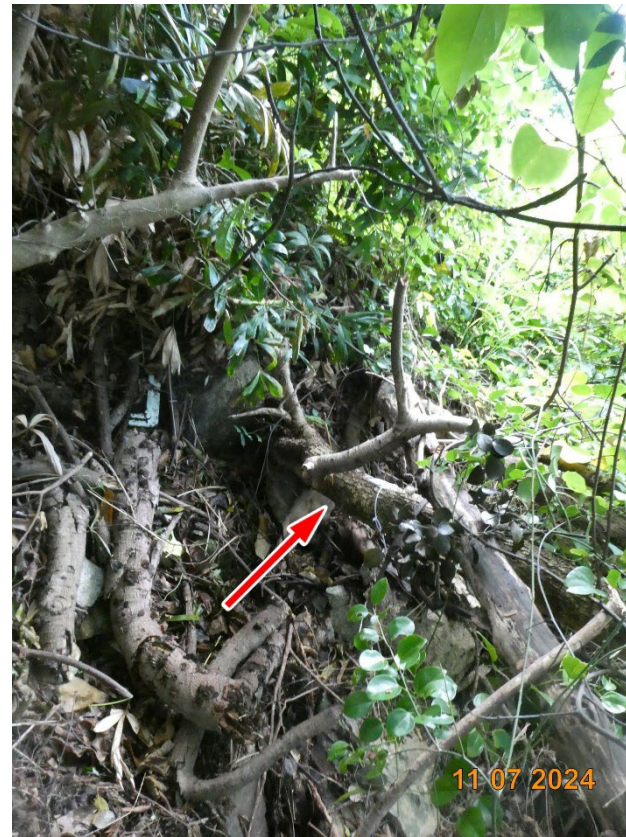
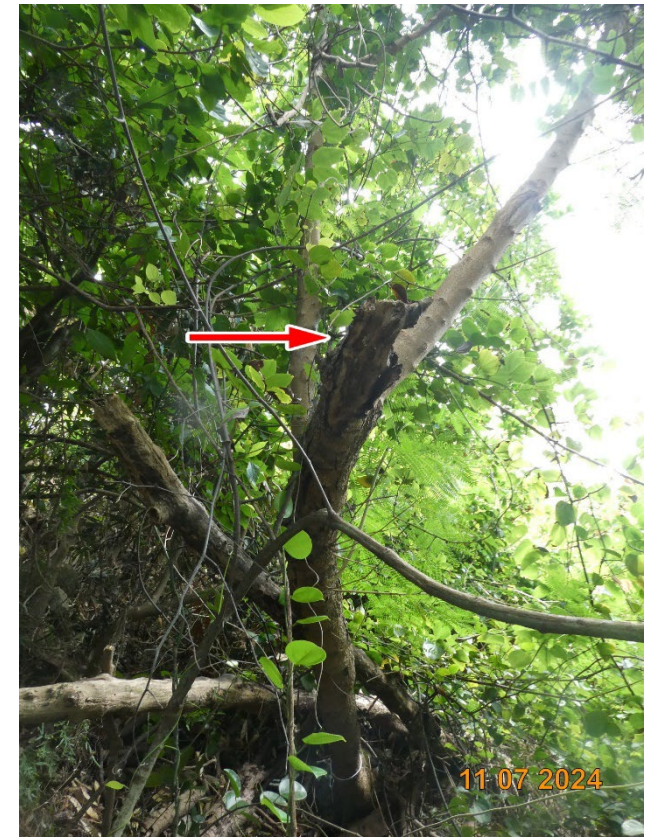
Photo No. 26 | T85 (Fell)

Photo No. 27 | T85 (Fell)

Photo No. 28 | T85 (Fell)

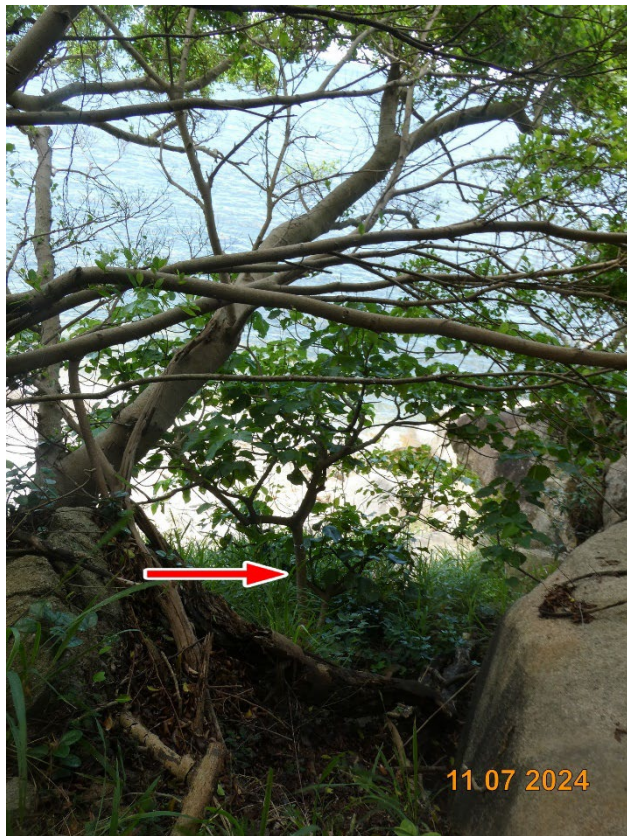
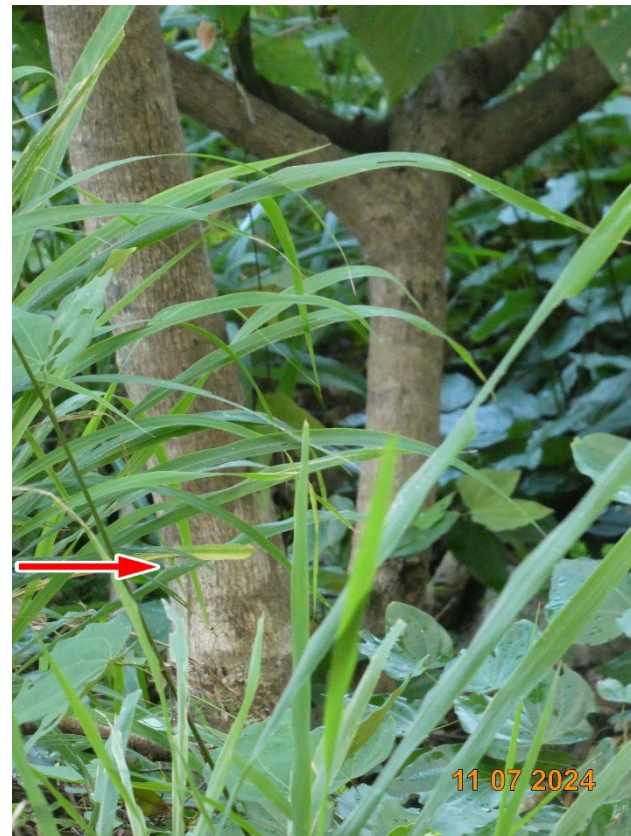
Photo No. 29 | T86 (Fell)

Photo No. 30 | T86 (Fell)
