Approved Geotechnical Planning Review Report of Last Application
No. A/SK-PK/268

**Proposed Temporary
Private Swimming Pool and Garden for
a Period of 3 Years at
Lot 1122 Ext and Adjoining Government Land in D.D. 217,
House 5B, Habitat, Pak Sha Wan,
Sai Kung, New Territories**

*Philip So & Associates Consulting Civil & Geotechnical Engineers Ltd.
December 2021*

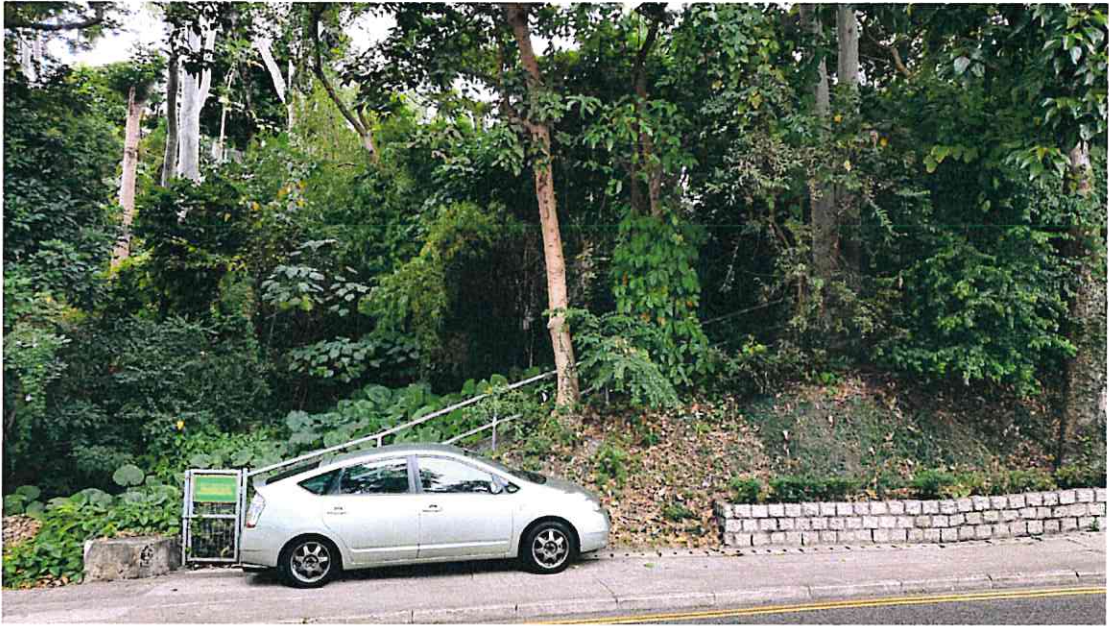
Photo 1: Photo showing the southern portion of Feature No. 7SE-D/C86

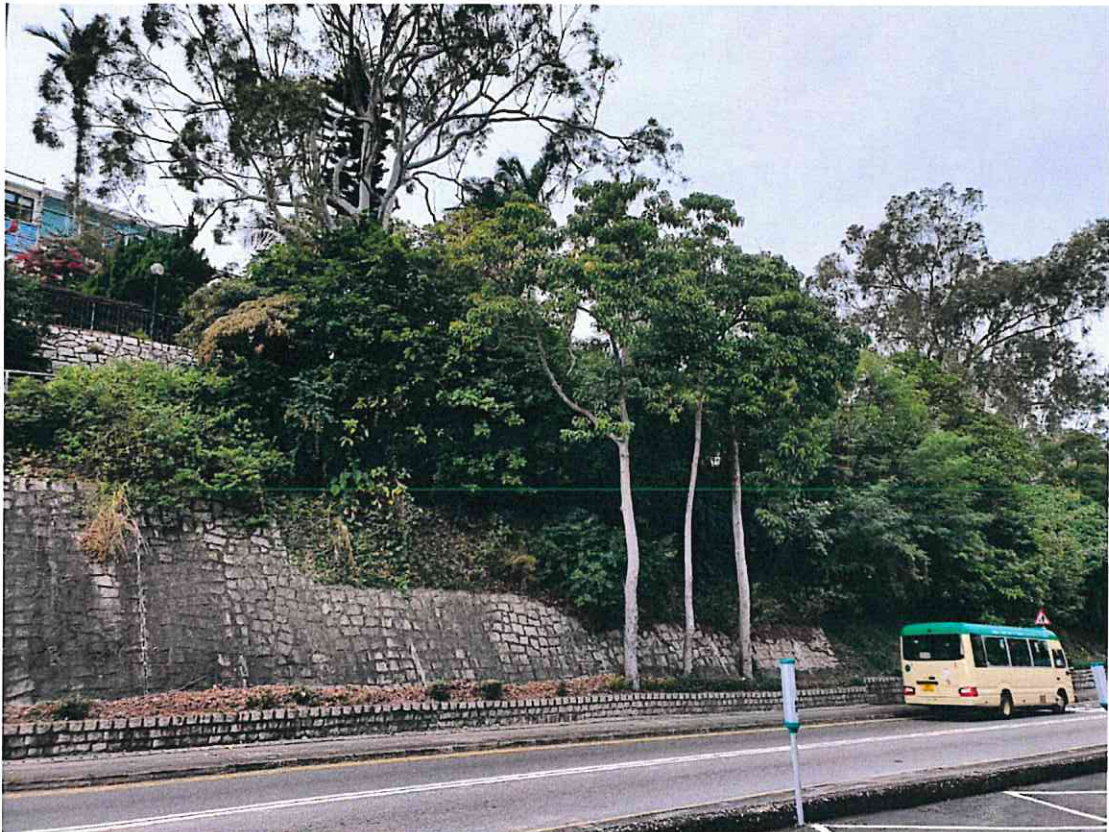
Photo 2: Photo showing the mid portion of Feature No. 7SE-D/C86

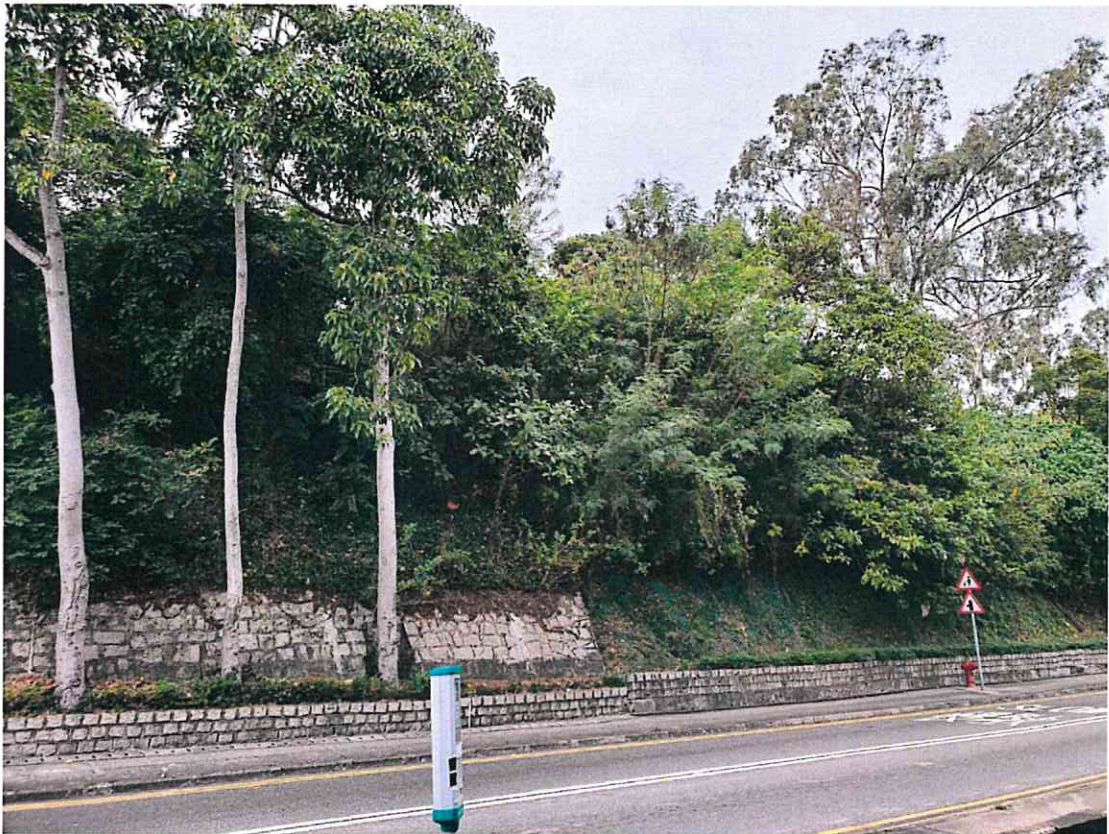
Photo 3: Photo showing the northern portion of Feature No. 7SE-D/C86

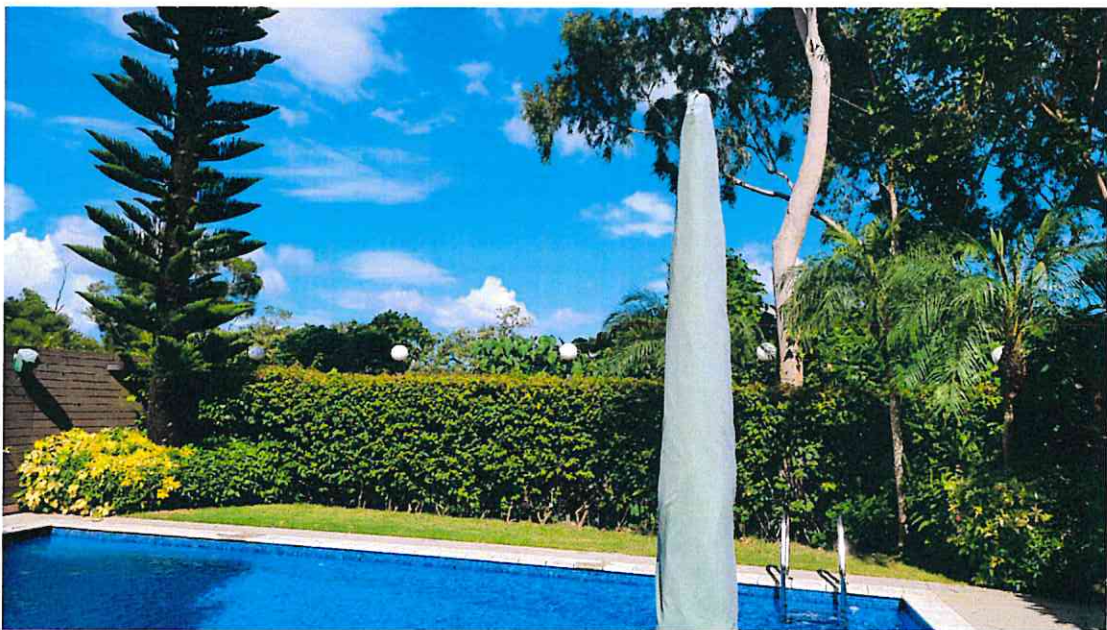
Photo 4: General view of existing swimming pool on site

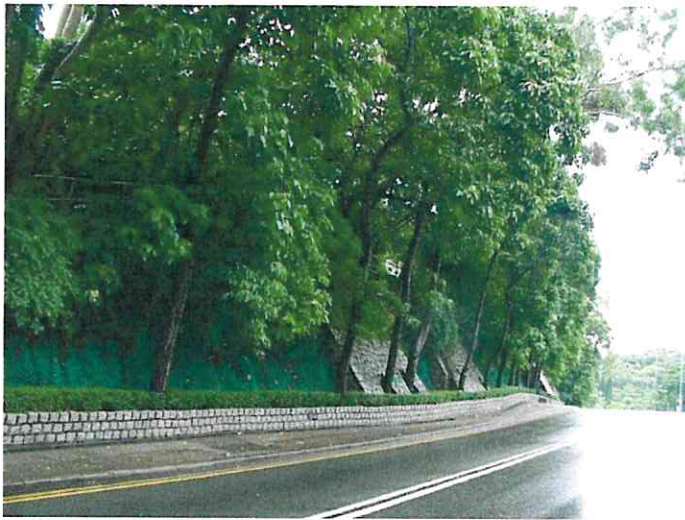
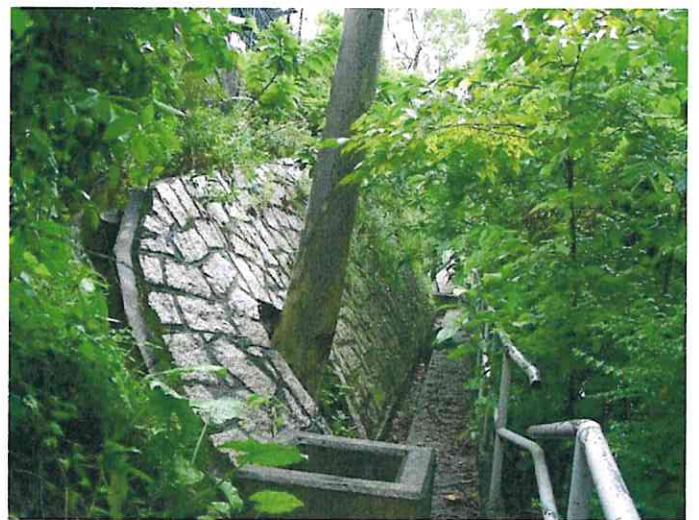
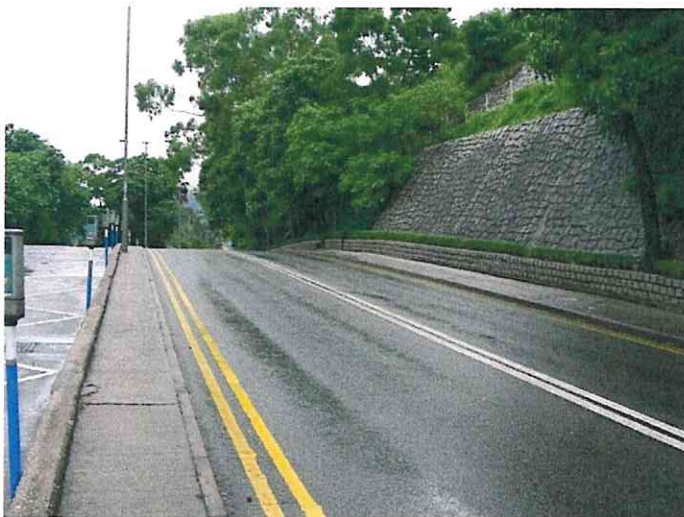
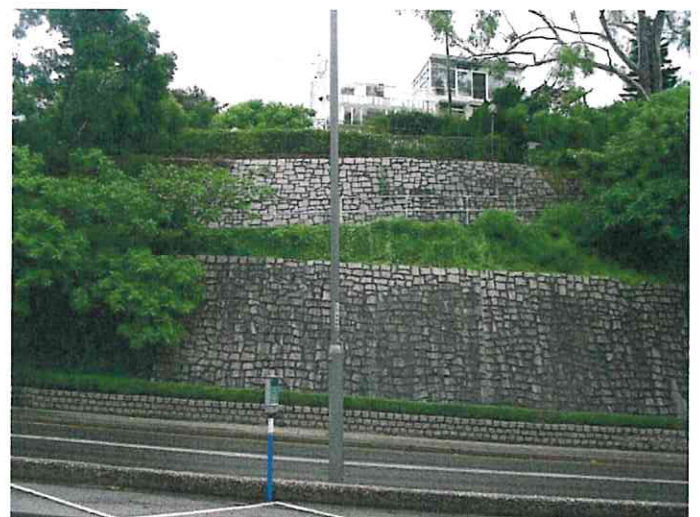
PHOTO

Sign of Seepage:	Slope : No signs of seepage Wall : N/A
Criterion A satisfied:	N
Sign of Distress:	Slope : Reasonable (near crest, mid-portion, at toe) Wall : N/A
Criterion D satisfied:	N
Non-routine maintenance required:	N
Note:	N/A
Masonry wall/Masonry facing:	N
Note:	N/A
Consequence category (for critical section):	2
Observations:	N/A
Emergency Action Required:	N
Action By:	N/A

Criterion A/Criterion D:	N/A
Action By:	N/A
Further Study:	Y
Action By:	Mixed
