**Proposed Development at Lot Nos. 332 (part),
333(part), 334(part), 335 (part), 337 (part), 338 (part),
339 (part), 340 (part), 341 (part), 342 (part), 344, 345
(part), 346 (part), 347 (part), 348, 350, 351, 352 (part),
354 (part), 355 (part), 356 (part), 357, 358, 360 (part),
361, 362 (part), 363 (part), 365 (part), and 366 (part)
and Adjoining Government Land in DD332L, Cheung
Sha, Lantau Island, New Territories**

GEOTECHNICAL PLANNING REVIEW REPORT

REVISION 1

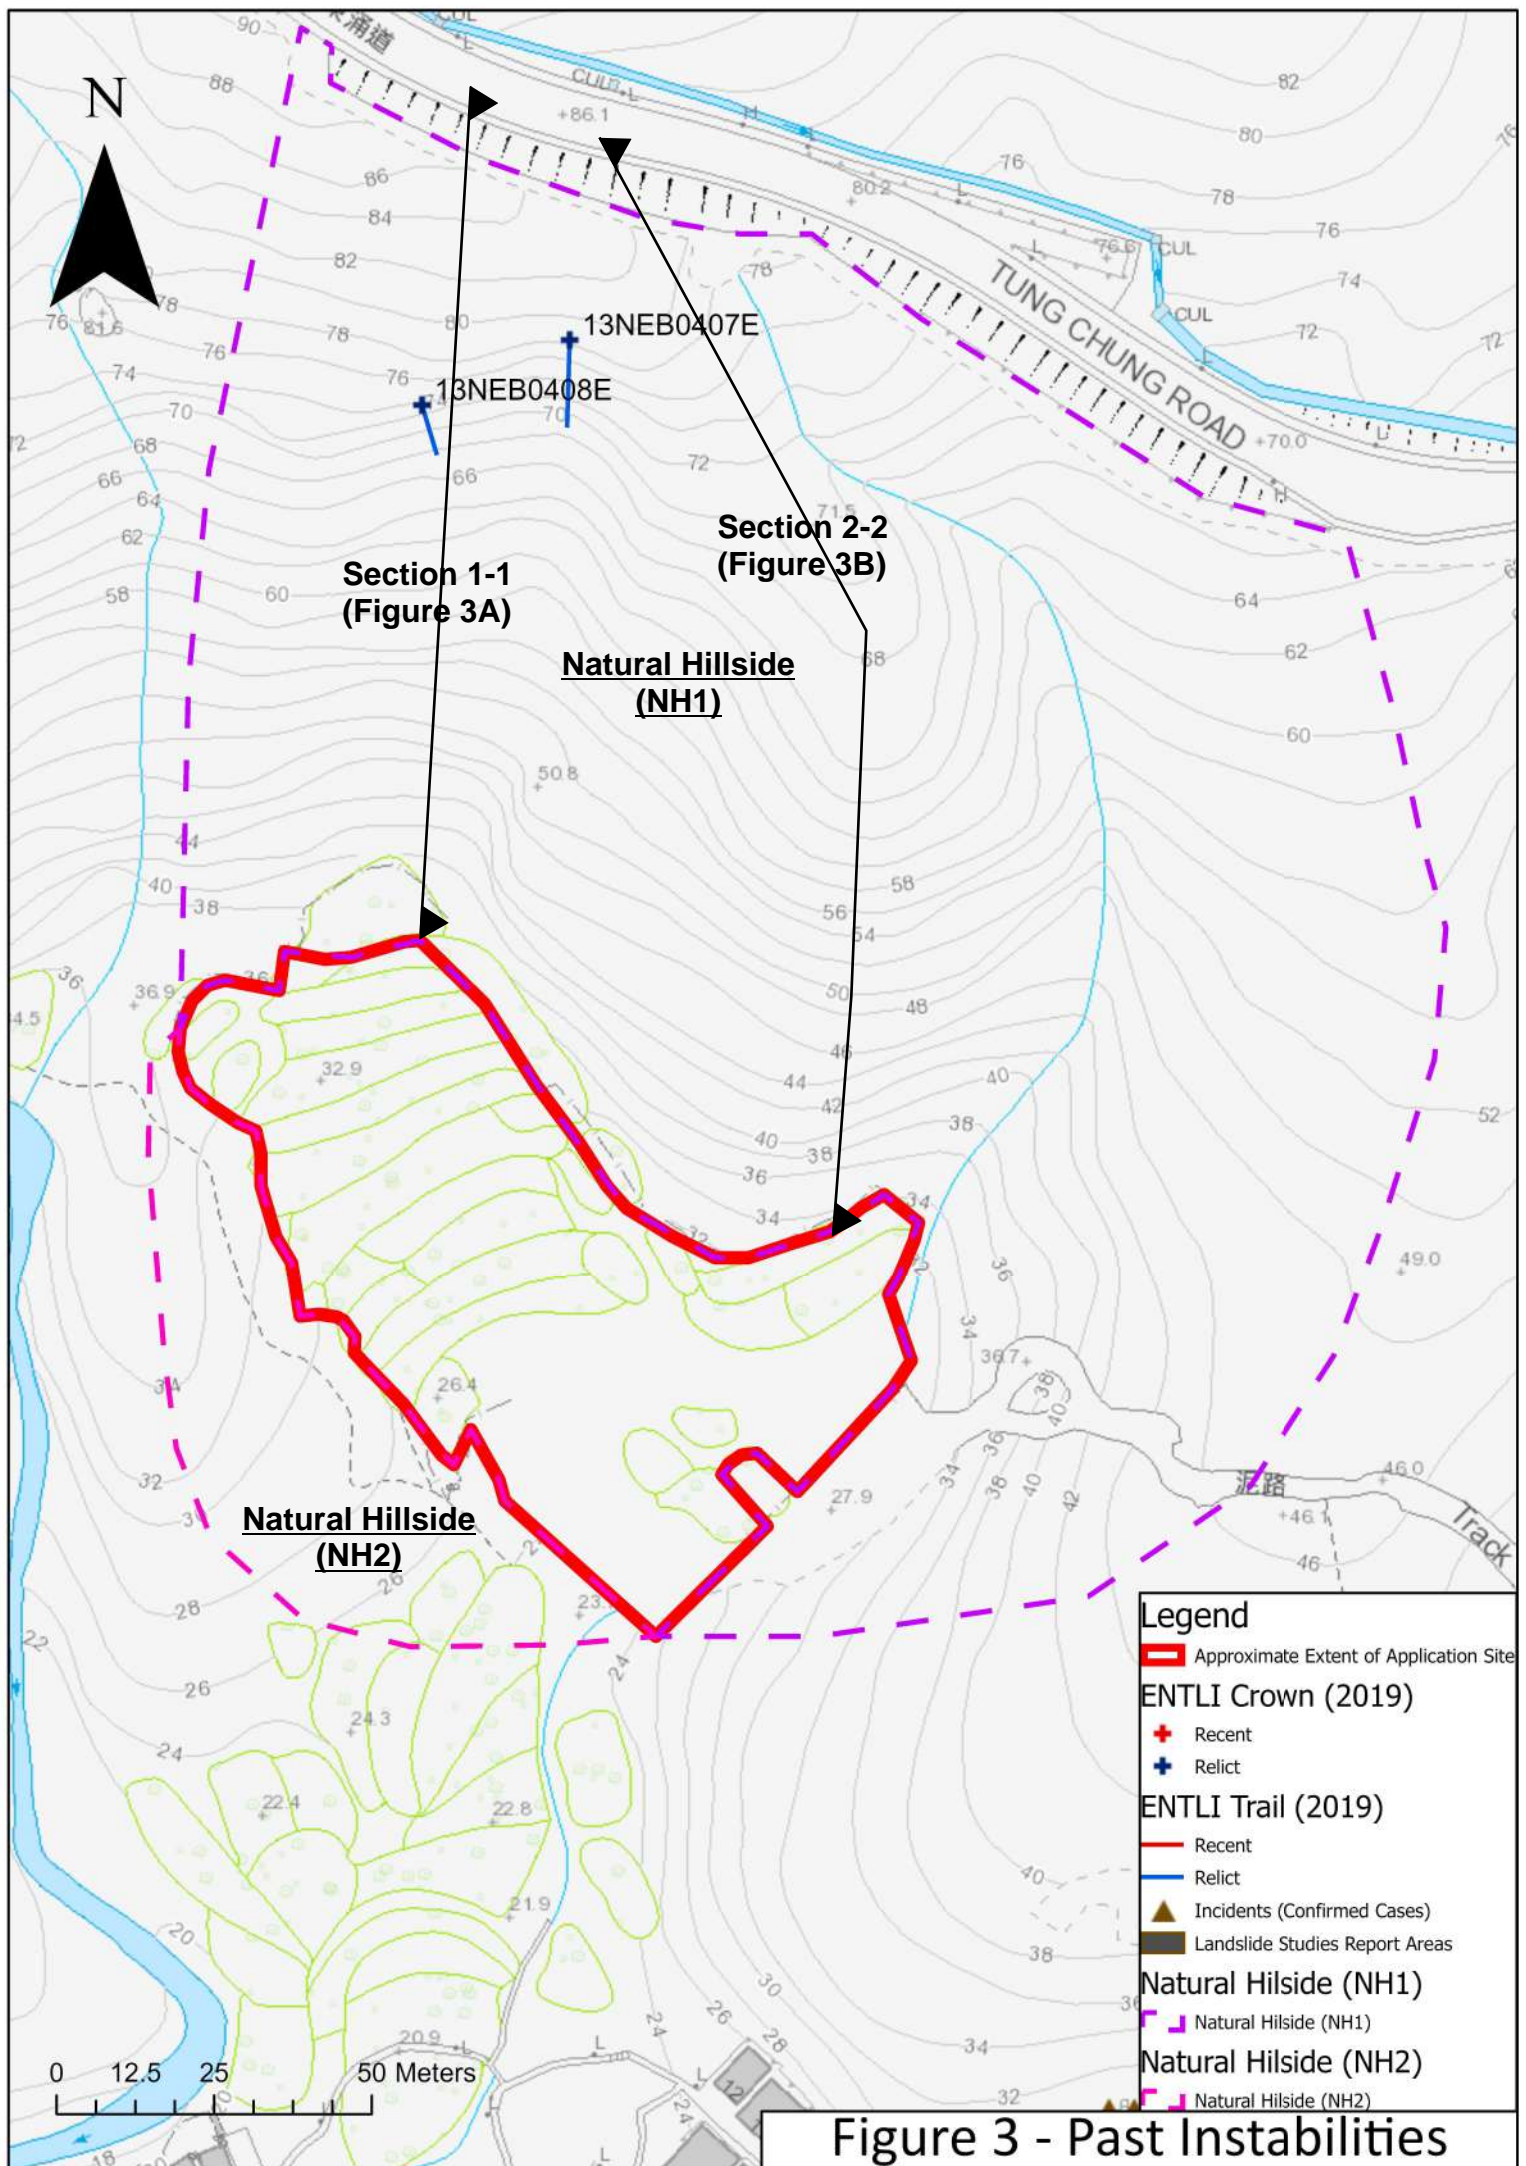
Figure 3

The ENTLI has recorded no relict or recent landslide within the Site (see **Figure 3**).

Historical Landslide Catchments (HLCs) have been defined by GEO based on the results of the ENTLI. According to the inventory, no catchment is located at or in the vicinity of the Site (see **Figure 3**).

The GEO has recorded no landslide incident within the Site. (see **Figure 3**)

As mentioned in Section 3.2 and 3.3, the ENTLI has recorded a no relict or recent landslide and no HLC catchment within the Site. The natural hillside (NH1) (as shown in **Figure 3** and **Photos A, B, C and F**) surrounds from north to east of the application site has an angular elevation more than 20° from the application site (see **Figures 3A and 3B**). The angular elevation is above the 'Alert Criteria' of 20° with respect to the concerned natural hillside according to the GEO Report No. 138 (2nd Edition). In addition, the natural hillside (NH2) located at southwest of the application site may affect by the proposed development (as shown in **Figure 3**). Thus, further study of the natural hillsides is required.

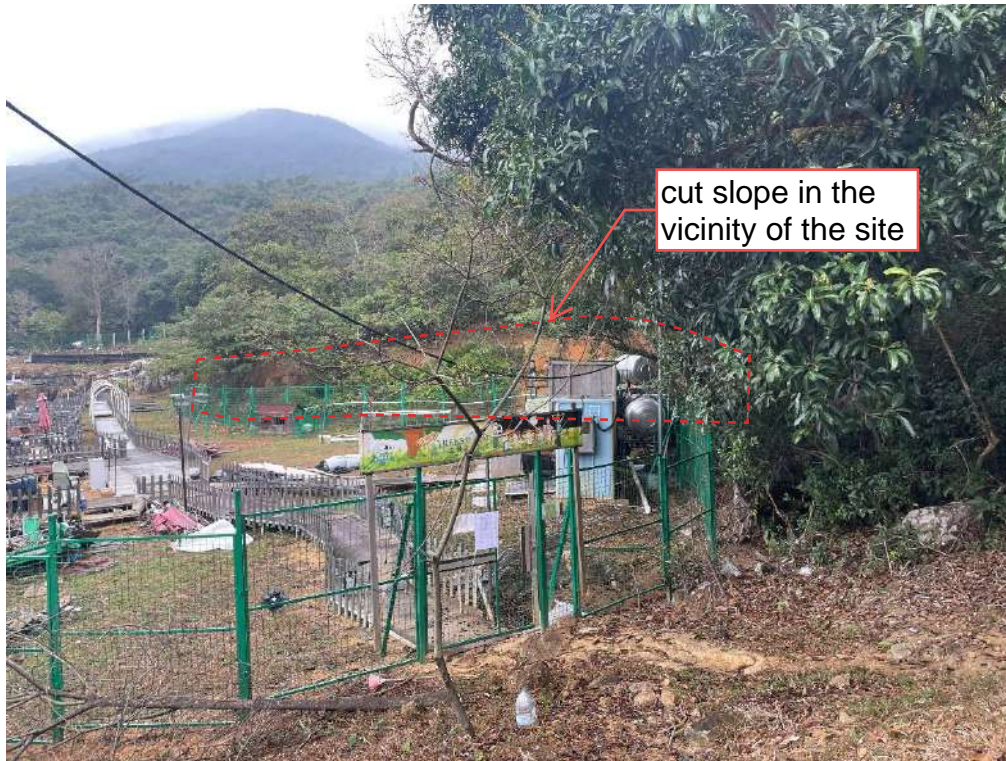
Photo A

According to the available SIMAR reports retrieved from Lands Department and SIS records obtained from Geotechnical Engineering Office (GEO), there is no registered geotechnical feature lies within or in the vicinity of the site (see **Figure 2**). However, during the site visit in February 2024, some cut slopes were found in the vicinity of the site (see **Photos A and H**).

As mentioned in Section 2, there is no registered slope feature within or at the vicinity of the application site. For those cut slopes in the vicinity of the site found during the site visit, which may affect or be affected by the proposed development, further study of the slopes is required.
