Tree Survey Report

Lots 1213 RP, 1215 RP, 1216 RP, 1217 S.C RP (Part), 2579 (Part), 2583 (Part) and 2584 (Part) in D.D. 104 and Adjoining Government Land, Ngau Tam Mei, Yuen Long

Date: 29th October 2024

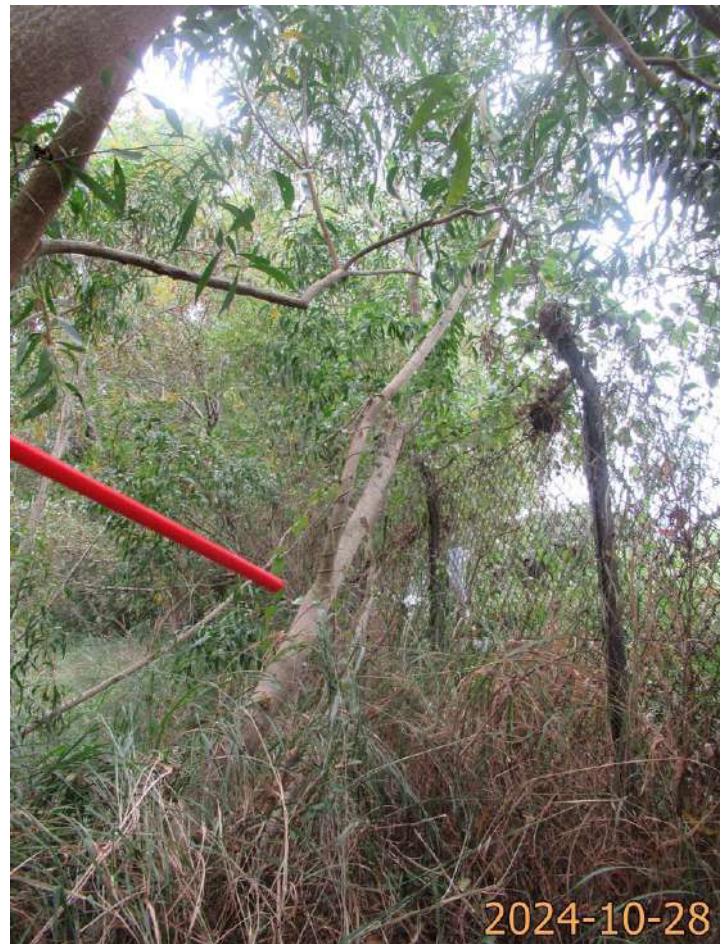
T4 (Overview) (Uprooted)

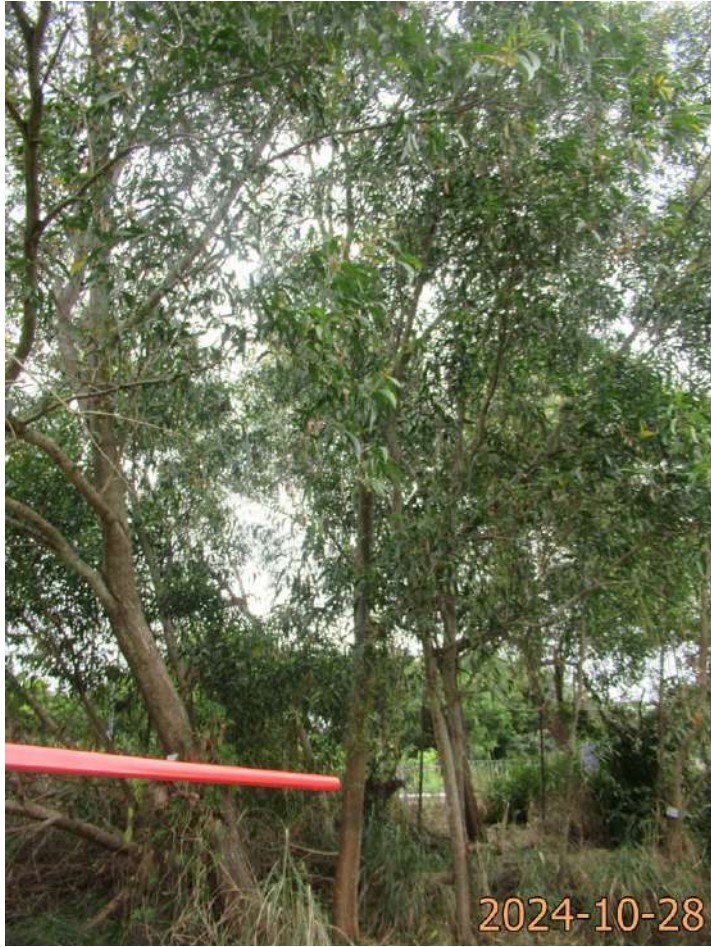
T5 (Overview) (Uprooted)

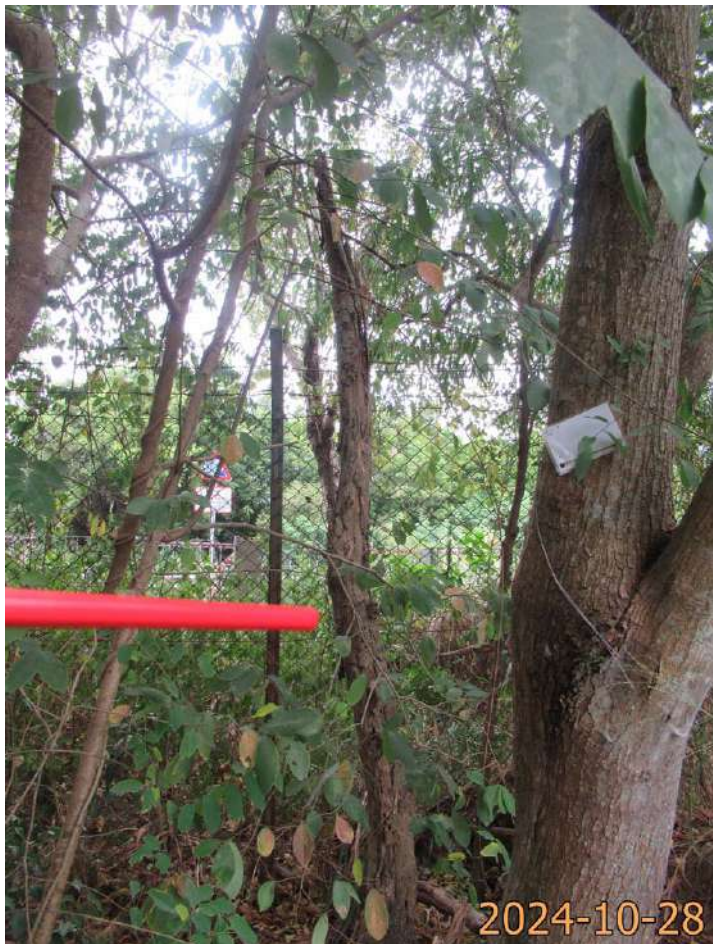
T9 Dead trunk

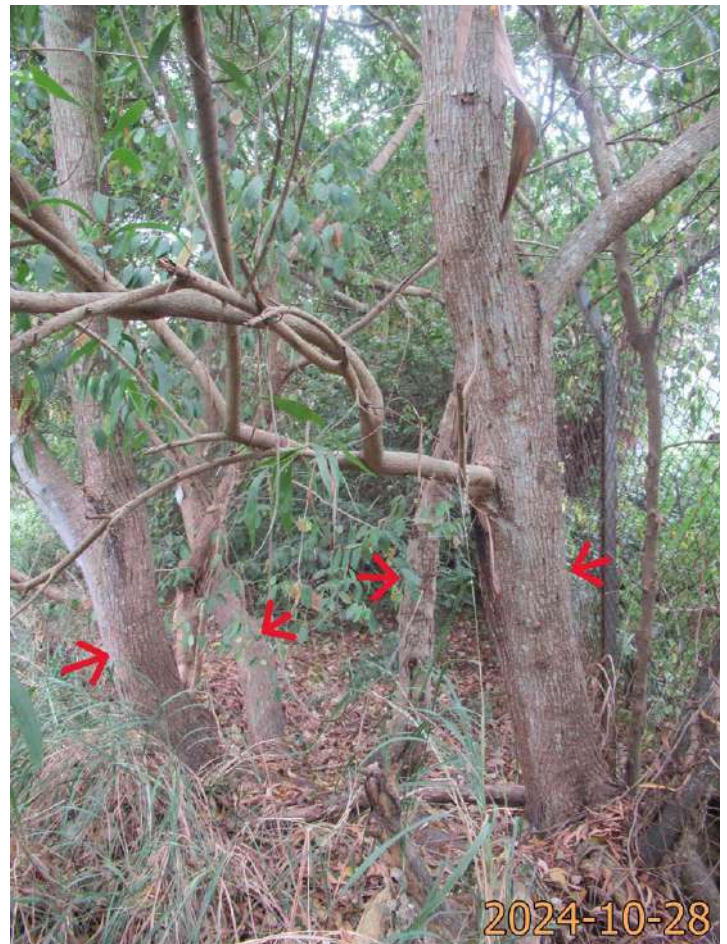
T9 Multi-trunks

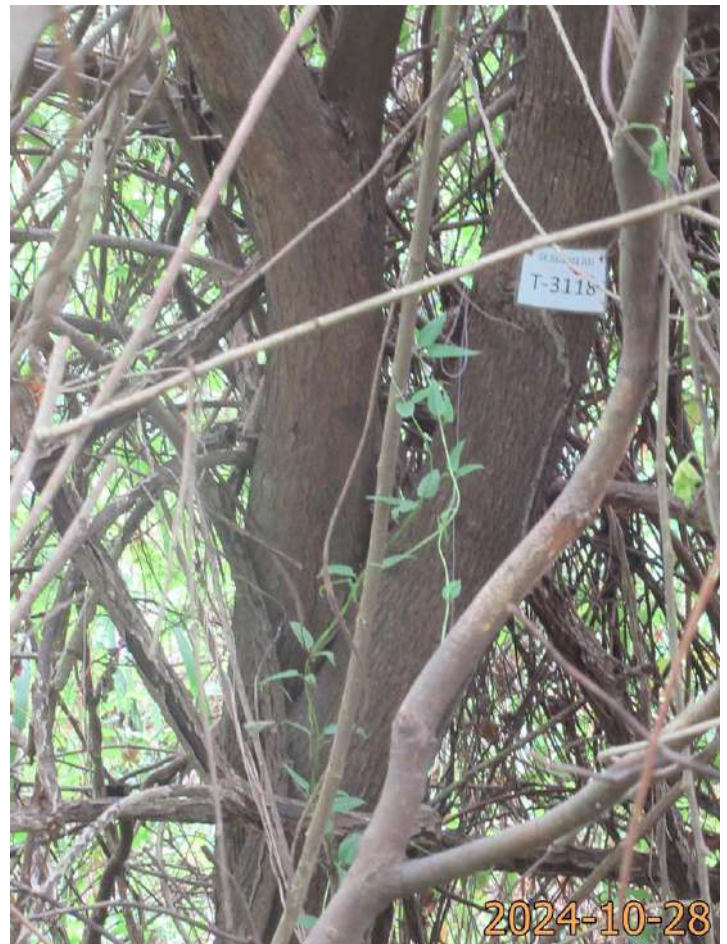
T16 Included bark

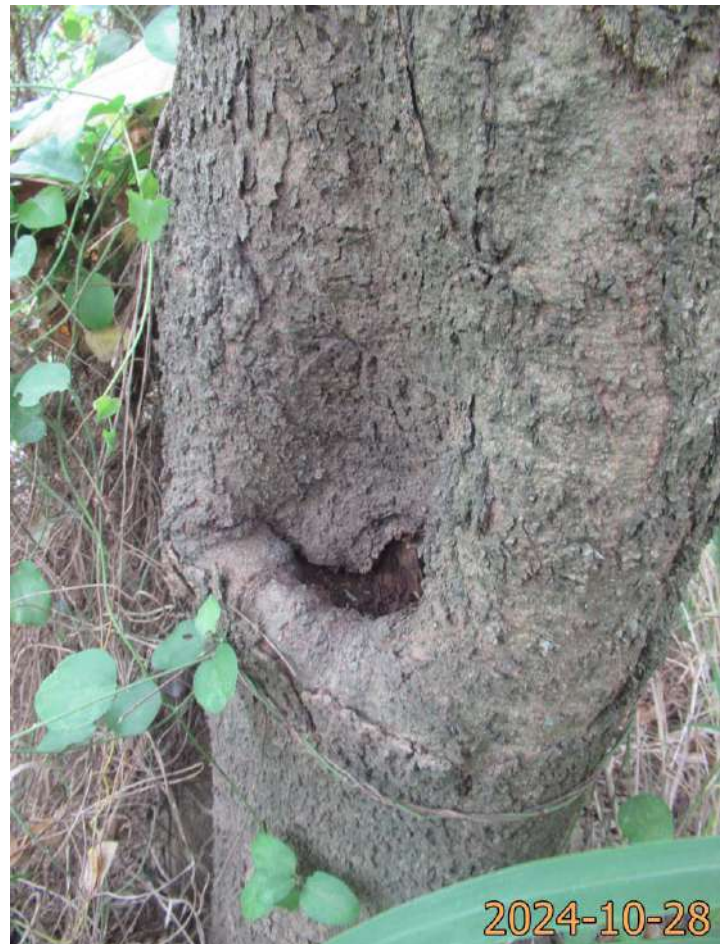
T19 Cavity at trunk

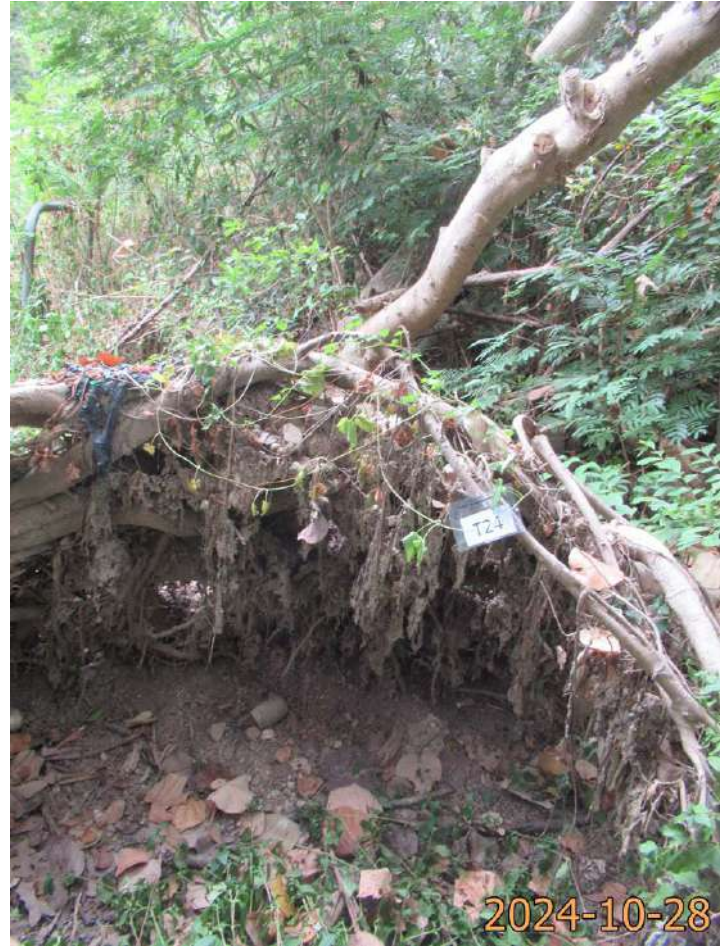
T24 Collapsed
