**Proposed Temporary Animal Boarding Establishment with Ancillary Facilities
for a Period of 5 Years and Associated Filling of Land in “Agriculture” Zone,
Lot 1756 (Part) in D.D. 118, Tai Tong, Yuen Long, New Territories**

(S.16 Planning Application No. A/YL-TT/665)

Tree Survey Report

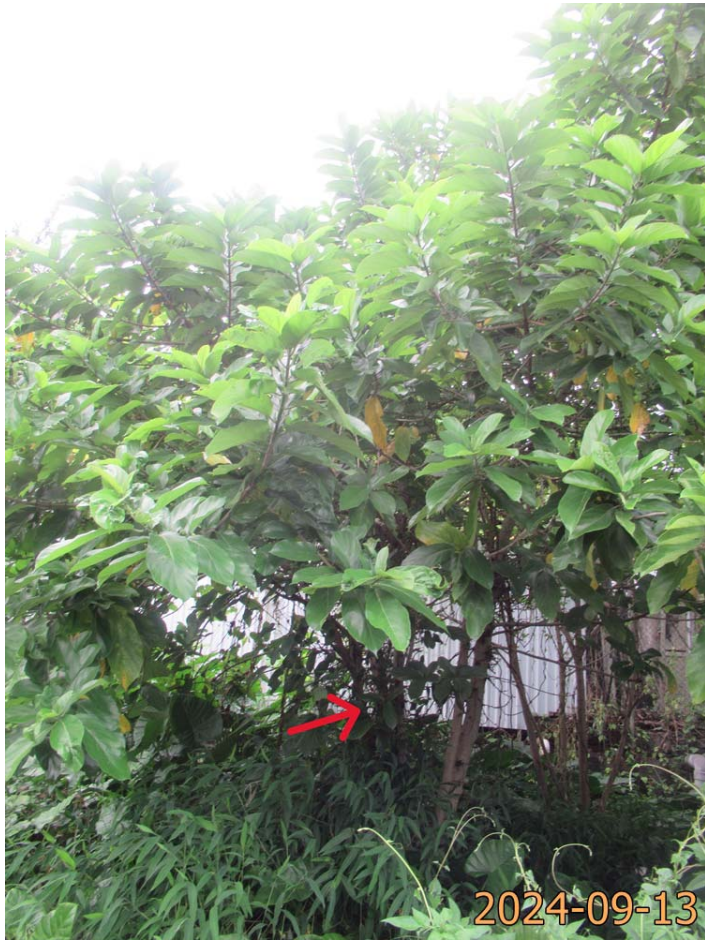
T1 (Overview)

Tree No.	Tree Species		Tree Size Measurements			Amenity Value	Form	Health Condition	Structural Condition	Suitability for Transplanting	Remarks
	Botanical Name	Chinese Name	Overall Height (m)	DBH (mm)	Average Crown Spread (m)	High /Med /Low	Good /Fair /Poor	Good /Fair /Poor /Dead	Good /Fair /Poor	High /Med /Low	
T1	<i>Ficus hispida</i>	對葉榕(牛乳樹)	7.0	120	4.0	Low	Fair	Fair	Fair	Low	multi-trunks
T2	<i>Ficus hispida</i>	對葉榕(牛乳樹)	7.0	95	4.0	Low	Fair	Fair	Fair	Low	multi-trunks
T3	<i>Ficus hispida</i>	對葉榕(牛乳樹)	7.0	160	6.0	Low	Fair	Fair	Fair	Low	multi-trunks

2. Comments of the Chief Town Planner/Urban Design & Landscape Section, Planning Department (CTP/UD&L, PlanD)		
(a)	No mitigation measures and landscape proposal are proposed by the applicant to demonstrate the proposed uses and associated filling of land would not have adverse landscape impact on the existing trees/vegetation within the Site. We would reserve our comment upon receipt of the required landscape technical information.	The site inspection conducted on 13.09.2024 identified 3 nos. of tree within the Site. The tree survey report is enclosed at Annex 1 . The existing trees are of common species i.e. <i>Ficus hispida</i> (對葉榕) which are in direct conflict with the proposed structure. Given their low amenity value and suitability for transplanting, all existing trees are proposed to be felled.
