Chung Hom Kok

Annex B

Visual Impact Assessment

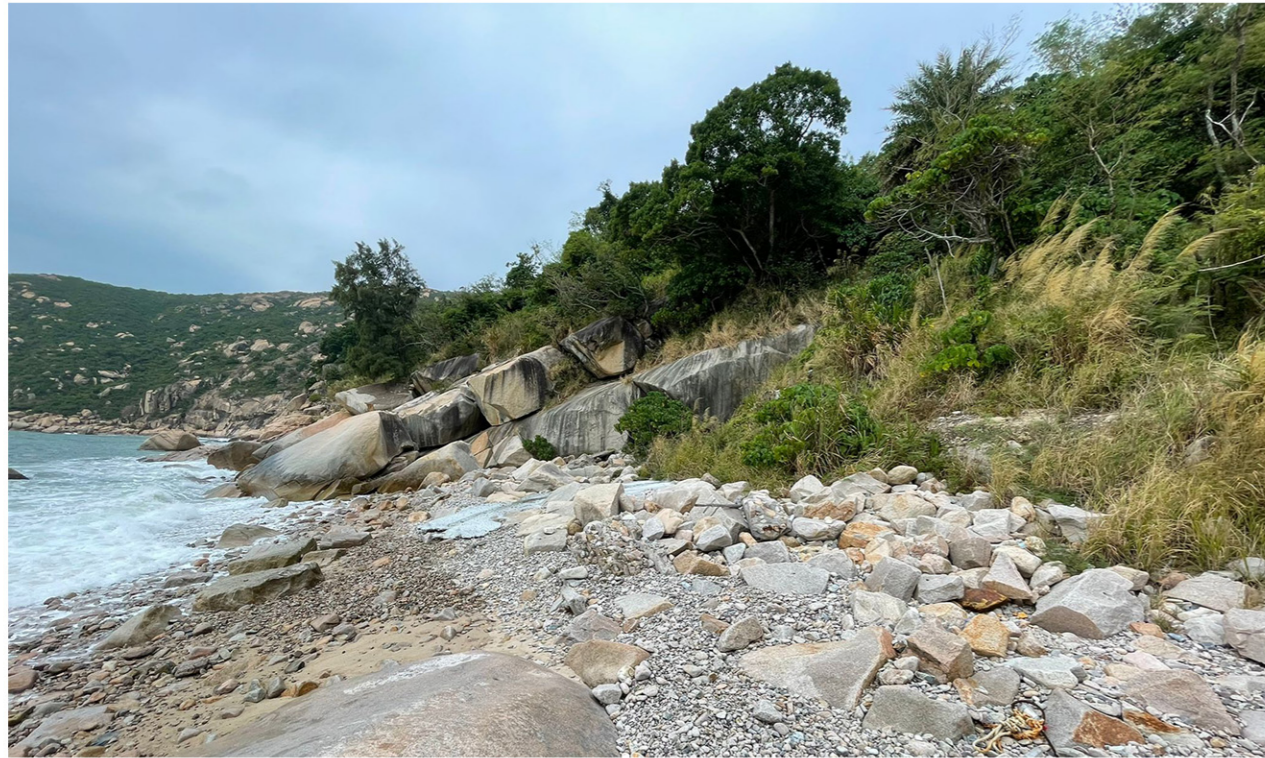
Before Implementation

- 4.4.6 The existing view at VP2 is primarily composed of sandy and rocky shore in the foreground and middle ground, accompanied by secondary woodland above the shore in the background.
- 4.4.7 As the proposed beach manholes will be buried below ground with only the manhole cover at ground level be hidden by re-established grass, and given the very limited scale of the proposed installation overall, it is anticipated that the proposed installation will not substantially change the visual composition at VP2.

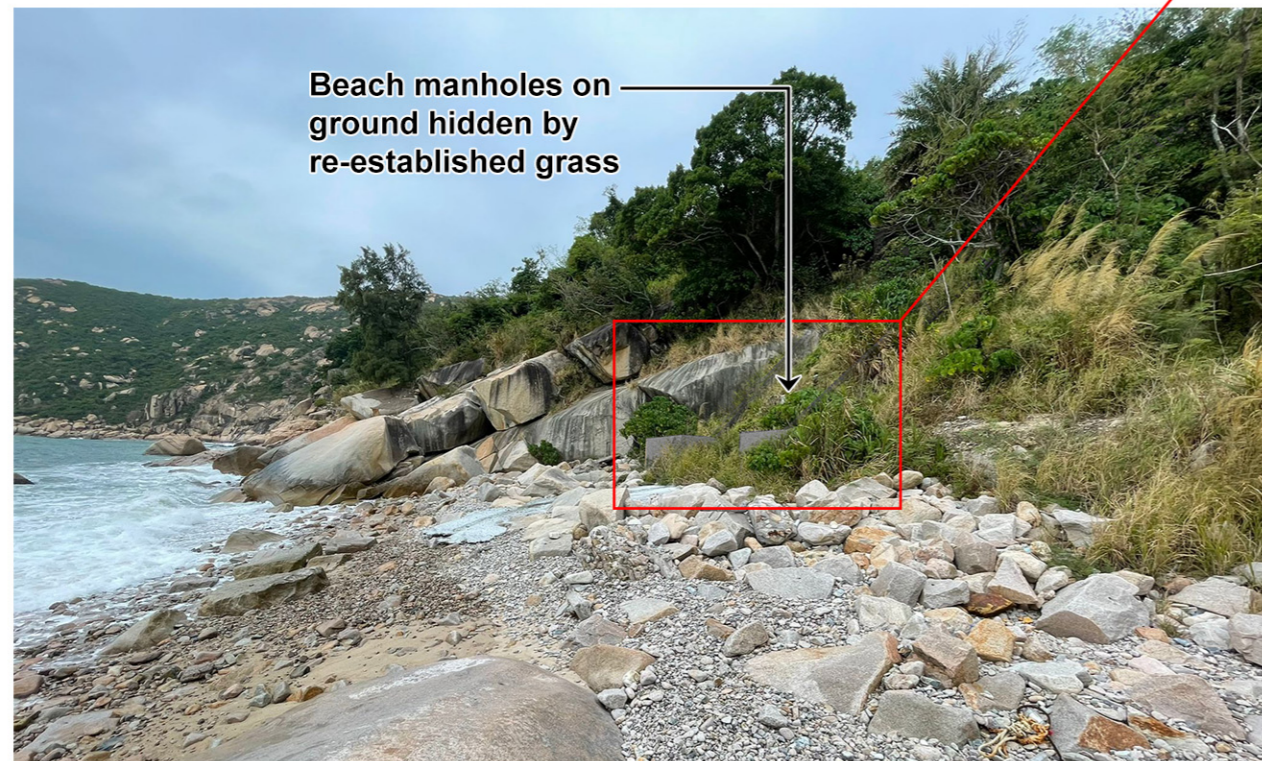
After Implementation

Beach manholes on ground hidden by re-established grass

- 4.4.8 Since the proposed installation will be screened by dense vegetation on the hillside, and since the proposed beach manholes will eventually be hidden by re-established grass (and therefore not be visible at VP2), it is considered that the proposed installation will not give rise to any visual obstruction at VP2.

- 4.4.9 The visual elements visible at VP2 include coastal water, boulders and shingle on the rocky and sandy shore in the foreground and middle ground, and secondary woodland in the background. The proposed beach manholes will not be visible at VP2 given the screening effect of the re-established grass. Taking into account the very limited footprint of the proposed installation, it is not anticipated that the proposed installation will significantly alter the view as shaped by a composition of these visual elements. The loss of 12 nos. trees on the hillside will result in very slight visual impacts during construction when seen against the mass of woodland vegetation along the coastal hillside as a whole. It can reasonably be expected that these impacts will be mitigated in the medium and long term by the colonisation and re-establishment of adventitious vegetation.
