Appendix C
Conservation Management Plan

Assessment and validation of the Revised Conservation Management Plan and design proposals of Maryknoll House

MARYKNOLL HOUSE STANLEY
CONSERVATION MANAGEMENT PLAN
ISSUE 01
AUGUST 2024

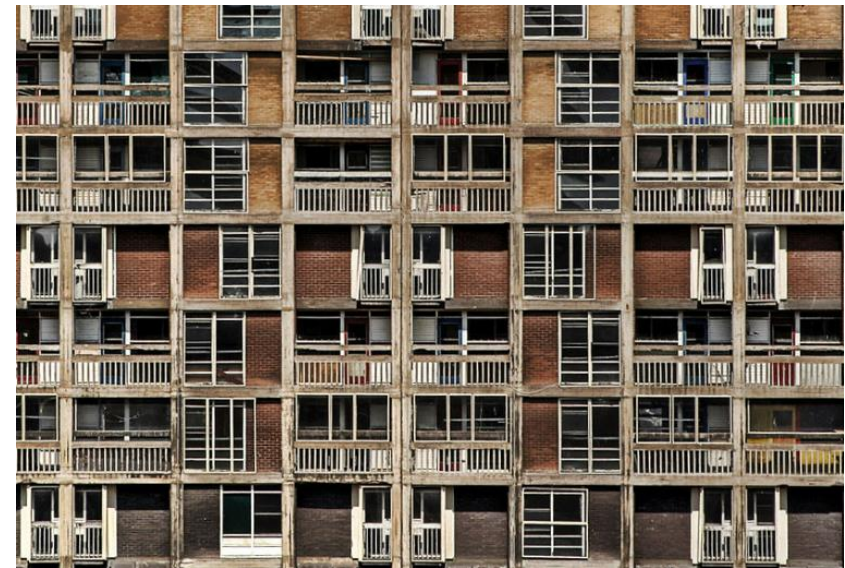
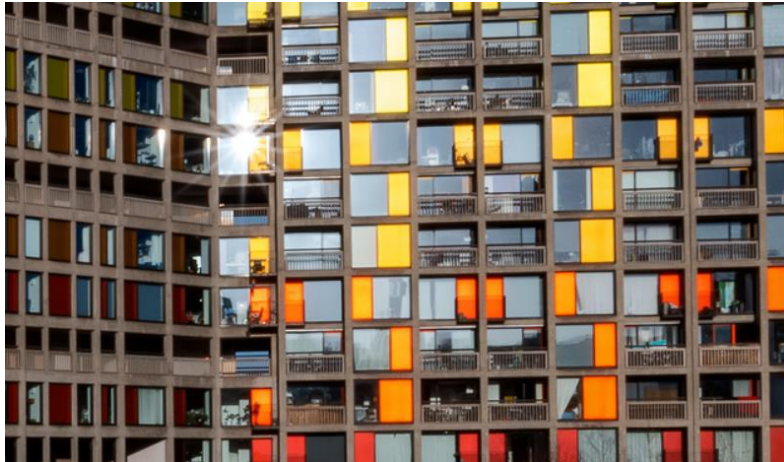
- 3.9 The illustrations show Park Hill before and after conversion. The essential structural principles of the elevations have been retained and the sense of light and shade by recessing the new glazed frontages into the concrete frame.

- 3.10 As at Park Hill the proposal at Maryknoll is to remove elements of the back wall of the verandas in order to take them into the volume of the apartments behind. The proposed removal of the timber windows and doors is undoubtedly a loss of historic fabric and has to be weighed up against the gains in making the apartments a successful adaptation of the old Rest House.

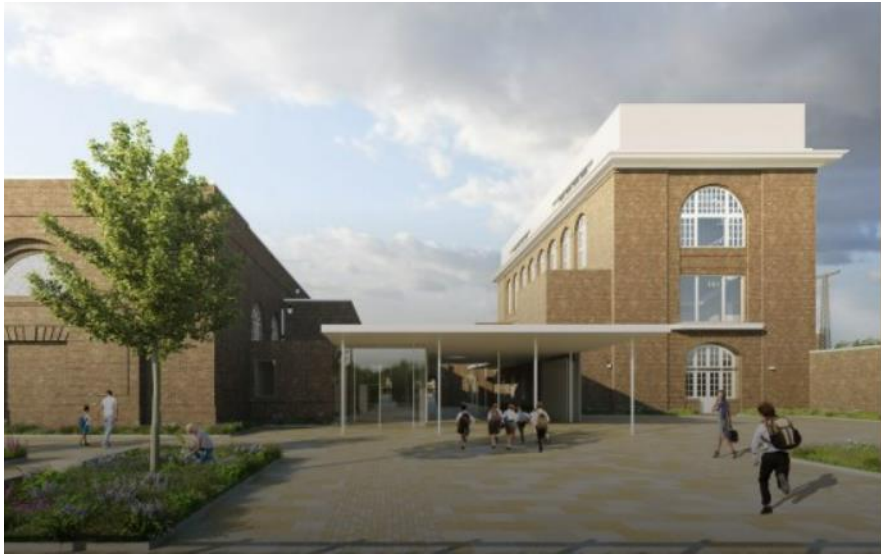
- 4.3 In recent years it has become very common to add entrance porticoes to historic buildings to facilitate better access and provide shelter from sun and rain. A nice recent example from the UK is the entranceway added to the Grade II listed Rugby Radio Station building, which was the hub of global communications in the 1920s and surrounded by the iconic 820ft radio masts. This was an adaptive reuse project to make an entrance to a school. The former industrial buildings have been converted into classrooms and lecture halls and are now entered by a minimalist entrance portal which does not complete with the heritage significance of the Victorian buildings.

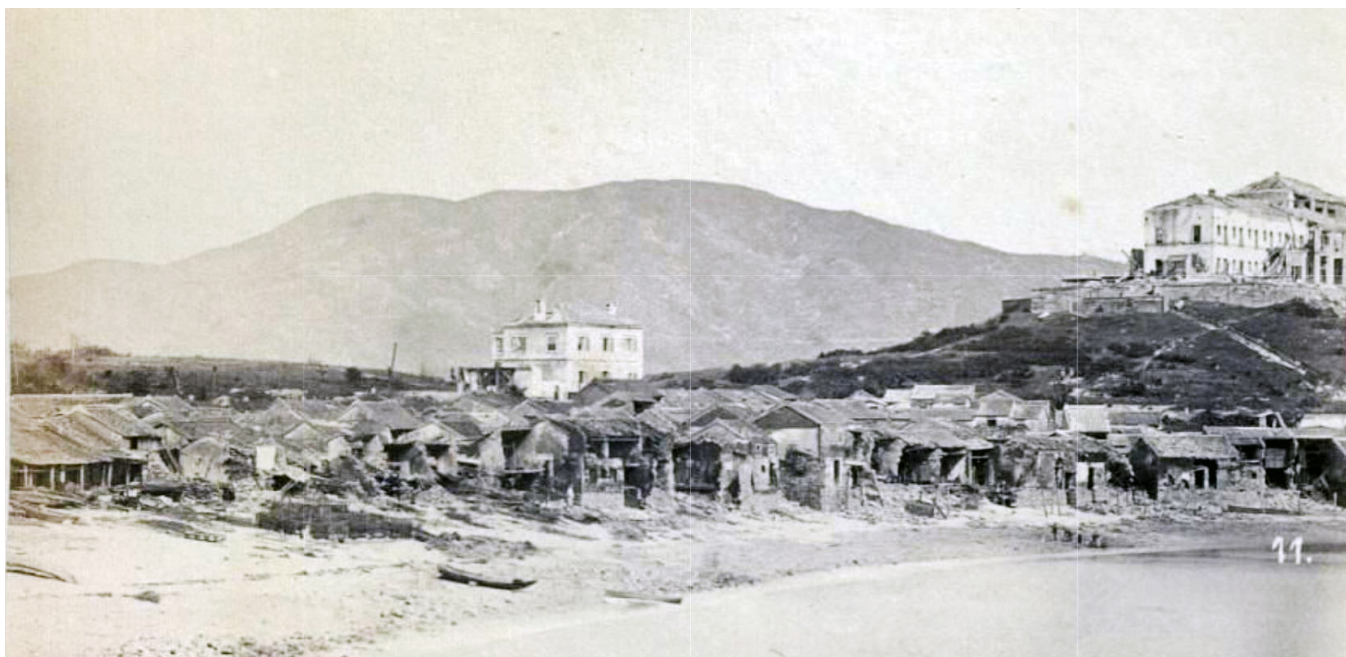
Fig 08: The Typhoon's destruction of Stanley. (Source: University of Michigan, '[11. Ruins of Stanley - Looking North -East & 12. Stanley - Continuation of the Preceding View](#)', detail from Gwulo, accessed 07/08/2024).

In 1874 the village was hit by a Typhoon which caused a great deal of damage. The Police station was partly unroofed, the Barracks were badly damaged. Many boats were wrecked on the beach, and the families that lived on them were drowned. The fishermen's houses were also badly damaged by the storm surge.¹¹

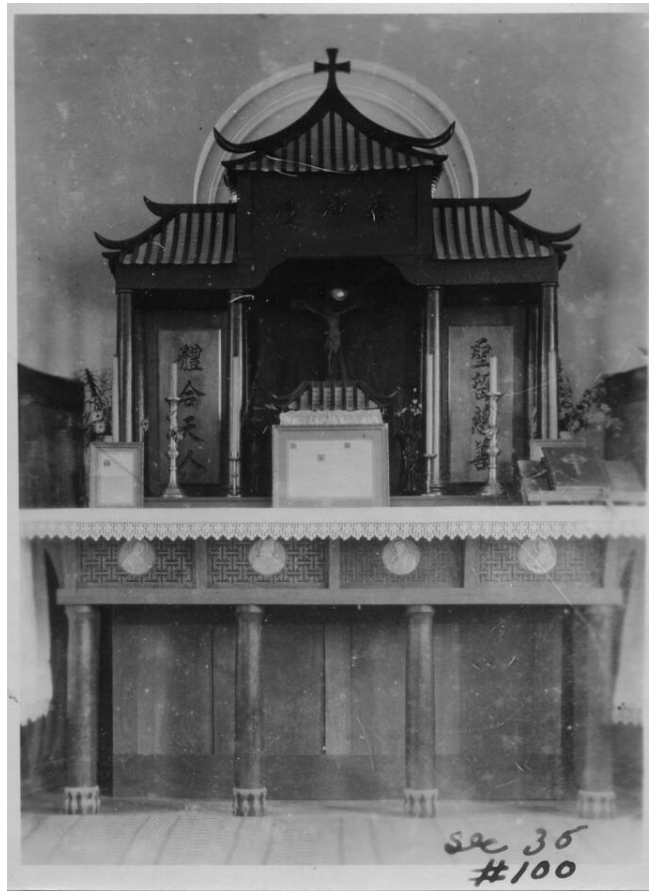
Fig 10: The Sun Chong Chapel main altar at Pakkai [now Beijie], made by Brother Albert Staubli in 1926 (Source: 'The main altar at Beijie, China, 1926', USC Maryknoll Mission Archives, UC1887384)

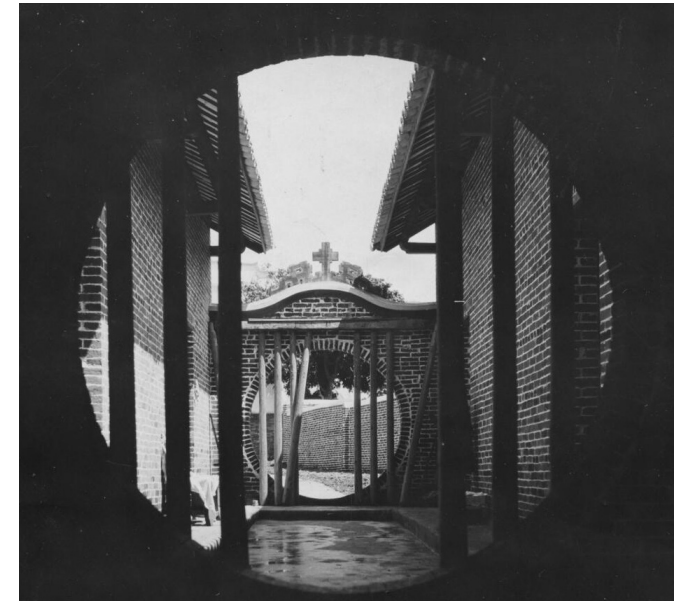
Fig 11: Two moon doors leading to the front of the new orphanage, designed and constructed under Brother Albert Staubli's supervision. (Source: Fr. Rauschenbach, 'The new orphanage at Luoding, China, 1927', USC Maryknoll Mission Archives, UC1775971).

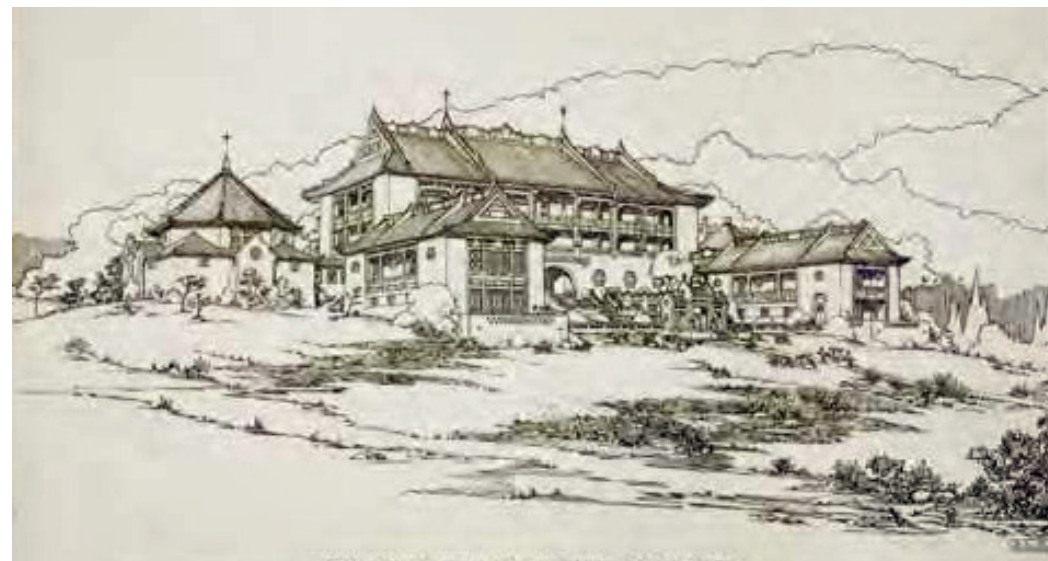
Fig 12: McGill's design for the Maryknoll House. (Source: Maryknoll Mission Archives).

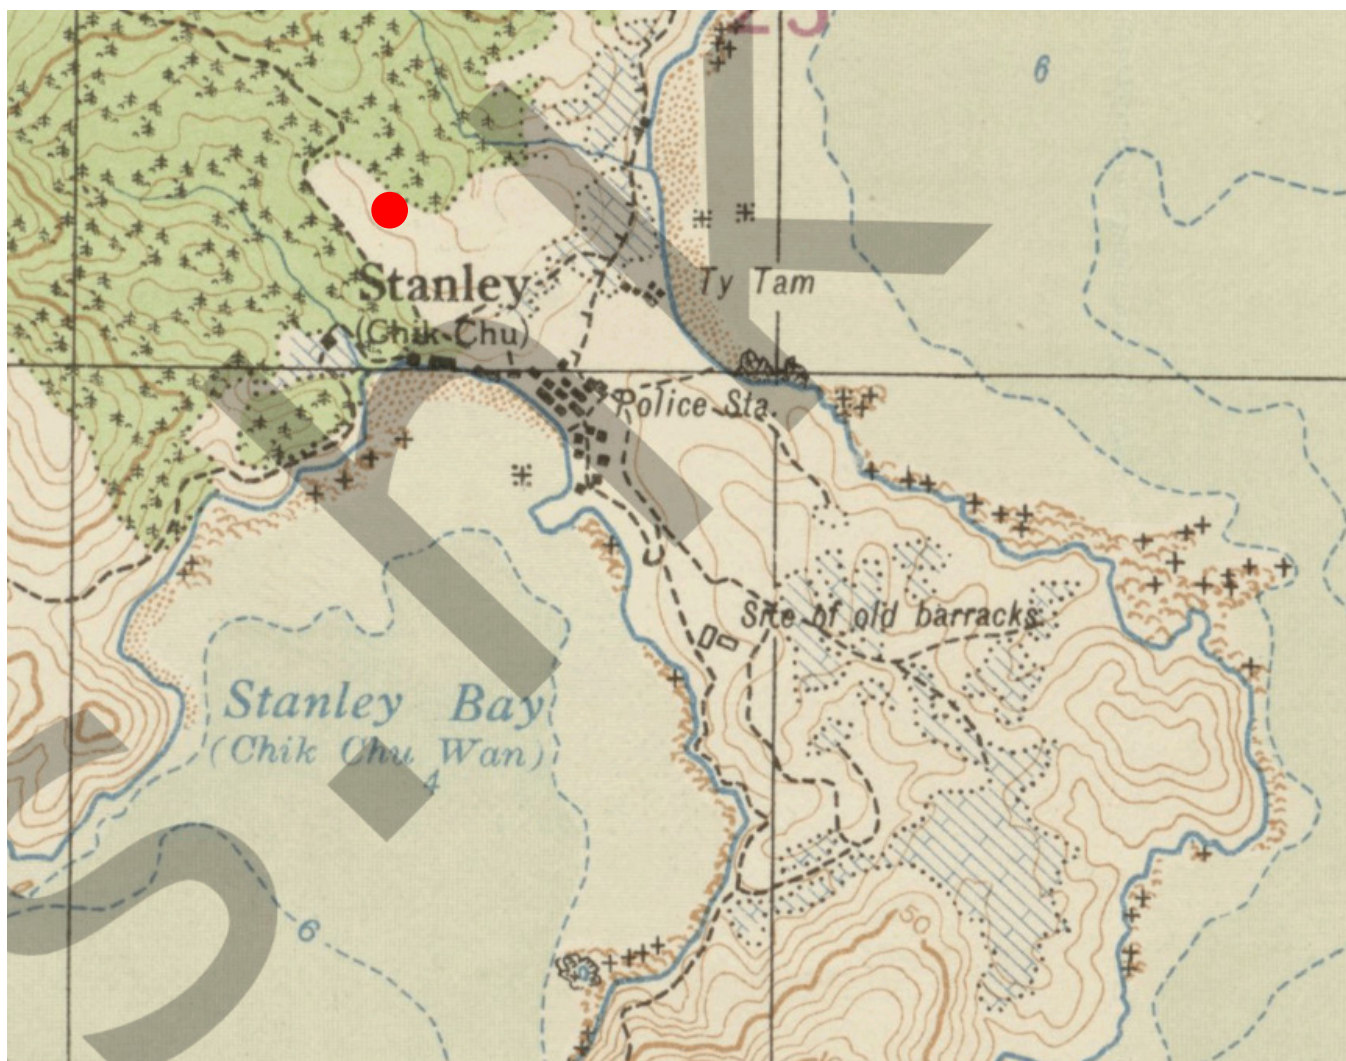
Fig 13: Future site of Maryknoll House (red circle). Map shows the Village, police station, and the site of the ruined barracks (Source: UK National Archives, 'Hong Kong leased territory. GSGS 3868. In progress. 1:20,000. War Office; FO 925/25283, 1928, from Hong Kong Historic Maps, 'HKMaps' [website], Last Revision Date: 20 May 2024).

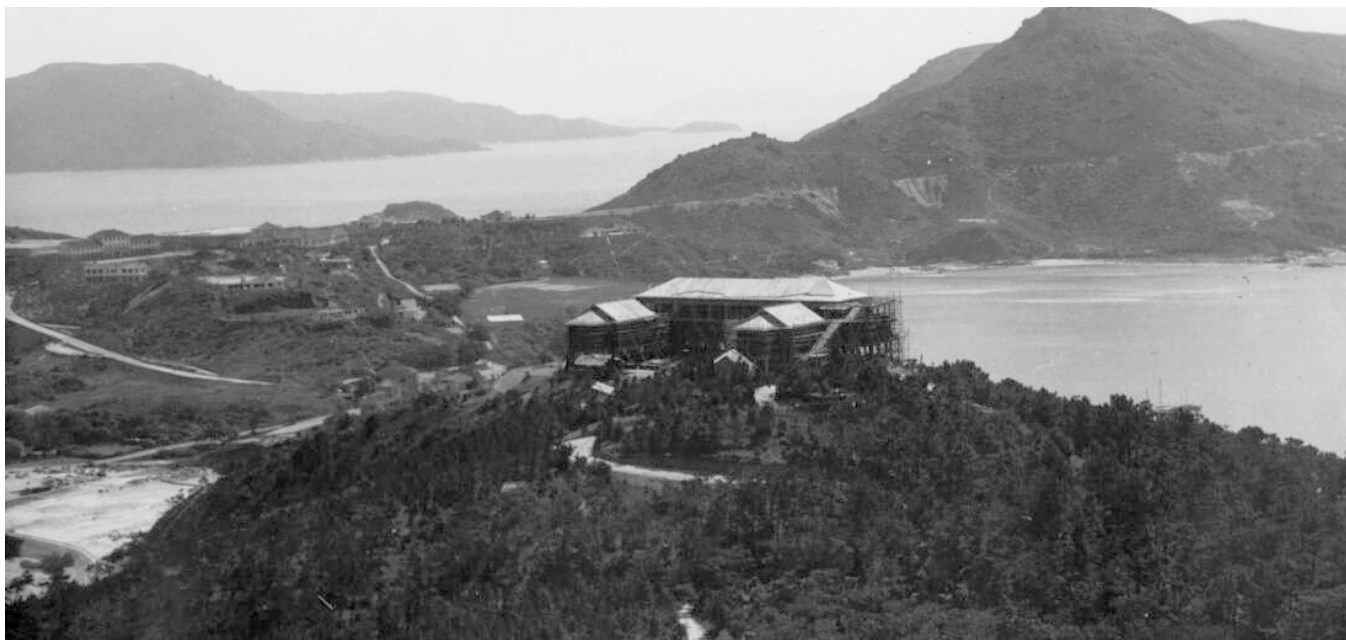
Fig 15: Maryknoll House under construction (Source: unknown, 'Construction of Maryknoll House, Stanley, Hong Kong, China, 1934', USC, Maryknoll Mission Archives, UC1856720).

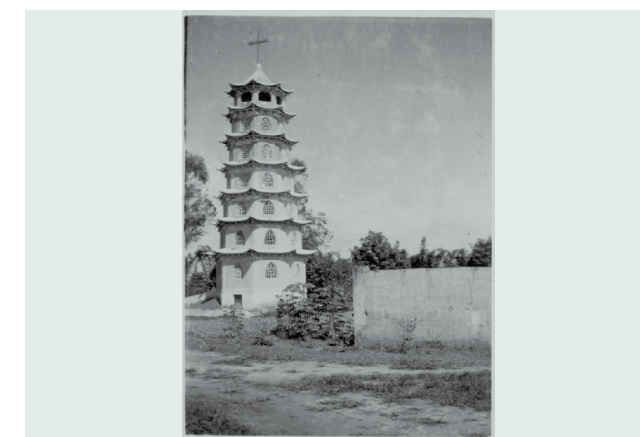
Fig 27: Bishop Ford's pagoda in Kaying [now Meixien], designed to serve as a powerhouse, water tank and as a landmark (Source: 'Bishop Ford's pagoda at Meixien, China, 1949', USC Maryknoll Mission Archives, UC1887354).

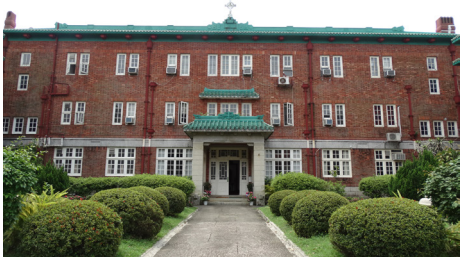
ID	Description	Level of Significance	Location Plan	Photographs (with photo reference extracted from previous CMPs ¹²⁹)
Exteriors				
E1	North elevation of Main Block with			
	01 red facing brick wall, granite band courses & plinth	High

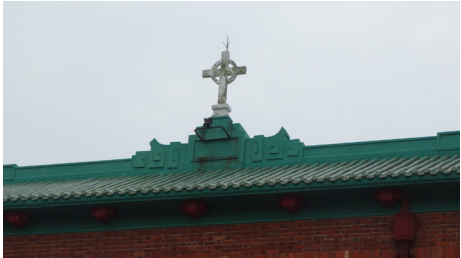
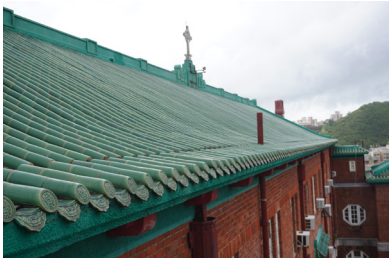
02 timber windows	High		
	03 Chimney on the roof (4 nos.)	High		
	04 original cast iron rainwater down pipe with hopper	High		
	05 Window A/C	Adverse		
E2	Cross on the roof ridge	High

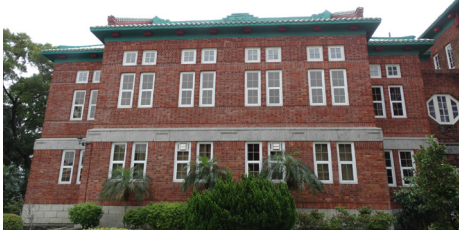
E6	North elevation of West Wing with 01 red facing brick wall 02 granite band courses and plinth 03 timber windows	High High High

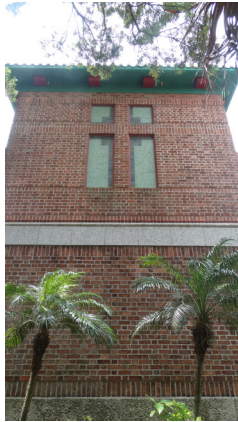
ID	Description	Level of Significance	Location Plan	Photographs (with photo reference extracted from previous CMPs ²⁹)
E7	<p>North elevation of East Wing with</p> <ul style="list-style-type: none"> 01 red facing brick wall 02 granite band courses and plinth 03 timber windows 04 embedded cross pattern on wall formed by tile finish 	<p>High</p> <p>High</p> <p>High</p> <p>High</p>

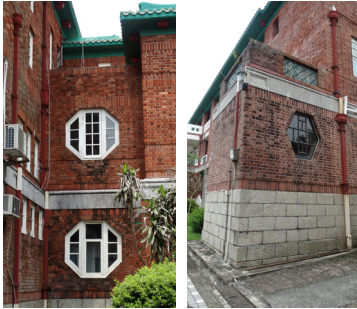
E14	<p>All elevations with</p> <ul style="list-style-type: none"> 01 timber windows and French doors 02 octagonal and hexagonal windows 03 windows with stained glasses 04 pitched (global or hip) roofs with Chinese green glazed-tiles and profiled ridges 05 ventilation tiles on gable walls 06 recessed gutter, chimneys and flying rafters at eaves 07 original cast iron rainwater down pipe with hopper 	<p>High</p> <p>High</p> <p>High</p> <p>High</p> <p>High</p> <p>High</p> <p>High</p>

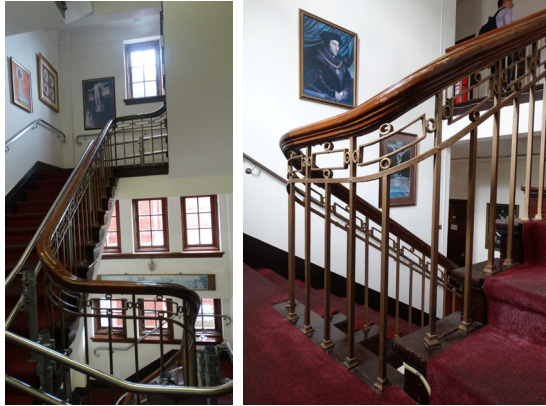
G/F

I3	Verandah at the South elevation of Main Block with 01 cement floor tiles in geometric pattern 02 brown cement skirting tiles	Moderate

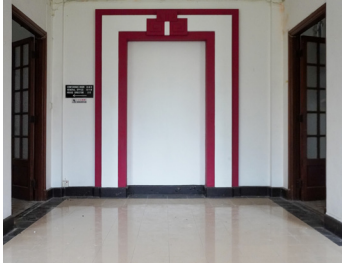
ID	Description	Level of Significance	Location Plan	Photographs (with photo reference extracted from previous CMPs ¹²⁹)
110	Decorative architrave at foyer of Main Block	Moderate

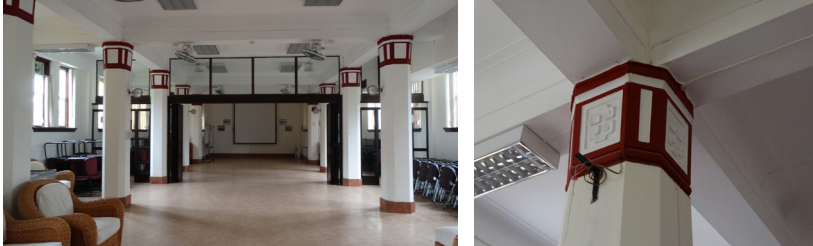
112	Decorative capital of columns at G/F Conference Room in East Wing	High

- Repairs to decorative capital of columns
- Repairs to the interiors of the Chapel
- Establish a heritage gallery for interpretive purposes

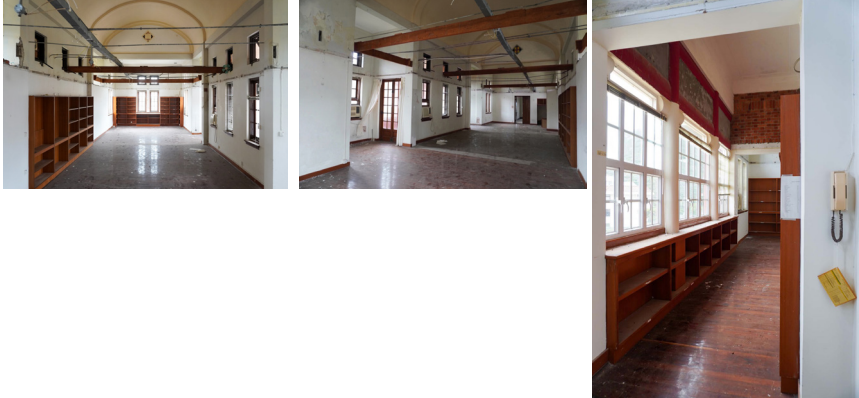
<p>1/F</p>

114	<p>1/F Recreation Room in West Wing</p> <p>01 high and barrel ceiling</p> <p>02 rhombus symbol on wall at high level</p> <p>03 enclosed verandah</p>	<p>High</p> <p>High</p> <p>Adverse</p>

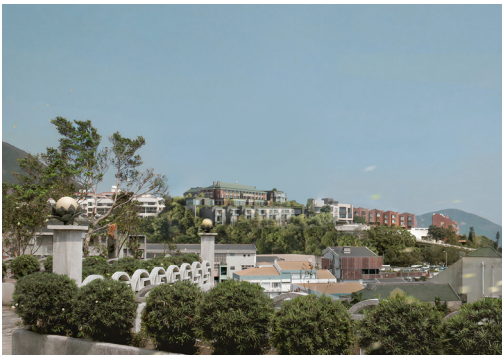
Item description

Construction of new residential blocks at upper deck & lower deck		
Assessment		Mitigation <ul style="list-style-type: none"> New buildings to be kept to a height that does not affect the appreciation of the existing buildings from the long view from Stanley Village and Kwun Yum Temple. The roof level of new buildings on lower deck on the south of the Main Block shall not be higher than the G/F level of the Main Block. The roof level of the new buildings on upper deck shall not be higher than the roof level of the Main Block.
CDE Affected	Significance of CDE	
S1	Moderate	
Potential impact		
<ul style="list-style-type: none"> Visual impact to curtilage, setting, prominence and appreciation of existing building 		
Justification		
To facilitate the site adaptive reuse.		
Level of impact		
Acceptable impact with mitigation measures

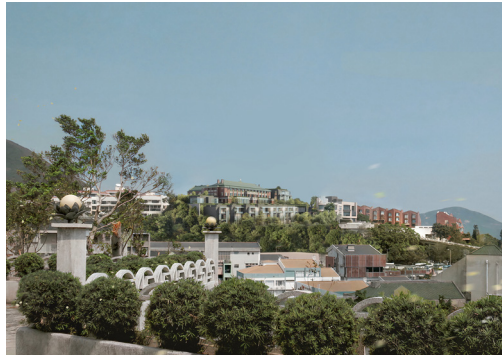
Item description

Extensive excavation for the construction of the basement & new buildings		
Assessment		Mitigation <ul style="list-style-type: none"> Further underground investigations, detailed sub-structure design proposals and methodologies with regular monitoring to be developed with minimal impact. The treatment of any discovery of antiquities during excavation shall adhere to the Antiquities and Monuments Ordinance. Structure proposals to be submitted for approval by relevant government departments.
CDE Affected	Significance of CDE	
S1, S4	Moderate	
Potential impact		
<ul style="list-style-type: none"> Visual impact of the Main Block Structural integrity Disturbance to possible archaeological remains 		
Justification		
Provision of carpark to facilitate the sites adaptive reuse and to meet operational needs.		
Level of impact		
Acceptable impact with mitigation measures

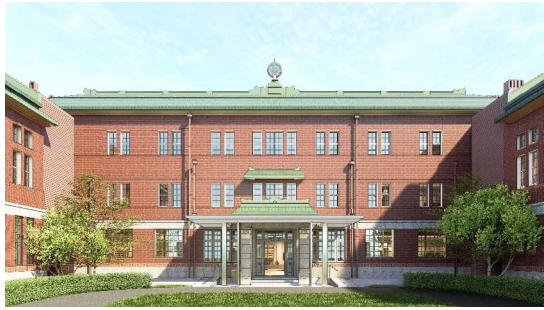
Item description

New layout and design of main entrance courtyard		
Assessment		Mitigation
CDE Affected	Significance of CDE	<ul style="list-style-type: none"> • Landscape elements to be kept to a height that does not affect the appreciation of the existing buildings from the site entrance. • Landscape design to respect symmetry and order of the existing setting. • Enhancement to existing building to emphasise the key features and character defining elements, and clearly distinguish new elements from heritage elements • Further impact assessment to landscape design proposals shall be conducted once they become available.
S3	Moderate	
Potential impact		
<ul style="list-style-type: none"> • Visual impact to curtilage, setting, prominence and appreciation of existing building 		
Justification		
Consideration of accessibility from the site entrance to the Main Block, and security		
Level of impact

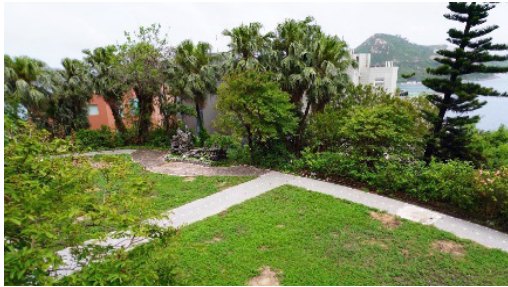
Item description

New design of landscape		
Assessment		Mitigation
CDE Affected	Significance of CDE	<ul style="list-style-type: none"> • New proposal will be designed to minimise loss of trees and greenery, with on-site replacement where appropriate. • Further impact assessment to landscape design proposals shall be conducted once they become available.
S1, S3, S4	Moderate	
Potential impact		
<ul style="list-style-type: none"> • Loss of trees and green landscape • Surfaces for vehicular access • Setting of existing building, visibility and appreciation of existing building 		
Justification		
Existing trees are not Old and Valuable Trees (OVTs). Some existing trees are in poor condition. Refer to the Tree Preservation and Landscape Proposal by others.		
Level of impact		
Acceptable impact with mitigation measures

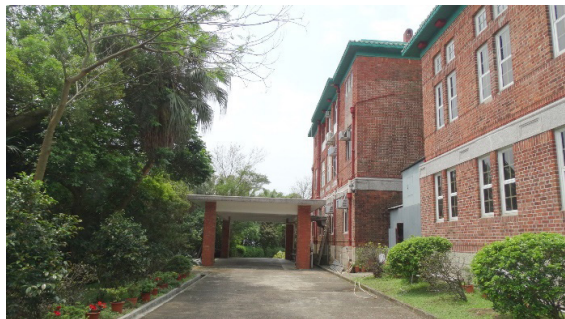
Item description	
<p>East side of Main Block:</p> <p>New car ramp to new basement level</p>

Assessment	
CDE Affected	Significance of CDE
S5	Low
Potential impact	
<ul style="list-style-type: none"> • Potential fabric impact of the main entrance area • Structural integrity of the existing building 	
Justification	
<p>Vehicular access to basement carpark to facilitate the sites adaptive reuse and to meet operational needs.</p>	
Level of impact	
<p>Acceptable impact with mitigation measures</p>	
Mitigation	
<ul style="list-style-type: none"> • Layout of the car ramp integrated with surrounding soft landscape elements to minimise impact • Material to be complimentary to the existing buildings and new elements • Structure proposals to be submitted for approval by relevant government departments. • Further visual impact assessment to be conducted in later design stage.

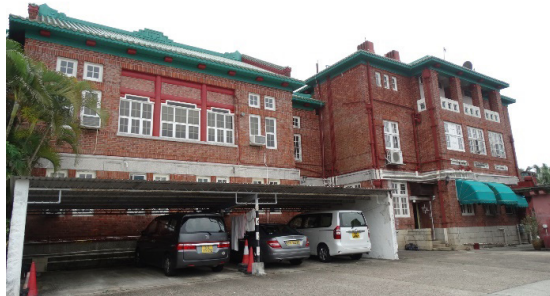
Item description	
<p>West side of West Wing:</p> <p>Construction of new swimming pool with material complimentary to the existing buildings and new elements</p>

Assessment	
CDE Affected	Significance of CDE
S5	Low
Potential impact	
<ul style="list-style-type: none"> • Fabric impact to the West Wing • Structural integrity 	
Justification	
<p>Modern provision to residents to facilitate the sites adaptive reuse.</p>	
Level of impact	
<p>Acceptable impact with mitigation measures</p>	
Mitigation	
<ul style="list-style-type: none"> • Integrate with the surrounding using soft landscape elements while maintaining privacy • Structure proposals to be submitted for approval by relevant government departments. • Further visual impact statement and reference to images to be produced for review and assessment

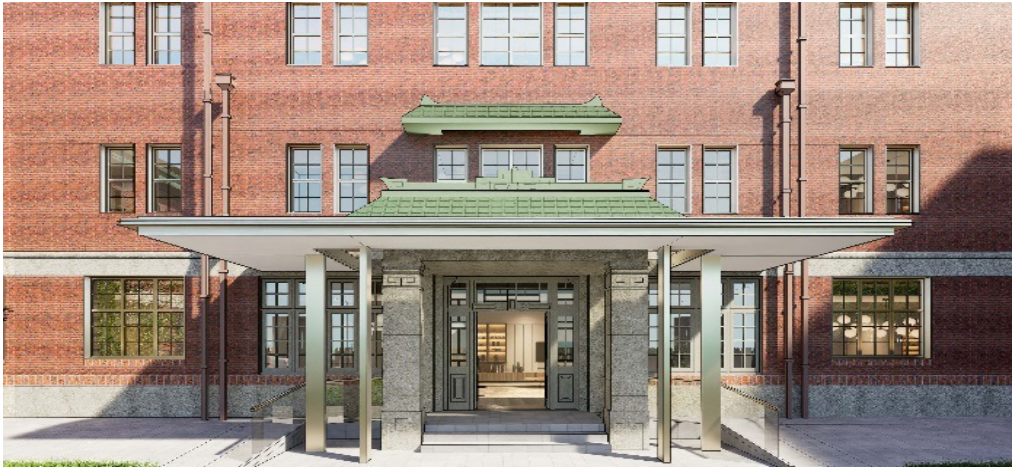
<p>Item description</p> <p>Entrance porch at North elevation of Main Block:</p> <p>Addition of a freestanding porte-cochere structure with translucent panels surrounding the existing entrance porch</p>

<p>Assessment</p>		<p>Mitigation</p>
<p>CDE Affected</p> <p>E3</p>	<p>Significance of CDE</p> <p>Exceptional</p>	<ul style="list-style-type: none"> • Minimise fixings to the historic fabric and coordinate these with the existing porch details so as to mitigate impact to significant detailing. • The design and material of new additions (including architectural finishes) shall be compatible with but distinguishable from the surrounding historic fabric, notably the highly significant porch and overall highly significant north elevation. • New additions should align with the language of other new external interventions across the main building. The width of the porch, when read in elevation should align with the rhythm and fenestration of the main façade and avoid conflict with the pattern of fenestration • Carry out a visual study that illustrates the appearance of the new design from key views and vistas, specifically along the vehicle and pedestrian approach. • Carry out a detailed condition survey prior to commencement of the works, and complete any required repair or maintenance works to the entrance porch prior to fixing the new canopy. • Complete a cartographic (using a digital 3D laser scan) and photographic record prior to commencement of the works. • Structural design calculations should be provided to demonstrate there is no impact to the building's structural integrity.

<p>Potential impact</p> <ul style="list-style-type: none"> • Visual impact – view from Courtyard • Fabric impact arising from fixing detail 		
<p>Justification</p> <p>The new canopy is desirable as part of the building's revitalisation and the provision of increased weather/ sheltered protection at resident drop off area.</p>		
<p>Level of impact</p>		
<p>Acceptable impact with mitigation measures</p>

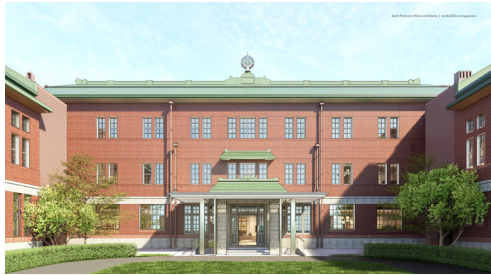
Item description	
North elevation of Main Block: New circulation core structure on both sides of the north elevation facing the Courtyard

Assessment	Mitigation
CDE Affected	Significance of CDE
EI	High
Potential impact	
<ul style="list-style-type: none"> Visual – view in Courtyard Fabric – connection with existing building and partial demolition of existing fabric 	
Justification	
To suit the revised layout and circulation of interior space.	
Level of impact	
Acceptable impact with mitigation measures	
<ul style="list-style-type: none"> Carry out a condition survey to the affected external wall for specifying the works required. The new circulation core structures will be set back from the existing north elevation façade so the windows and brickwork will not be altered. The wall of the lift core to be constructed as an independent structure to the north façade of the Main Block with connections to the Main Block. The infilling internal floor slabs and walls in these locations will not be connected to the wall areas immediate surrounding the window openings. The existing octagonal windows (plain and stained glass) on the west elevation of east wing and east elevation of west wing will be salvaged for installation to the new circulation façade.

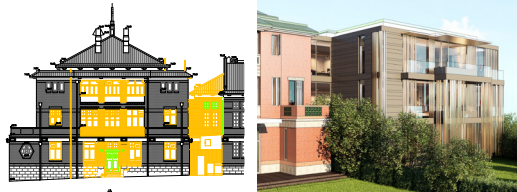
<p>East elevation Proposed east extension</p>
Assessment	Mitigation
CDE Affected	Significance of CDE
EI1.1	High
EI1.2	High
EI1.3	High
EI1.4	High
EI1.5	High
Potential impact	
<ul style="list-style-type: none"> Visual impact to the appreciation of the East Elevation of the Main Block from within the site and afar. Fabric impact arising from the demolition for connection with new interventions. 	
Justification	
To suit the site adaptive reuse needs.	
Level of impact	
Undetermined	
<ul style="list-style-type: none"> The height of the east extension is lower than the whole historic building. Minimise fixings to the historic fabric around the affected area. Carry out a visual study that illustrates the appearance of the new design from key views and vistas, specifically along the vehicle and pedestrian approach. Undertake a further impact assessment based on this study. Carry out a detailed condition survey to the whole elevation prior to commencement of the works. Complete a cartographic (using a digital 3D laser scan) and photographic record prior to commencement of the works. The design and material of new additions (including architectural finishes) shall be compatible with but distinguishable from the surrounding historic fabric. New additions should align with the language of other new external interventions across the main building.

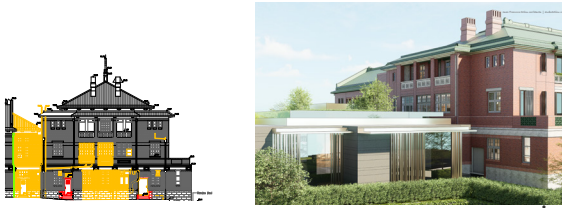
<p>West elevation Proposed west extension</p>	
Assessment		<ul style="list-style-type: none"> The existing verandahs on 2/F with squared patterned parapet and brick column to be retained. The height of the west extension is to be lower than the historic building, being a single storey. Minimise fixings to the historic fabric around the affected area. Carry out a visual study that illustrates the appearance of the new design from key views and vistas, specifically along the vehicle and pedestrian approach. Undertake a further impact assessment based on this study. Carry out a detailed condition survey prior to commencement of the works. Complete a cartographic (using a digital 3D laser scan) and photographic record prior to commencement of the works. The design and material of new additions (including architectural finishes) shall be compatible with but distinguishable from the surrounding historic fabric. New additions should align with the language of other new external interventions across the main building.

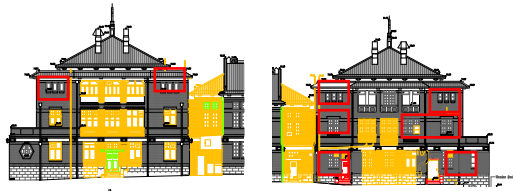
<p>East elevation West elevation</p>	
Assessment		<ul style="list-style-type: none"> Record the condition of the affected timber windows prior to the commencement of works. The windows that are in good condition, including timber sections and ironmongery, will be salvaged for later use.
CDE Affected	Significance of CDE	
E9.4	High	
E11.4	High	
Potential impact		
<ul style="list-style-type: none"> Visual – appreciation of the east and west elevations Fabric – change in connection detail 		
Justification		
The weather tightness and environmental parameters can be improved.		
Level of impact		
<p>Acceptable impact with mitigation measures</p>

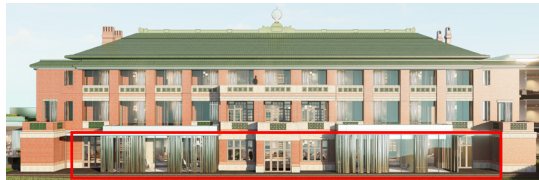
Item description	
<p>G/F of South elevation of Main Block: Addition of loggias, and installation of new doors at the modified opening of original windows. Demolition of granite band course and plinth, timber windows, granite flight of staircase within the loggia extension.</p>

<p>1/F of South elevation of Main Block: Demolition of 4nos. bays of parapet walls to provide access to new flat roof above the loggias, and retention of 2nos. bays.</p>	
Assessment	
CDE Affected	Significance of CDE
E12	High
E13	Exceptional
Potential impact	
<ul style="list-style-type: none"> Visual impact to the appreciation of the South elevations of the Main Block from within the site and afar. Fabric impact arising from the demolition for connection with new interventions 	
Justification	
To suit site adaptive reuse needs.	
Level of impact	
Undetermined	
Mitigation	
<ul style="list-style-type: none"> The new fabric, including the glass walls, metal cladding of the loggias, and the parapet at 1/F surrounding the new flat roof, shall be compatible with but distinguishable to the existing. Complete a cartographic (using a digital 3D laser scan) and photographic record prior to commencement of the works. Carry out a detailed condition survey prior to commencement of the works. New additions should align with the language of other new external interventions across the main building.

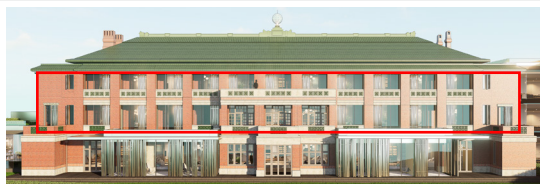
<p>1/F and 2/F of South elevation of Main Block:</p> <p>Addition of folding/sliding glazed enclosure to full extent of the verandahs except the central protrusion bay of 1/F.</p>			
Assessment			Mitigation
CDE Affected	Significance of CDE		<ul style="list-style-type: none"> The design of the new glazed enclosure to be compatible with but distinguishable to the existing. The verandahs with the french doors of the central protrusion bay on 1/F to be kept intact and repaired. The rear verandah walls are retained so that from long views the characteristics of verandahs could still be distinctive. The fixing folding/sliding glazed enclosure to be designed carefully so that the existing cornice feature is not disturbed. The glazed enclosure to be set back from the existing parapet. Division of the panels to be sympathetic with the glazed block distribution. New additions should align with the language of other new external interventions across the main building.

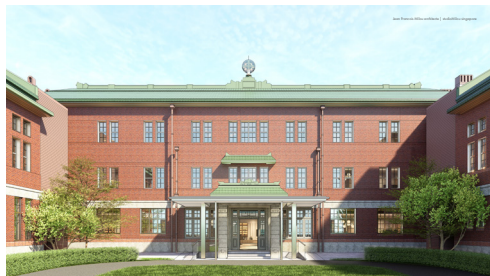
<p>All elevations of Main Block:</p> <p>New metal capping to underside of roof eaves</p>			
Assessment			Mitigation
CDE Affected	Significance of CDE		<ul style="list-style-type: none"> Record the condition of the affected eaves and flying rafter ends prior to the commencement of works. Fixing details of the capping to be designed with gaps to allow natural ventilation so to minimise mould and condensation. The change is reversible, and it should be ensured that there will be no fixings to the retained flying rafter ends. The covered underside of roof eaves and flying rafter ends will be featured in interpretation proposals.
E1	High		
E9	High		
E11	High		
E12	High		
Potential impact			
<ul style="list-style-type: none"> Visual impact – to overall composition Fabric impact arising from fixing detail and risk of condition deterioration of covered area 			
Justification			
The new metal capping will be distinguishable and compatible to the original building.

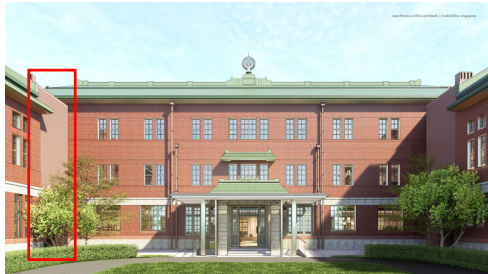
Item description		
West elevation of East Wing: Addition of vertical circulation core

Assessment		Mitigation
CDE Affected	Significance of CDE	<ul style="list-style-type: none"> Any affected elements to be recorded before construction, restored and displayed as interpretation elements if retention in-situ is not possible New element will be clearly distinguishable from the existing elements, with connection between the new elements with the existing elements will be designed to minimise impact of the existing elements, and any impact to be managed in a reversible manner as much as possible.
E5	High	
Potential impact		
<ul style="list-style-type: none"> Visual impact on view in courtyard Connection with existing building 		
Justification		
<ul style="list-style-type: none"> Change of internal layout New building fabric will be distinguishable and compatible with the existing building. 		
Level of impact

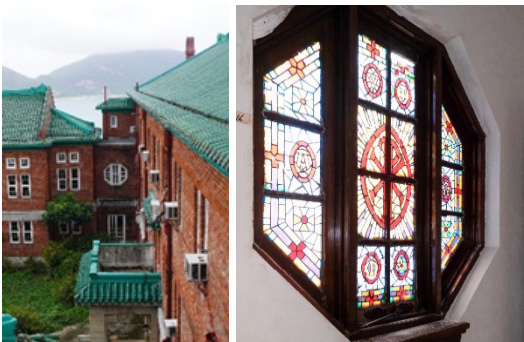
Item description		
West elevation of East Wing (existing Chapel on 1/F): Relocation of octagonal window with stained glass panels onto the new façade

Assessment		Mitigation
CDE Affected	Significance of CDE	<ul style="list-style-type: none"> Carry out a detailed condition survey to the octagonal window prior to commencement of the works. Complete a cartographic (using a digital 3D laser scan) and photographic record prior to commencement of the works.
E5	High	
E14.2	High	
Potential impact		
<ul style="list-style-type: none"> Visual impact on view in courtyard 		
Justification		
<ul style="list-style-type: none"> Change of internal layout 		
Level of impact		
Acceptable impact with mitigation measures

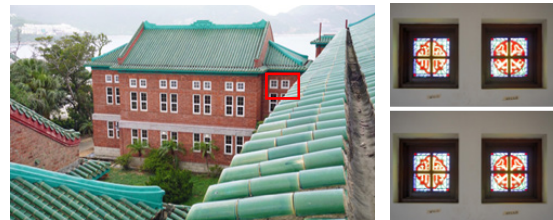
<p>West elevation</p>								
Assessment		Mitigation

Item description		Item description								
<p>East & West elevations of East Wing:</p> <p>Salvage of 4 nos. of stained-glass panels for display at heritage gallery; and</p> <p>Restoration and reinstatement of remaining stained glass panels.</p>

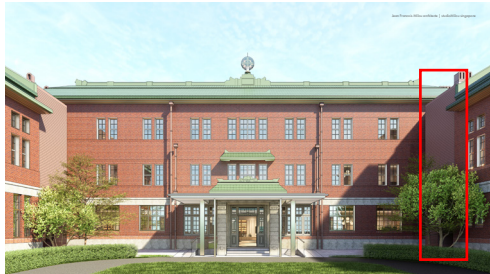
East elevation of West Wing: Addition of vertical circulation core.		
Assessment		Mitigation <ul style="list-style-type: none"> Any affected elements to be recorded before construction, restored and displayed as interpretation elements if retention in-situ is not possible. New element will be clearly distinguishable from the existing elements, with connection between the new elements with the existing elements will be designed to minimise impact of the existing elements, and any impact to be managed in a reversible manner as much as possible. Windows on the affected external wall to be salvaged for display and interpretation use.
CDE Affected	Significance of CDE	
E4	High	
E8	High	
Potential impact		
<ul style="list-style-type: none"> Impact on view in courtyard Connection with existing building requires demolition of existing walls Details such as the octagonal windows

Justification		
<ul style="list-style-type: none"> Change of internal layout New building fabric will be distinguishable and compatible with the existing building. 		
Level of impact		
Acceptable impact with mitigation measures

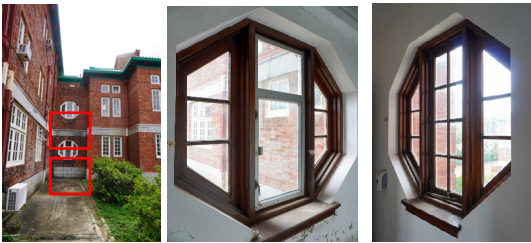
East elevation of West Wing: Restoration of octagonal windows with clear glass panels on the new façade		
Assessment		Mitigation <ul style="list-style-type: none"> Carry out a detailed condition survey to the octagonal window prior to commencement of the works. Complete a cartographic (using a digital 3D laser scan) and photographic record prior to commencement of the works.
CDE Affected	Significance of CDE	
E4.5	High	
Potential impact		
<ul style="list-style-type: none"> Impact on view in courtyard Connection with existing building Details such as the octagonal windows 		
Justification		
<ul style="list-style-type: none"> Change of internal layout 		
Level of impact		
Acceptable impact with mitigation measures

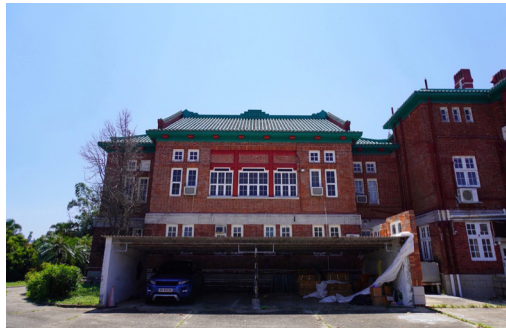
Item description		
West elevations of West Wing: Removal of carpark shelter

Assessment		Mitigation
CDE Affected	Significance of CDE	N/A
E8.7	Adverse	
Potential impact		
<ul style="list-style-type: none"> Overall composition Restoration – authenticity, consistency 		
Justification		
The carpark shelter is a later addition to the site.		
Level of impact		
Beneficial

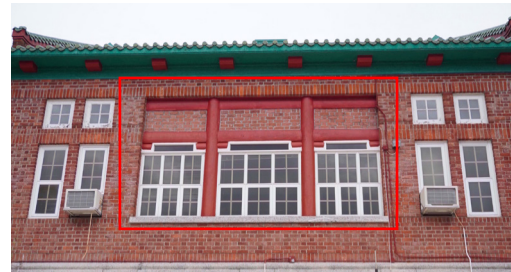
Item description		
West elevation of West Wing (1/F): Reinstatement of enclosed verandahs with red painted Chinese bracket style columns and beams

Assessment		Mitigation
CDE Affected	Significance of CDE	<ul style="list-style-type: none"> Carry out a detailed condition survey prior to commencement of the works. Complete a cartographic (using a digital 3D laser scan) and photographic record of the windows to be demolished prior to commencement of the works. Carry out a detailed condition survey prior to commencement of the works, and complete any required repair or maintenance works to the entrance porch prior to fixing the new canopy. Complete a cartographic (using a digital 3D laser scan) and photographic record prior to commencement of the works. Carry out a detailed condition survey prior to commencement of the works, and complete any required repair or maintenance works to the entrance porch prior to fixing the new canopy. Complete a cartographic (using a digital 3D laser scan) and photographic record prior to commencement of the works. Make good the surrounding building fabric if necessary.

E8.5	Adverse	
Potential impact		
<ul style="list-style-type: none"> Overall composition Restoration – authenticity, consistency 		
Justification		
To restore the verandah to its original appearance.		
Level of impact		
Beneficial

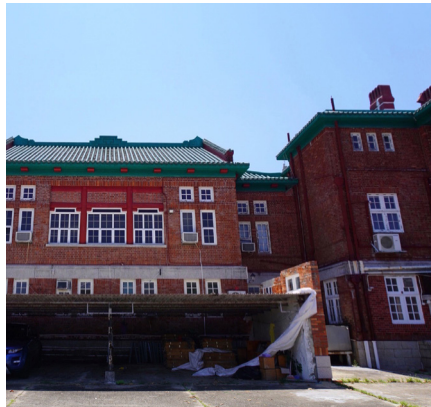
Item description		
<p>All elevations of West Wing:</p> <p>Restoration and retention of all cast iron rainwater downpipes and associated hoppers, and relocation of those clash with the new circulation core.</p>

Assessment		Mitigation
CDE Affected	Significance of CDE	<ul style="list-style-type: none"> Record the condition of the external downpipes prior to the commencement of works. Make good openings in the masonry façade to match existing. All external cast iron rainwater downpipes and hoppers will be restored and re-instated in-situ where technically possible, i.e. at locations that will not clash with newly introduced fabric or openings. Options will be studied for the appropriate relocation of the prominent cast iron rainwater downpipe and decorated hopper in the East Wing area affected by the insertion of the new vertical circulation core.
E4	High	
E6	High	
E8	Moderate	
Potential impact

<ul style="list-style-type: none"> Visual 		
Justification		
<p>To enhance the appearance of the facades with pipes in coordinated locations.</p>		
Level of impact		
<p>Acceptable impact with mitigation measures</p>

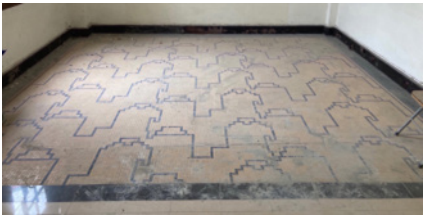
Item description		
Main Block: Salvage and relocation of the patterned mosaic floor tiles next to foyer for display at Heritage Gallery

Assessment		Mitigation
CDE Affected	Significance of CDE	<ul style="list-style-type: none"> Recording of all existing internal elements will be carried out prior to construction Removed elements of good condition will be salvaged for further repair or interpretation purposes
III	Moderate	
Potential impact		
<ul style="list-style-type: none"> Level of retention and restoration Overall composition Alterations required – authenticity, consistency Structural integrity and safety 		
Justification		
Change of use of the interior.		
Level of impact		
Acceptable impact with mitigation measures

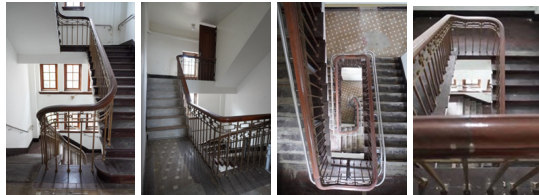
Item description	
<p>Main Block:</p> <p>Relocation of staircases at East and West ends from G/F to 2/F to new circulation cores</p>

Assessment	
CDE Affected	Significance of CDE
12	High
Potential impact	
<ul style="list-style-type: none"> Relocation of key architecture feature Level of retention and restoration Overall composition Alterations required – authenticity, consistency Structural integrity and safety 	
Justification	
<ul style="list-style-type: none"> Change of internal layout New building fabric will be distinguishable and compatible with the existing building. 	
Level of impact	
<p>Acceptable impact with mitigation measures</p>

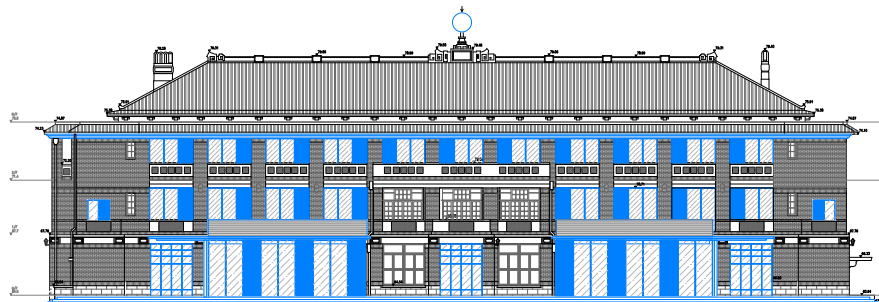
Elevation A - Proposal

— to be removed
— salvaged
— new element

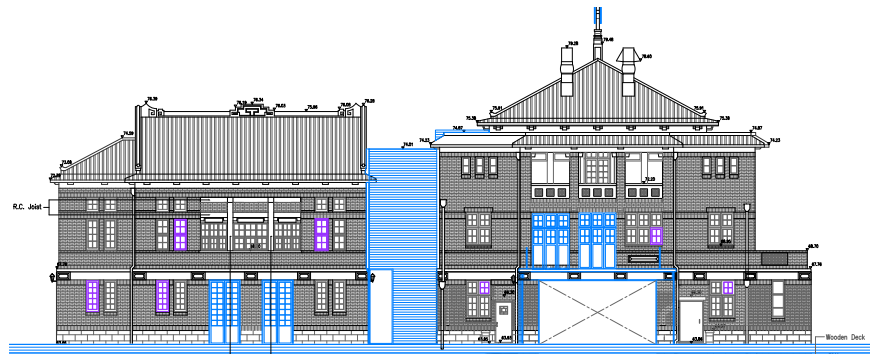
Elevation B - Proposal

— to be removed
— salvaged
— new element
