**AMENDMENT TO THE APPROVED SOCIAL WELFARE FACILITY
(RESIDENTIAL CARE HOME FOR THE ELDERLY) IN
"RESIDENTIAL (GROUP B)" ZONE AT 349 PRINCE EDWARD
ROAD WEST, KOWLOON**

SEWERAGE IMPACT ASSESSMENT

Document No. **R9454_V1.1.docx**

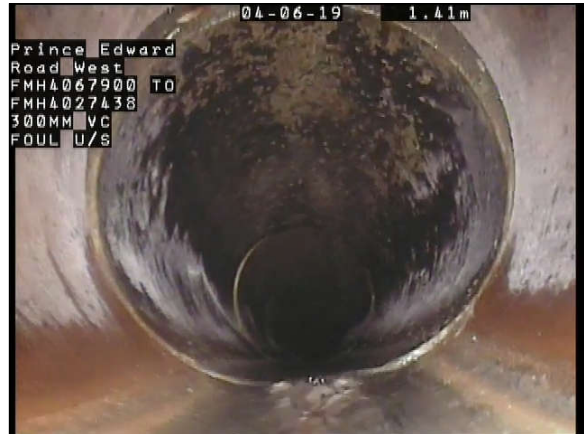
Photo Ref. : 009
 Video Tape : 0001, 0:00:47
 Observation : Crack Circumferential AT Joint, from 10 to 05 o'clock

0:00:37		0.0	GP	General Photograph	008	0
0:00:47		1.4	CCJ	Crack Circumferential AT Joint, from 10 to 05 o'clock	009	2
0:00:54		2.7	FCJ	Fracture Circumferential AT Joint, from 03 to 05 o'clock	010	3

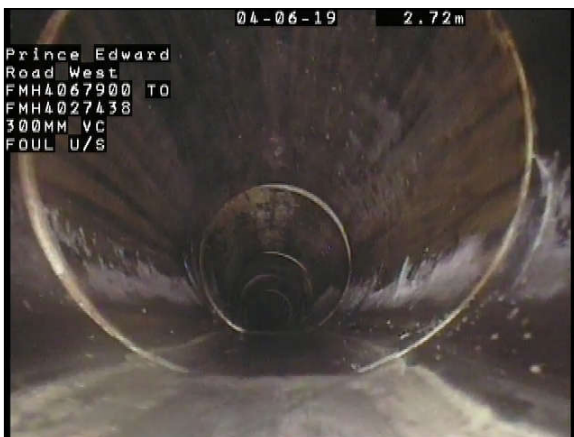
Photo Ref. : 010
 Video Tape : 0001, 0:00:54
 Observation : Fracture Circumferential AT Joint, from 03 to 05 o'clock

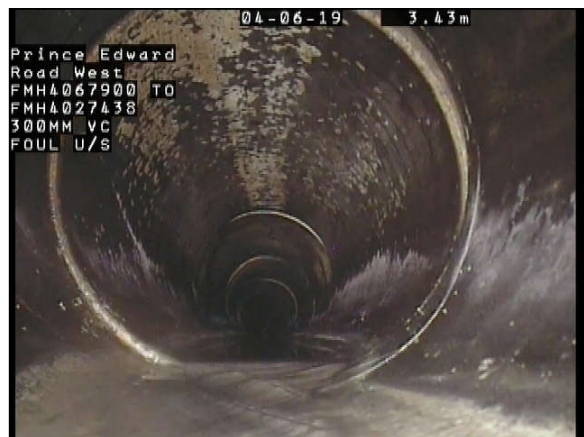
Photo Ref. : 011
 Video Tape : 0001, 0:00:58
 Observation : Fracture Circumferential AT Joint, from 02 to 06 o'clock

0:00:58		3.4	FCJ	Fracture Circumferential AT Joint, from 02 to 06 o'clock	011	3
0:01:03		4.5	FM	Fracture Multiple, from 07 to 10 o'clock	012	4
0:01:13		5.6	FM	Fracture Multiple, from 07 to 01 o'clock	013	4

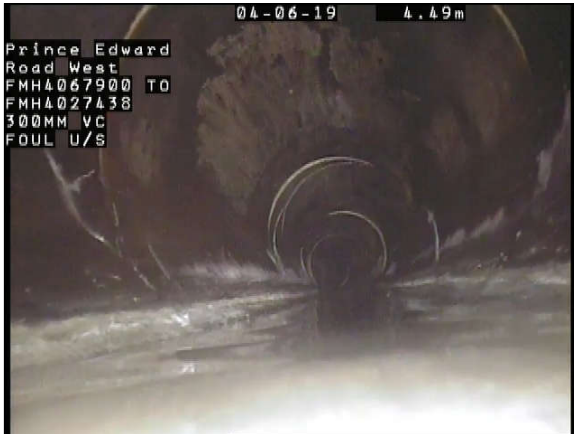
Photo Ref. : 012
 Video Tape : 0001, 0:01:03
 Observation : **Fracture Multiple, from 07 to 10 o'clock**

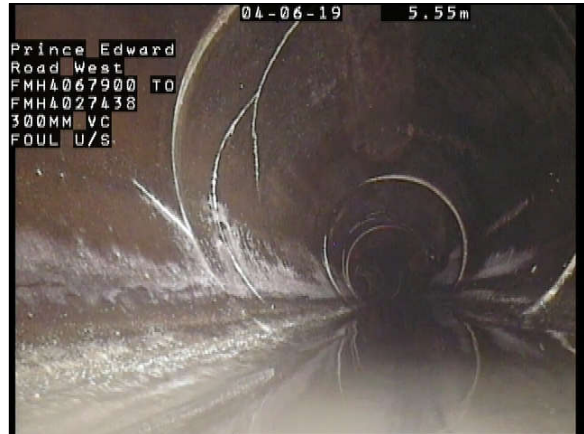
Photo Ref. : 013
 Video Tape : 0001, 0:01:13
 Observation : **Fracture Multiple, from 07 to 01 o'clock**

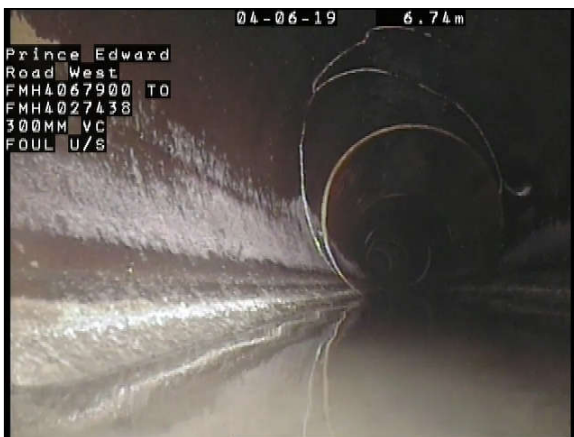
Photo Ref. : 014
 Video Tape : 0001, 0:01:33
 Observation : **Fracture Circumferential, from 07 to 04 o'clock**

0:01:33		6.7	FC	Fracture Circumferential, from 07 to 04 o'clock	014	3
0:02:00		10.5	FCJ	Fracture Circumferential AT Joint, from 09 to 03 o'clock	015	3
0:02:06		11.5	FL	Fracture Longitudinal, at 09 o'clock	016	3

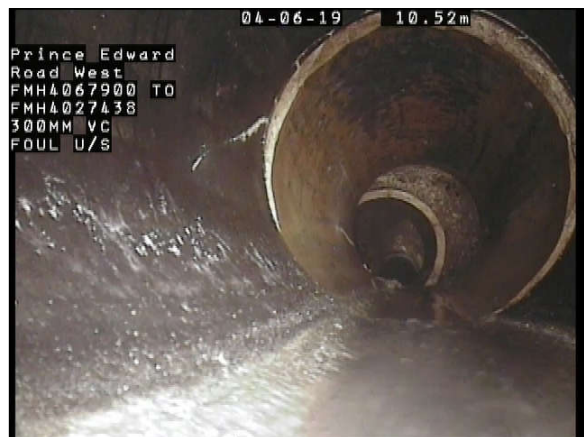
Photo Ref. : 015
 Video Tape : 0001, 0:02:00
 Observation : **Fracture Circumferential AT Joint, from 09 to 03 o'clock**

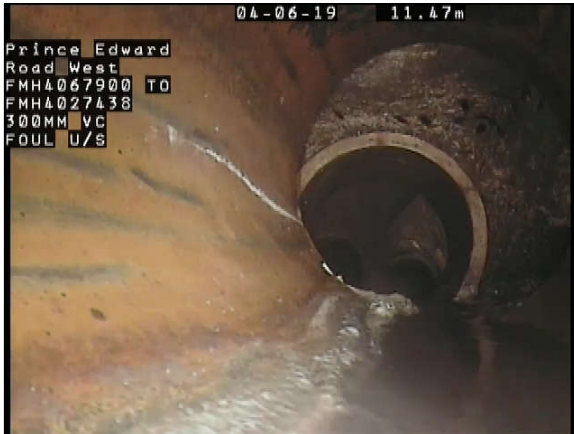
Photo Ref. : 016
 Video Tape : 0001, 0:02:06
 Observation : **Fracture Longitudinal, at 09 o'clock**

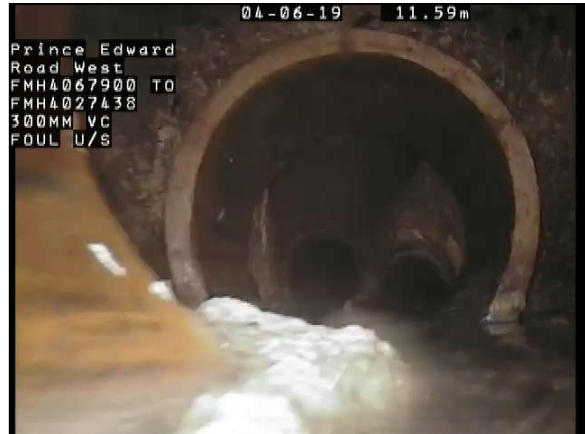
Photo Ref. : 017
 Video Tape : 0001, 0:02:09
 Observation : **Open Joint Large**

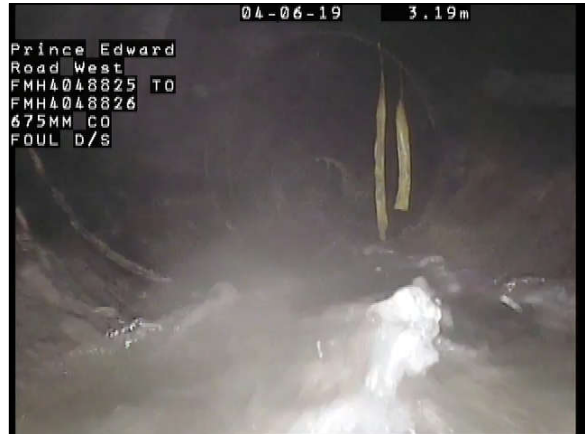
Photo Ref. : 027
Video Tape : 0001, 0:03:19
Observation : Fracture Circumferential, from 06 to 09 o'clock

Video No.	1:300	Chainage	Code	Observation	Photo	Grade
				FMH4048825		
0:00:00		0.0	ST	Start Of Survey		0
		0.0	MH	Manhole Remark : FMH4048825		0
		0.0	WL	Water Level, 15 % height/diameter		0
000054		1.1	GP	General Photograph	026	0
0:03:19		3.2	FC	Fracture Circumferential, from 06 to 09 o'clock	027	3
0:01:20		7.6	DE	Debris, 20 % cross-sectional area loss	028	1
0:01:32		11.4	DE	Debris, 05 % cross-sectional area loss	029	1
0:01:42		14.5	DE	Debris, 10 % cross-sectional area loss	030	1
0:02:15		24.5	DE	Debris, 10 % cross-sectional area loss	031	1
0:02:28		28.3	DE	Debris, 15 % cross-sectional area loss	032	1
0:02:52		35.9	GP	General Photograph	033	0
0:01:28		39.1	SA	Survey Abandoned Remark : UNABLE TO PUSH FORWARD	034	0

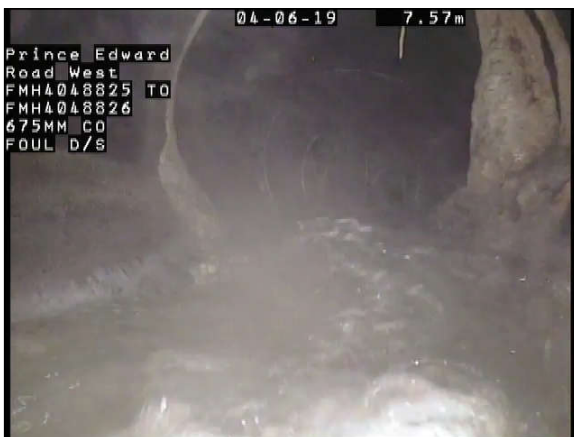
Photo Ref. : 028
Video Tape : 0001, 0:01:20
Observation : Debris, 20 % cross-sectional area loss

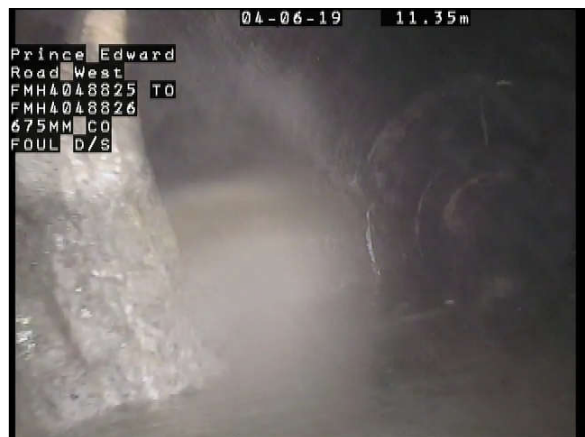
Photo Ref. : 029
Video Tape : 0001, 0:01:32
Observation : Debris, 05 % cross-sectional area loss

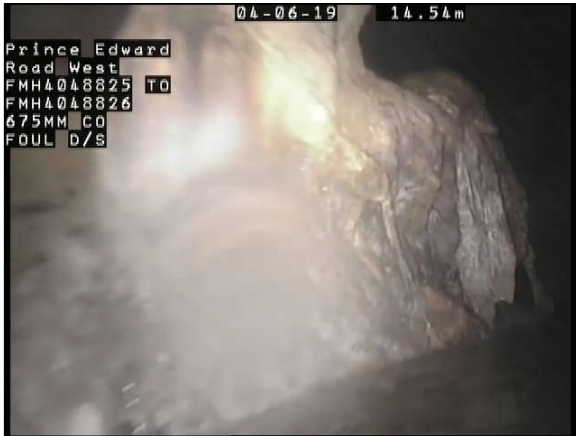
Photo Ref. : 030
 Video Tape : 0001, 0:01:42
 Observation : Debris, 10 % cross-sectional area loss

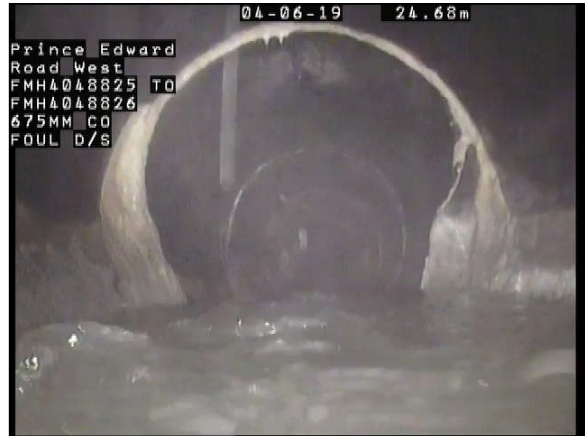
Photo Ref. : 031
 Video Tape : 0001, 0:02:15
 Observation : Debris, 10 % cross-sectional area loss

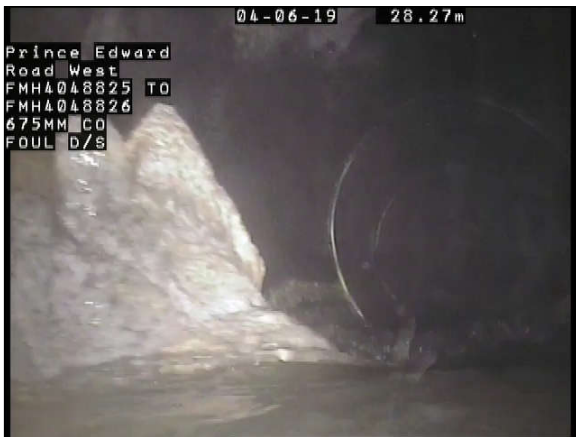
Photo Ref. : 032
 Video Tape : 0001, 0:02:28
 Observation : Debris, 15 % cross-sectional area loss

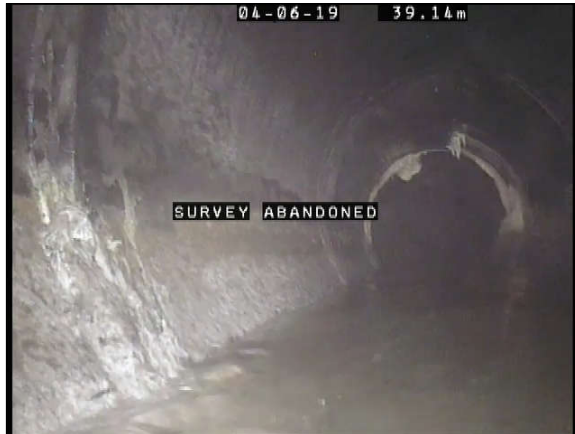
Photo Ref. : 034
Video Tape : 0001, 0:01:28
Observation : Survey Abandoned
Remark : UNABLE TO PUSH FORWARD

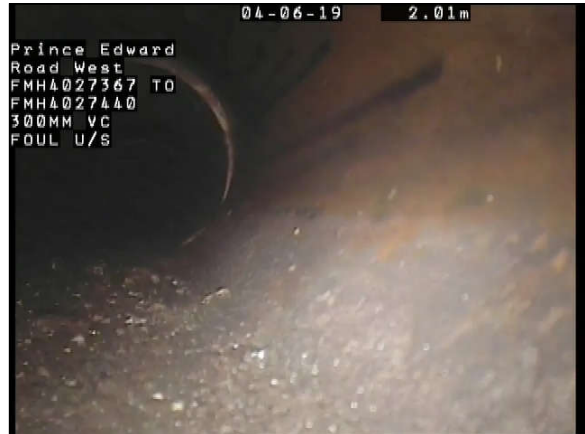
Photo Ref. : 040
 Video Tape : 0001, 0:01:31
 Observation : Debris Silt, 05 % cross-sectional area loss, Start

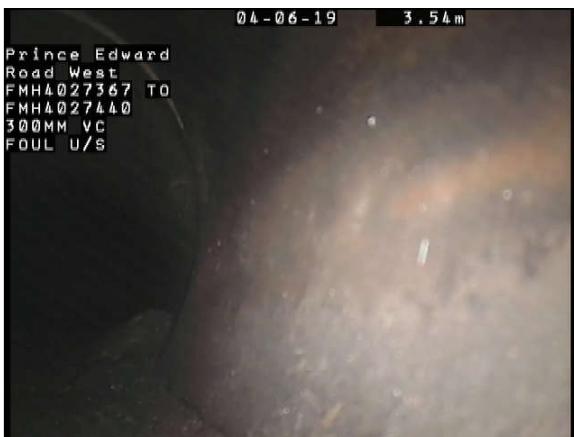
Photo Ref. : 041
 Video Tape : 0001, 0:01:40
 Observation : Debris Silt, 15 % cross-sectional area loss, Change

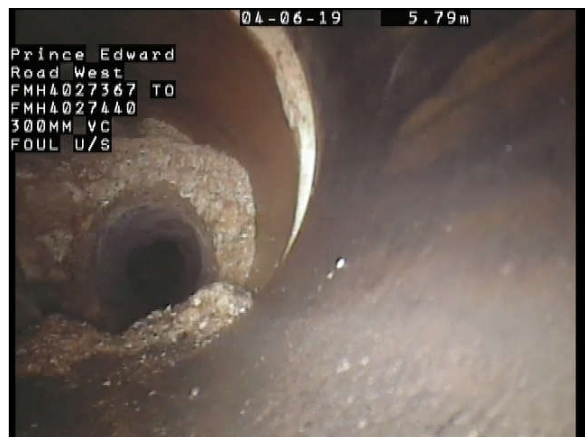
Photo Ref. : 042
 Video Tape : 0001, 0:01:55
 Observation : Broken Pipe, from 12 to 12 o'clock

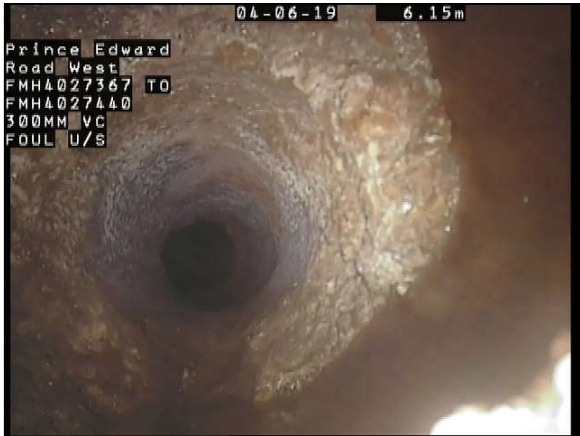
Photo Ref. : 043
Video Tape : 0001, 0:01:57
Observation : Material Change
Remark : Concrete

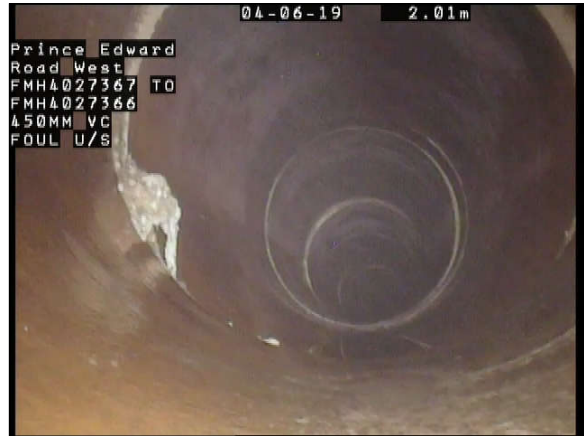
Photo Ref. : 046
Video Tape : 0001, 000327
Observation : Surface Damage Spalling Slight, from 08 to 09 o'clock

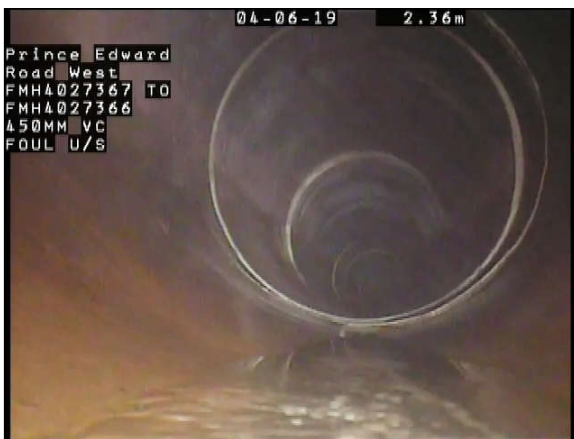
Photo Ref. : 047
Video Tape : 0001, 0:00:45
Observation : Fracture Circumferential AT Joint, from 12 to 08 o'clock
