## **Section 16 Planning Application**

Proposed Filling of Land for Site Formation Works for Permitted Agricultural Use

**Planning Statement**

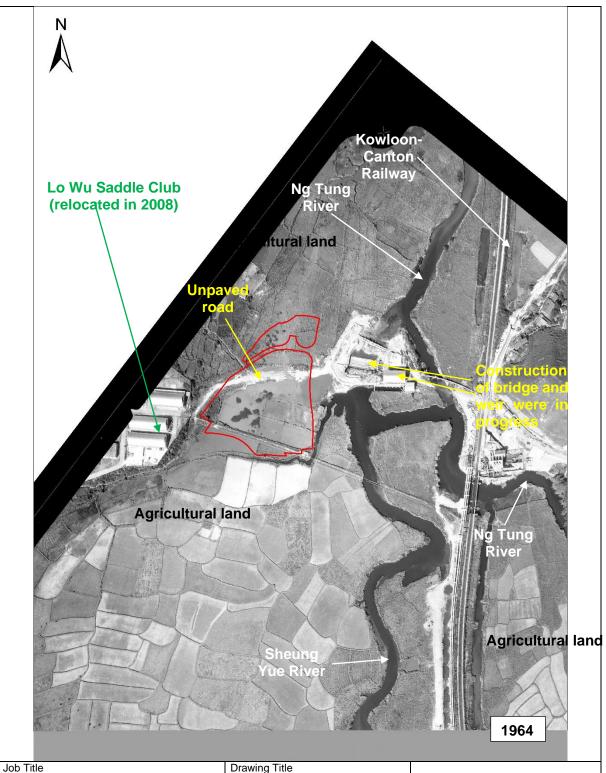
<b>AECOM</b>		
Drn. By	Drn. By	
JYCT	THLM	
Scale	Date	
-	16/04/2024	
Job No.	Plate. No.	
60624717	B2

Aerial Photograph
Interpretation of Site
KTN-2

- 3.5.2 The earliest aerial photograph in 1924 indicates that the Site and its vicinity appeared to be occupied by agricultural land. The meandering Sheung Yue River and Ng Tung River were visible. In 1964, construction of bridge and weir across the Sheung Yue River were in progress. An unpaved road, traversing in the southern Site, was observed connecting to the construction site. To the west of the Site, structures belonging to the Lo Wu Saddle Club, which was relocated in association with the construction of the Lo Wu Correctional Institution in 2008, was visible.
