Geotechnical Planning Review Report (GPRR)

This Geotechnical Planning Review Report (GPRR) has been prepared to support Planning Application No. A/NE-TKLN/89 for the proposed development at Lin Ma Hang Road, DD80, Lot 516 and others. The report addresses the Civil Engineering and Development Department's (CEDD) comments, including unauthorized slope works (USW), natural terrain hazards, and the commitment to conducting a Natural Terrain Hazard Study (NTHS). Key measures include exclusion of the USW-affected area, clarification of maintenance activities, and mitigation proposals.

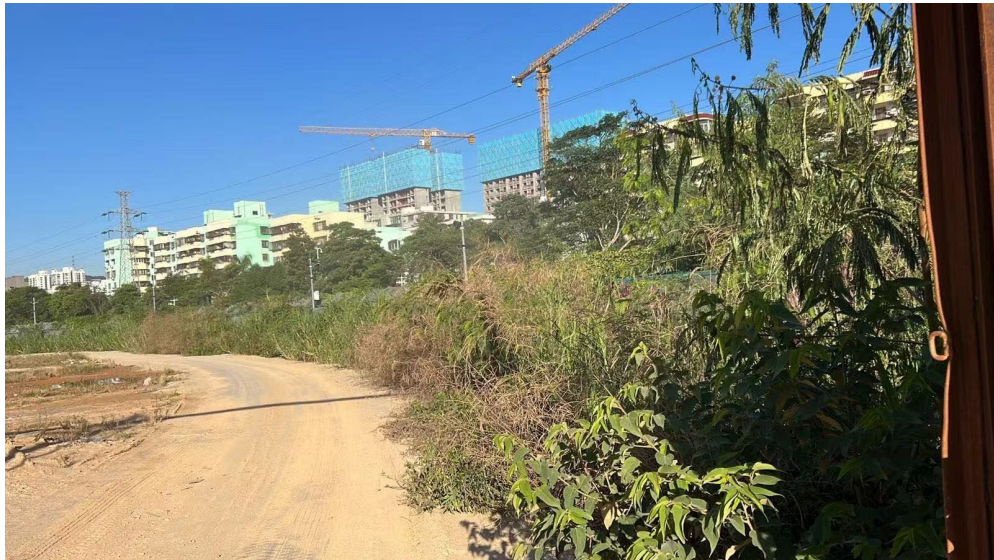
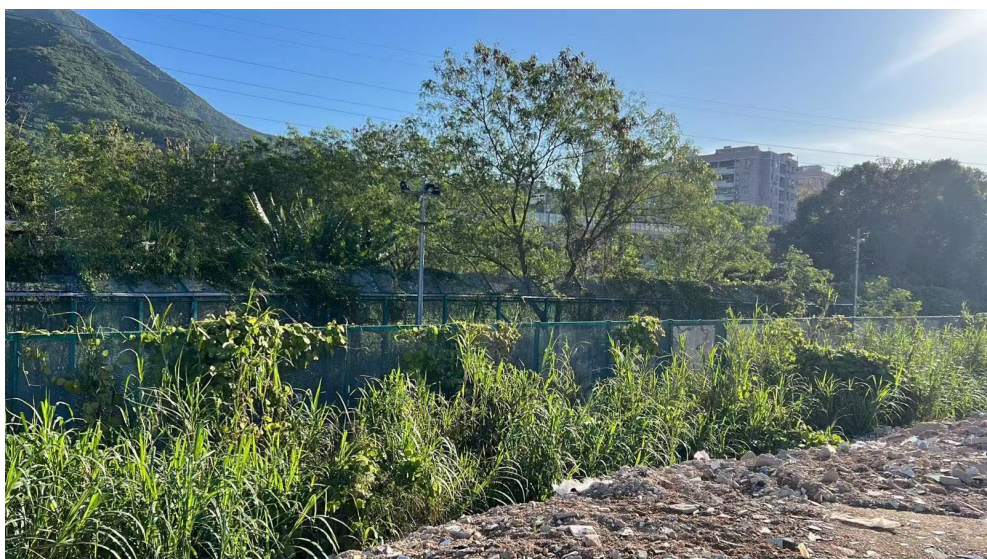
- A southern section with a slope gradient of approximately 3.44 (25 m length, 1.5 m height) leading from the site gate to the main road.
- Steep natural terrain to the north overlooking the site is not near the main building.

- **Southern Slope Stability:** The gentle slope near the gate (3.44 gradient) shows no significant geotechnical risks.
- **Northern Terrain Risks:** Moderate to high hazard risks require mitigation.

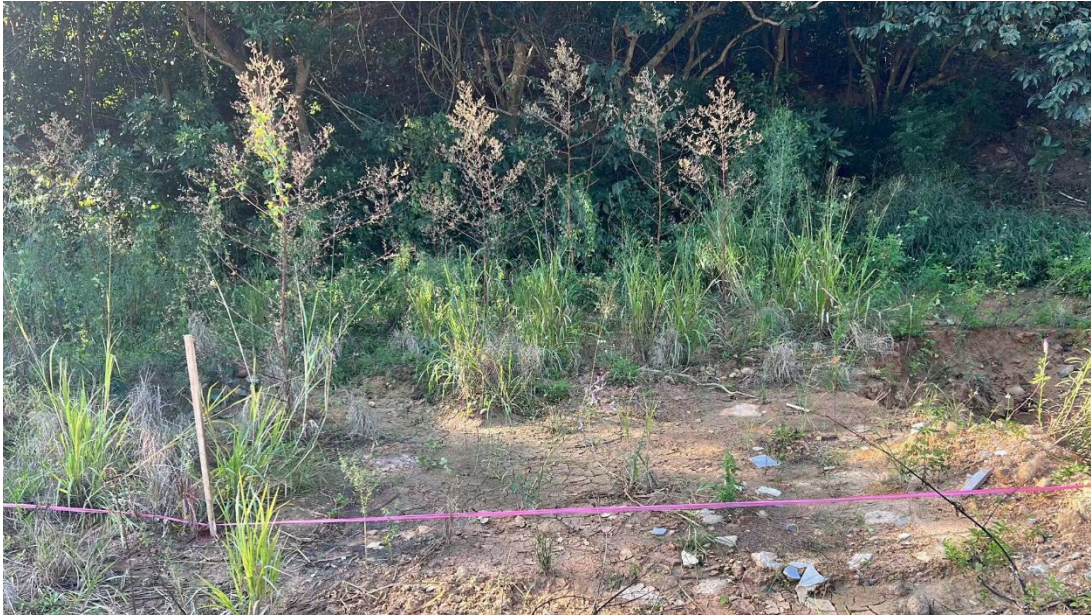
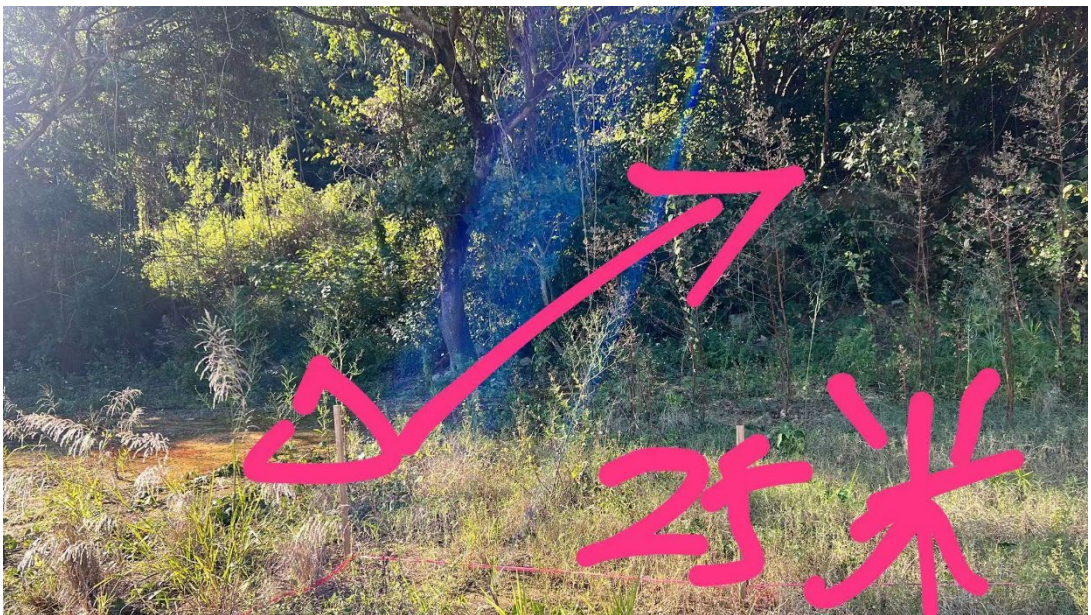
- **Existing Use:** The site is currently used for nothing.
- **Unauthorized Slope Works:** Maintenance near the gate but not in the application area following typhoon erosion.

Unauthorized slope works have been identified near the site, but the area indicated in CEDD's Attachment 1 does not align with the actual maintenance location. The works involved minor road repairs to ensure safety following typhoon-induced erosion. No fill soil engineering or significant slope modifications were conducted.
