**S16 PLANNING APPLICATION  
APPROVED CLEAR WATER BAY PENINSULA NORTH  
OUTLINE ZONING PLAN NO. S/SK-CWBN/6**

**Proposed Filling and Excavation of Land  
for the Permitted “Agricultural Use” in “Conservation Area”  
at Various Lots in DD238 in Clear Water Bay**

## **SUPPORTING PLANNING STATEMENT**

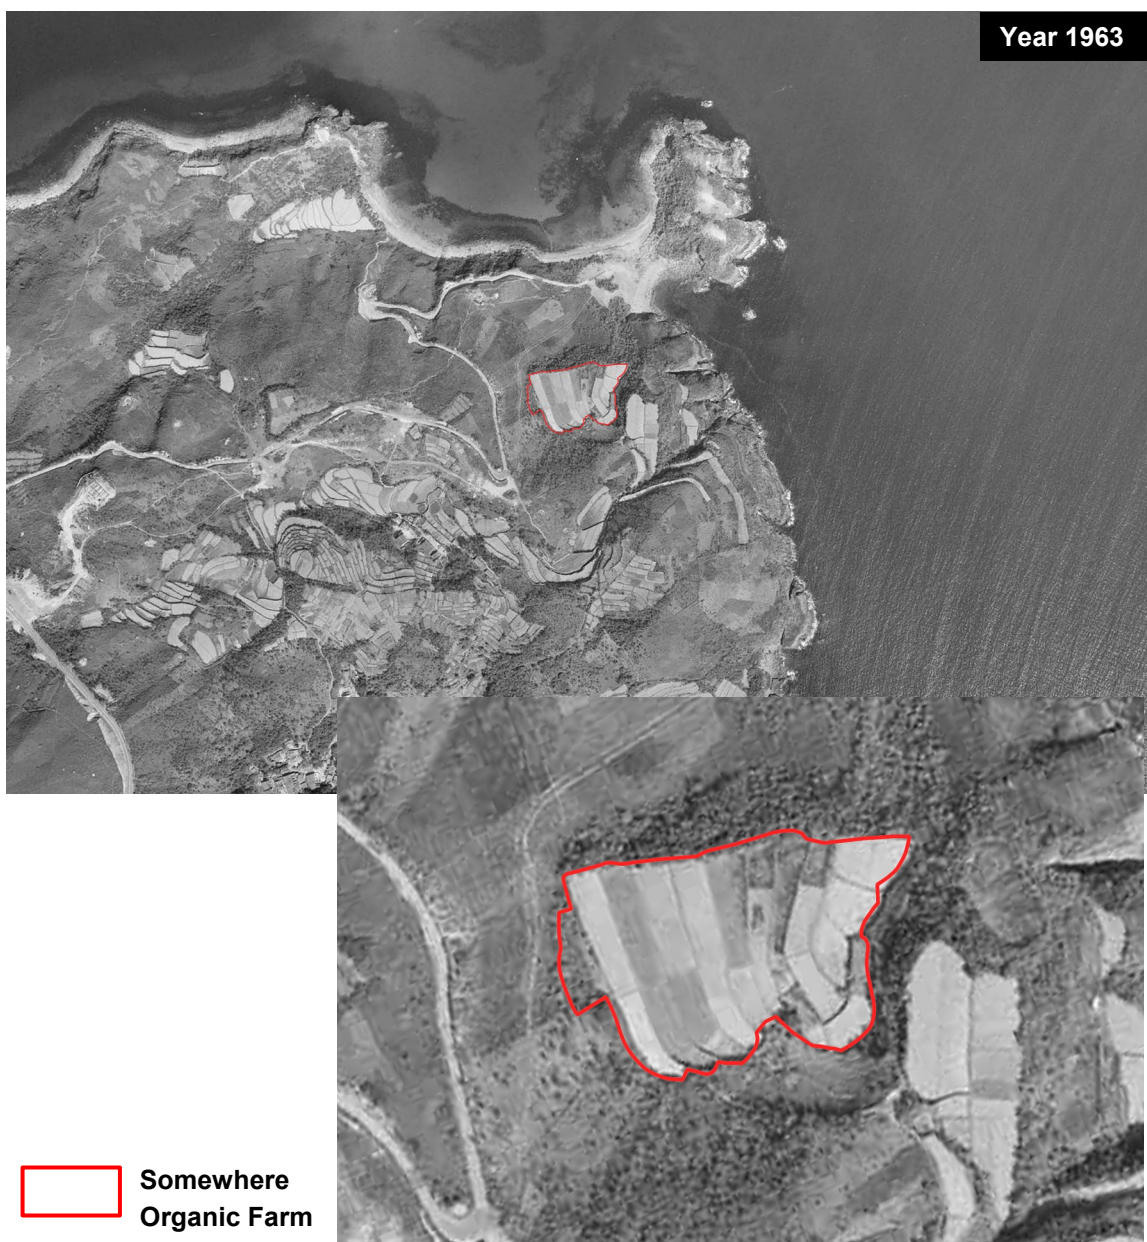
**Figure 3.1 Aerial Photo (Year 1963)**

3.1.1 As shown in the aerial photo (**Figure 3.1** refers), there were several patches of farmland in the area being used for agricultural use; not in the form of field or paddock, but in the form of terrace. In agriculture, terracing creates flat steps or terraces into a mountain or hillside. These steps are made to provide flat farmland and control water run-off. These terraces are considered a historic feature which recorded the farming history of Hong Kong, particularly at locations where no flat and arable land is available.

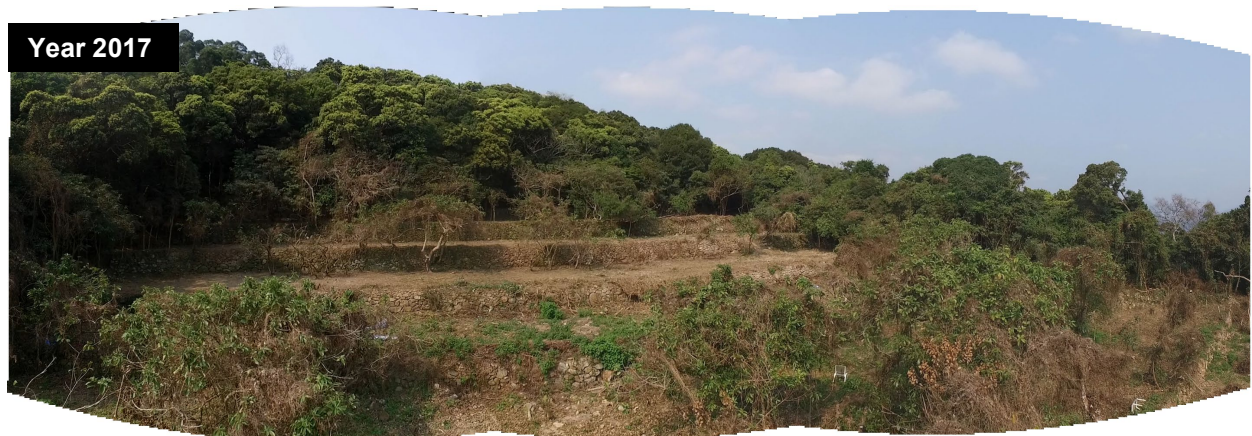
Figure 3.4 Site Photo (Year 2017)

3.3.2 **Figure 3.4** shows the condition of the Farm at the time when the Landowner took over the site. There are items left behind by the previous occupant, weeds and dried bushes and overgrown vegetation. It is also important to note that one of the ponds within the Farm now was a hollowed area and a water pump is found (**Figure 3.5** refers).

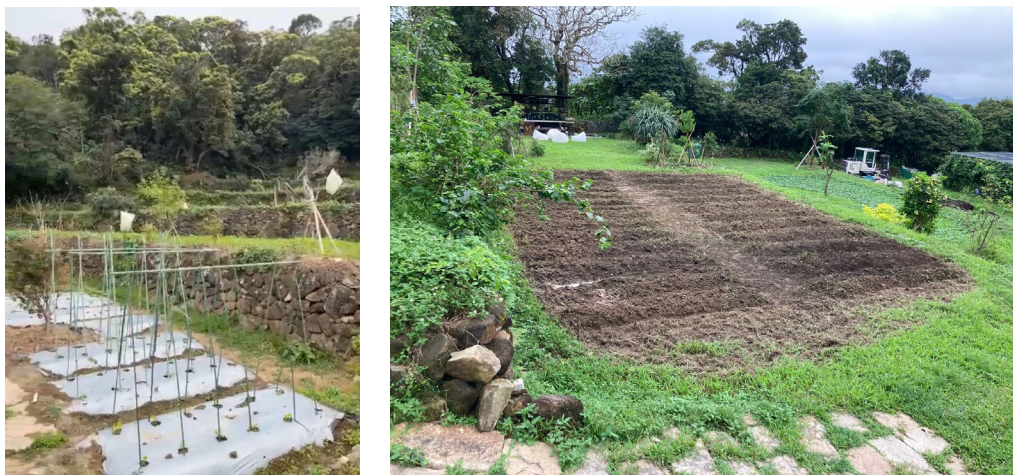
**Figure 3.6** Farming Activities (Current)

3.4.1 Practicing active farming is the best way to maintain the valuable historic feature. The Farm takes part in experimental farming, for example succulent garden, trial tropical fruits, miracle fruit, peanut butter fruits, cashew tree, Jabuticaba and etc.

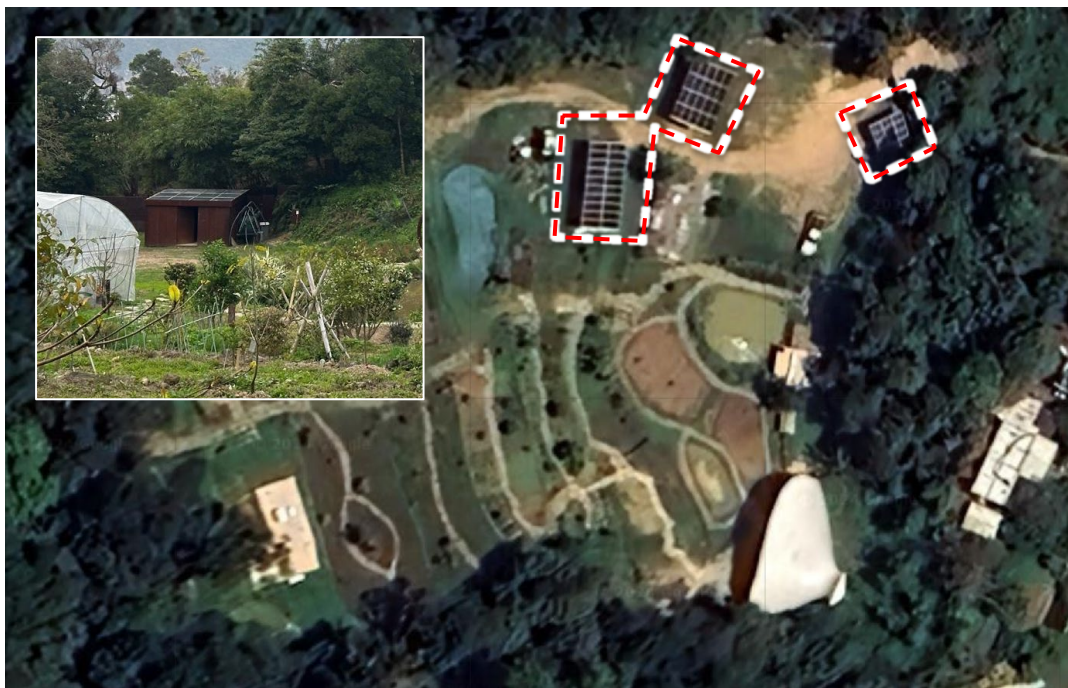
**Figure 3.7 Location of Solar Panels at the Farm**

3.4.4 The Farm is also harvesting solar energy to provide electricity within the farmland. The solar panels have been in place since 2021 and is currently still in use.

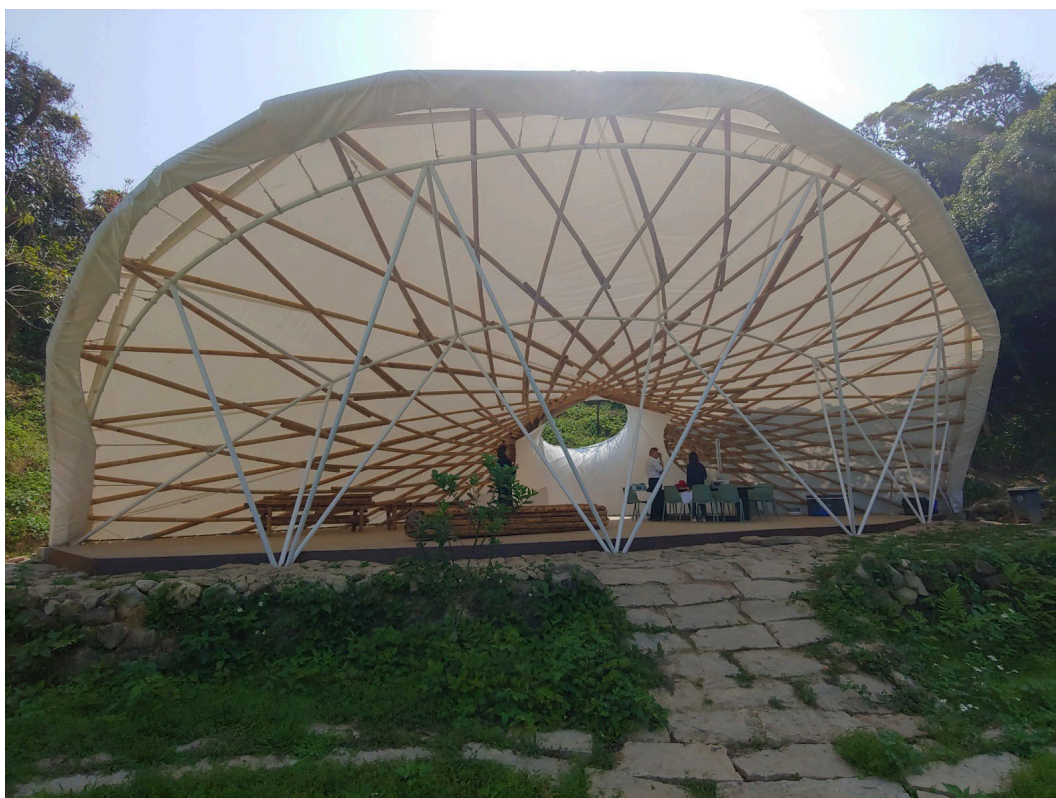
**Figure 3.8 The Bamboo Shelter**

3.4.6 The shelter is a bamboo shelter that is a long-span bending-active bamboo gridshell structure with a dimension of 16.81m x 13.68m x 5.3m (H). It is built from bamboo poles that are bent onsite to shape the structure and that are hand-tied together with metal wire using techniques based on Cantonese bamboo scaffolding craftsmanship. The shelter is located at the edge of the Farm and overlook the entire farm. It is elegantly designed and makes it visually compatible with the terraces and natural setting. It allows natural ventilation and captures cool breeze, thus offers a sustainable and naturally ventilated shelter for

- 3.4.7 The bamboo shelter is designed as a free-standing, standalone structure, placed on top of the ground surface without the need of piling foundations. At its back edge, the shelter is anchored to a small concrete plinth/ridge/dam which was installed to stabilise the terrain and prevent further landslides due to recent heavy rainfalls. In the front, the shelter is anchored to four concrete ballast slabs (diameter 1.2m) that prevent uplift in case of strong wind.

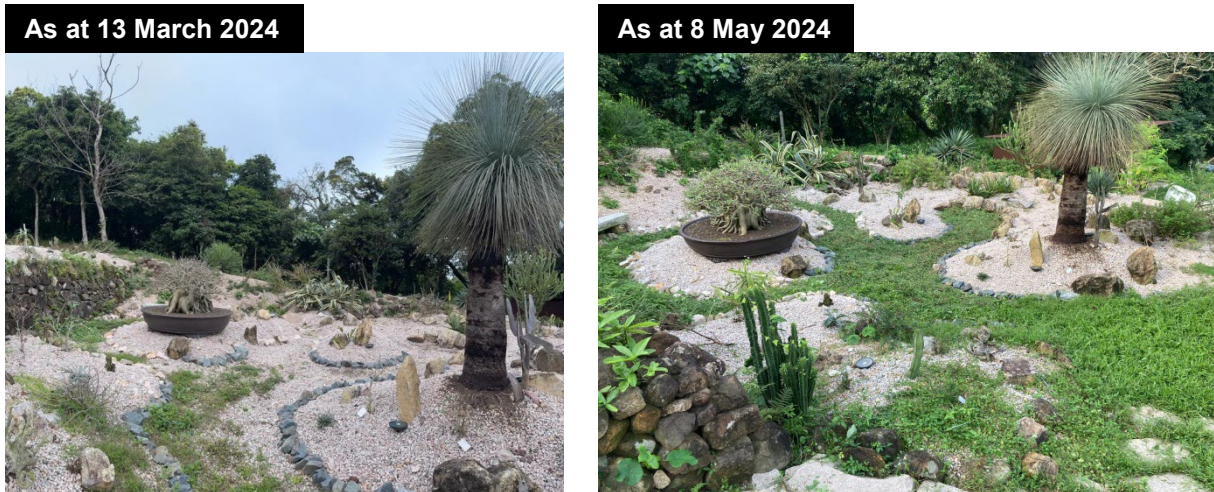
**Figure 3.9** Greening of Plantation Area

3.5.2 The Landowner has started with the reinstatement works as far as practicable. They have reduced the area covered by gravels and grassed the area concerned (**Figure 3.9** refers). At the same time, the Landowner has also made the platforms ready for further inspection by the Planning Department.

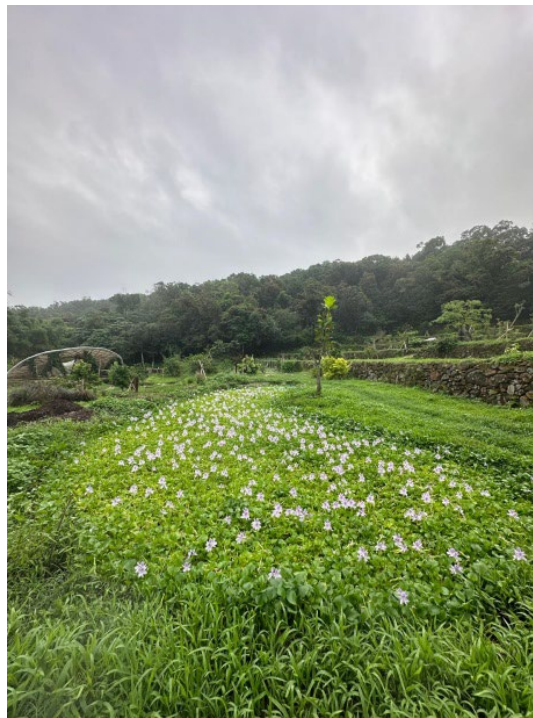
**Figure 4.1 Existing Condition of the Upper Pond**

4.1.3 **Figure 4.1** above shows the existing condition of the upper pond, where reinstatement work has yet to begun. Aquatic plants have fully occupied the surface of the pond. It is barely distinguishable with human eyes whether it is a pond or part of the grassland when standing at such a close distance.

4.1.2 The upper pond was excavated by the previous tenant for irrigation purpose. Comparing with the entire farmland of about 6,175m<sup>2</sup>, the size of the lower pond is considered **not excessive** and is of a **reasonable size** (just 3.07% of the total area of the Farm) for agricultural purpose.

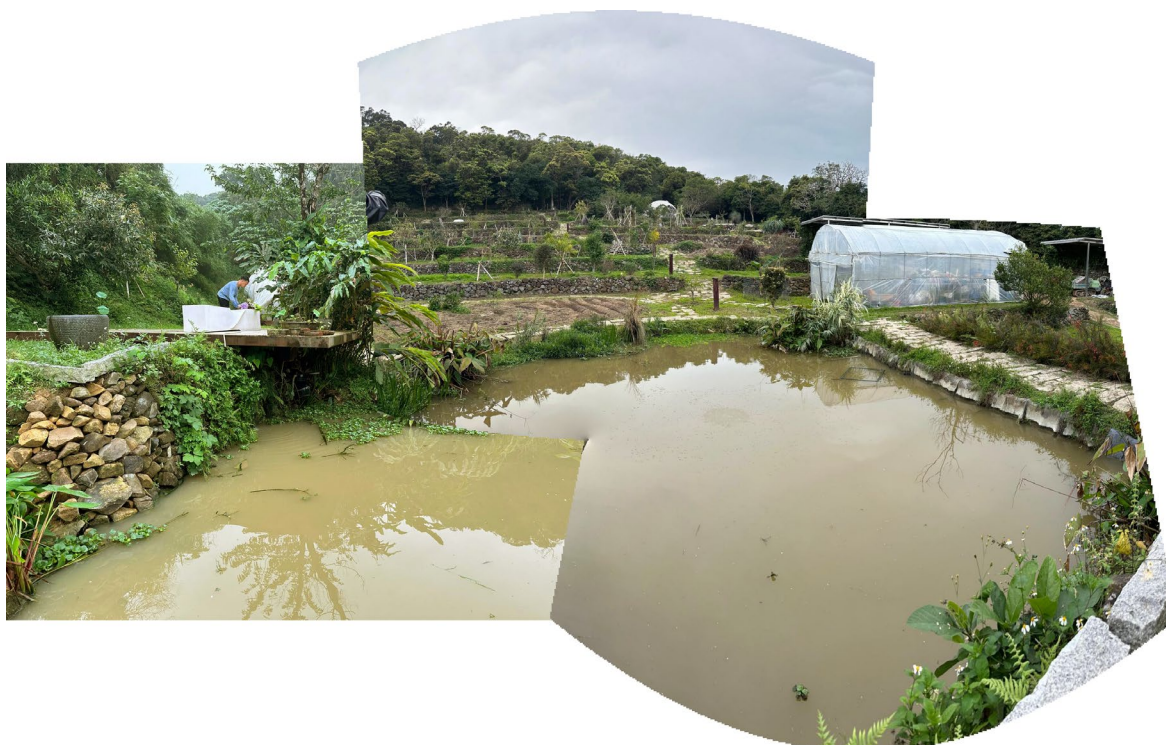
**Figure 4.2 Existing Condition of the Lower Pond**

- 4.1.4 The lower pond was a hollowed area at the time when the landowner took over the site. During dry season, the bottom of the hollowed area showed up and it is shown in the **Figure 3.5** that it was partially grassed. There are reasons to believe that aerial photos that were taken a few thousand feet above ground by the Lands Department would not be able to capture the hollowed area that was partially grassed or covered by aquatic plants.
- 4.1.5 The Applicant slightly modified and lined the lower pond for fish cultivation and adopting hydroponics in the future.

- 4.1.6 After all, the excavation of the upper pond and minor adjustment to the original hollowed area are all carried out **in support of the ongoing agriculture activities** within the Farmland, which is a Column 1 Use under the “Conservation Area”. At the same time, these ponds capture rainwater seeping down the terraces.
- 4.2 Minor Filling of Land for a Better Finishing of the Free-Standing Bamboo Shelter**
- 4.2.1 According to Para. 3.4.5 and Para. 3.4.6, the bamboo shelter is a free-standing structure that showcases Cantonese bamboo scaffolding craftsmanship. It creates a naturally ventilated resting space for the staff and volunteers working at the Farm. The shelter is located at the edge of the Farm below the slope and elegantly designed. These make it visually compatible with the terraces and natural setting. It allows natural ventilation and captures cool breeze, thus offers

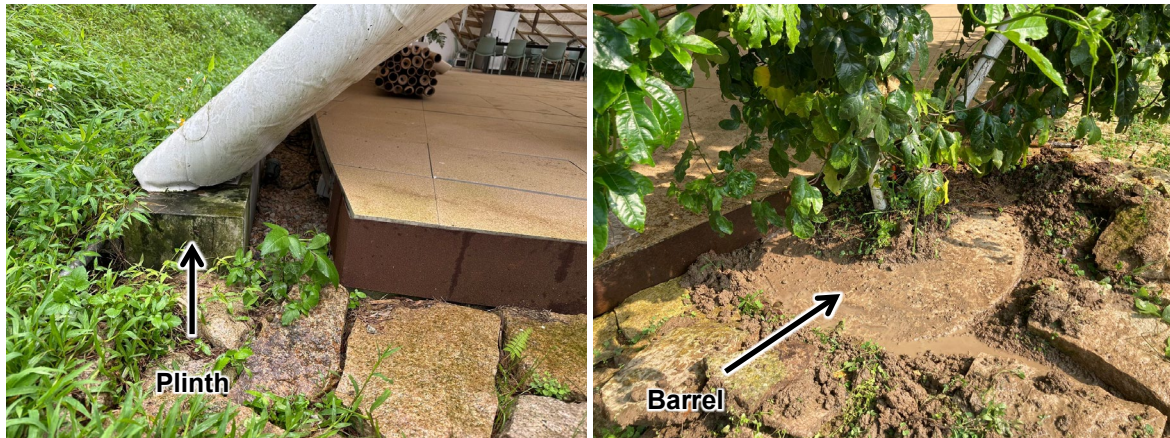
Figure 4.4 The Plinthes and Barrels of the Standalone Bamboo Shelter

4.2.2 The curvilinear plinth and barrels can in fact be placed at the ground. These odd and stiff features will then become visible. Since these are visually incompatible with the natural setting, the Applicant took steps to conceal these features underground so that only the elegant bamboo shelter is showcased at the Farm. From aesthetic and visual compatibility point of view, the current condition is considered a more acceptable option.

- 4.3.3 Similarly, the minor filling of land to conceal the curvilinear plinth and barrels is also aiming to maintain the natural setting and its visual environment. This conforms to the planning intention of the "Conservation Area" zone.
