## Geotechnical Planning Review Report

**Geotechnical Planning Review Report  
for Proposed Minor Relaxation of Building  
Height Restriction for Permitted House  
Development in “Residential (Group C) 2”  
Zone at Lot No. 214 & the Extension thereto  
in D.D. 219 and Adjoining Government Land,  
Tin Shek Road, Sai Kung, New Territories**

**November 2024**

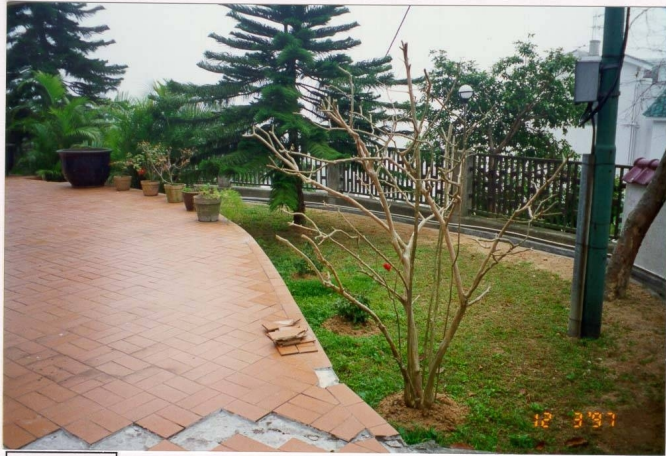
Close Area.

The proposed ELS works at the Site includes excavation of earth to form space for the construction of the permanent foundation works. The retaining wall 7SE-D/R46 is at 5m from the Site and thus fall into the influence zone of settlement due to the earth excavation works. The wall thus would experience ground settlements due to the pipe pile wall deflection and groundwater drawdown. The settlement would be controlled to 25mm at maximum and the effects of settlements on the retaining wall would be maintained at minimal. Regarding the loads from the permanent foundation within the Site, they would be founded as deep as possible to minimize the effects to the existing retaining wall including the sub-surface portion of the wall. The details of controlling
