Dear Sirs,

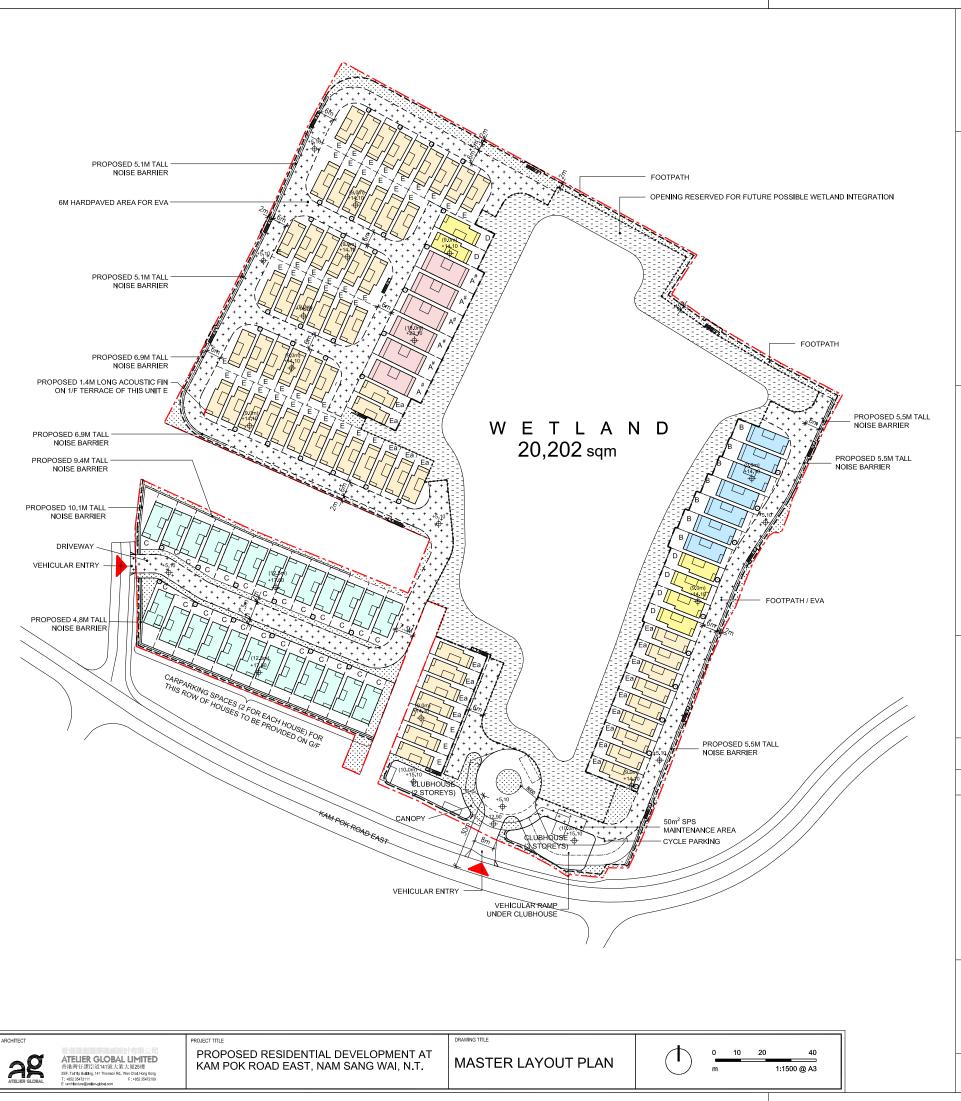
- 4.1 To assess the possible visual impact of the proposed development at this piece of wide flat land area of the Nam Sang Wai area, a total of 11 initial visually sensitive public viewing points ("VPs") were selected at the early assessment stage (i.e. 10 of them represent the local context and 1 for the district context) (Plan 8). As the topography at this part of the Nam Sang Wai area is relatively flat and being surrounded by brownfield activities, it is rather difficult to locate any other meaningful public VPs in the local- or district-wide context.
- 4.2 However, after site inspections, only seven of them (i.e. VP2, VP4, VP5, VP6, VP9, VP10 and VP11) (**Plan 8**) are considered appropriate for this VIA as the others cannot view the
