Yuba Company Limited

Proposed Amendment to the Approved Wan Chai Outline Zoning Plan No. S/H5/31 from Comprehensive Development Area", "Residential (Group C)", "Open Space" and "Government, Institution or Community" zones and Areas shown as "Road" to "Other Specified Uses (Residential Development with Historic Building Conserved)" and "Other Specified Uses (Elevated Walkway)" at Nos. 1, 1A, 2 and 3 Hill Side Terrace, No. 55 Ship Street (a.k.a. Nam Koo Terrace), Nos. 1-5 Schooner Street, No. 53 Ship Street, No. 18 Sau Wa Fong, Inland Lot No. 9048 and adjoining Government Land, Wan Chai

Geotechnical Planning Review Report

August 2024

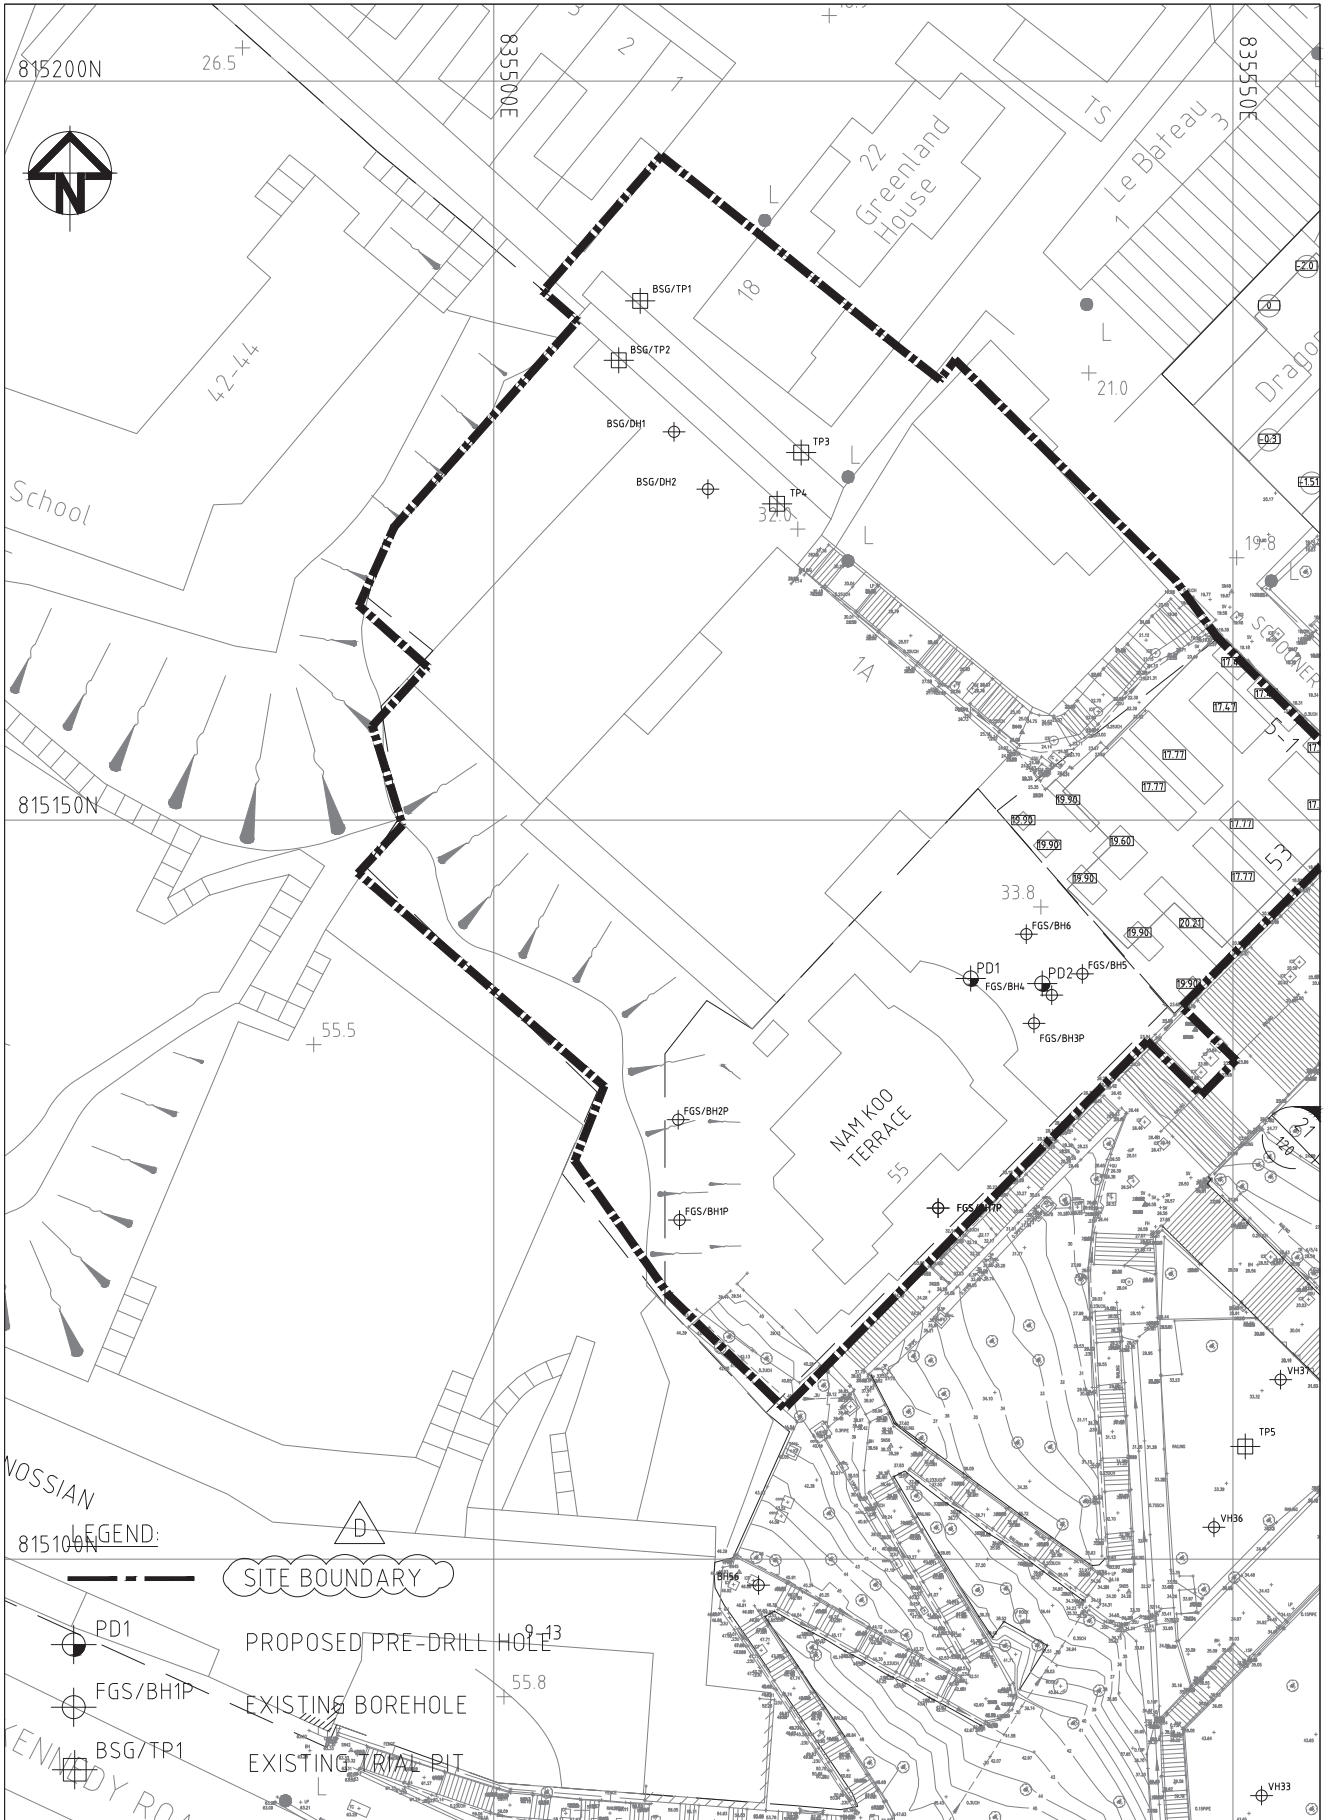
- SITE BOUNDARY
- PD1
- FGS/BH1P
- BSG/TP1
- PROPOSED PRE-DRILL HOLE
- EXISTING BOREHOLE
- EXISTING TRIAL PIT

The location of existing and proposed GI is presented in Figure 2. The geological section illustrating the typical ground condition of the Site is presented in Figure 3. The records of existing and proposed GI are attached in Appendix A.
