Tree Survey Report

**Section 16 Planning Application for Proposed Public Utility
Installation (Submarine Cable and Landing System) on
Government Land near Rural Building Lot No. 1220 and 1221,
Chung Hom Kok, Hong Kong Island**

Tree Survey Report (Final Rev.1)

Document No. 004

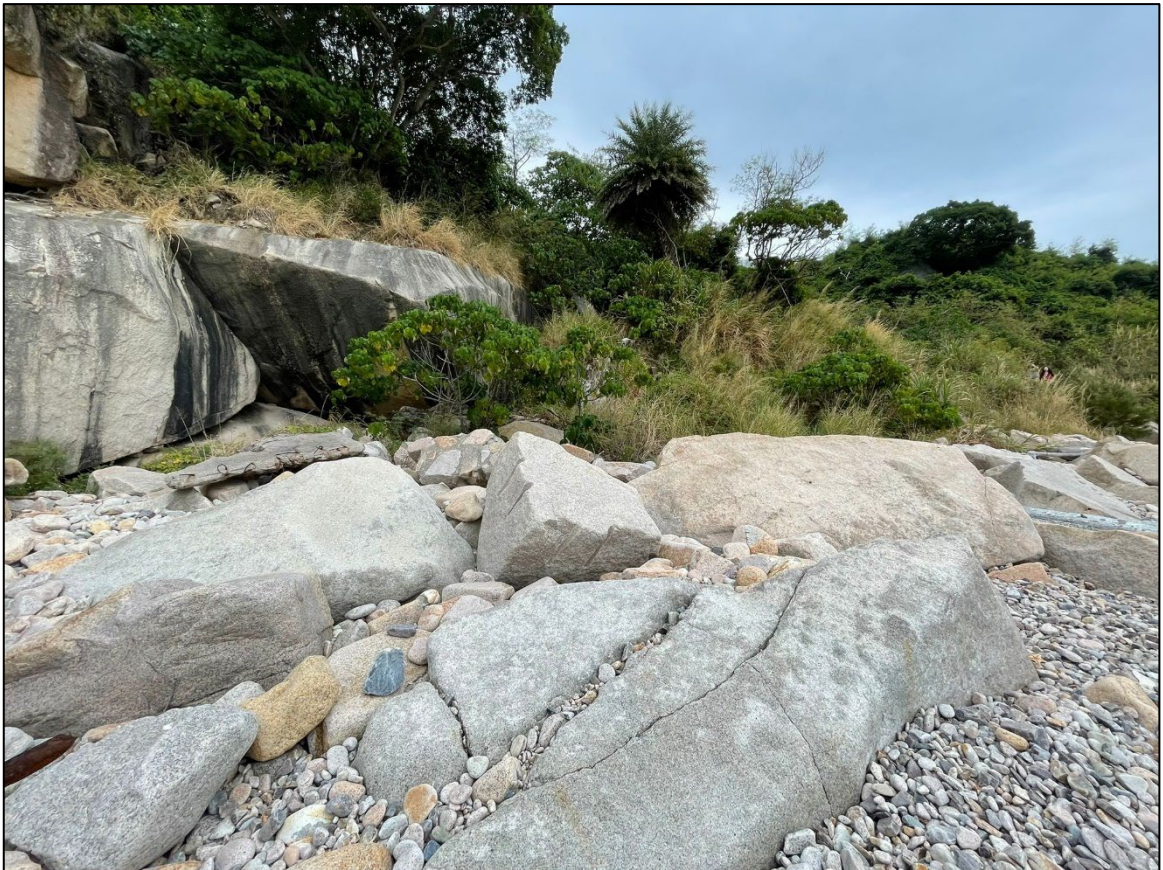
Exhibit 6.1 - View of Existing Hillside and Beach around Application Site

- 6.1.3 Government regulation (Page C2 of Appendix C of DEVB TC(W) No. 4/2020) states that seedling trees should be planted on slopes, as their root balls are better adapted to sloping terrain than larger Light Standard or Standard trees. Inside and around the Application Site, the thin, rocky soils and competition and shading from existing vegetation make planting and successful establishment of seedlings in these areas impracticable. In addition, space within the Application Site is extremely limited and seedling trees planted close to the cable ducts are likely to be shaded out by the shadows cast by the twin ducts themselves.
