Natural Terrain Hazard Study

Application for Permission under Section 16 of The Town Planning Ordinance (Cap. 131)

Minor Relaxation of Building Height Restriction
from 2 Storeys to 4 Storeys for
Proposed 4-Storey Columbarium
at Part of Inland Lot No. 7755 RP and
Government Land sandwiched between
Inland Lot No. 7755 RP and Inland Lot No. 7713,
Cape Collinson Road, Chai Wan

Philip So & Associates Limited

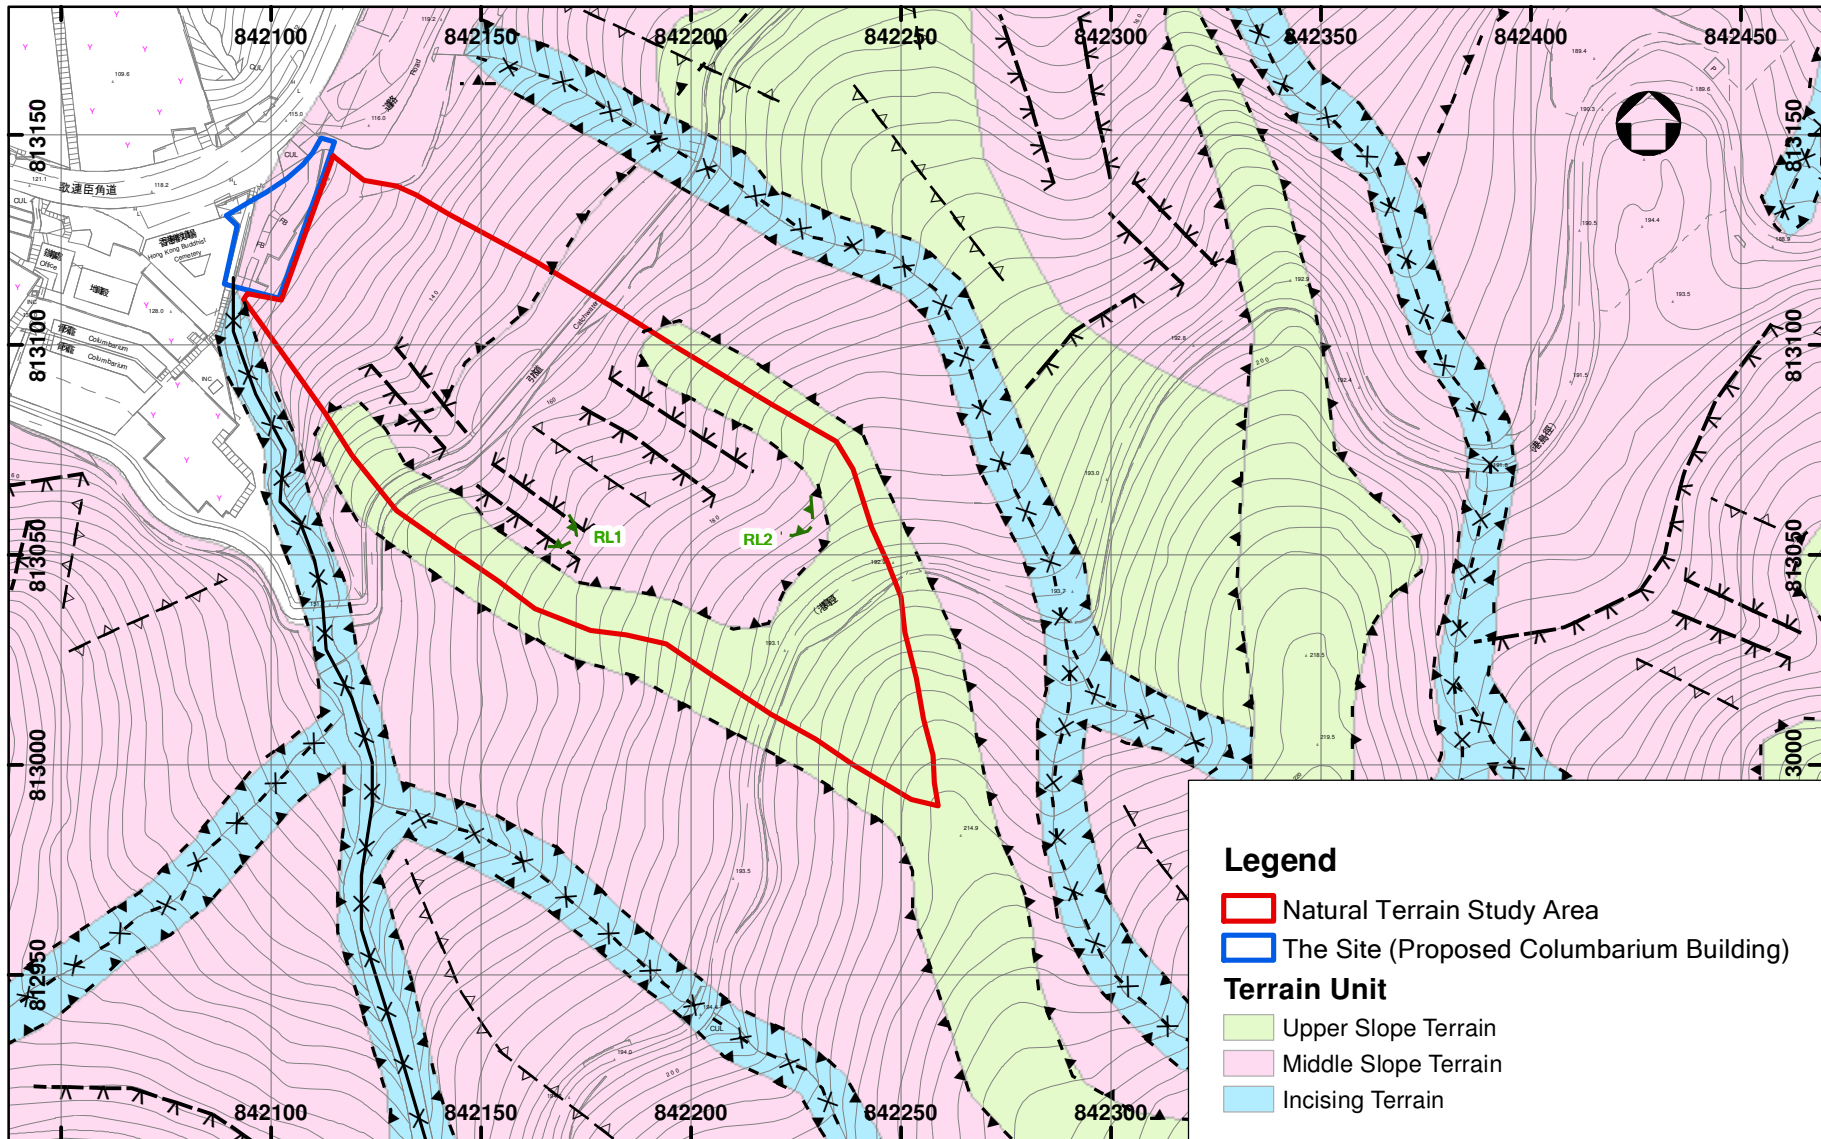
TITLE: Terrain Unit Map

To appreciate the geomorphological process within the NTSA, it is better to look at a wider picture within the Study Region. Terrain Units within the Study Region are divided into three main units developed based on the simplified land surface model (Dalrymple, et al., 1968) according to their geomorphological characteristics. The terrain units identified within the NTSA are described below and presented in **Figure 10**.

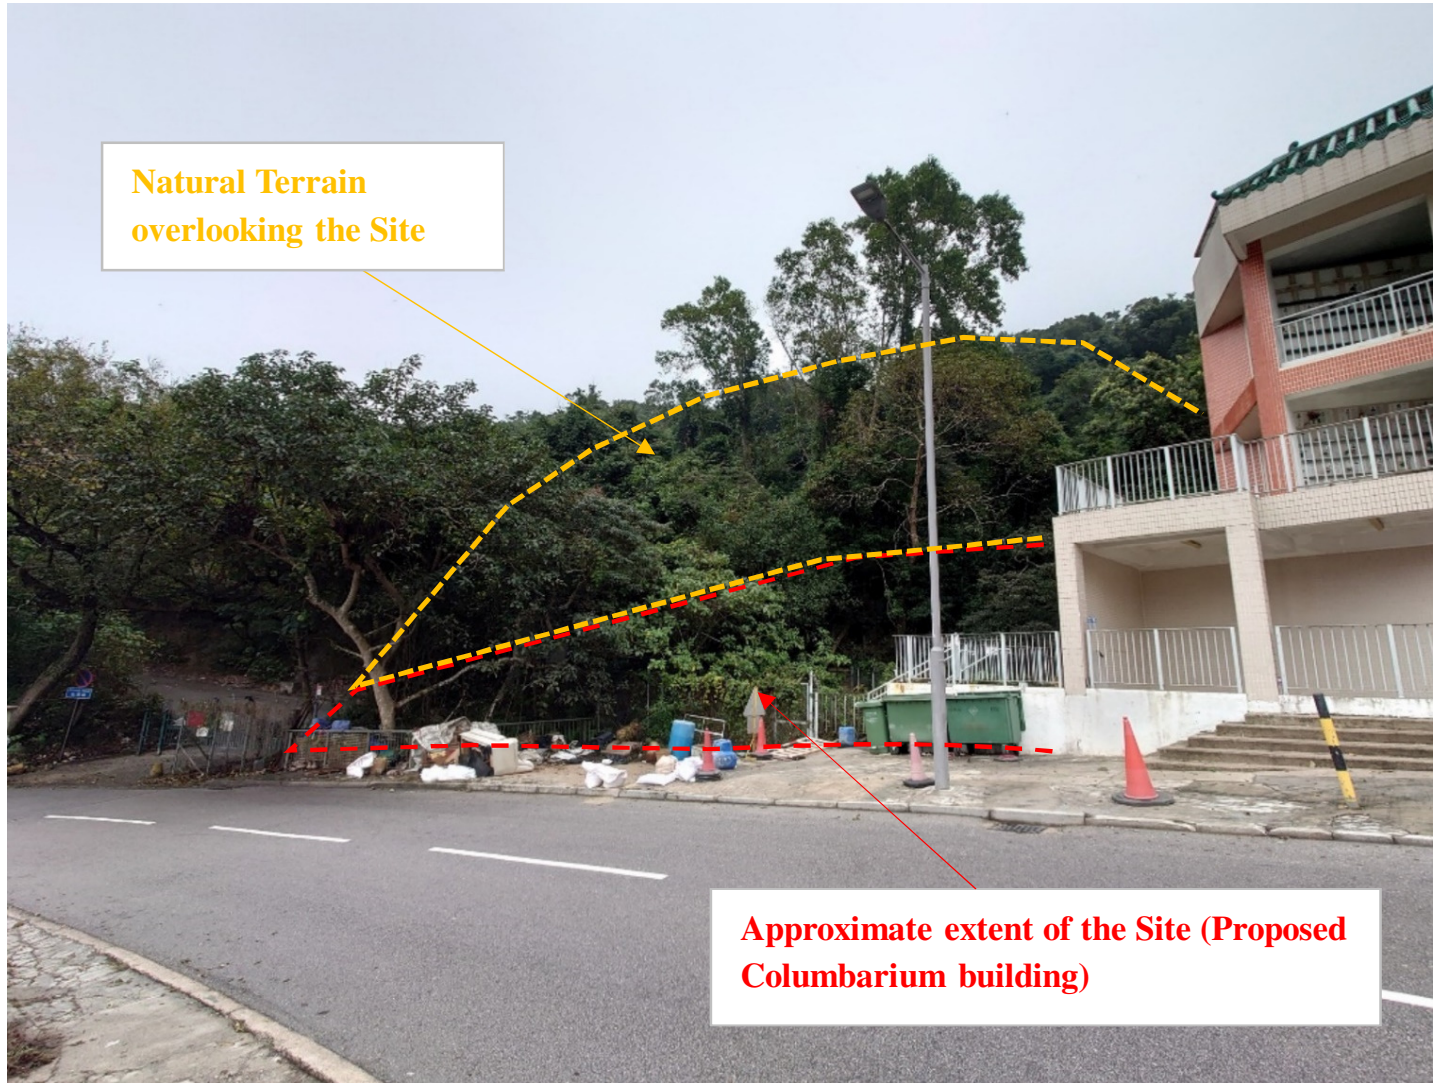
Plate 1 General View of the Natural Terrain Hazard Study Area (NTSA) overlooking the Site

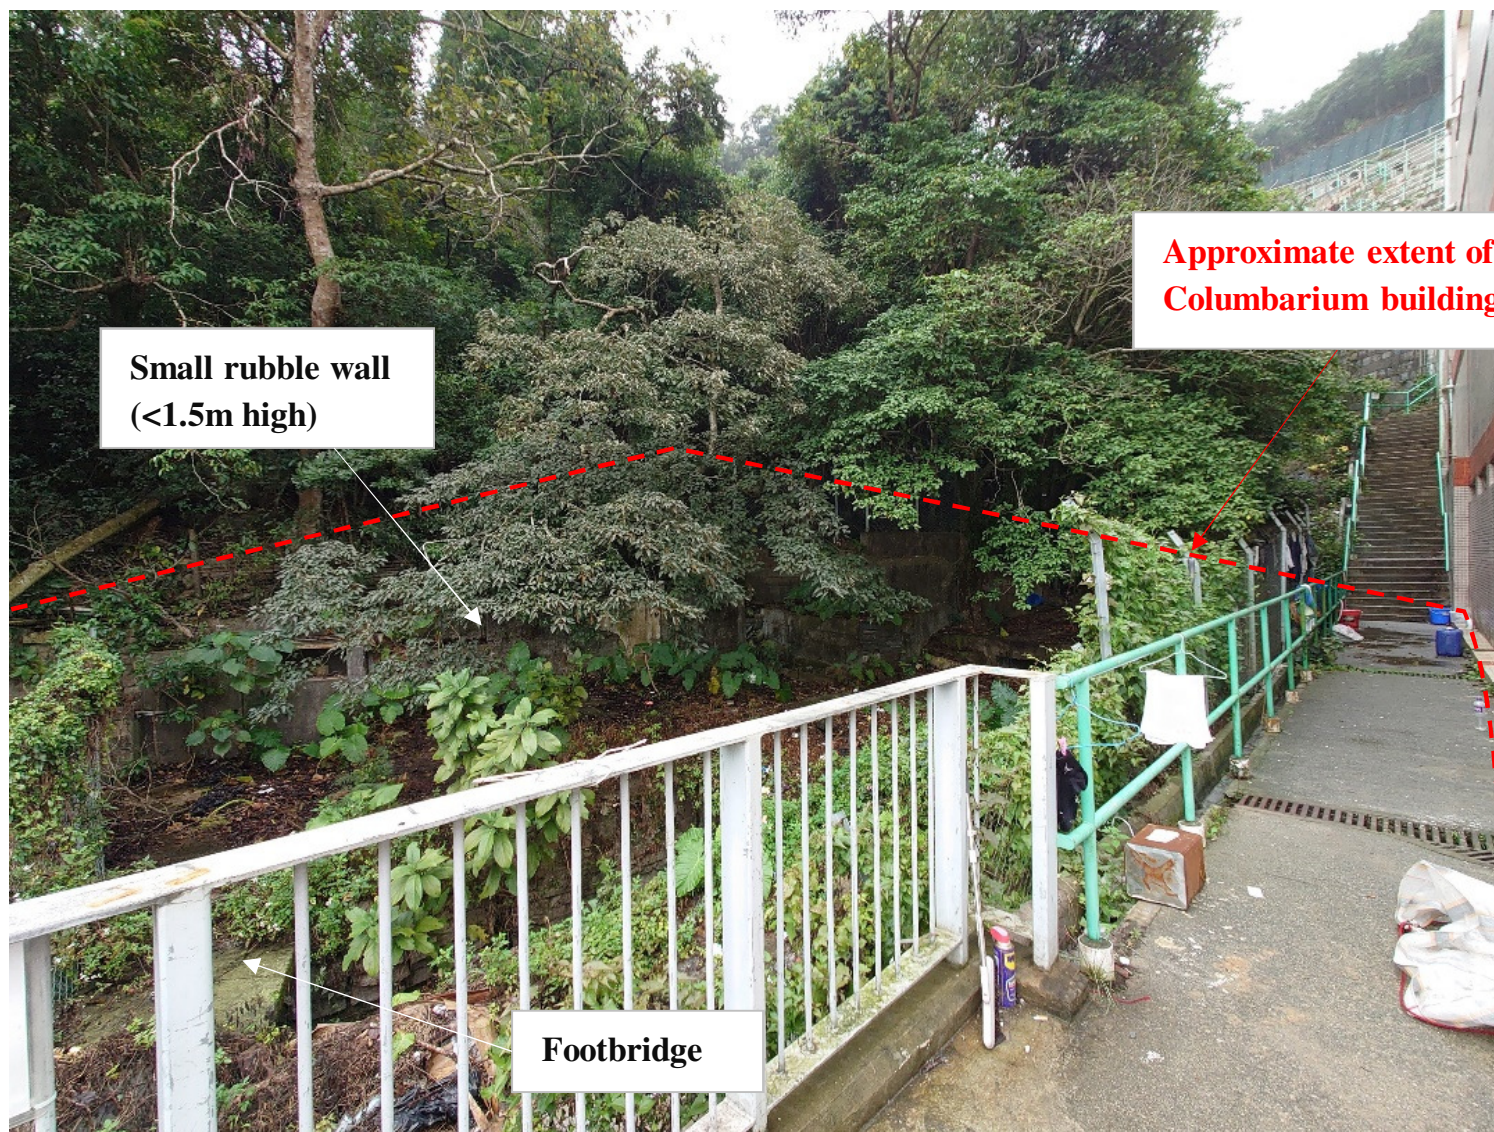
Plate 2 Close up view of the Southern Portion of the Site (looking south)

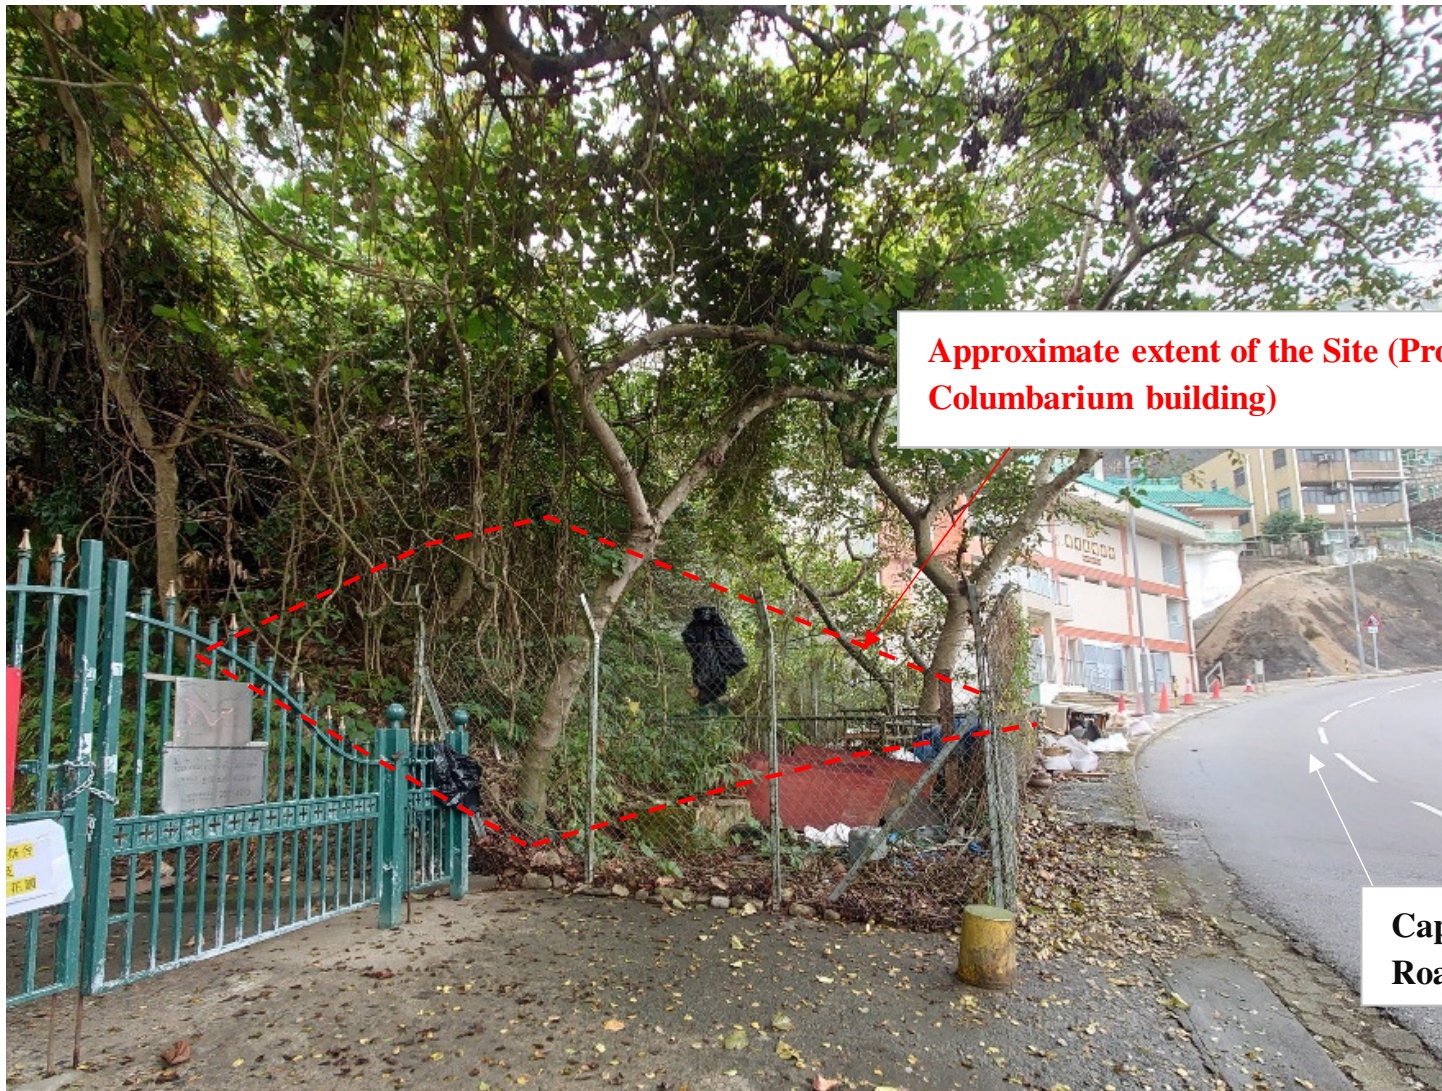
Plate 3 Close up view of the Northern Portion of the Site (looking west)

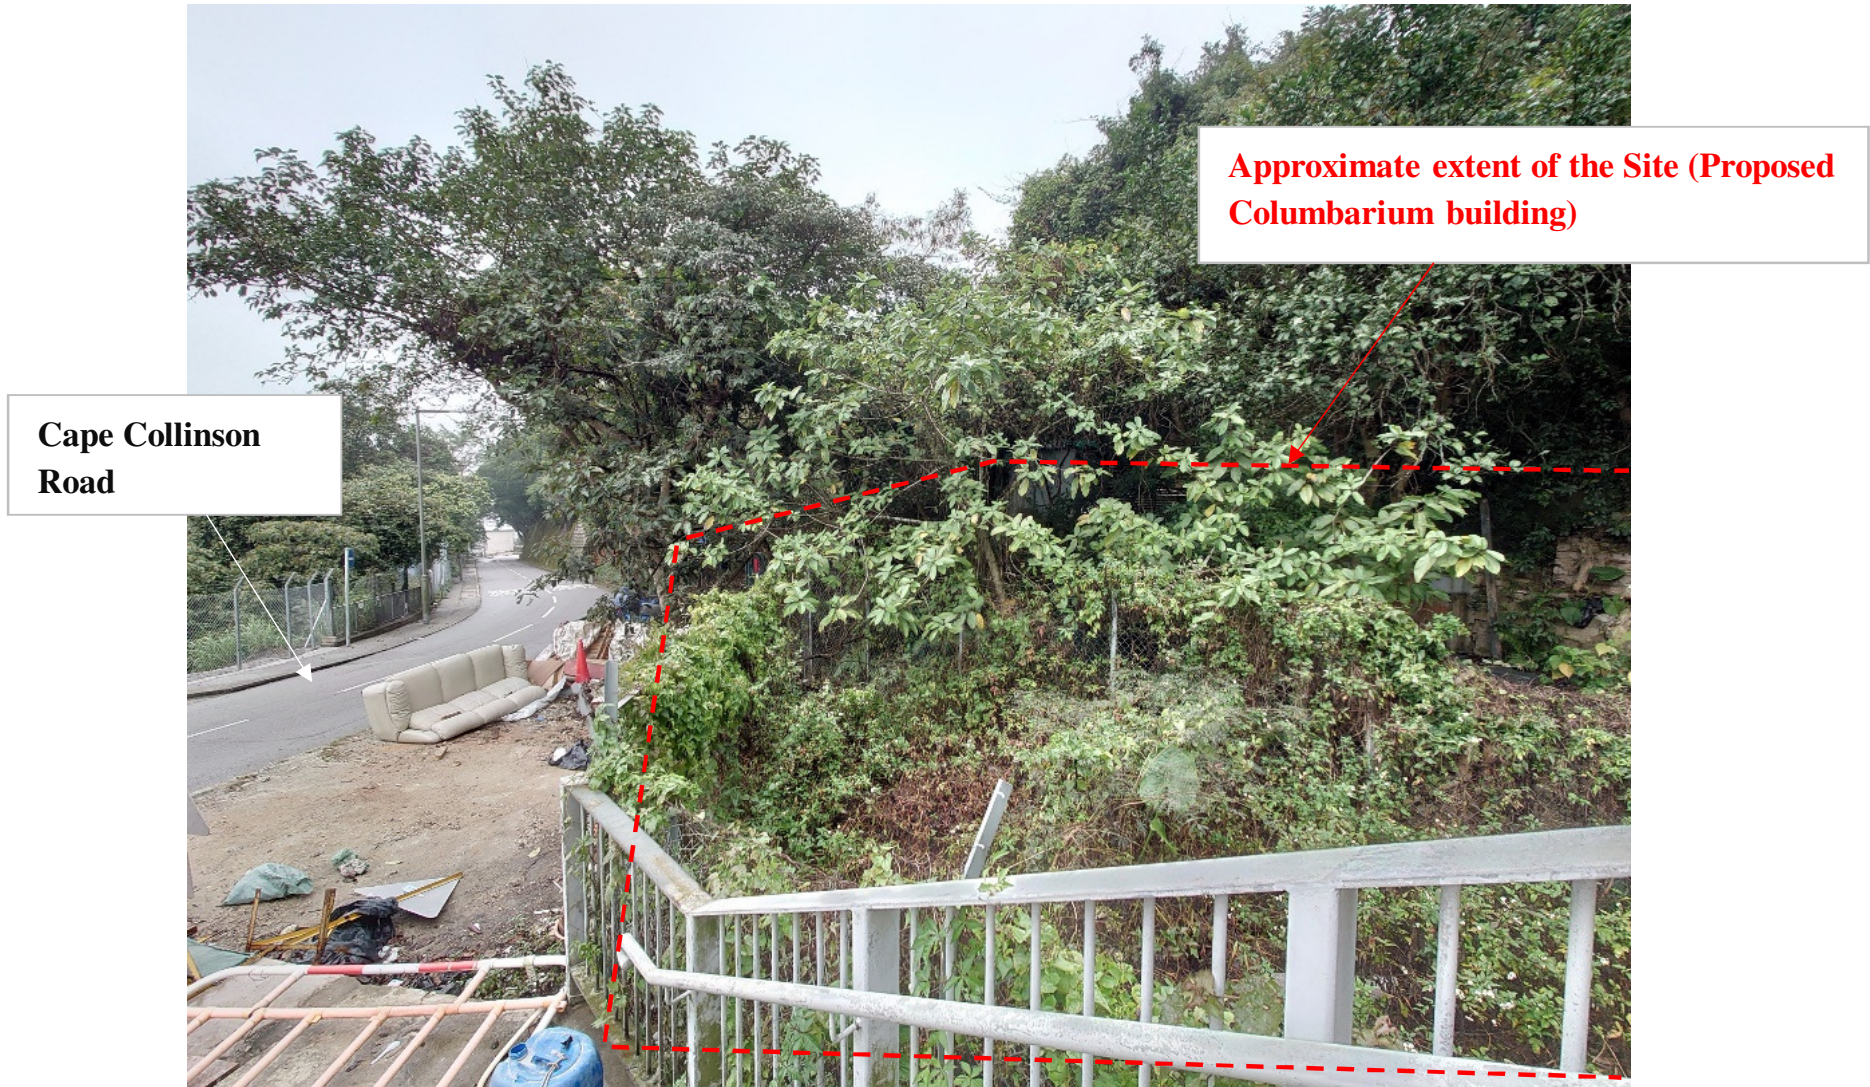
Plate 4 Close up view of the Northern Portion of the Site (looking east)

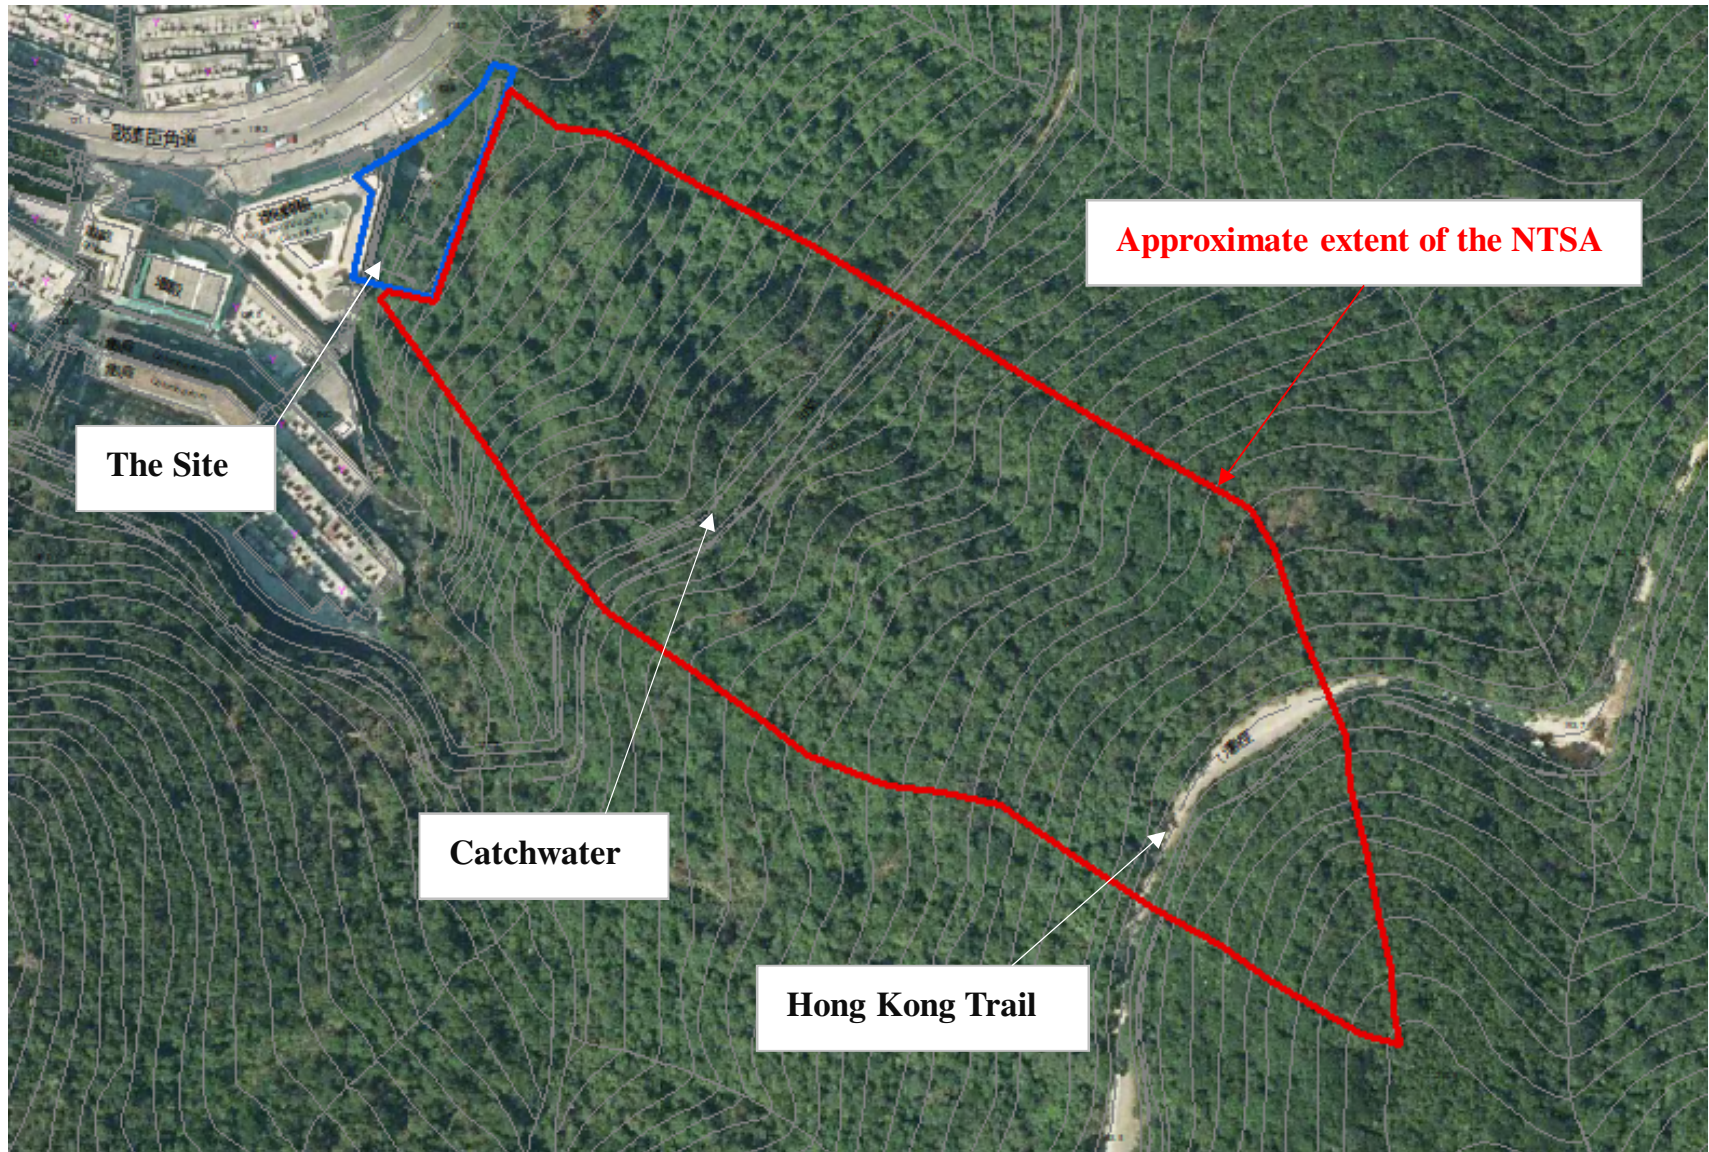
Plate 5 Aerial View of the NTSA and the Site

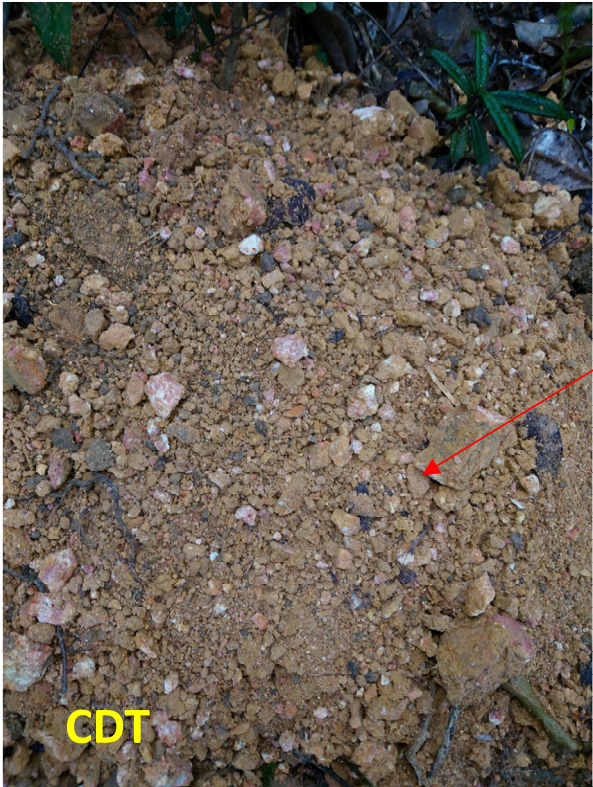
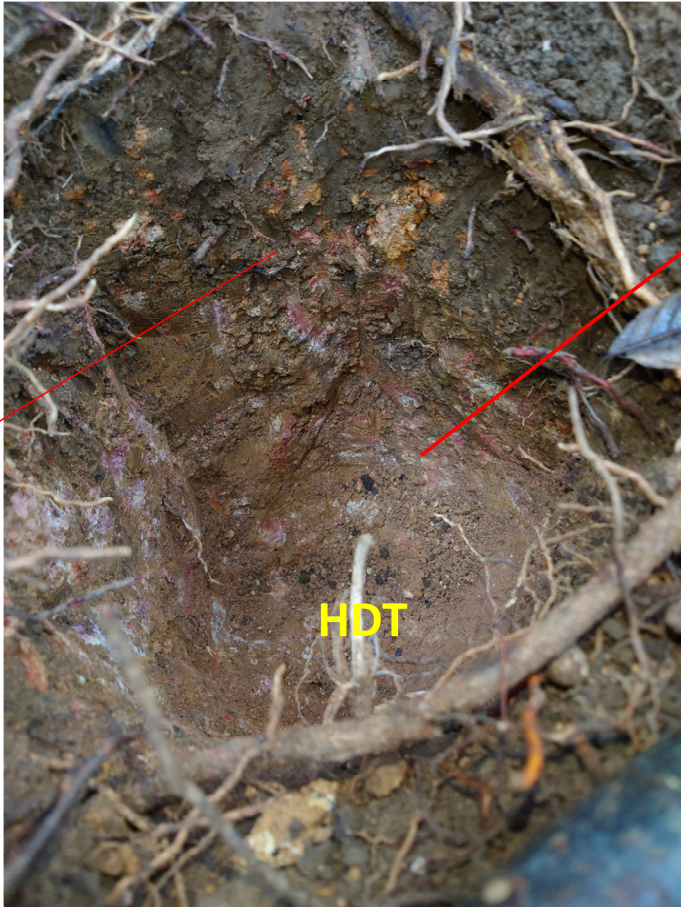
IP1 at the upper spur of the NTSA

0.1m thick top soil (TS) overlying completely decomposed fine ash vitric TUFF (CDT). CDT encountered at 0.1m BGL and can be described as extremely weak, reddish brown, mottled white, pink and orange, completely decomposed fine ash vitric TUFF which comprises stiff, sandy SILT with many angular fine to medium gravel.

HDT encountered at 1.10m below ground of IP1 which can be described as weak, brown, mottled white and pink, highly to moderately decomposed fine ash vitric TUFF.

Plate 6 Saprolitic soil cover the spurs of the NTSA (IP1)

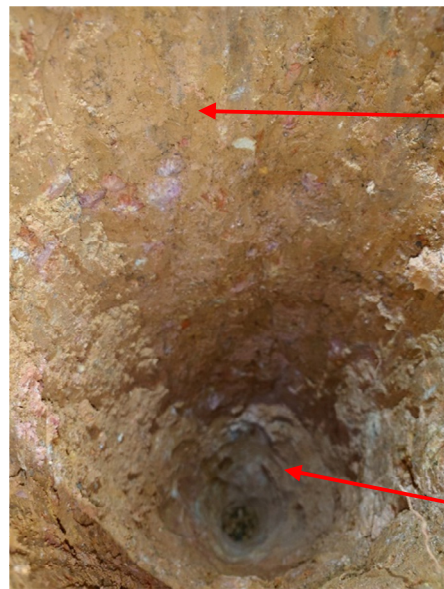
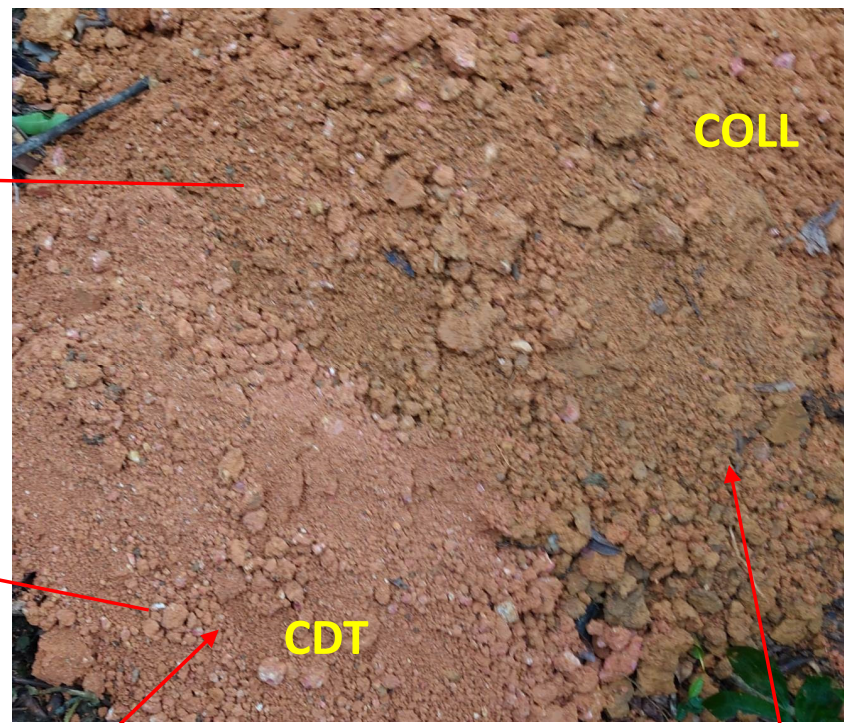
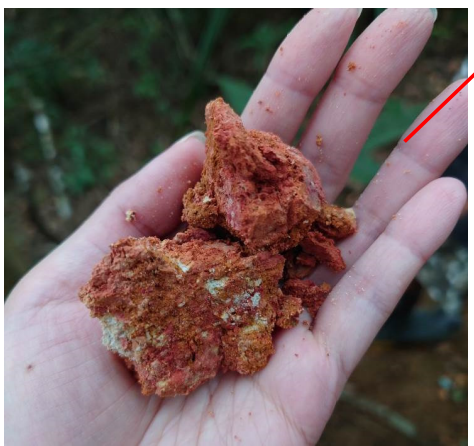
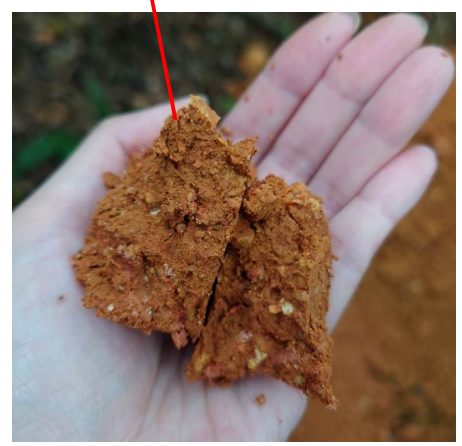
IP2 at the upper portion of the NTSA

From 0 to 0.8m below ground level, colluvium was retrieved from IP2 which can be described as firm, brown, sandy SILT with some subangular fine to coarse gravel sized rock fragments.

CDT encountered at 0.8m BGL and can be described as extremely weak, reddish brown, mottled white and red, completely decomposed fine ash vitric TUFF which comprises of stiff, slightly sandy SILT with some subangular fine to medium gravel.

Plate 7 Open hillslop colluvium revealed at IP2 (about +183 mPD) in the vicinity of the upper portion of the NTSA

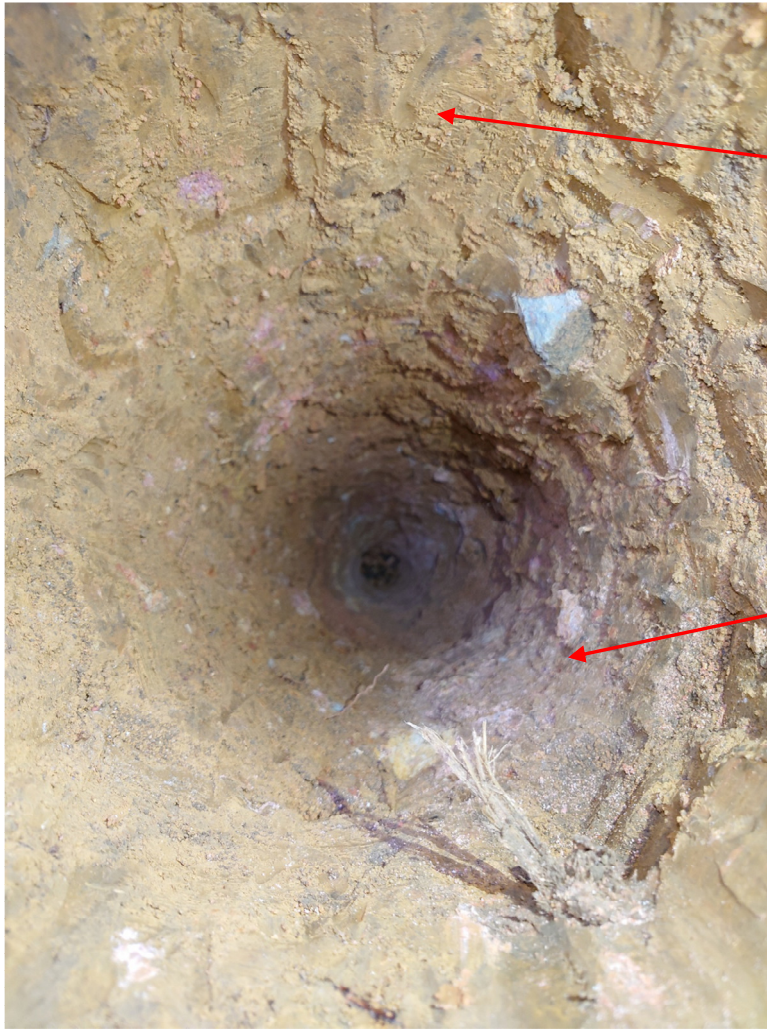
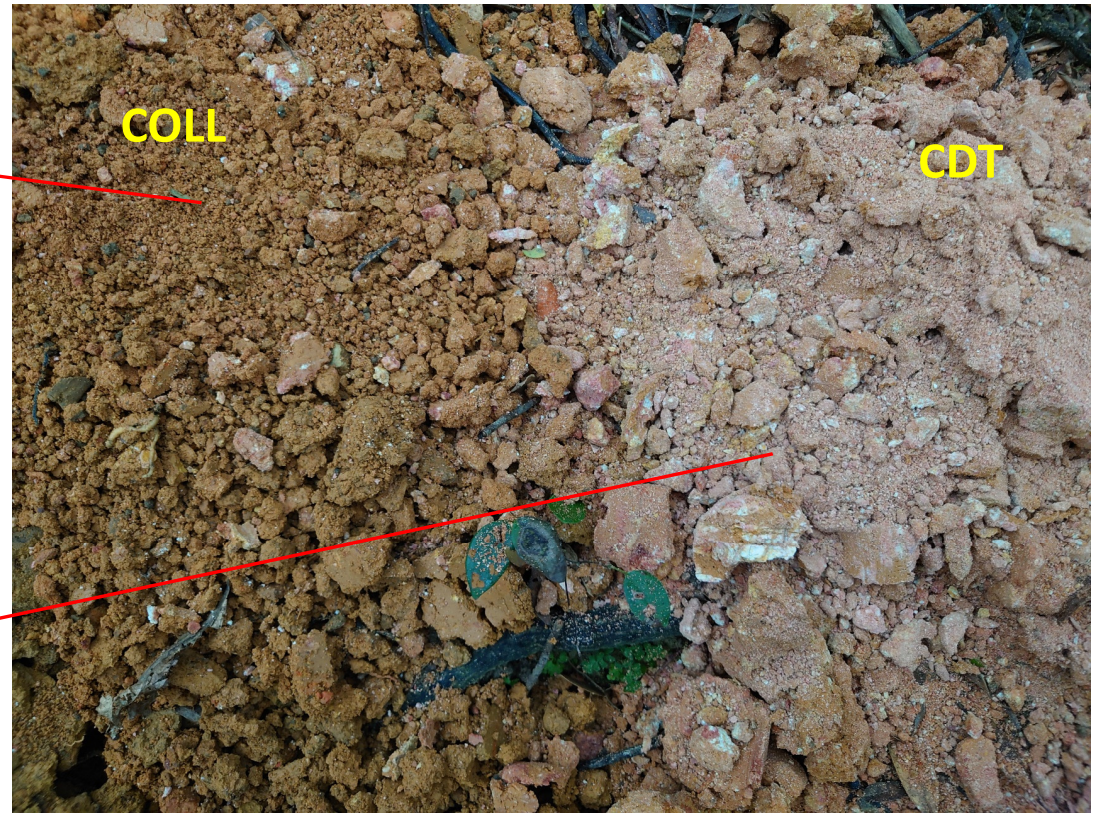
IP3 at the middle portion of the NTSA

Colluvium was retrieved at IP3 from 0m to 1.0m BGL which can be described as firm, brown, sandy SILT with many subangular fine to coarse gravel sized rock fragments.

CDT encountered at 1.0m BGL and can be described as extremely weak, light pink, mottled white and brown, completely decomposed fine ash vitric TUFF which comprises of stiff, sandy SILT with some angular to subangular fine to medium gravel.

Plate 8 Open hillslope colluvium revealed at IP3 (about +161 mPD) in the middle portion of the NTSA

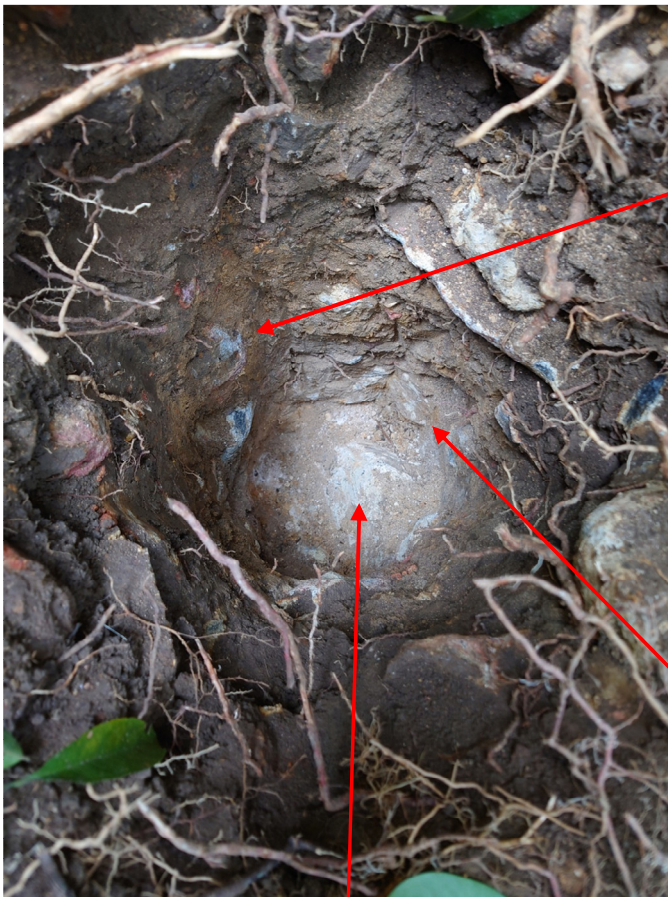
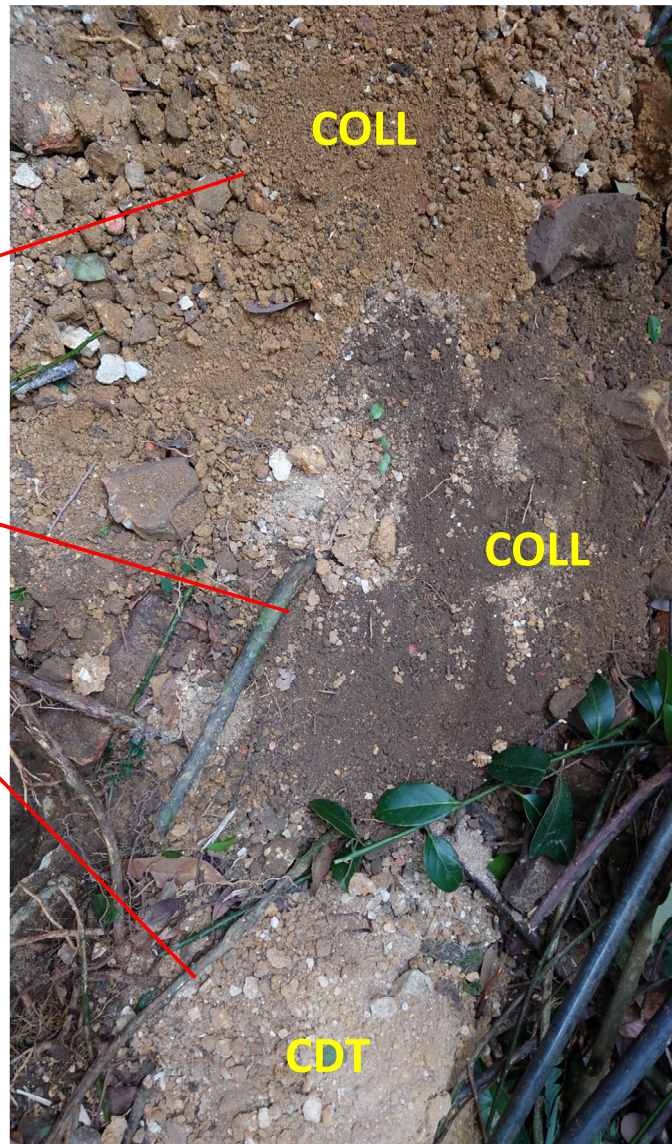
IP4 at the toe of
the NTSA

MDT encountered at the bottom of IP4 which can be described as weak, light brown, mottled white, highly to moderately decomposed fine ash vitric TUFF.

From 0 to 0.3m below ground level, colluvium was retrieved from IP4 which can be described as firm, dark brownish grey, sandy SILT with some subangular fine gravel sized rock fragments and occasional rootlets.

Colluvium was also retrieved at IP4 from 0.3m to 1.10m which can be described as firm, brown, dappled grey, sandy SILT with many subangular fine to coarse gravel sized rock fragments.

CDT encountered at 1.10m BGL and can be described as extremely weak, light brown, mottled white, completely decomposed fine ash vitric TUFF which comprises of stiff, sandy SILT with some angular to subangular fine to medium gravel.

Plate 9 Open hillslope colluvium revealed at IP4 (about +126 mPD) near the toe of the NTSA

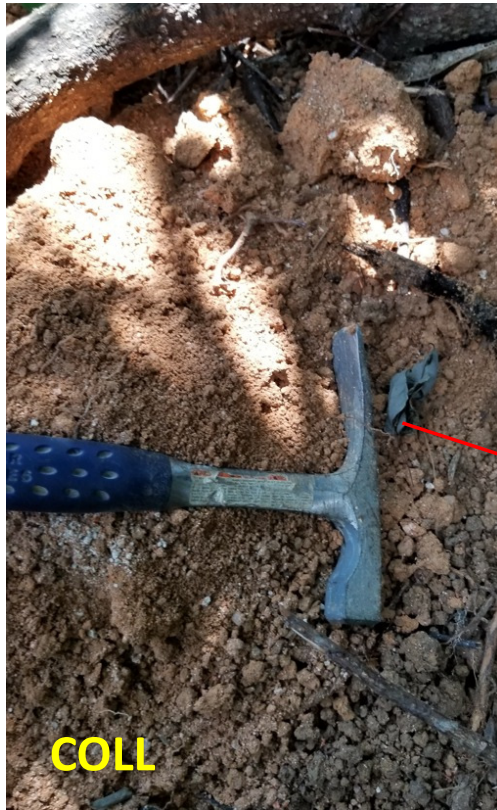
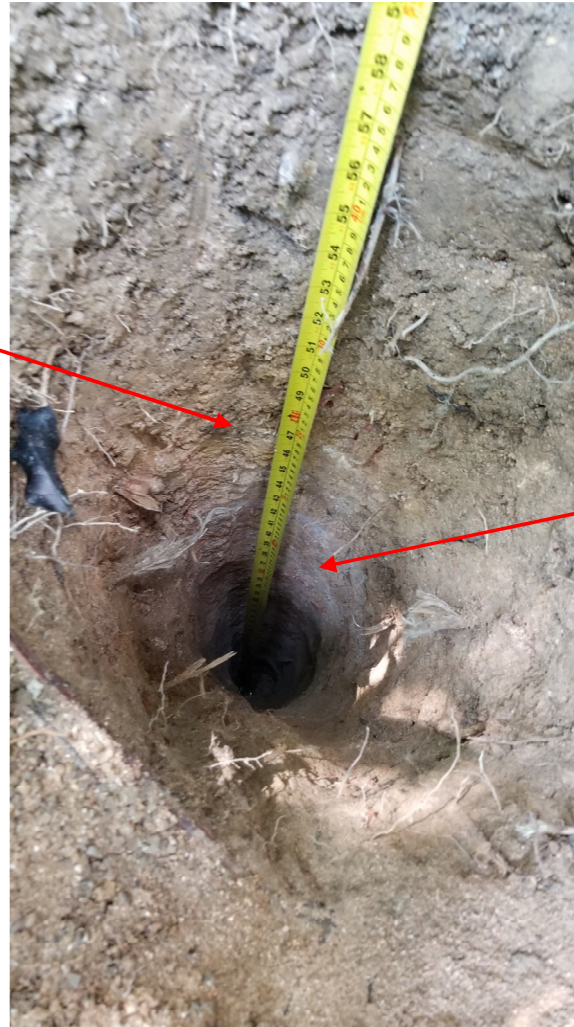
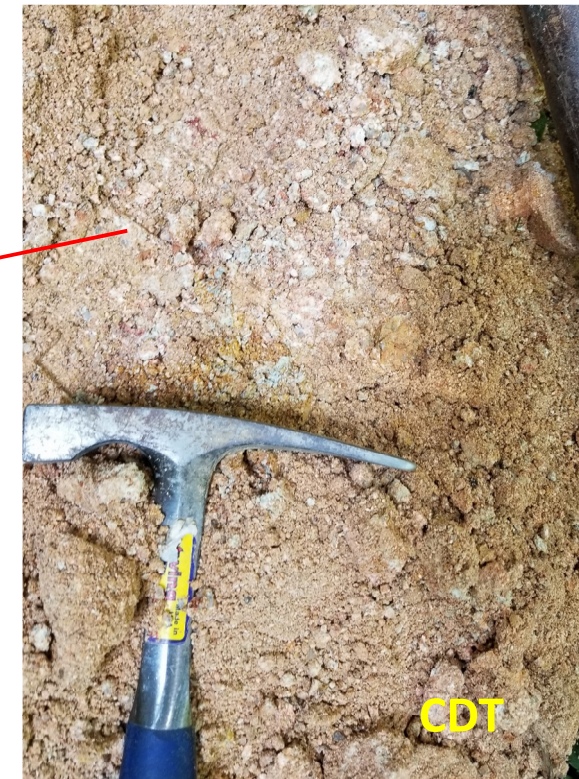
IP5 at the lower portion of the NTSA

From 0 to 1.0m below ground level, colluvium was retrieved from IP5 which can be described as firm, brown, dappled grey, sandy SILT with some subangular fine to coarse gravel sized rock fragments.

CDT encountered at 1.0m BGL and can be described as extremely weak, yellowish brown, mottled white, completely decomposed fine ash vitric TUFF which comprises stiff, slightly sandy SILT with some subangular fine to medium gravel.

Plate 10 Open hillslope colluvium revealed at IP5 (about +136 mPD) near the lower portion of the NTSA

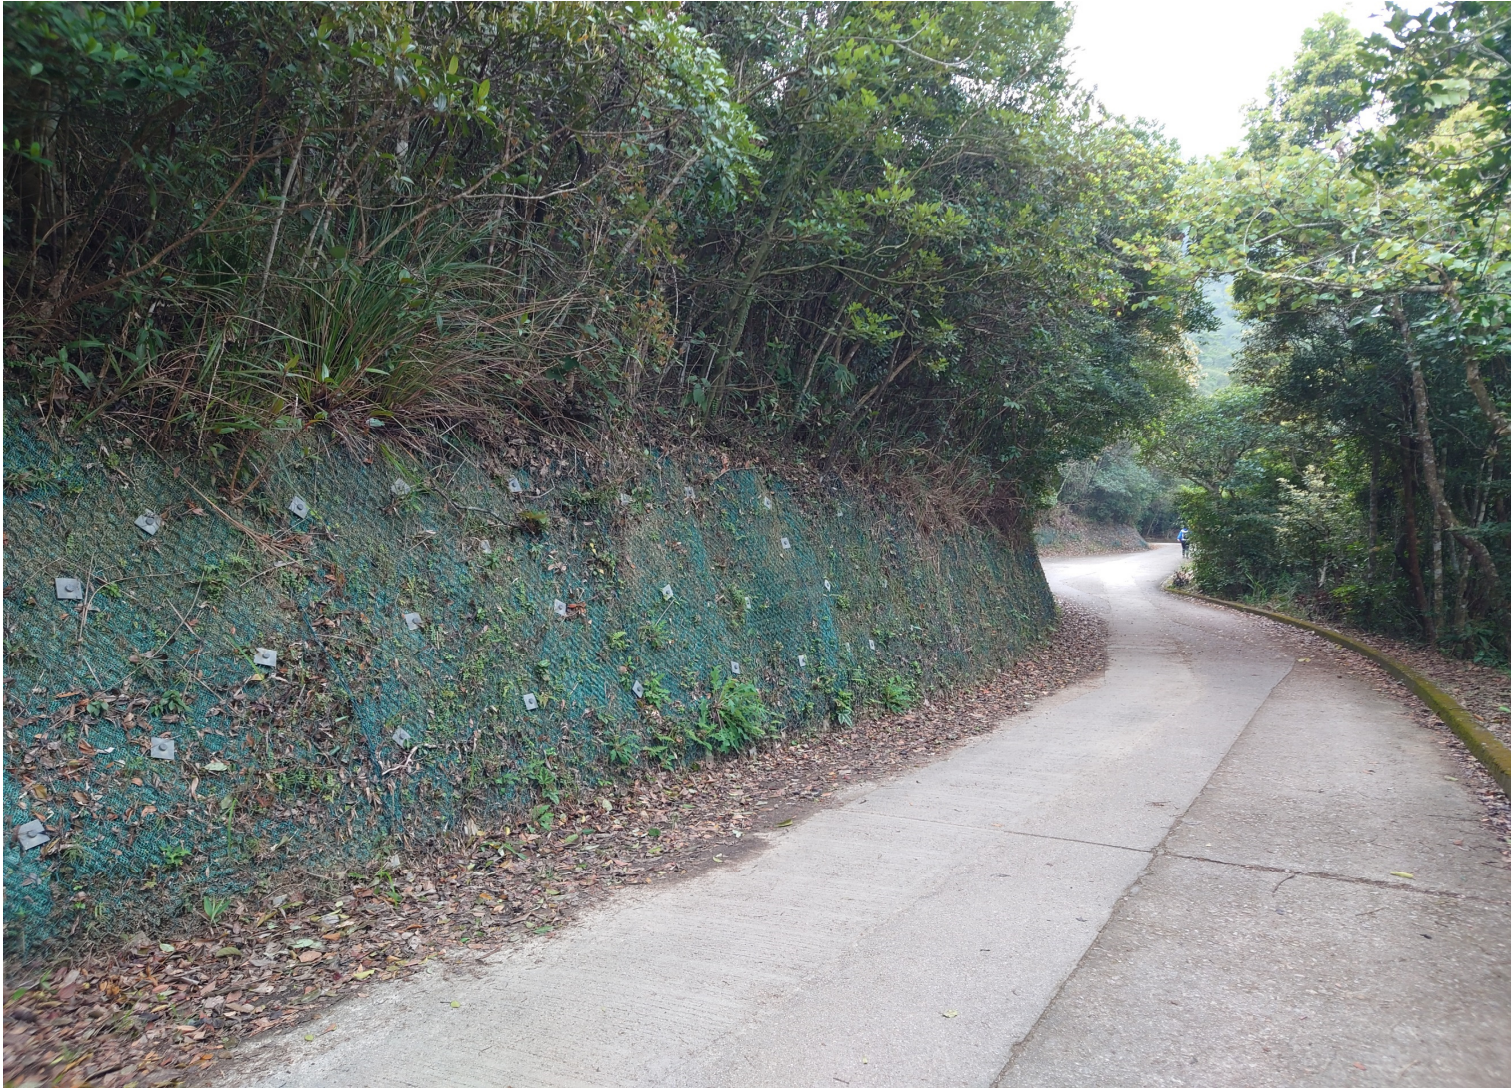
The major anthropogenic activities within the NTSA include the formation of the Hong Kong Trail (Section 8) and the catchwater which are traversed across the upper and middle portions of the NTSA respectively. Man-made cut slope Feature No. 11SE-D/C356 was formed as a small the upper cut slope along the Hong Kong Trail (Section 8) (**Plate 16**). Another two man-made cut slopes Feature Nos. 11SE-D/CR351 and 11SE-D/CR350 are existed along the upslope adjoining the catchwater which lies at the middle level of the NTSA (**Plate 17** and **Plate 18**).

Plate 16 Hong Kong Trail (Section 8) and man-made cut slope Feature No. 11SE-D/C356

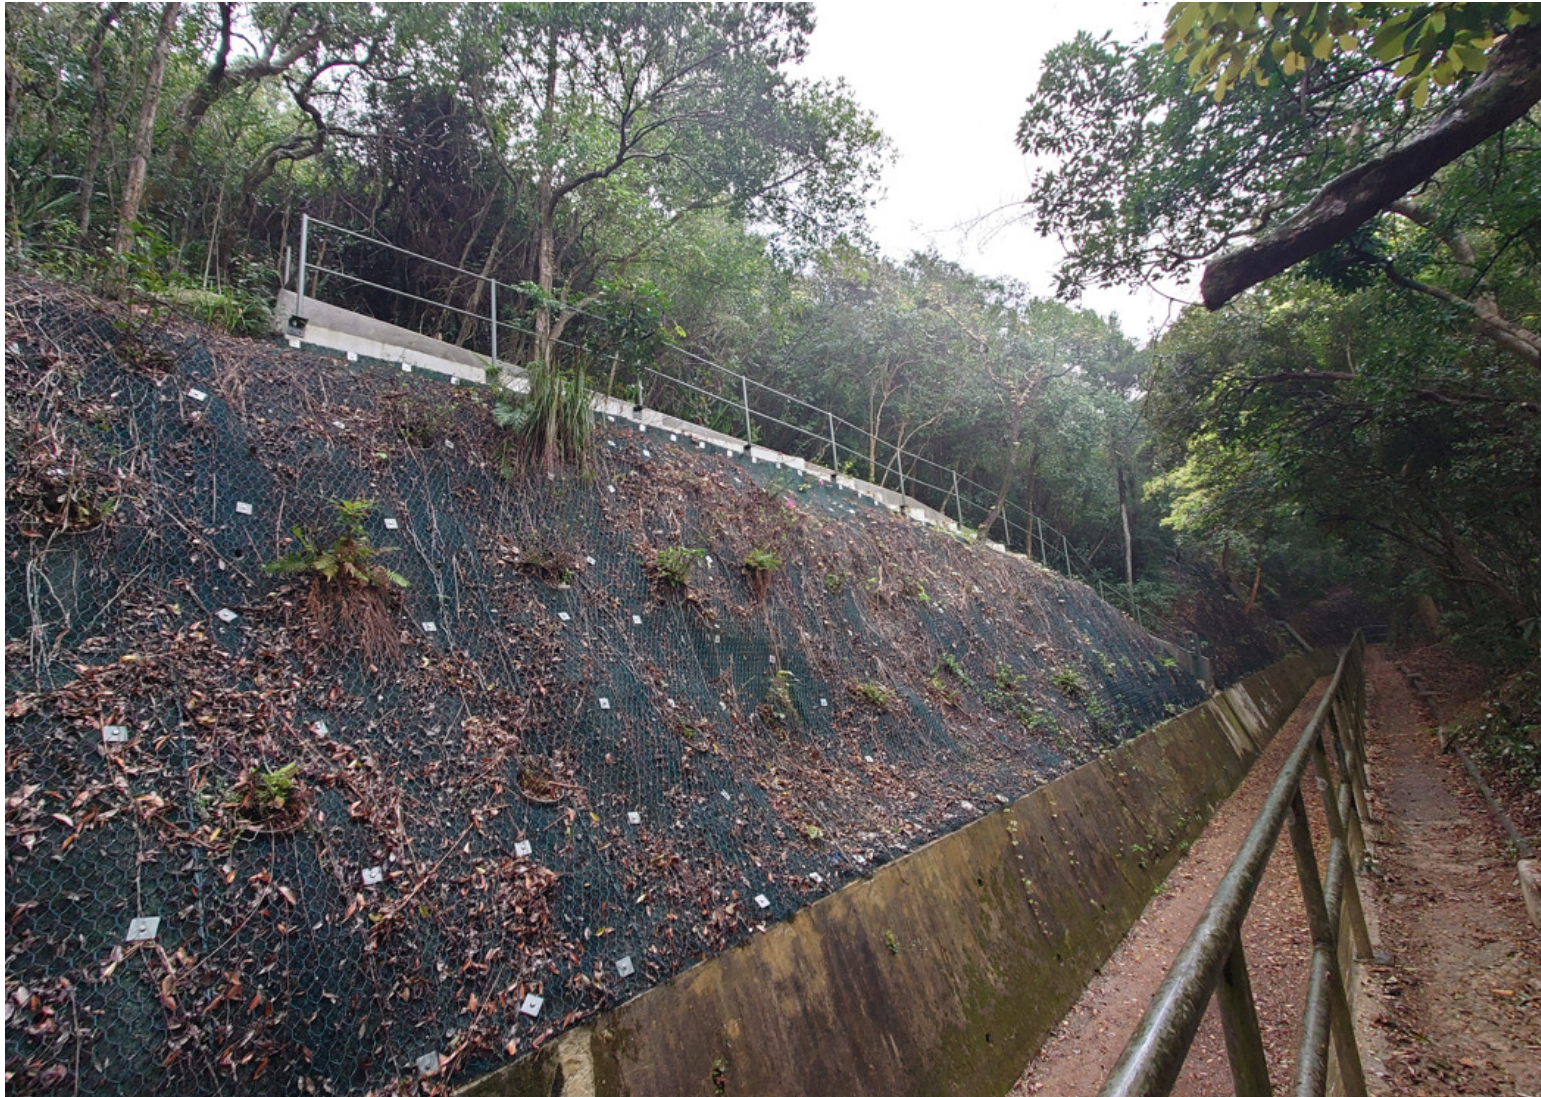
Plate 17 Catchwater and man-made cut slope Feature No. 11SE-D/CR351 located at the middle level of the NTSA
