Natural Terrain Hazard Study

Application for Permission under Section 16 of The Town Planning Ordinance (Cap. 131)

Minor Relaxation of Building Height Restriction
from 2 Storeys to 4 Storeys for
Proposed 4-Storey Columbarium
at Part of Inland Lot No. 7755 RP and
Government Land sandwiched between
Inland Lot No. 7755 RP and Inland Lot No. 7713,
Cape Collinson Road, Chai Wan

Philip So & Associates Limited

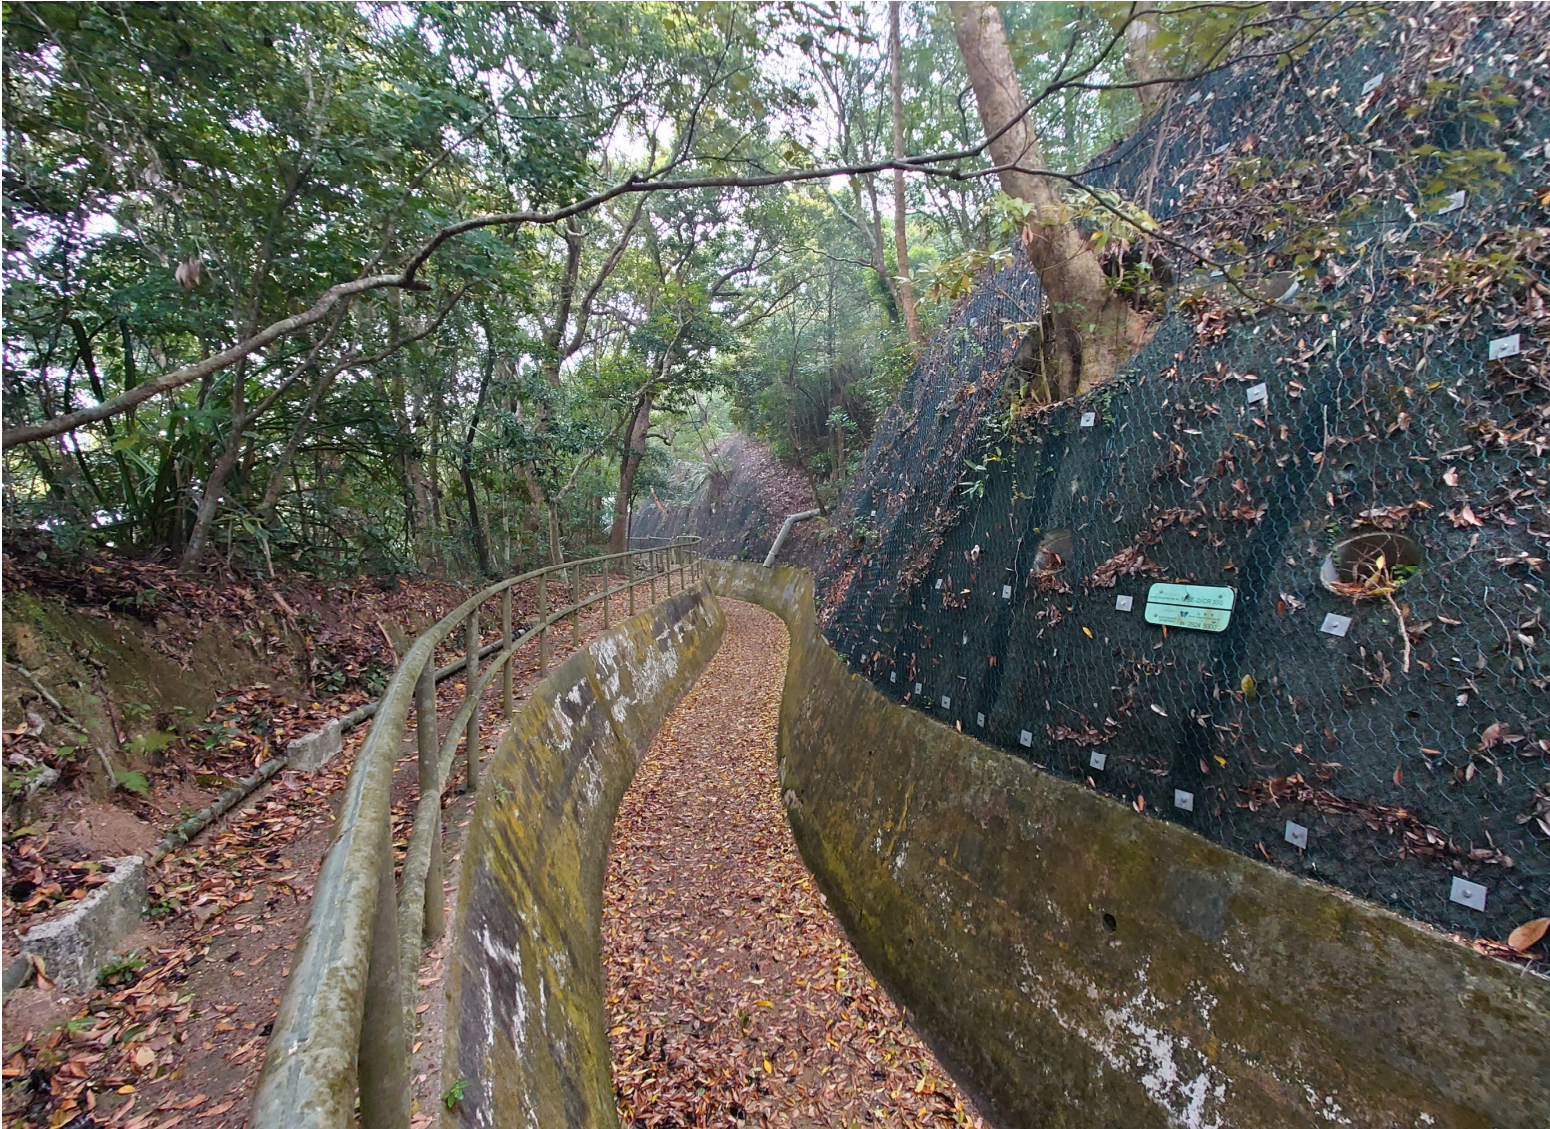
The major anthropogenic activities within the NTSA include the formation of the Hong Kong Trail (Section 8) and the catchwater which are traversed across the upper and middle portions of the NTSA respectively. Man-made cut slope Feature No. 11SE-D/C356 was formed as a small the upper cut slope along the Hong Kong Trail (Section 8) (**Plate 16**). Another two man-made cut slopes Feature Nos. 11SE-D/CR351 and 11SE-D/CR350 are existed along the upslope adjoining the catchwater which lies at the middle level of the NTSA (**Plate 17** and **Plate 18**).

Plate 18 Catchwater and man-made cut slope Feature No. 11SE-D/CR350 located at the middle level within the NTSA
