TREE GROUP INSPECTION REPORT FOR

LOT NO. 478 S.A. RP, 479, 487, 484 & 482 IN

D.D. 90

Proposed Temporary Warehouse for Storage of Food Provisions for a Period of 3 Years and Filling of Land at Lot 478 S.A RP, 482 (Part), 484 & 487 (Part) in D.D. 90, Lin Ma Hang Road, Ta Kwu Ling, NT

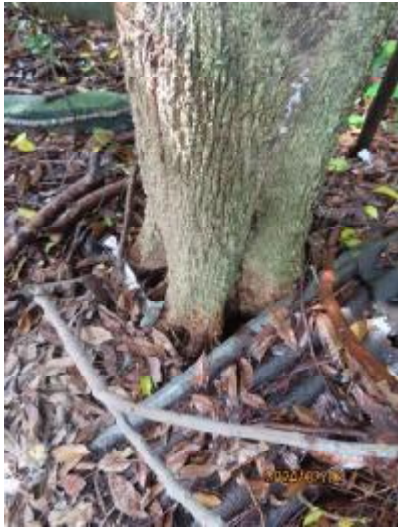
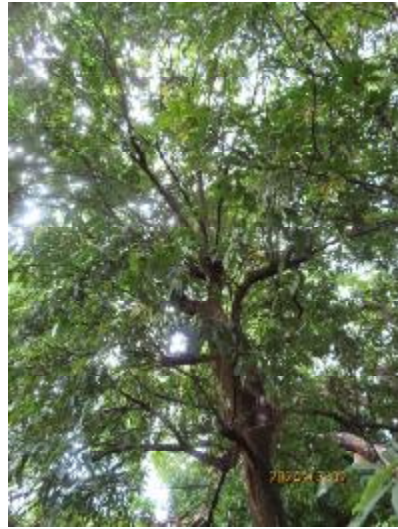
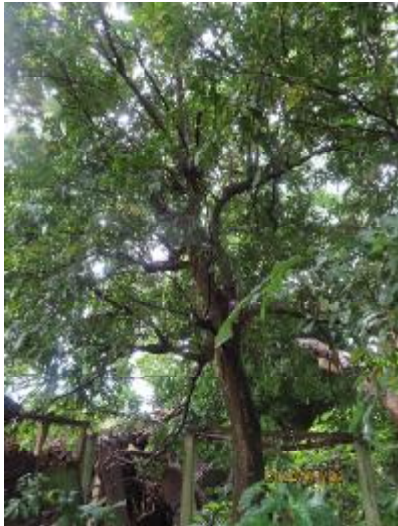
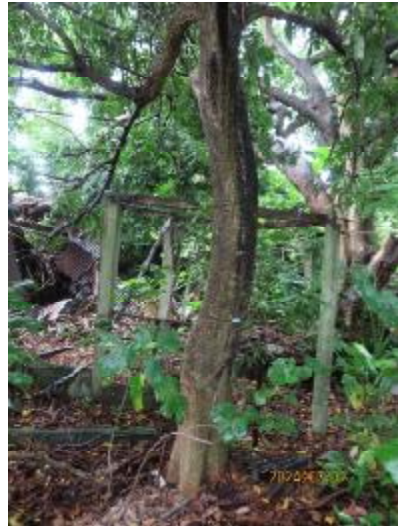
T44	<i>Dimocarpus longan</i>	龍眼	290	8	6	Low	Fair	Fair	Fair	Low	Exotic	
T45	<i>Delonix regia</i>	鳳凰木	900	11	14	Low	Poor	Fair	Poor	Low	Exotic	large wound (trunk), decay, vine,
T46	<i>Dimocarpus longan</i>	龍眼	100	6	4	Low	Fair	Fair	Fair	Low	Exotic	vine
