**Geotechnical Planning Review Report for Proposed House
(New Territories Exempted House) Development**

**Lot No. 361 in D.D. 32,
Ha Wong Yi Au, Tai Po,
New Territories**

JDF Engineering Consultants Limited

March 2024

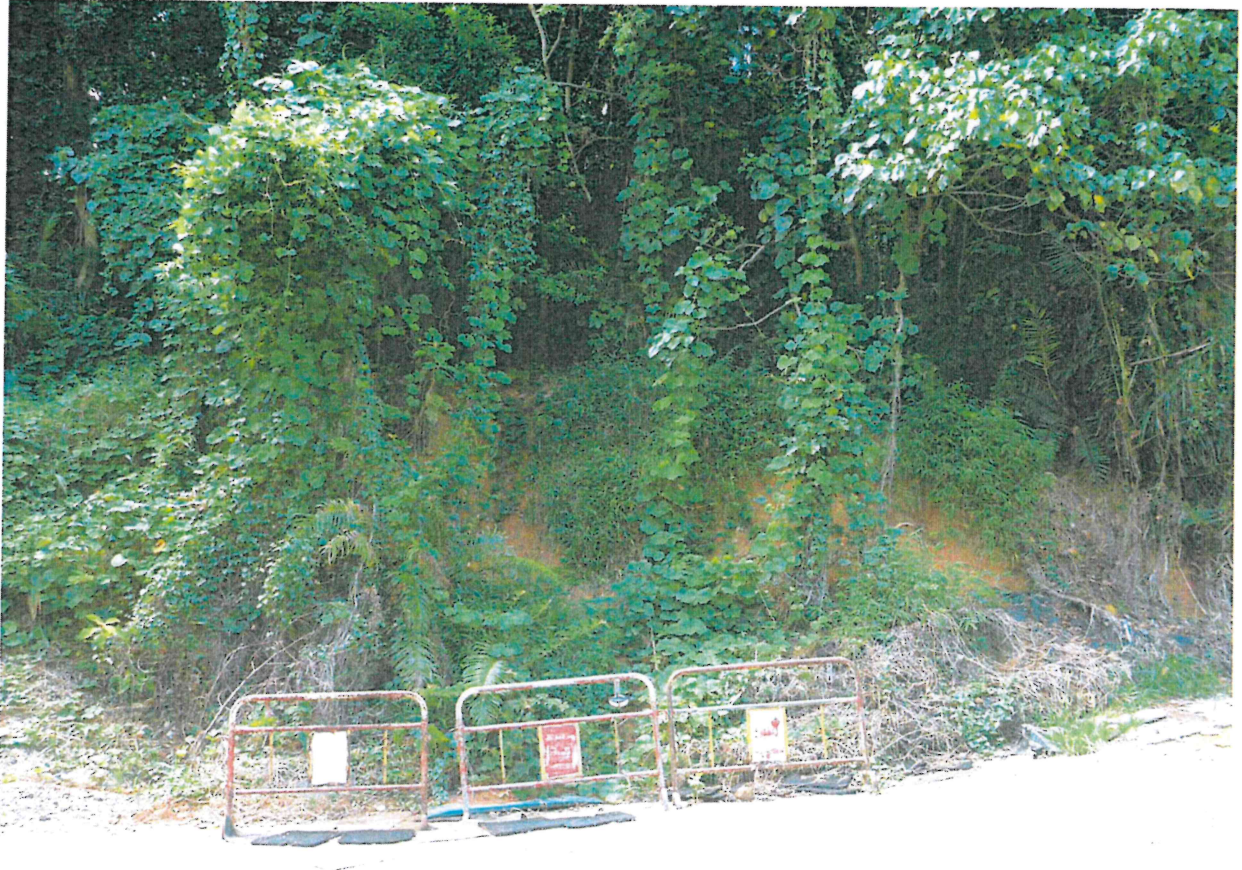
Photo 1

(2.1.9) Scar length (L) [Notes 2.1.9] 4.00 m	(2.1.10) Scar depth (D) 0.25 m

(2.1.11) Scar width (W) 8.00 m	(2.1.12) Volume of landslide debris [Notes 2.1.12] 4.000 m³
<div style="display: flex; justify-content: space-around;"> <div style="text-align: center;"> <p>(a) Ellipsoid</p>

(2.5) CAUSES OF FAILURE	
(2.5.1) Possible contributing causes of failure	
<u>Geotechnical causes</u> Infiltration	<u>Non-geotechnical causes</u>
(2.5.2) Remarks

(2.7) IMMEDIATE ADVICE GIVEN	
(2.7.1) Immediate advice given [Note 2.7.1] *	
Cordon off area in danger Cover failure scar with tarpaulin properly secured against wind Provide hard surface protection (with weepholes) to trimmed failure surface Remove landslide debris which threatens life or property	
(2.7.2) Responsible Works Department [Note 2.7.2]	
Lands Department Slope Maintenance Section (SMS)	
SMRIS (MR) :	NPRS Score :
SC Nos. :	
(2.7.3) Remarks
