Tree Survey Report

Date of Survey: 15th October 2024

Lot 385 Rp (Part) In D.D. 128 And Adjoining Government Land, Ha Tsuen, Yuen Long, New Territories

Registered Arborist

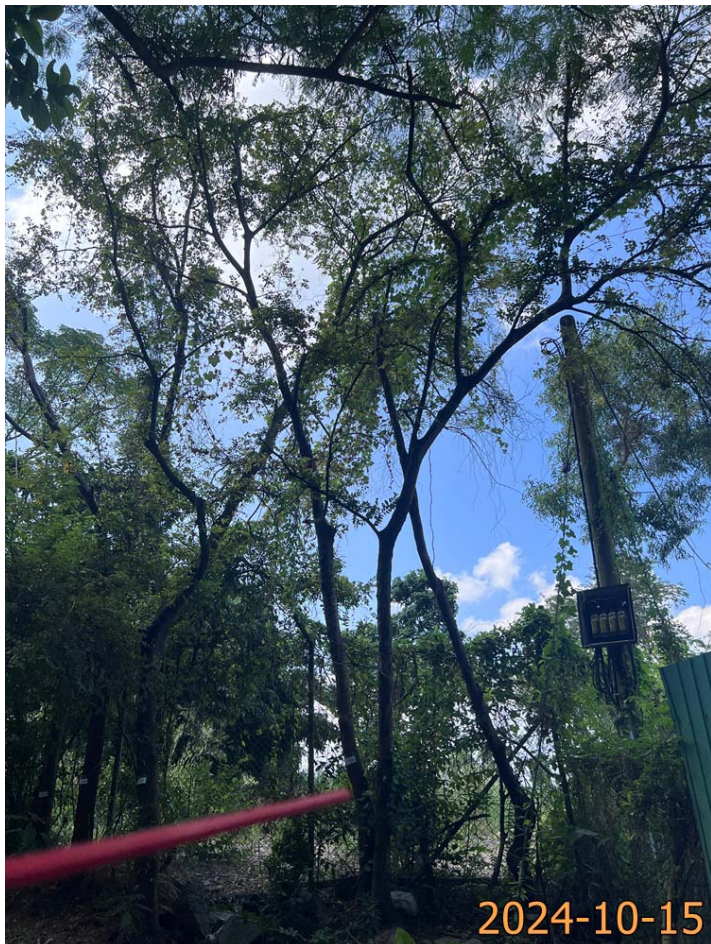
T18 (Overview)

T10	<i>Celtis sinensis</i>	朴樹	8.0	150	5.0	Low	Fair	Fair	Fair	Low	
T11	<i>Celtis sinensis</i>	朴樹	9.0	160	5.0	Low	Fair	Fair	Fair	Low	
T12	<i>Celtis sinensis</i>	朴樹	6.5	110	4.0	Low	Fair	Fair	Fair	Low	
T13	<i>Melia azedarach</i>	楝(苦楝)	7.0	95	4.0	Low	Fair	Fair	Fair	Low	
T14	Dead tree	死樹	6.5	150	1.0	-	-	Dead	-	-	dead tree
T15	Dead tree	死樹	5.0	150	1.0	-	-	Dead	-	-	dead tree
T16	Dead tree	死樹	5.0	150	1.0	-	-	Dead	-	-	dead tree
T17	<i>Celtis sinensis</i>	朴樹	8.0	160	5.0	Low	Fair	Fair	Poor	Low	crooked trunk
T18	<i>Celtis sinensis</i>	朴樹	8.0	190	7.0	Low	Poor	Poor	Poor	Low	co-dominant trunks with included bark, crack at trunk base
