Tree Survey Report

Lots 1213 RP, 1215 RP, 1216 RP, 1217 S.C RP (Part), 2579 (Part), 2583 (Part) and 2584 (Part) in D.D. 104 and Adjoining Government Land, Ngau Tam Mei, Yuen Long

Date: 29th October 2024

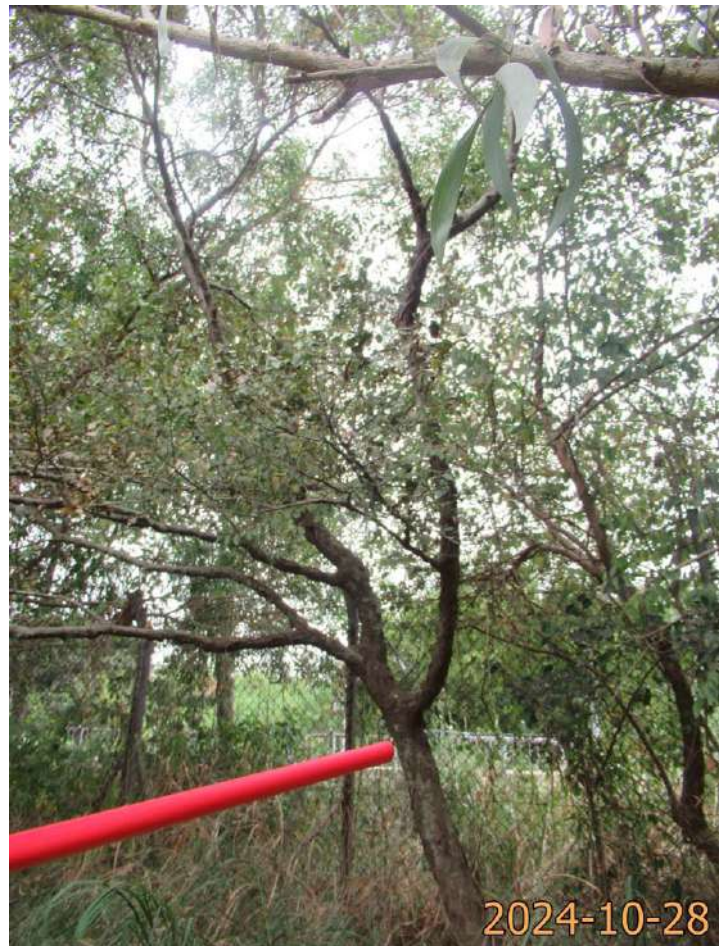
T8 (Overview)

Tree No.	Tree Species		Tree Size Measurements			Amenity Value	Form	Health Condition	Structural Condition	Suitability for Transplanting	Remarks
	Botanical Name	Chinese Name	Overall Height (m)	DBH (mm)	Average Crown Spread (m)	High /Med /Low	Good /Fair /Poor	Good /Fair /Poor /Dead	Good /Fair /Poor	High /Med /Low	
T1	<i>Acacia auriculiformis</i>	耳果相思(耳葉相思)	8.0	230	6.0	Low	Fair	Fair	Fair	Low	
T2	<i>Acacia auriculiformis</i>	耳果相思(耳葉相思)	8.0	130	5.0	Low	Fair	Fair	Fair	Low	
T3	<i>Acacia auriculiformis</i>	耳果相思(耳葉相思)	7.0	120	4.0	Low	Fair	Fair	Fair	Low	
T4	<i>Acacia auriculiformis</i>	耳果相思(耳葉相思)	7.0	120	4.0	Low	Poor	Fair	Poor	Low	uprooted
T5	<i>Acacia auriculiformis</i>	耳果相思(耳葉相思)	7.0	160	4.0	Low	Poor	Fair	Poor	Low	uprooted
T6	<i>Acacia auriculiformis</i>	耳果相思(耳葉相思)	6.0	110	4.0	Low	Fair	Fair	Fair	Low	
T7	<i>Acacia auriculiformis</i>	耳果相思(耳葉相思)	6.0	240	5.0	Low	Fair	Fair	Fair	Low	
T8	<i>Celtis sinensis</i>	朴樹	8.0	220	7.0	Low	Fair	Fair	Fair	Low

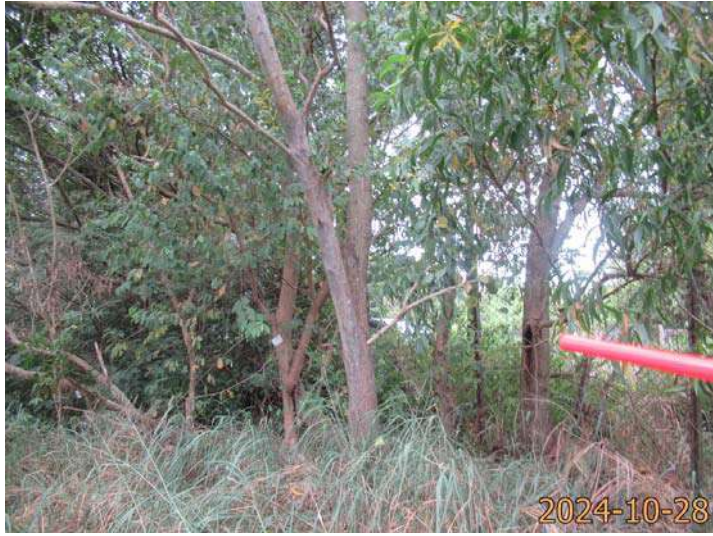
T9 (Overview)

T9	<i>Acacia auriculiformis</i>	耳果相思(耳葉相思)	7.0	393	9.0	Low	Poor	Fair	Poor	Low	collapsed, dead trunk, multi-trunks
T10	<i>Acacia auriculiformis</i>	耳果相思(耳葉相思)	7.5	110	5.0	Low	Fair	Fair	Fair	Low	
T11	<i>Acacia auriculiformis</i>	耳果相思(耳葉相思)	8.0	300	6.0	Low	Fair	Fair	Fair	Low	
T12	<i>Acacia auriculiformis</i>	耳果相思(耳葉相思)	7.0	100	5.0	Low	Fair	Fair	Fair	Low	
T13	<i>Macaranga tanarius var. tomentosa</i>	血桐	6.0	120	6.0	Low	Fair	Fair	Fair	Low	
T14	<i>Macaranga tanarius var. tomentosa</i>	血桐	7.0	120	6.0	Low	Fair	Fair	Fair	Low	
T15	<i>Citrus maxima</i>	柚	6.0	100	3.0	Low	Fair	Fair	Fair	Low	
T16	<i>Celtis sinensis</i>	朴樹	7.0	210	5.0	Low	Poor	Fair	Poor	Low	included bark
T17	<i>Macaranga tanarius var. tomentosa</i>	血桐	7.0	110	6.0	Low	Fair	Fair	Fair	Low	
T18	<i>Macaranga tanarius var. tomentosa</i>	血桐	8.0	149	7.0	Low	Fair	Fair	Fair	Low	
T19	<i>Celtis sinensis</i>	朴樹	7.0	280	8.0	Low	Poor	Poor	Poor	Low	cavity at trunk

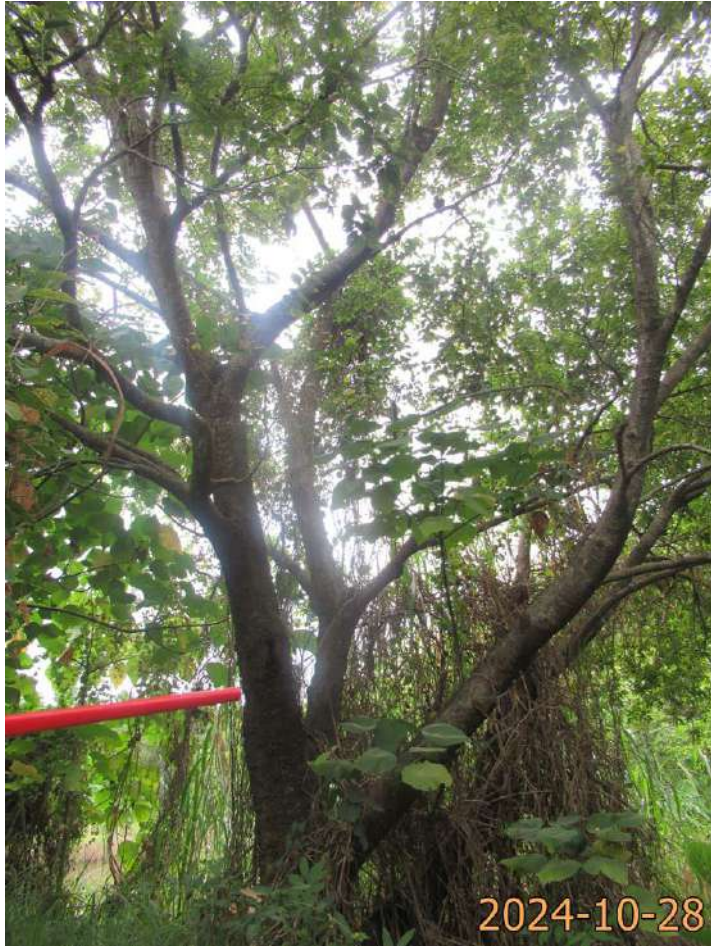
T20 (Overview)

T20	<i>Celtis sinensis</i>	朴樹	10.0	390	8.0	Low	Fair	Fair	Fair	Low	
T21	<i>Bischofia javanica</i>	秋楓	11.0	330	8.0	Low	Fair	Fair	Fair	Low	
T22	<i>Hibiscus tiliaceus</i>	黃槿	9.0	230	7.0	Low	Fair	Fair	Fair	Low	
T23	<i>Hibiscus tiliaceus</i>	黃槿	9.0	340	6.0	Low	Fair	Fair	Fair	Low	
T24	<i>Hibiscus tiliaceus</i>	黃槿	8.0	410	8.0	Low	Poor	Fair	Poor	Low	collapsed
T25	<i>Melia azedarach</i>	楝(苦楝)	11.0	330	9.0	Low	Fair	Fair	Fair	Low	
T26	<i>Leucaena leucocephala</i>	銀合歡	7.0	110	5.0	Low	Fair	Fair	Fair	Low	
T29	<i>Macaranga tanarius var. tomentosa</i>	血桐	7.0	110	5.0	Low	Fair	Fair	Fair	Low	
T31	<i>Macaranga tanarius var. tomentosa</i>	血桐	6.0	120	7.0	Low	Fair	Fair	Fair	Low	
T32	<i>Macaranga tanarius var. tomentosa</i>	血桐	6.0	220	6.0	Low	Fair	Fair	Fair	Low	
T33	<i>Celtis sinensis</i>	朴樹	10.0	470	9.0	Low	Fair	Fair	Fair	Low	
T34	<i>Macaranga tanarius var. tomentosa</i>	血桐	6.0	95	7.0	Low	Fair	Fair	Fair	Low	
T35	<i>Albizia lebbek</i>	大葉合歡	9.0	210	5.0	Low	Fair	Fair	Fair	Low

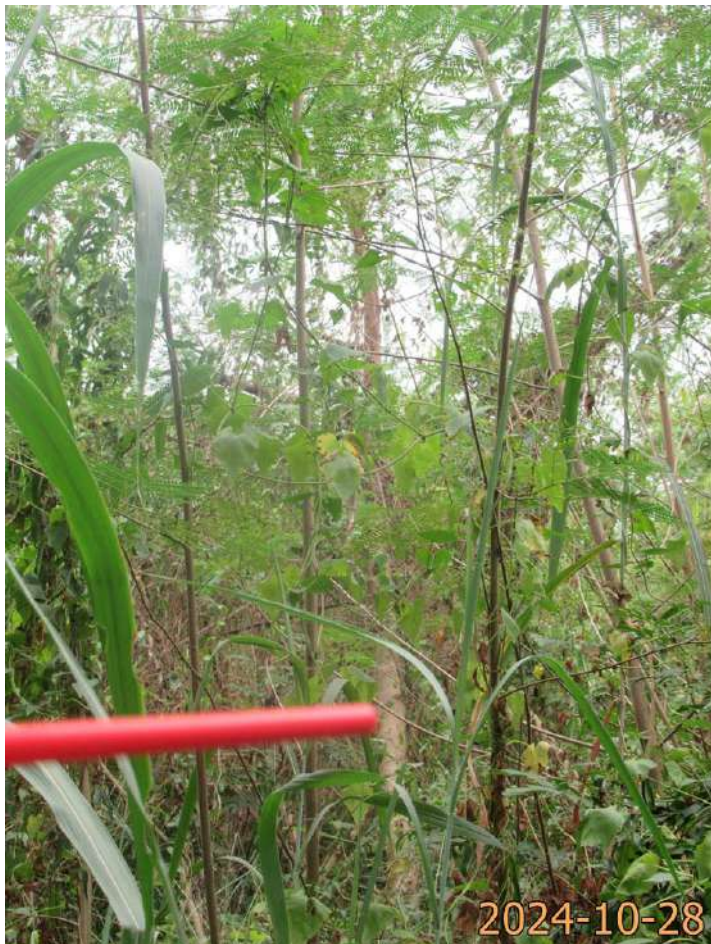
T36 (Overview)

T36	<i>Leucaena leucocephala</i>	銀合歡	8.0	100	4.0	Low	Fair	Fair	Fair	Low	
T38	<i>Leucaena leucocephala</i>	銀合歡	9.0	120	7.0	Low	Fair	Fair	Fair	Low
