## **Conservation Management Plan**

## Nam Koo Terrace at no. 55 Ship Street, Wan Chai, Hong Kong

## **Hopewell Holdings Limited / Yuba Company Limited**

October 2024

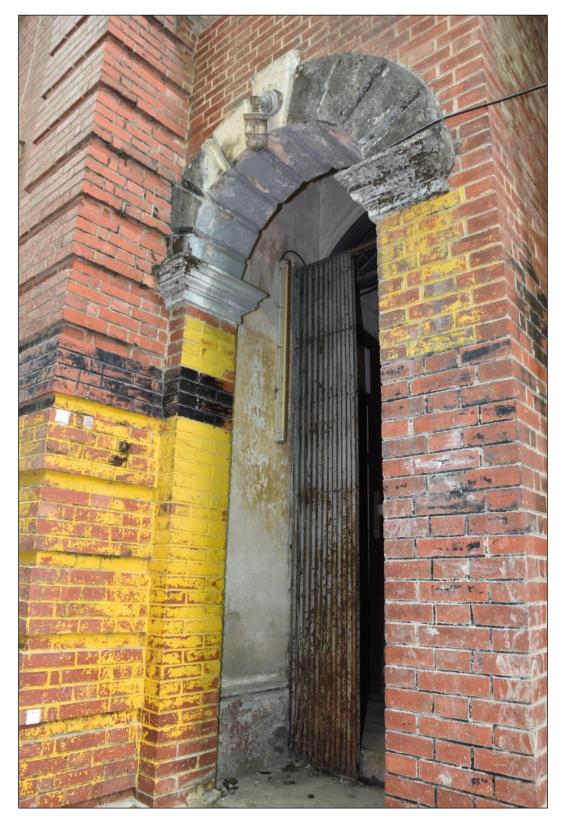
<u>Photo B-03 – Main Building east elevation, the voussoir arch over the side entrance, (21st March, 2023)</u>

- This includes the plastered arch at the entrance, (photos B-03, and B-17).
  - Level of significance high.

- (8) Repair the plaster at the voussoir arch over the side entrance at ground floor, and paint.

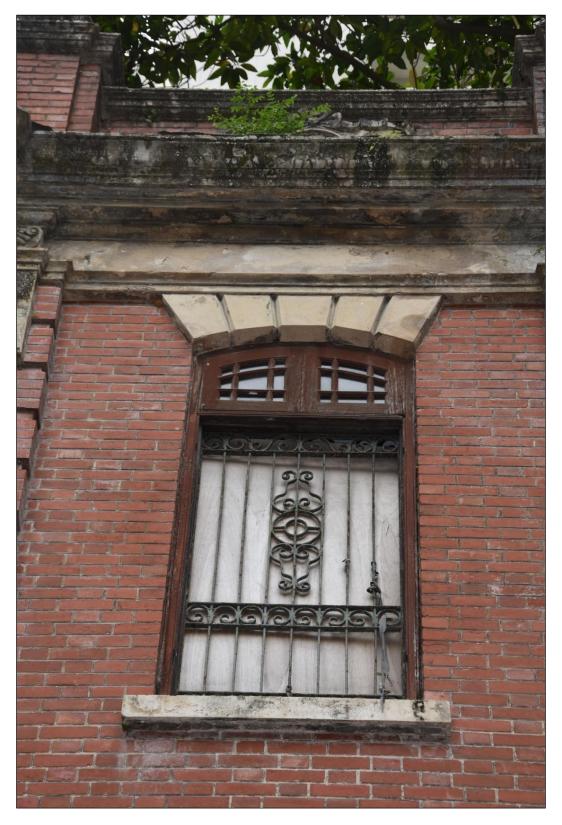
Photo B-06 – Main Building main facade, the window on first floor east side with the wrought iron window grille, (21st March, 2023)

- (3) Some of the windows including the wrought iron window grille have been taken down, and from our preliminary inspection, the existing timer casement windows and frames are in very poor condition, and beyond repair.

- (4) Supply and install new timber windows and frame in accordance with the cartographic survey drawings and ironmongery information.
- (5) Remove the paint and rust on the existing wrought iron window grille, and paint.

- (6) Replicate the wrought iron window grille (of different dimensions).
- (7) Replace the missing wrought iron window grille, and paint.
- (8) Repair the plaster at the voussoir arch on top of each window, and paint.

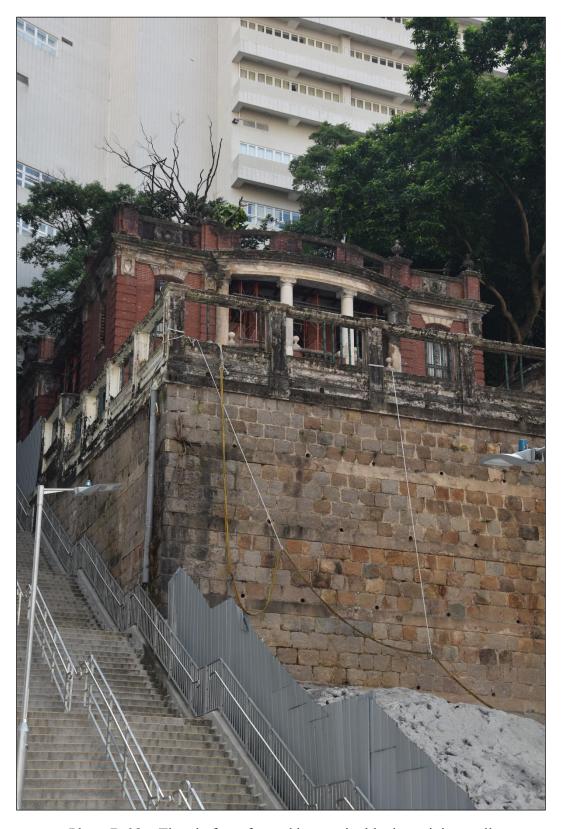
Photo B-08 – The platform formed by granite block retaining wall at the north-west (front) side and south-east (Ship Street) side, (8th October, 2024)

- Nam Koo Terrace is located on a slope, so the flat site was formed by "cut and fill slope", (drawing B-02). So the front part (landscaped garden) sits on the filling surrounded by a retaining wall built with granite blocks, forming its unique and superior geographical location, (photo B-08).
- Level of significance moderate.

- C4.1 Platform and granite block retaining wall
- (1) The granite block retaining wall will be preserved.
- (2) Clean the granite blocks, and repair the defective pointing.

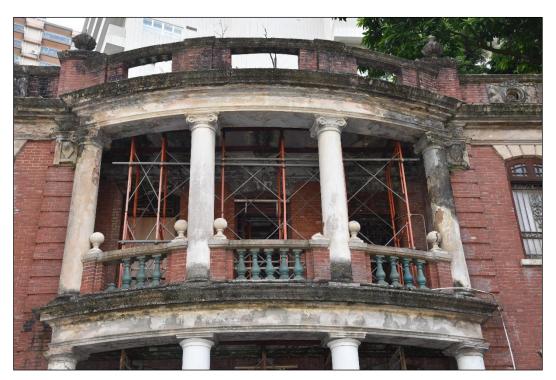
<u>Photo B-10 – Main Building main façade first floor middle part verandah, showing</u>
<u>the Ionic columns and the parapet wall in between, (8<sup>th</sup> October, 2024)</u>

- The parapet wall spans between the columns (except the entrance at the middle of ground floor), with red facing brickwork with small protruding part towards the middle at both ends and glazed ceramic bottle shape balusters at the middle. The plan shape of the coping follows the profile of the brickwork with rebate at the bottom edges, and with plastered ball shaped decorative feature with support at both ends, (photos B-10 to B-12).

- (4) Repair the plaster on the ground floor Doric columns and first floor Ionic columns including the capital and column base and the curve spandrel beam with cornice on top of the columns, and painted.

- Clean the red facing brickwork with small protruding parts towards the middle at both ends at all five bays, and repair the defective pointing,
  - Replicate the glazed ceramic bottle shape baluster,

- Replace the broken balusters all four are broken at both bays on ground, and one broken at the east bay on first floor,
  - Check and clean the balusters on first floor (remaining three at east bay, five at the middle, and four at the west bay), and also replace the cracked balusters,

- Clean the granite coping at all five bays, and repair the defective pointing with the red facing brickwork below,
  - Repair the plaster on the ball shape decorative feature at both ends of the granite coping, and paint,

- Restore the two broken ball shape decorative feature at the end of the granite coping, (one at ground floor and one at first floor).
- (6) Repair the plastered wall frieze below the roof parapet wall with the cornice on top, and paint.
- (7) Clean the red facing brickwork at both sides including the brickwork quoins at both corners, and repair the defective pointing.
- (8) Repair the plastered relief on top of the brickwork quoin, and paint.

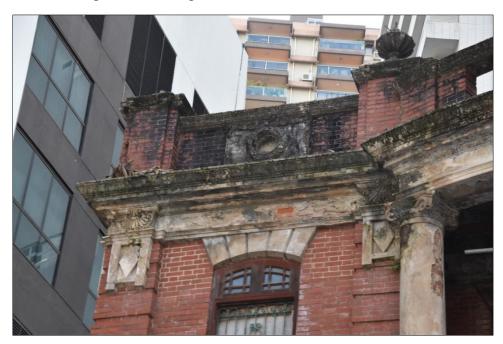
Photo B-13 – Main Building main façade east part, the roof parapet wall and the wall cornice below, (8th October, 2024)

- B6.7 <u>Character defining element (CDE) Main Building main façade, the plastered wall frieze below the roof parapet wall with the cornice on top</u>
  - This include the wall frieze (canopy projecting) below the roof parapet wall, (photos B-13 and B-14).
  - Level of significance high.

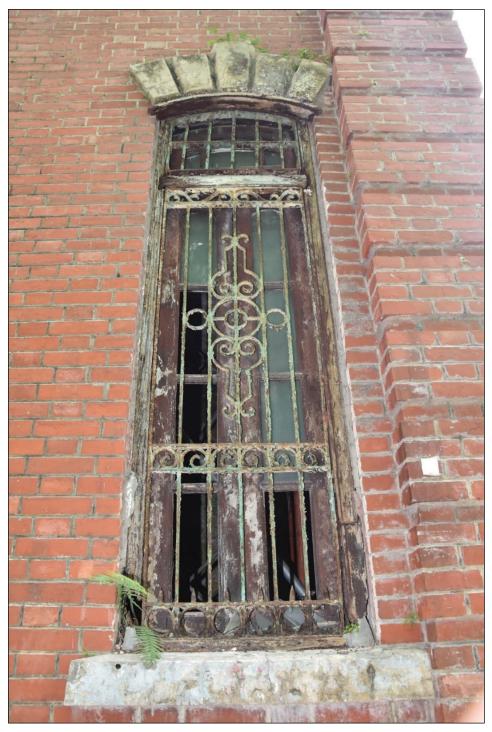
- B6.11 <u>Character defining element (CDE) Main Building window, including the wrought iron window grille</u>
  - The windows are of typical design with wrought iron grille, (photo B-18, and appendix 3 photo record of the windows in Main Building).
  - Level of significance high.

<u>Photo B-18 – Window with wrought iron window grille of typical design, at southeast elevation (facing Ship Street), ground floor front part, (21st March, 2023)</u>

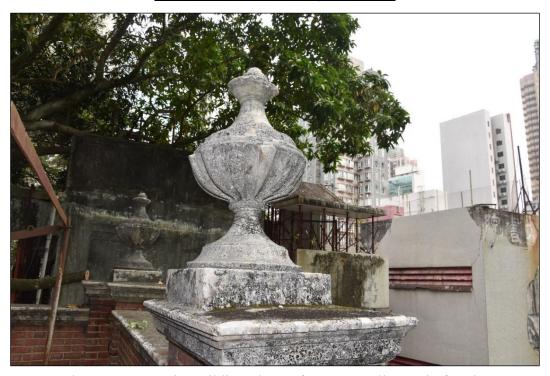
Photo B-25 – Main Building, the roof parapet wall at main façade, the vase shaped plastered decorative feature on top of the red facing brick pillar, (17<sup>th</sup> March, 2023)

- Repair the plaster on coping of each bay, and on top of the slightly higher corner brick pillars, and paint,
  - Repair the plaster on the vase shape decorative feature on top of the brick pillars, and paint, and

- Restore the broken and missing vase shape decorative feature on top of the brick pillars.
- (3) Remove the paint and rust on the two wrought iron balustrades, and paint.

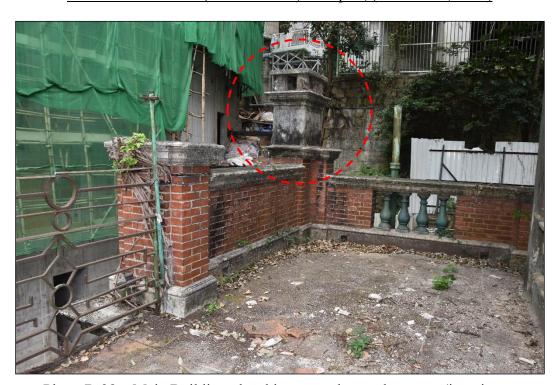
- The plastered chimney is on top of the parapet wall brick pillar at the south corner, and this is the only chimney on the roof Main Building, (drawing B-05, and photo B-28).
- There is no chimney flue at the corresponding position in the rooms on first floor and ground floor.
- There is no fire place inside the building.
- Level of significance high.

<u>Photo B-28 – Main Building, the chimney at the south cornet, (junction at south-east elevation (facing Ship Street) and south-west elevation</u>

(rear elevation), (17<sup>th</sup> March, 2023)

- (1) Repair the cracks on the plastered top and sides.
- (2) Repair the plaster on the top and sides, and paint.
- (3) Block up the opening on the chimney stack properly, such that no water can seep into the chimney.

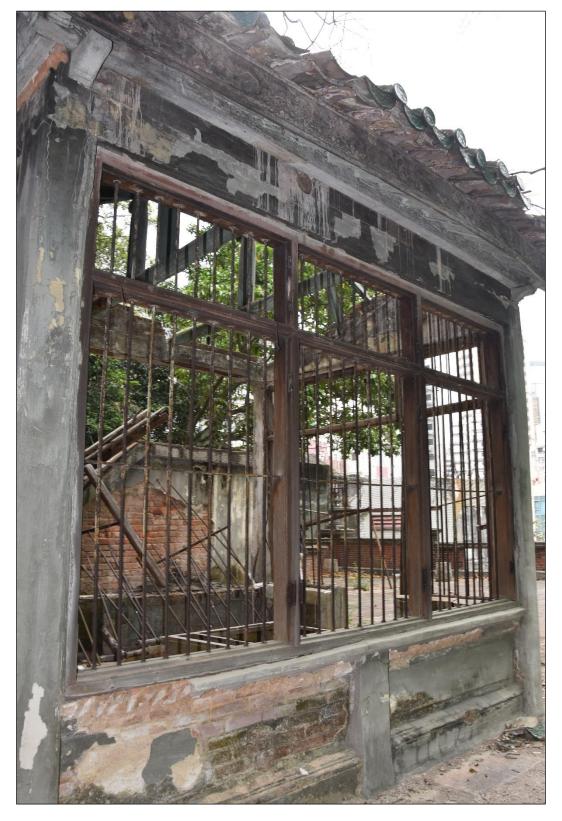
Photo B-31 – Main Building, the Chinese style pavilion on the roof, the side showing the roof eaves and the carved timber eaves board, (17<sup>th</sup> March, 2023)

- (9) Form the four hip ridges including the decorative feature at the junction (top).
- (10) There is one carved timber eaves board remaining
  - Salvage this carved timber eaves board, repair, paint and apply gold gilding, and re-install back after restoration, and

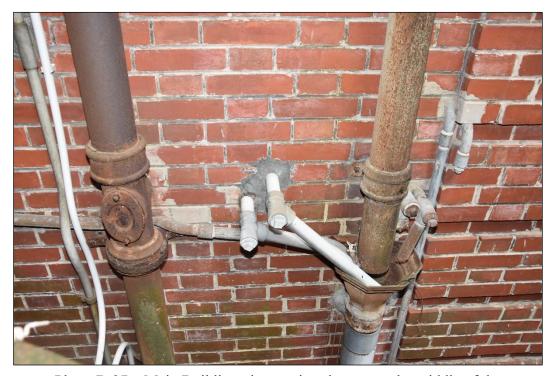
Photo B-37 – Main Building, the cast iron hopper at the middle of the rainwater downpipe, (all pipes discharging water into the hopper should be later additions), (8<sup>th</sup> October, 2024)

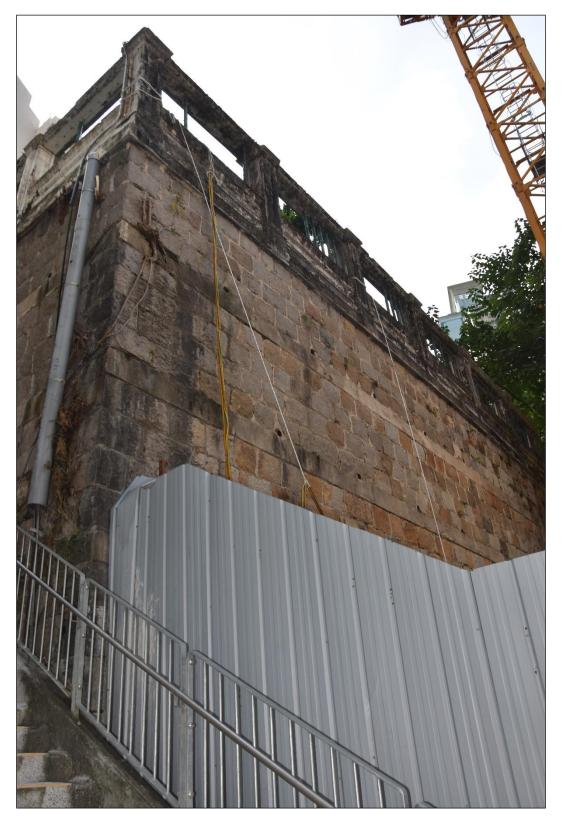
Photo B-59 – The boundary wall above the granite block retaining wall at north-east elevation (facing Queen's Road East), (8<sup>th</sup> October, 2024)

- (1) Repair the cracks at the wall.
- (2) Repair the rendering, and paint.
- (3) Replicate the glazed ceramic bamboo shape fencing bar at the upper part.
- (4) Replace the missing, broken and cracked glazed ceramic bamboo shape fencing bar at the upper part.

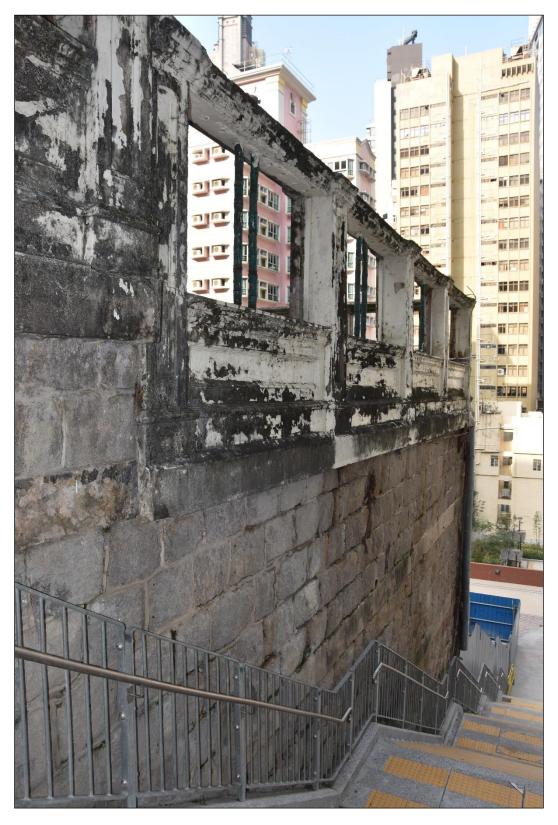
<u>Photo B-60 – The boundary wall above the granite block retaining wall at south-east elevation (facing Ship Street), (8<sup>th</sup> October, 2024)</u>

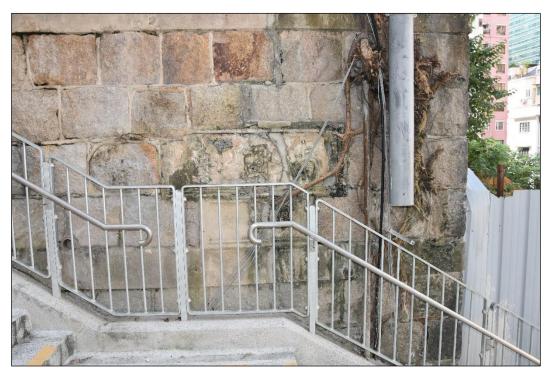
- Both are in poor condition, (photo C-02),
  - The upper one with 3 Chinese characters the two Chinese characters "固" and "臺" are partly broken, the semi-circular protruding surround is also broken at various locations, and the left edge (when view towards the plate) of the base plate had been repaired by covering with a "chunan" look paste

Photo C-02 – The two street name plates at the south-east elevation (facing Ship Street), (front corner of the retaining wall) with Chinese characters "南国臺" (upper) and "洋船街" (lower), (8<sup>th</sup> October, 2024)

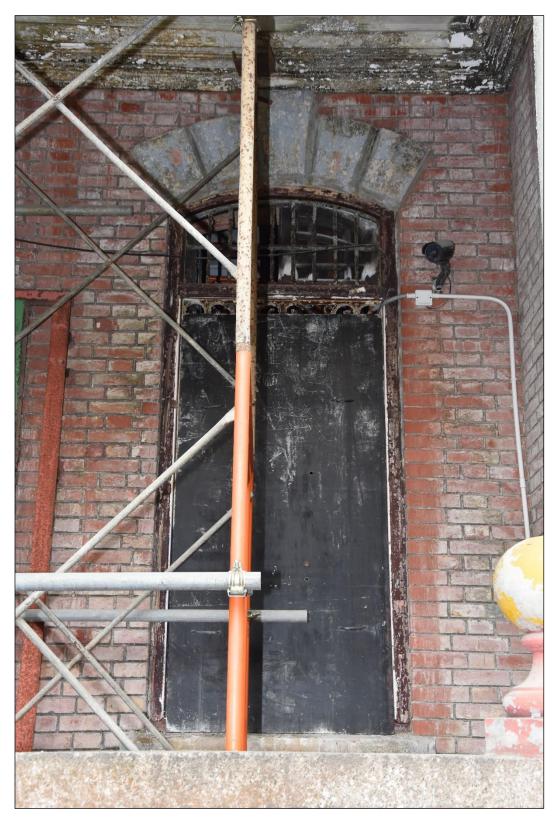
Photo App3-02 – North-east elevation (front elevation), ground floor, window Wdw-Gf02 inside recess entrance porch, external side, covered with plywood panel, (21st March, 2023)

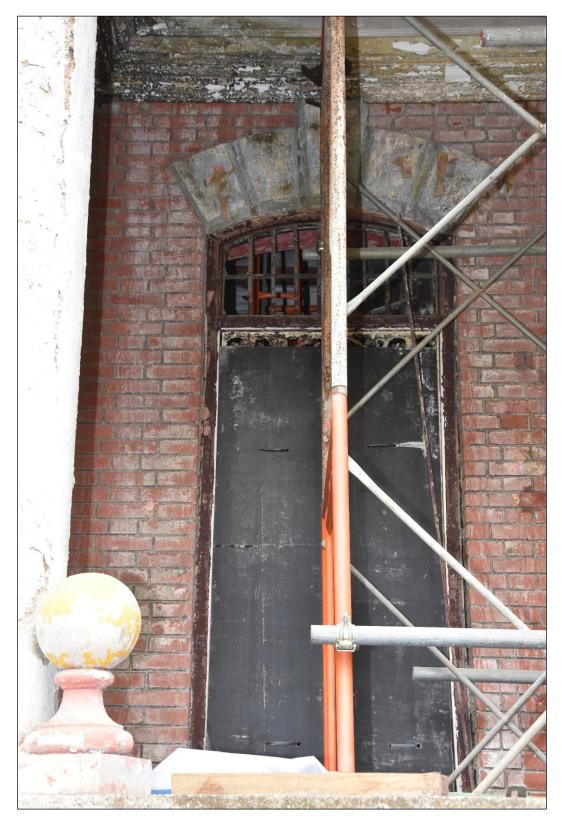
<u>Photo App3-03 – North-east elevation (front elevation), ground floor,</u> <u>window Wdw-Gf03 inside recess entrance porch, external side,</u> <u>covered with plywood panel, (21st March, 2023)</u>

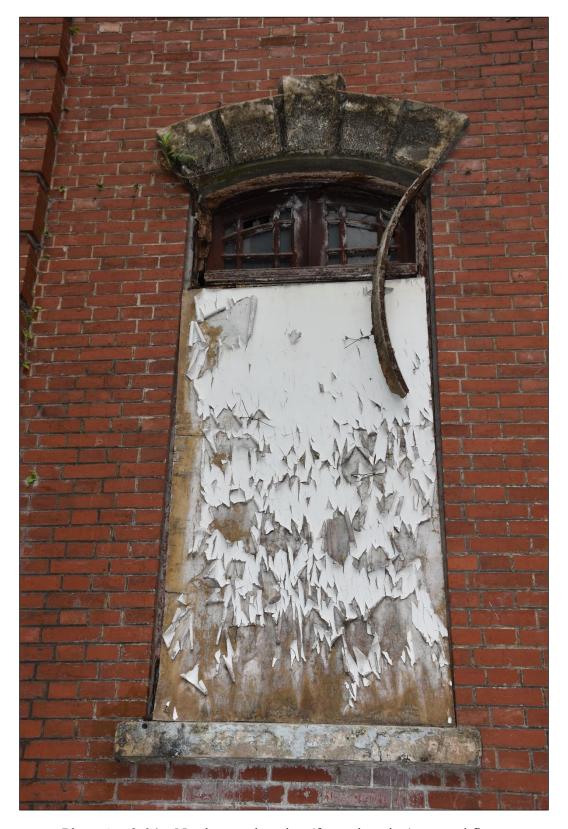
Photo App3-04 – North-east elevation (front elevation), ground floor, window Wdw-Gf04, external side, covered with plywood panel, (21st March, 2023)

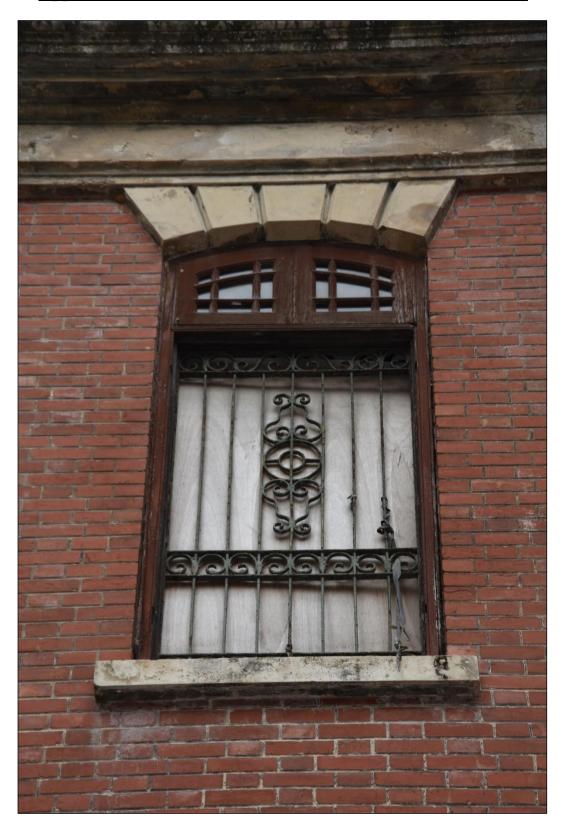
Photo App3-05 – North-east elevation (front elevation), first floor, window Wdw-1f01, external side, covered with plywood panel, (21st March, 2023)

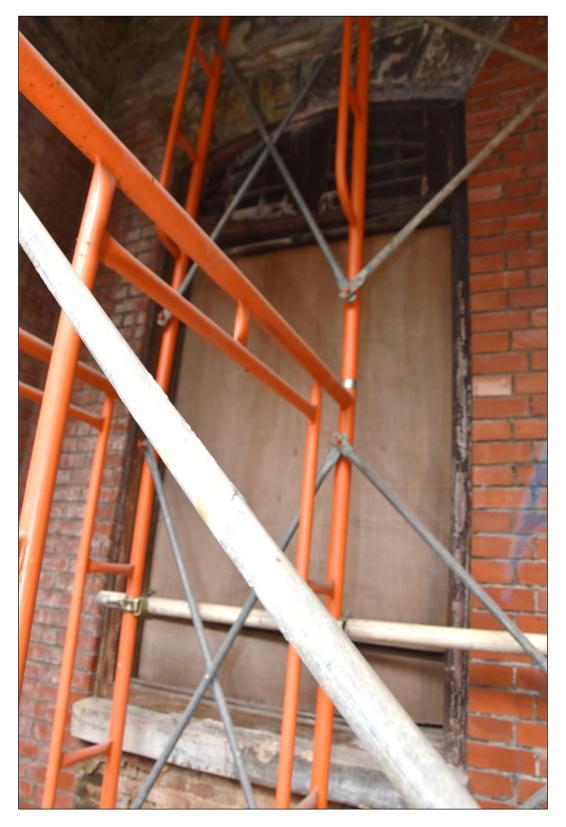
Photo App3-07 – North-east elevation (front elevation), first floor, window Wdw-1f03 inside verandah, external side, covered with plywood panel, (21st March, 2023)

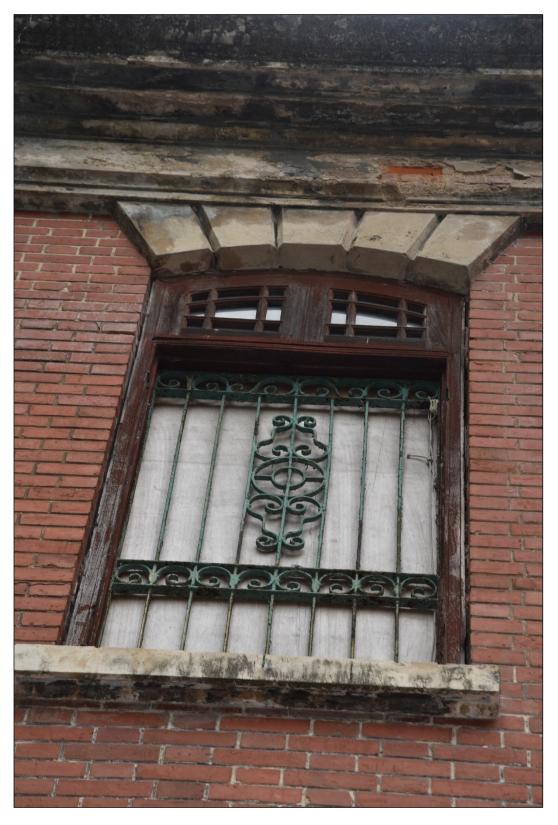
Photo App3-08 – North-east elevation (front elevation), first floor, window Wdw-1f04, external side, covered with plywood, (21st March, 2023)

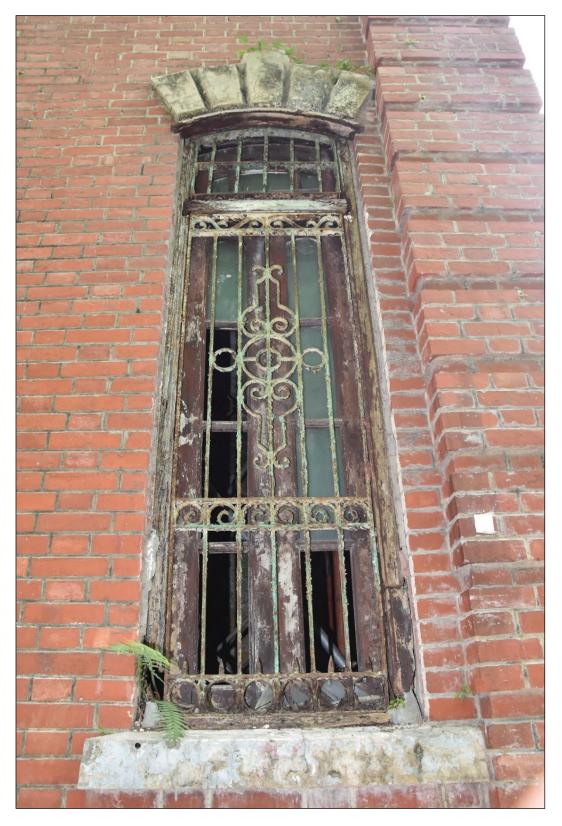
Photo App3-09 – South-east elevation (facing Ship Street), ground floor, window Wdw-f05, (21st March, 2023)

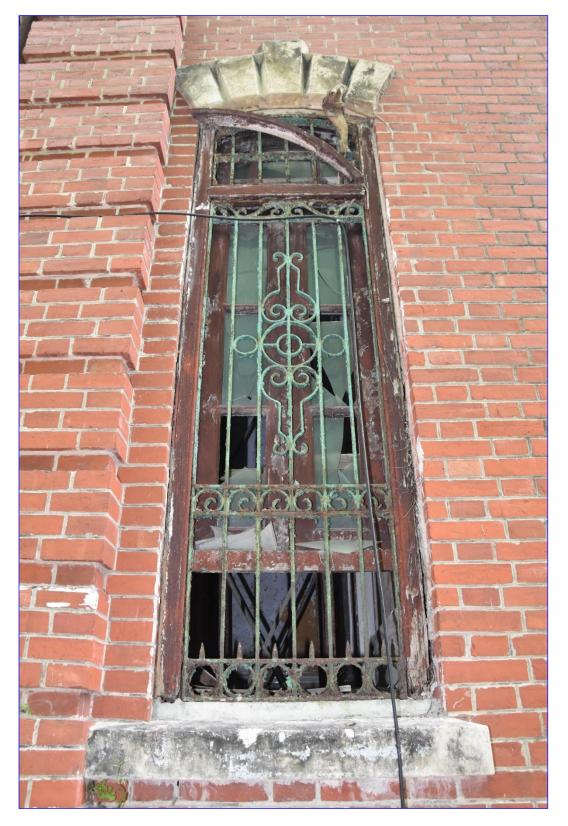
Photo App3-10 – South-east elevation (facing Ship Street), ground floor, window Wdw-Gf06, (21st March, 2023)23)

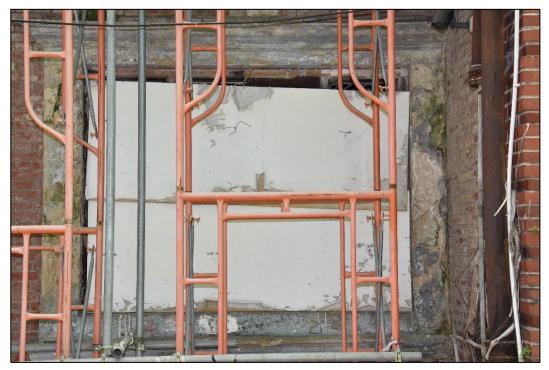
Photo App3-11 – South-east elevation (facing Ship Street), ground floor, window Wdw-Gf07, rectangular shape (not the typical design), external side, covered with plywood panel, (21st March, 2023)

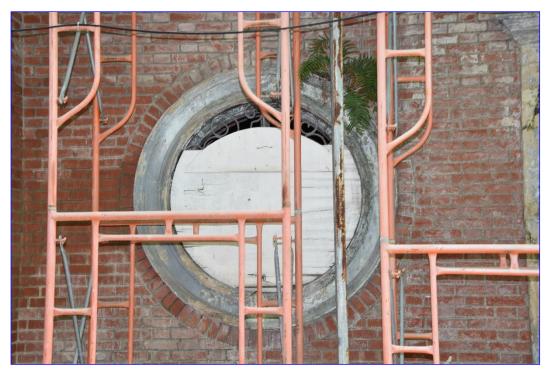
Photo App3-12 – South-east elevation (facing Ship Street), ground floor, window Wdw-Gf08, circular shape (not the typical design), external side, covered with plywood panel, (21st March, 2023)

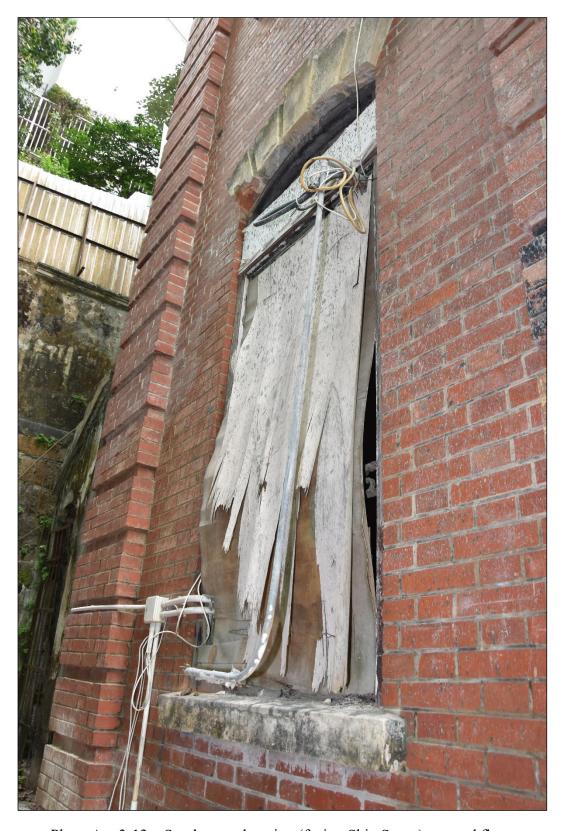
Photo App3-13 – South-east elevation (facing Ship Street), ground floor, window Wdw-G09, external side, covered with plywood panel, (21st March, 2023)

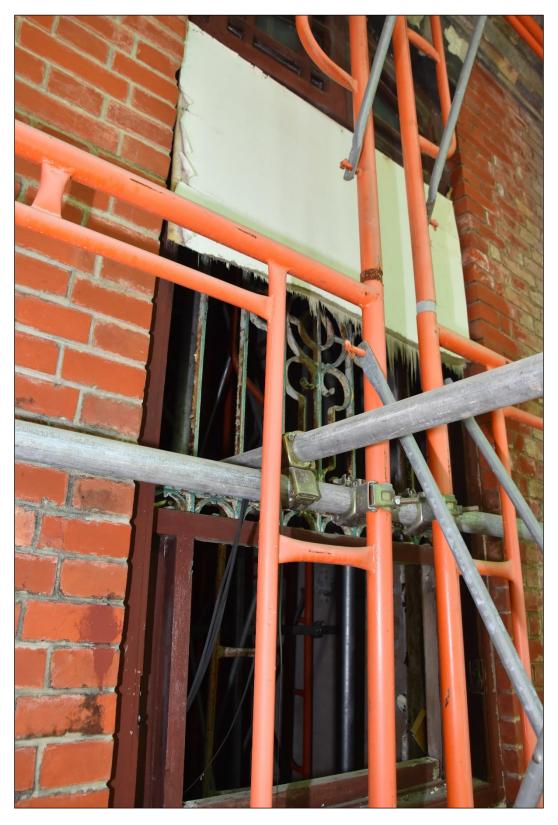
<u>Photo App3-15 – South-east elevation (facing Ship Street), first floor,</u> <u>window Wdw-1f06 at balcony, external side, (22<sup>nd</sup> March, 2023)</u>

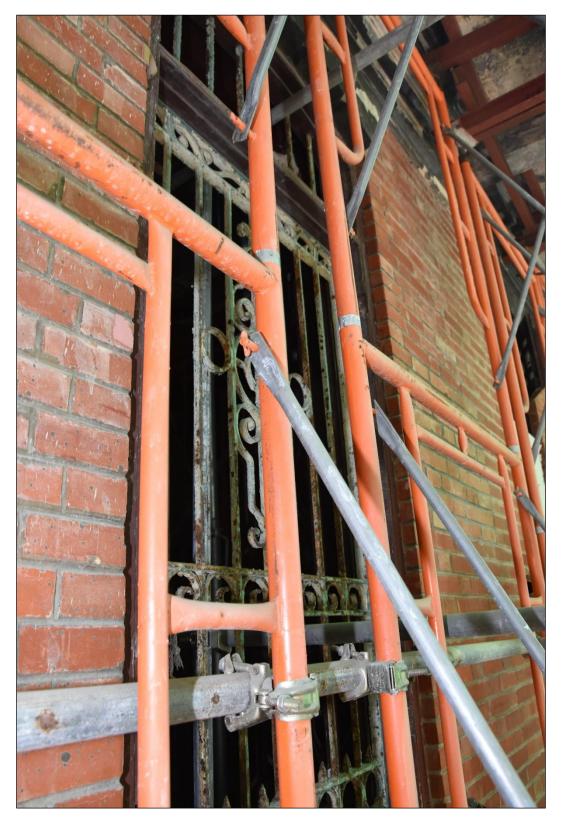
<u>Photo App3-16 – South-east elevation (facing Ship Street), first floor,</u> window Wdw-1f07 at balcony, external side, (22<sup>nd</sup> March, 2023)

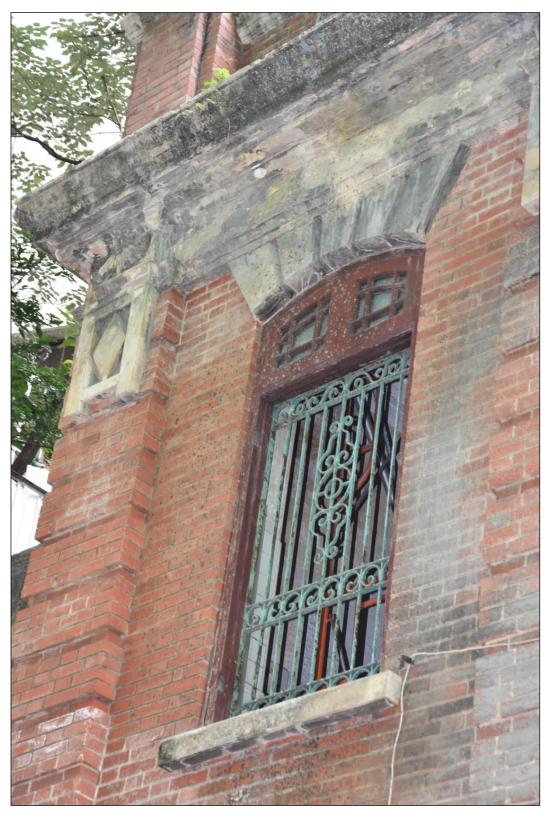
Photo App3-17 – South-east elevation (facing Ship Street), first floor, window Wdw-1f08, external side, (21st March, 2023)

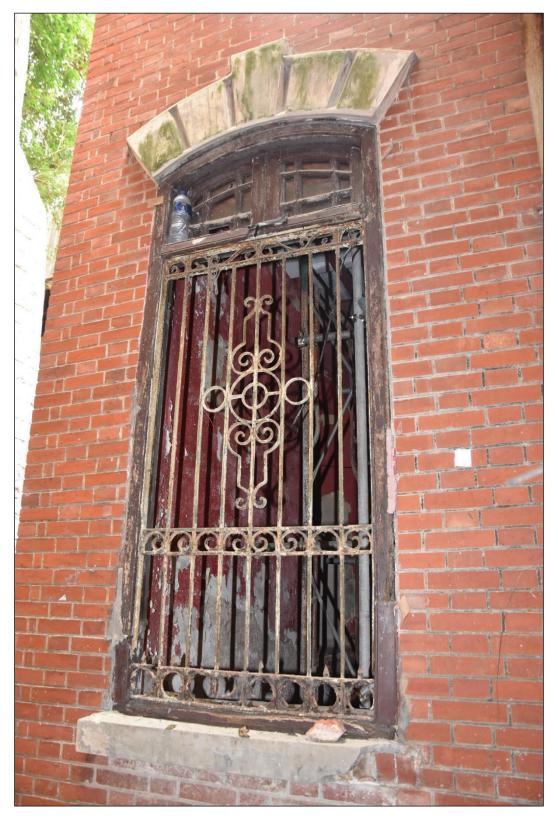
<u>Photo App3-18 – South-west elevation (rear elevation), ground floor,</u> <u>window Wdw-Gf10, external side, (21st March, 2023)</u>

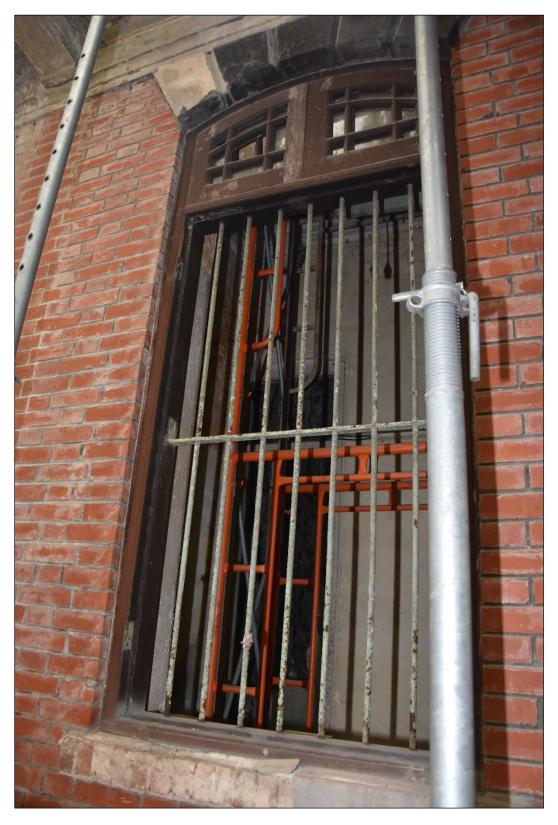
Photo App3-19 – South-west elevation (rear elevation), first floor, window Wdw-1f09 at balcony, external side, (22<sup>nd</sup> March, 2023)

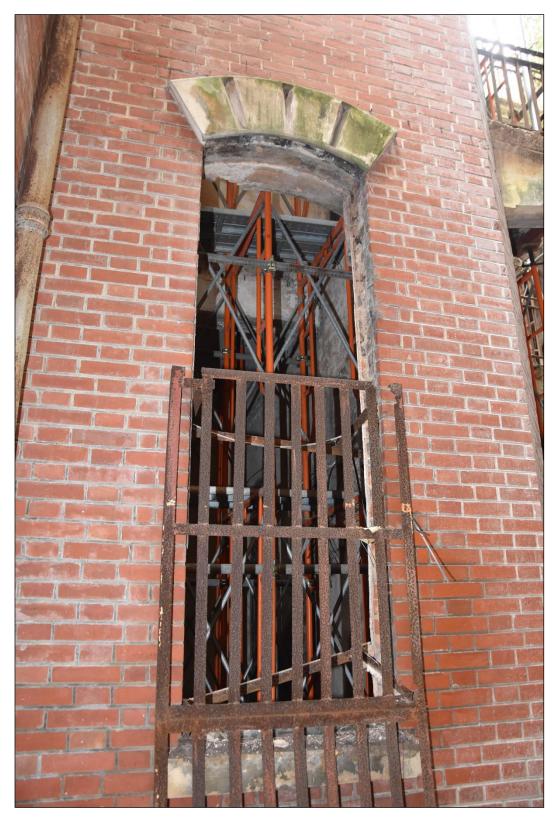
Photo App3-20 – North-west elevation (facing Admiralty side), ground floor, window Wdw-Gf11, external side, (21st March, 2023)

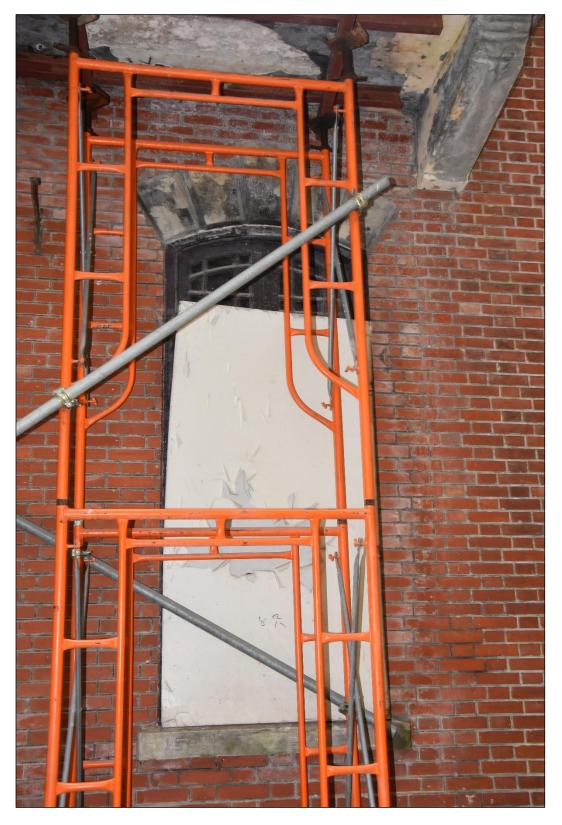
Photo App3-21 – North-west elevation (facing Admiralty side), ground floor, window Wdw-Gf12, external side, covered with plywood panel, (21st March, 2023)

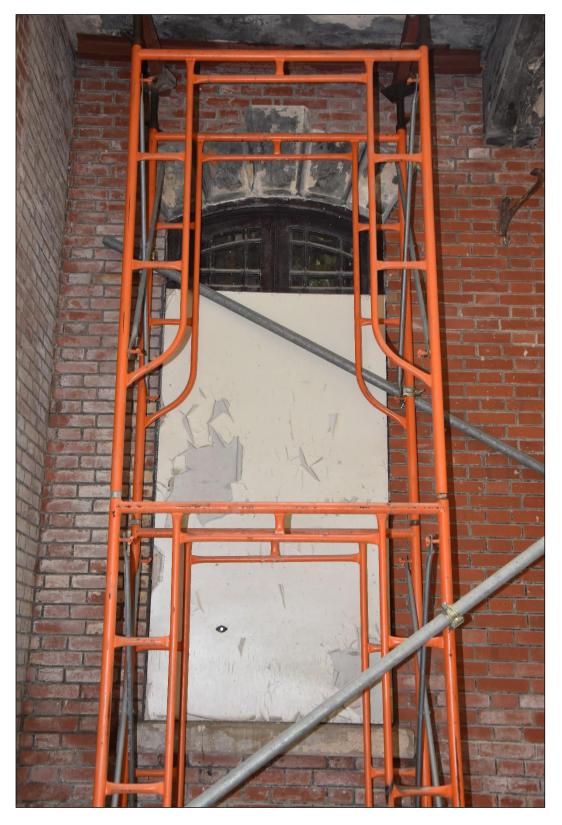
Photo App3-22 – North-west elevation (facing Admiralty side), ground floor, window Wdw-Gf13, external side, (21st March, 2023)

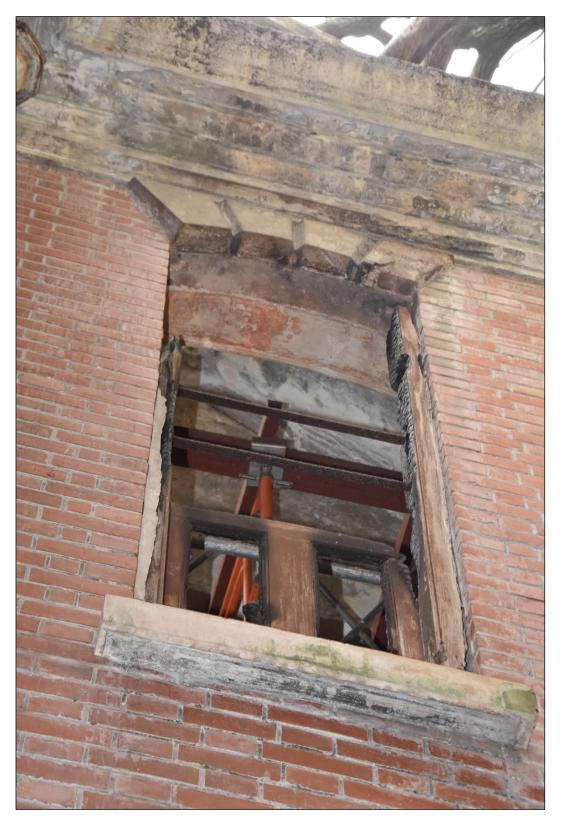
Photo App3-23 – North-west elevation (facing Admiralty side), first floor, window Wdw-1f10, external side, the window and window grille removed, (21st March, 2023)

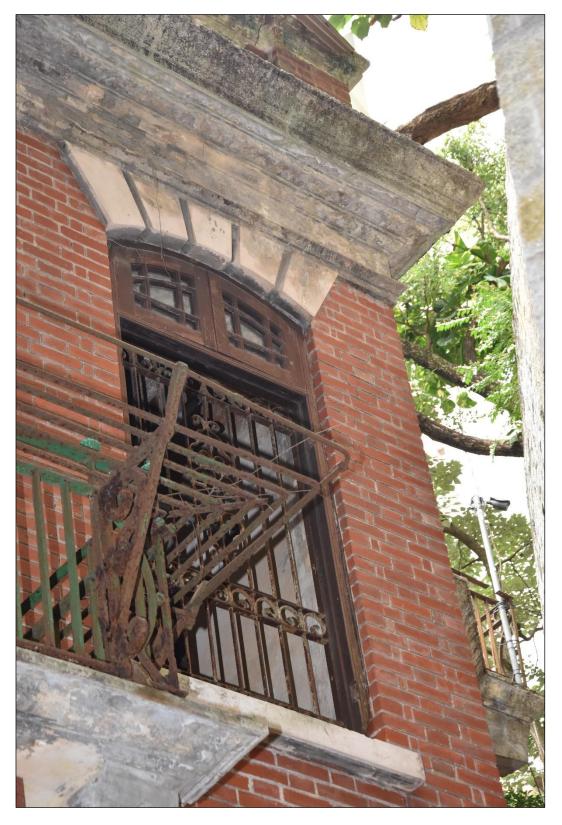
Photo App3-24 – North-west elevation (facing Admiralty side), first floor, window Wdw-1f11, external side, (21st March, 2023)

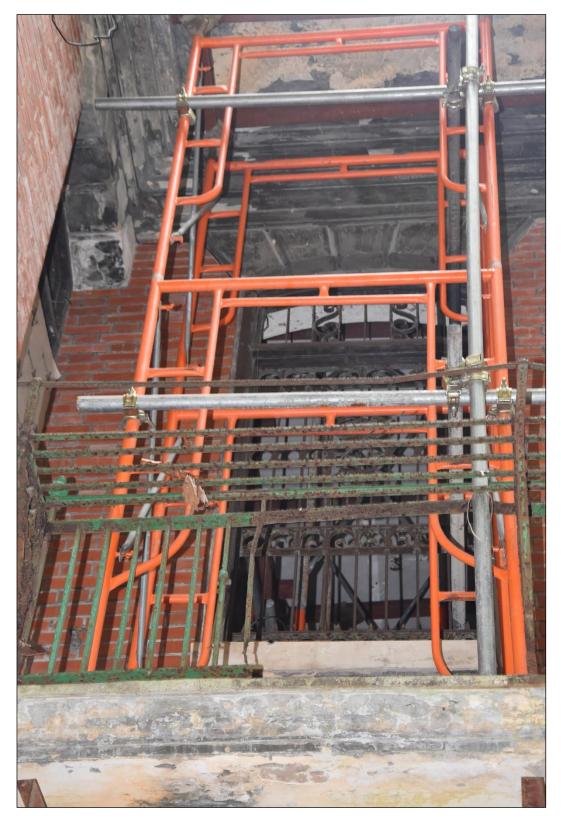
Photo App3-25 – North-west elevation (facing Admiralty side), first floor, window Wdw-1f12 at balcony, external side, (21st March, 2023)

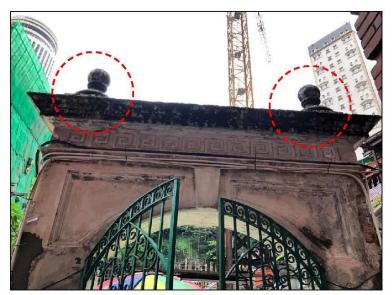
Photo 02 - the two spherical shape with moulding base decorative features

- The spherical shape with moulding base decorative feature should be a plastered feature.
- 2. Carefully saw-cut at the base of the spherical shape with moulding base decorative feature (decorative feature).
- Clean the decorative feature and repair the surface if necessary with mortar.
   The mix of the mortar shall follow the mix of the rendering of entrance gateway,

- Install the decorative feature on top of the entrance gateway in new position.
   Stainless steel pin should be inserted between the top of the entrance gateway and the decorative feature.
- Apply mineral paint to the decorative feature. The colour shall follow the colour of the entrance gateway.
- 6. Record the whole process by photo record.
- (b) Artefact no. 2 address number plate shown in the photo below

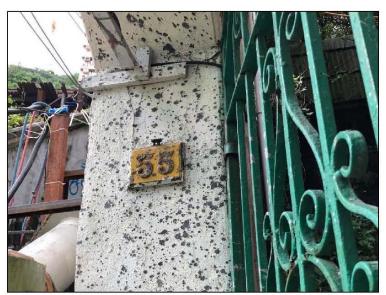
Photo 02 - the address number plate

- 7. Take down the address number plate. It should be constructed of two yellow colour "insert" number plate and the black colour receiving pocket fixed to the pillar.
- 8. Remove all paint.
- 9. Remove all rust by sanding.
- 10. After repair, apply water based enamel paint to the number plate.
- 11. Install the address number plate in the pillar of the entrance gateway in new
