**LOT NO. 63, 296 (PART), 331 RP (PART) &
393 RP (PART) IN DD185, SHEUNG WO CHE NO. 198
SAI LAM TEMPLE, SHATIN, NEW TERRITORIES**

GEOTECHNICAL PLANNING REVIEW REPORT

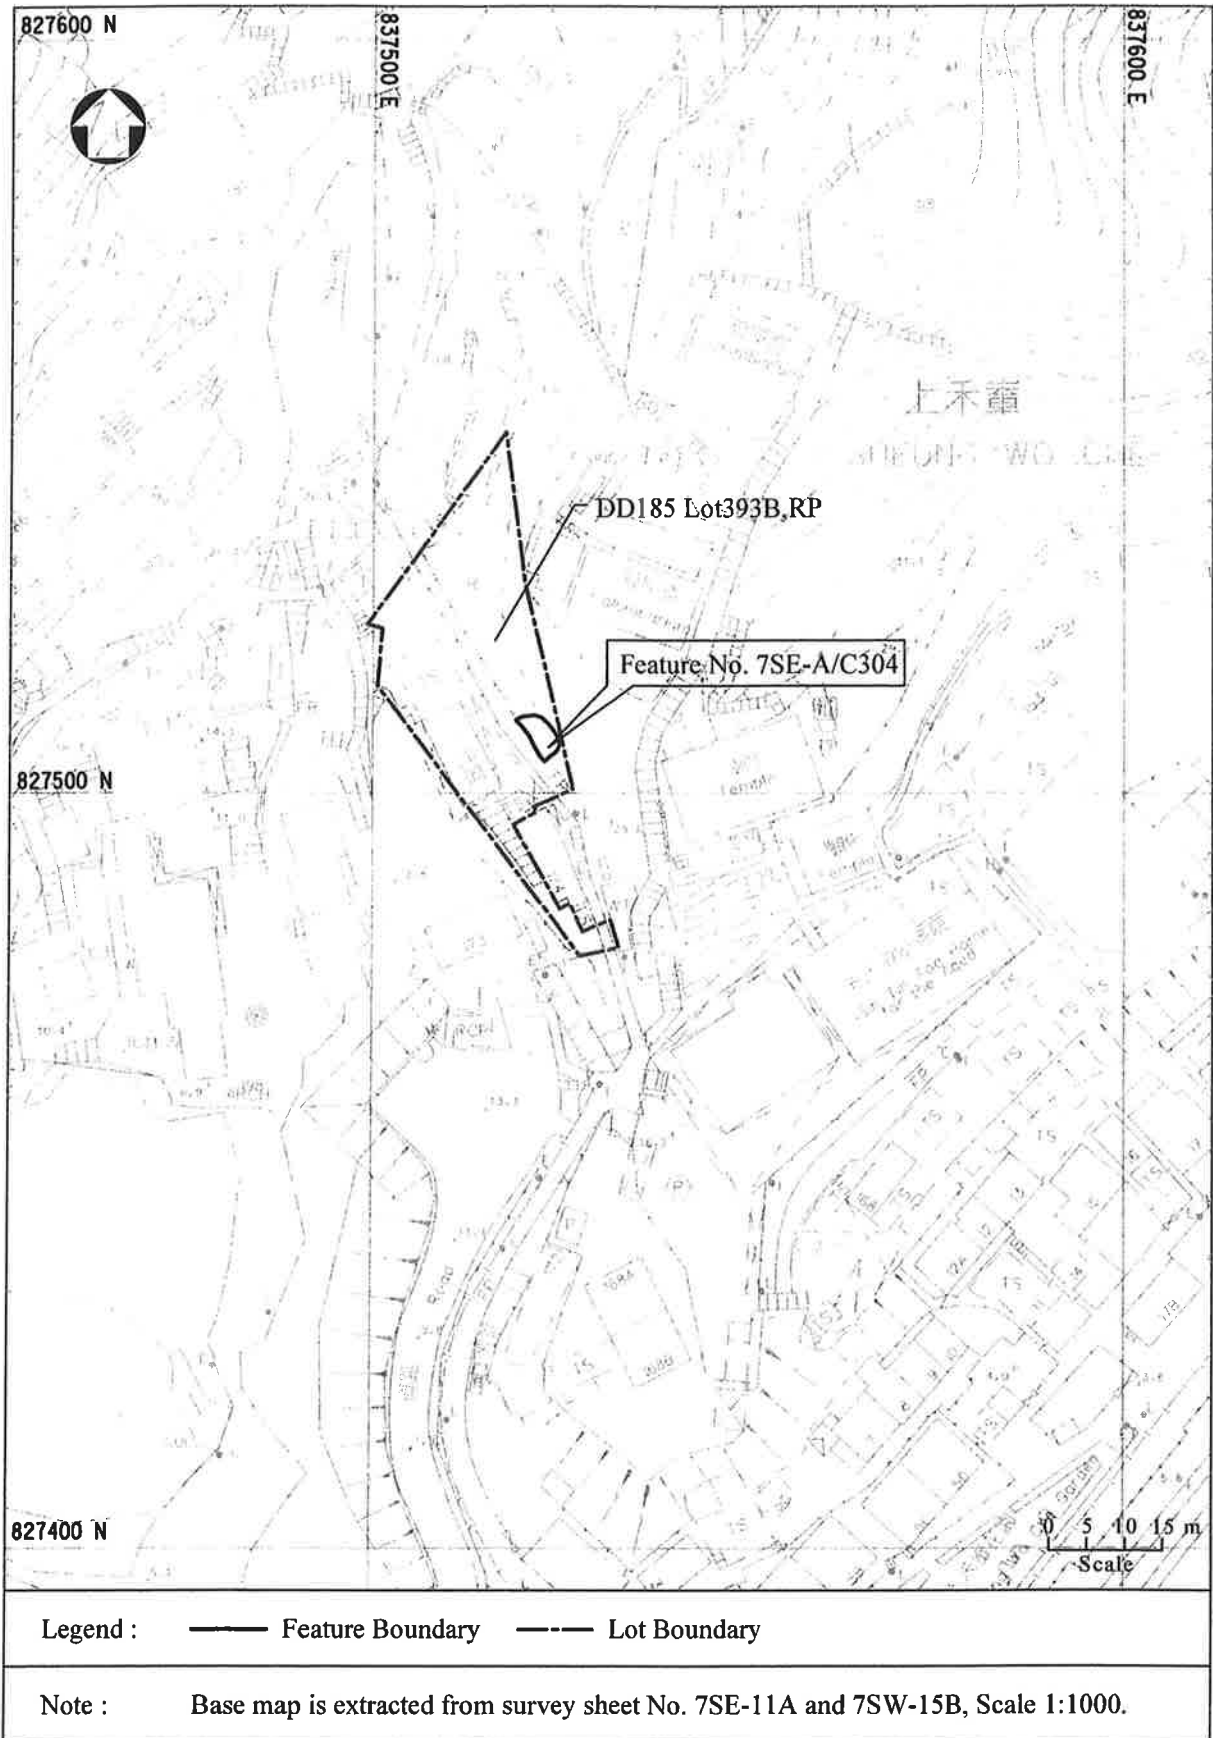
Figure 1.1 General Location Plan

Feature No. **7SE-A/C304** is a 7.5m long soil cut slope with maximum height of about 5.6m and it is generally facing northeast. An undeveloped greenbelt is located at the crest of the feature whereas a footpath and a temple were located at the toe of the feature. The detailed description of the feature is shown in Section 2.2 of this report. The location of the study feature is shown in Figure 1.1.

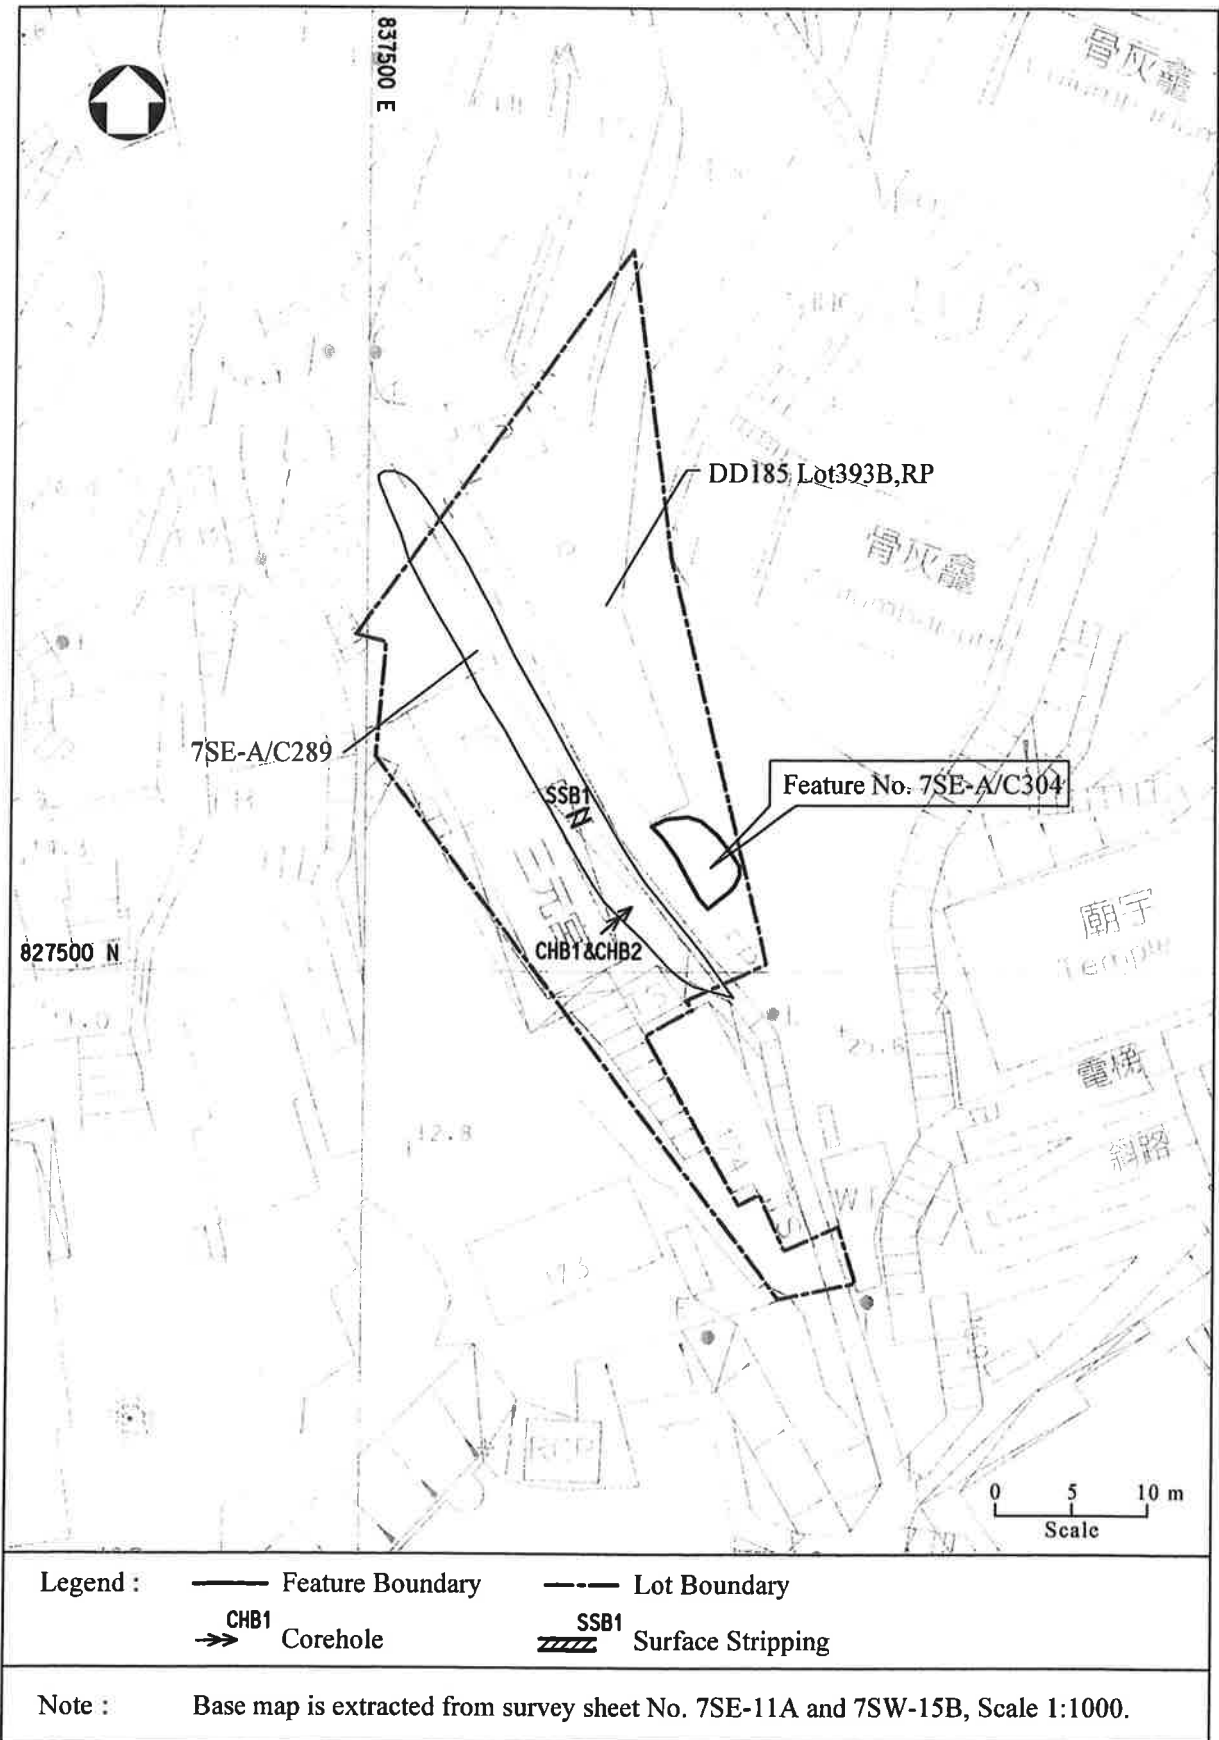
Figure 2.1 Location Plan of Nearby Ground Investigations & Feature No. 7SE-A/C289

A geotechnical assessment report prepared by Meinhardt Mouchel Ltd in September 2005 for the nearby Feature No. 7SE-A/C289 was located in file No. GCME 3/5/DH46/01/NT. The report contains relevant ground investigation (GI) records and design of stabilization works for Feature No. 7SE-A/C289. The locations of the feature and relevant GI stations are shown in Figure 2.1. According to the report, the design shear strength parameters for fill, colluvium and completely decomposed granite (CDG) were $c' = 0\text{kPa}$ & $\phi' = 30^\circ$, $c' = 0\text{kPa}$ & $\phi' = 35^\circ$ and $c' = 5\text{kPa}$ & $\phi' = 35^\circ$ respectively.

There were no construction details, formation history or background details of the study feature could be located in DLO.

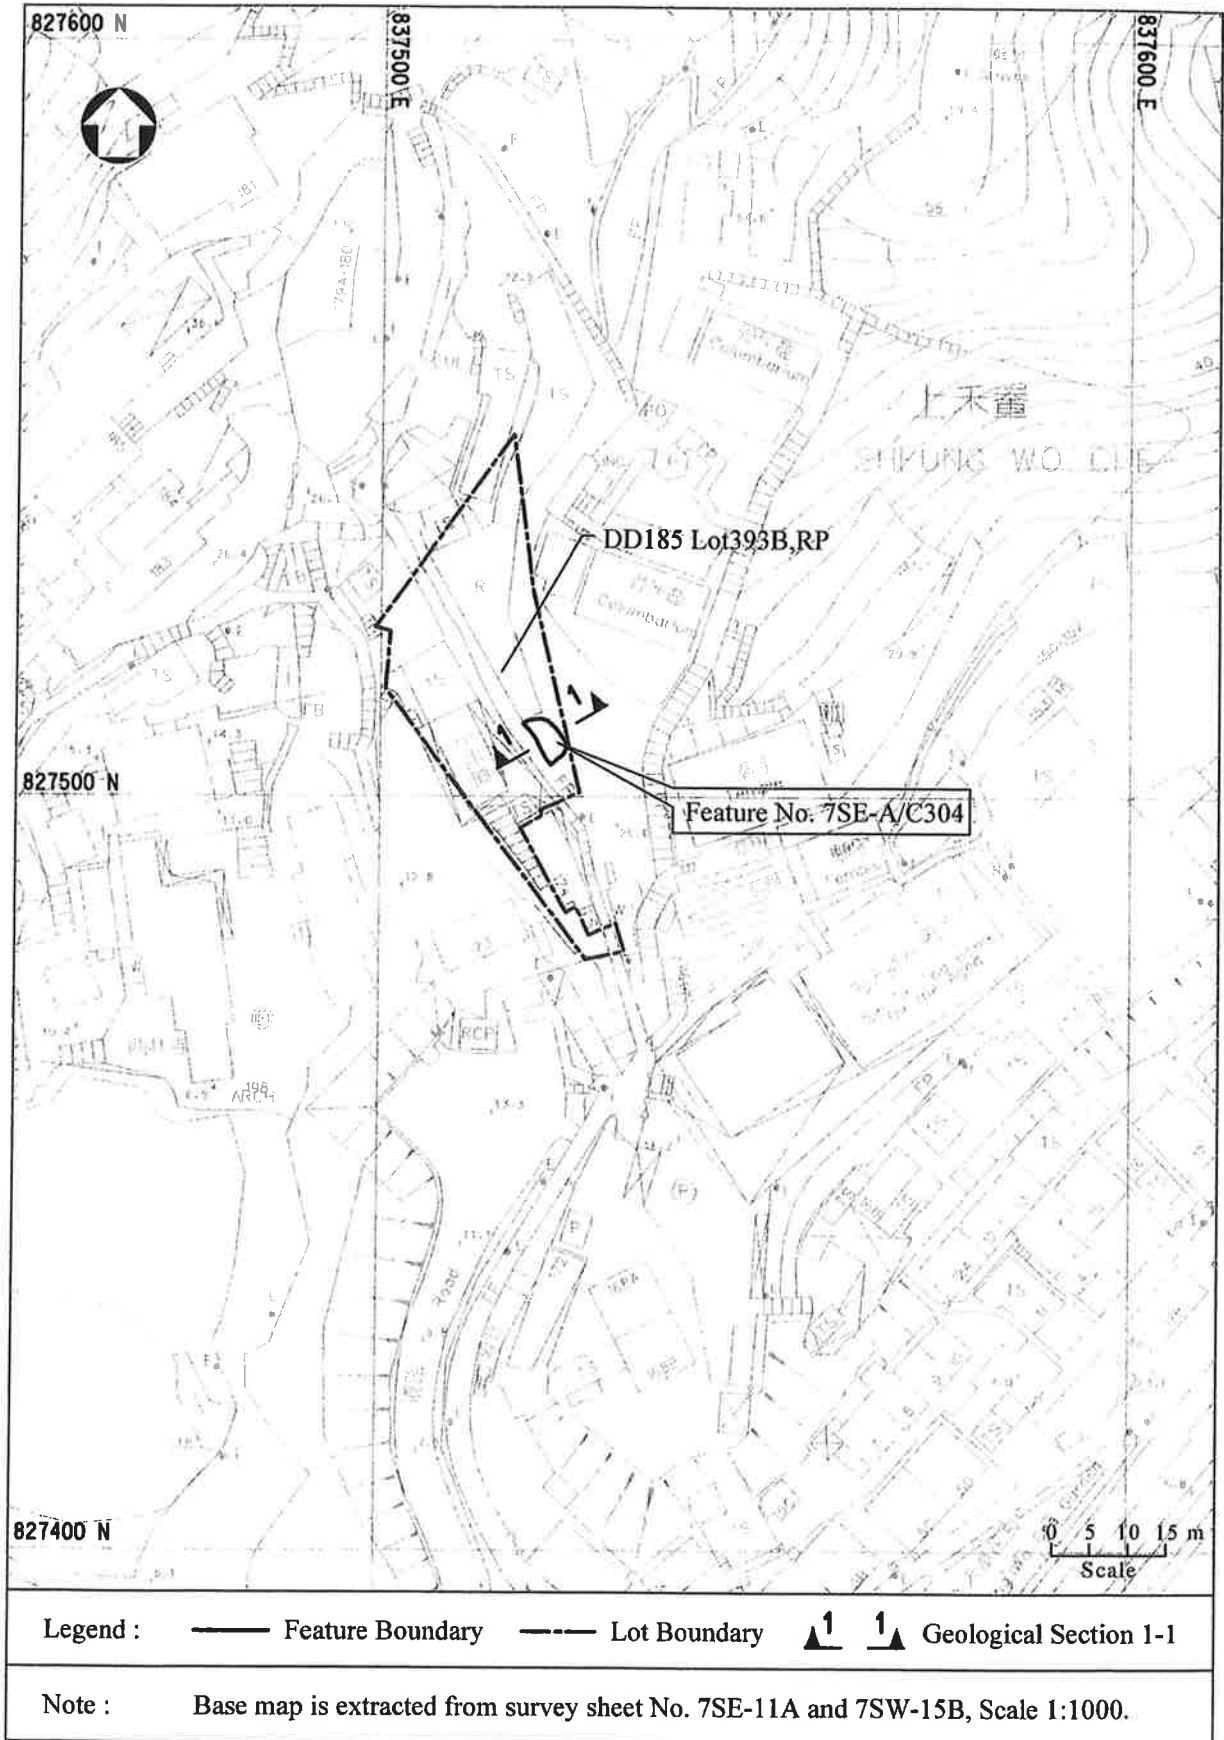
Figure 3.1 Location Plan of Section

The study feature was formed by cutting to accommodate the footpath at its toe. The critical section (Section 1-1) of the study feature was determined based on the feature height, gradient and consequence of failure. The location of this section is shown in Figure 3.1.

No groundwater monitoring records exist for the study feature and no signs of seepage were observed on site. However, the groundwater table for Sections 1-1 was assumed at one-third of the slope height to account for 1 in 10 year return period of rainfall.

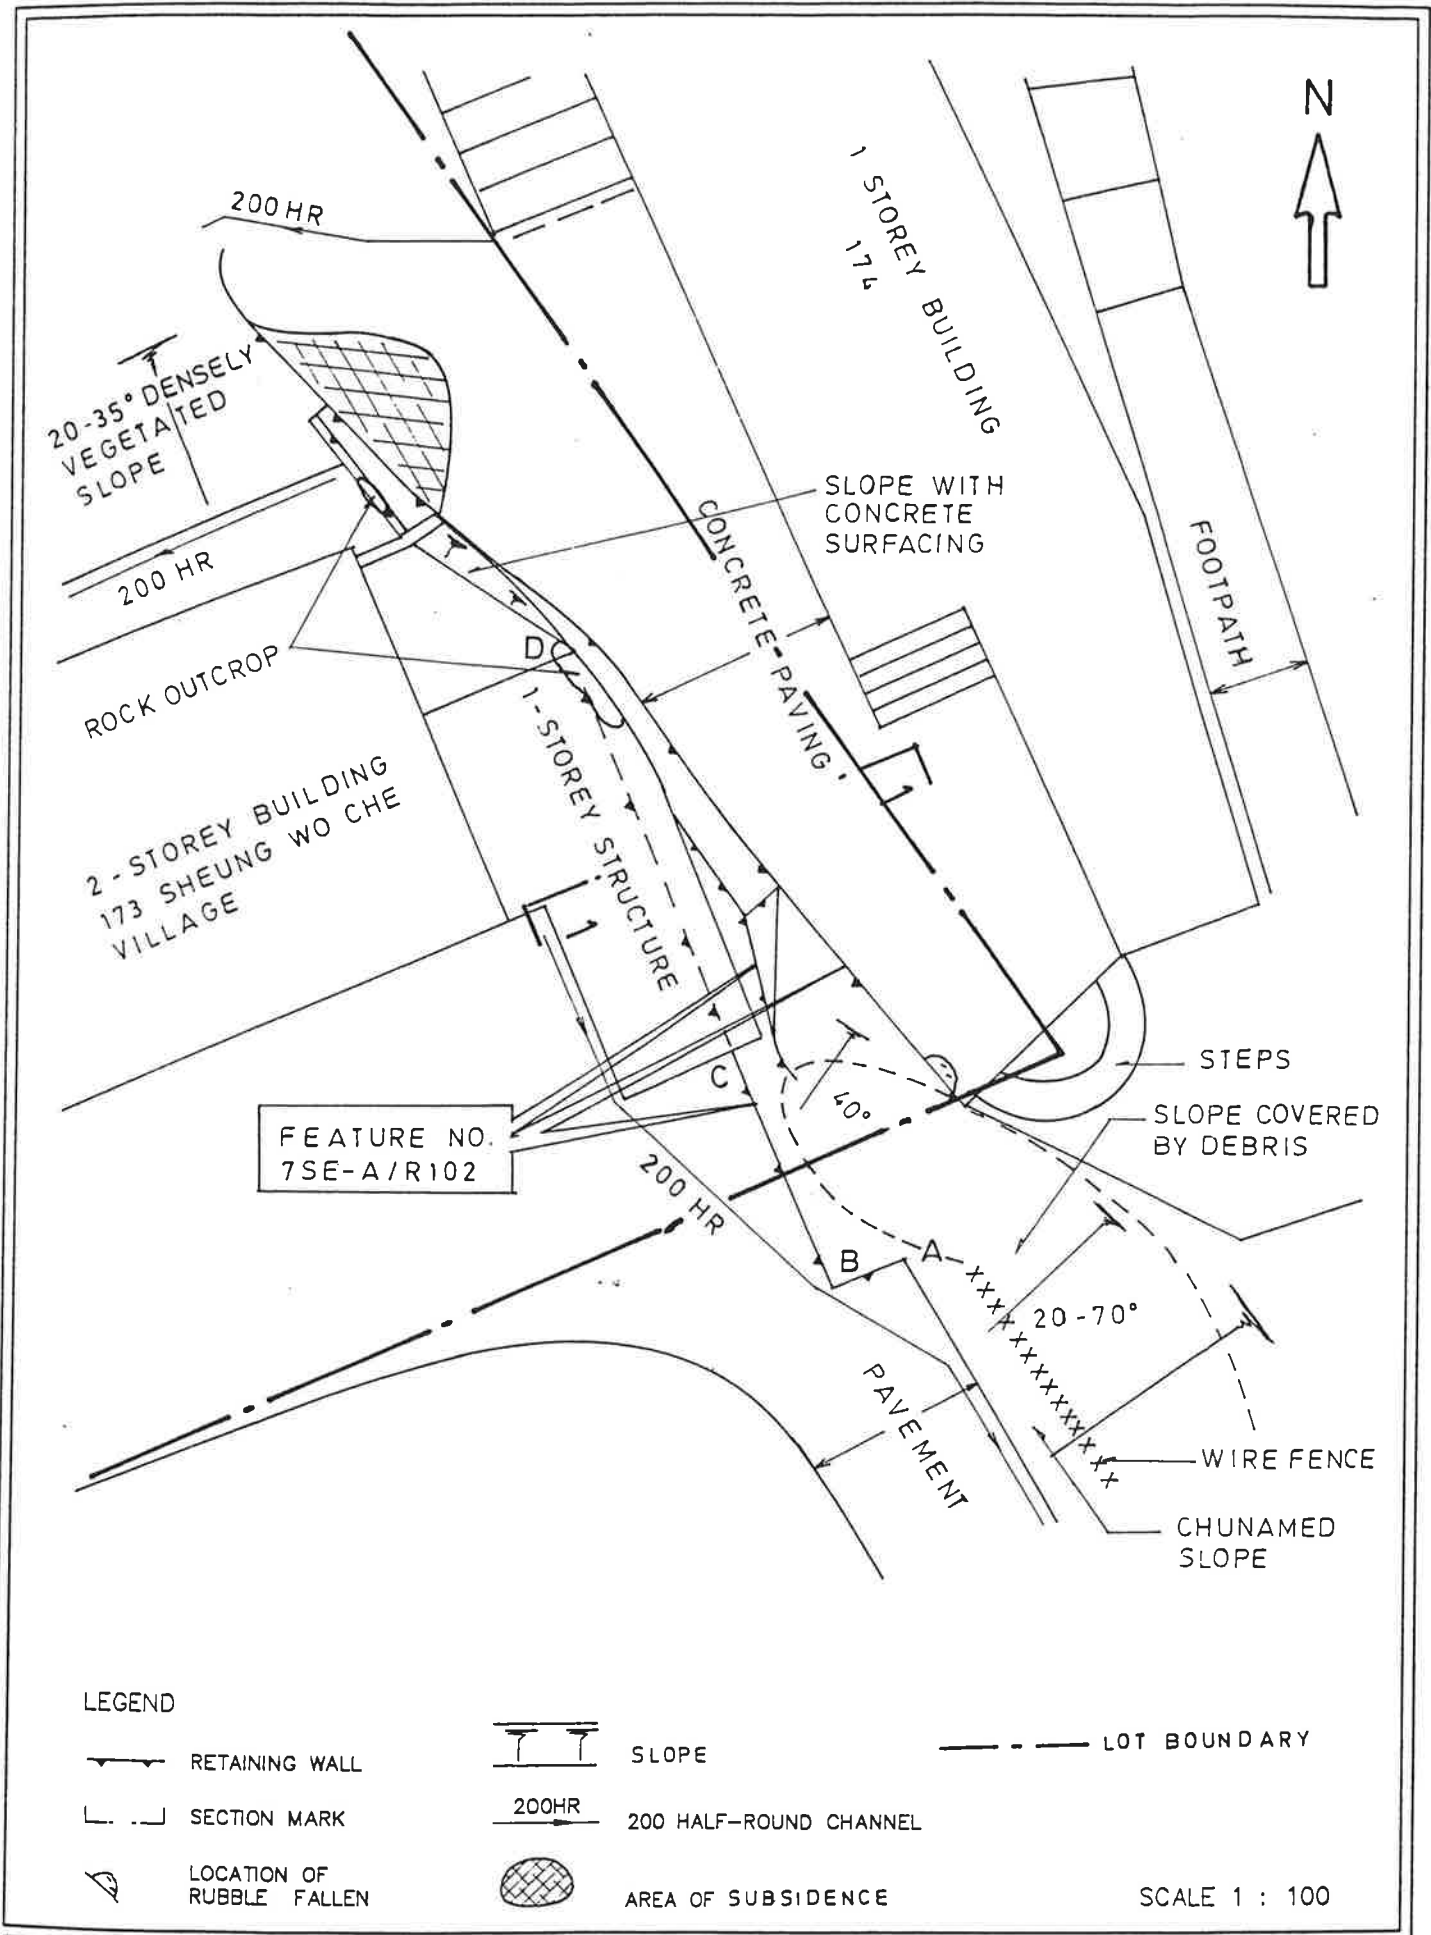
FIGURE 2

The lower random rubble wall (from point 'A' to point 'D' in Figure 2) is approximately 10 m long, about 2.1 m maximum high and has a slanted face with an inclination of 85 degrees to horizontal. The northern portion of the rubble wall is under the shelter of a corrugated sheet canopy and is rendered with plaster. Above the northern portion of the rubble wall are two recent masonry walls with height varying from 0.78 m to 1.70 m. The total height of the Feature is maximum about 4.6 m. There are no weepholes on these walls. Behind the crest of the upper masonry wall is a concrete paved platform. A single-storey building is situated at a horizontal distance of at least 2.5 m from the crest of the upper masonry wall. Above the southern portion of the lower rubble wall is a slope ascending at gradient between 20 and 70 degrees to the horizontal. The lower part of the slope is rendered with chunam plaster whilst the upper part is covered by debris. The northern end of the Feature joins with a 70 degrees cut slope with concrete cover. Rock outcrops are exposed at the cut slope.

Site inspection of the Feature was undertaken in September 1999. Observations made are set out below. Salient features noted are shown on the sketch plan in Figure 2 and developed elevation in Figure 3. Photographic records are depicted in Plates 1 to 4.

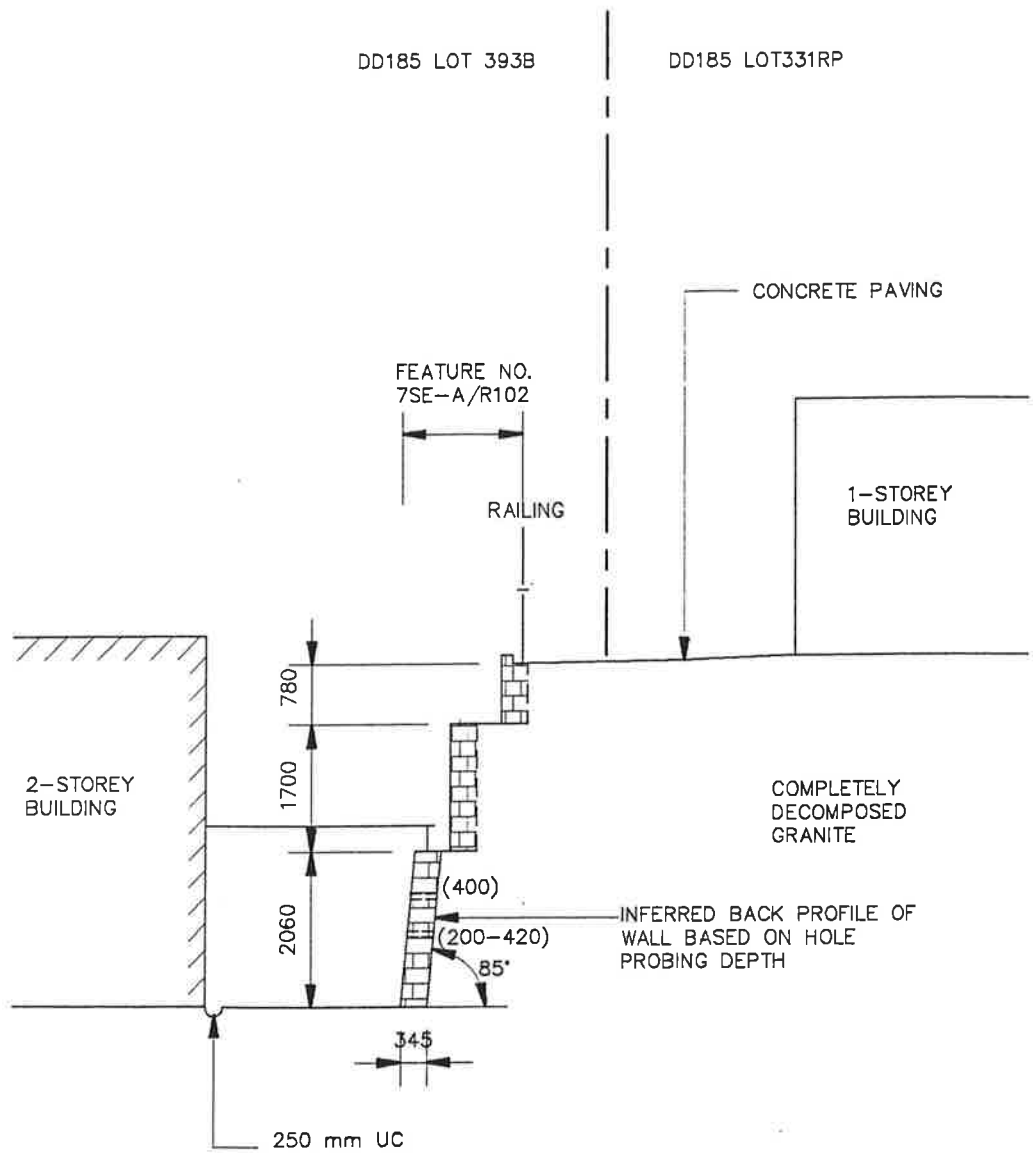
SECTION 1-1

The geometrical model adopted for stability assessment of the Feature at Section 1-1 is depicted in Figure 4. The 75 mm plastering to the lower rubble wall is not considered as part of the wall feature and is not shown in Figure 4 for clarify.

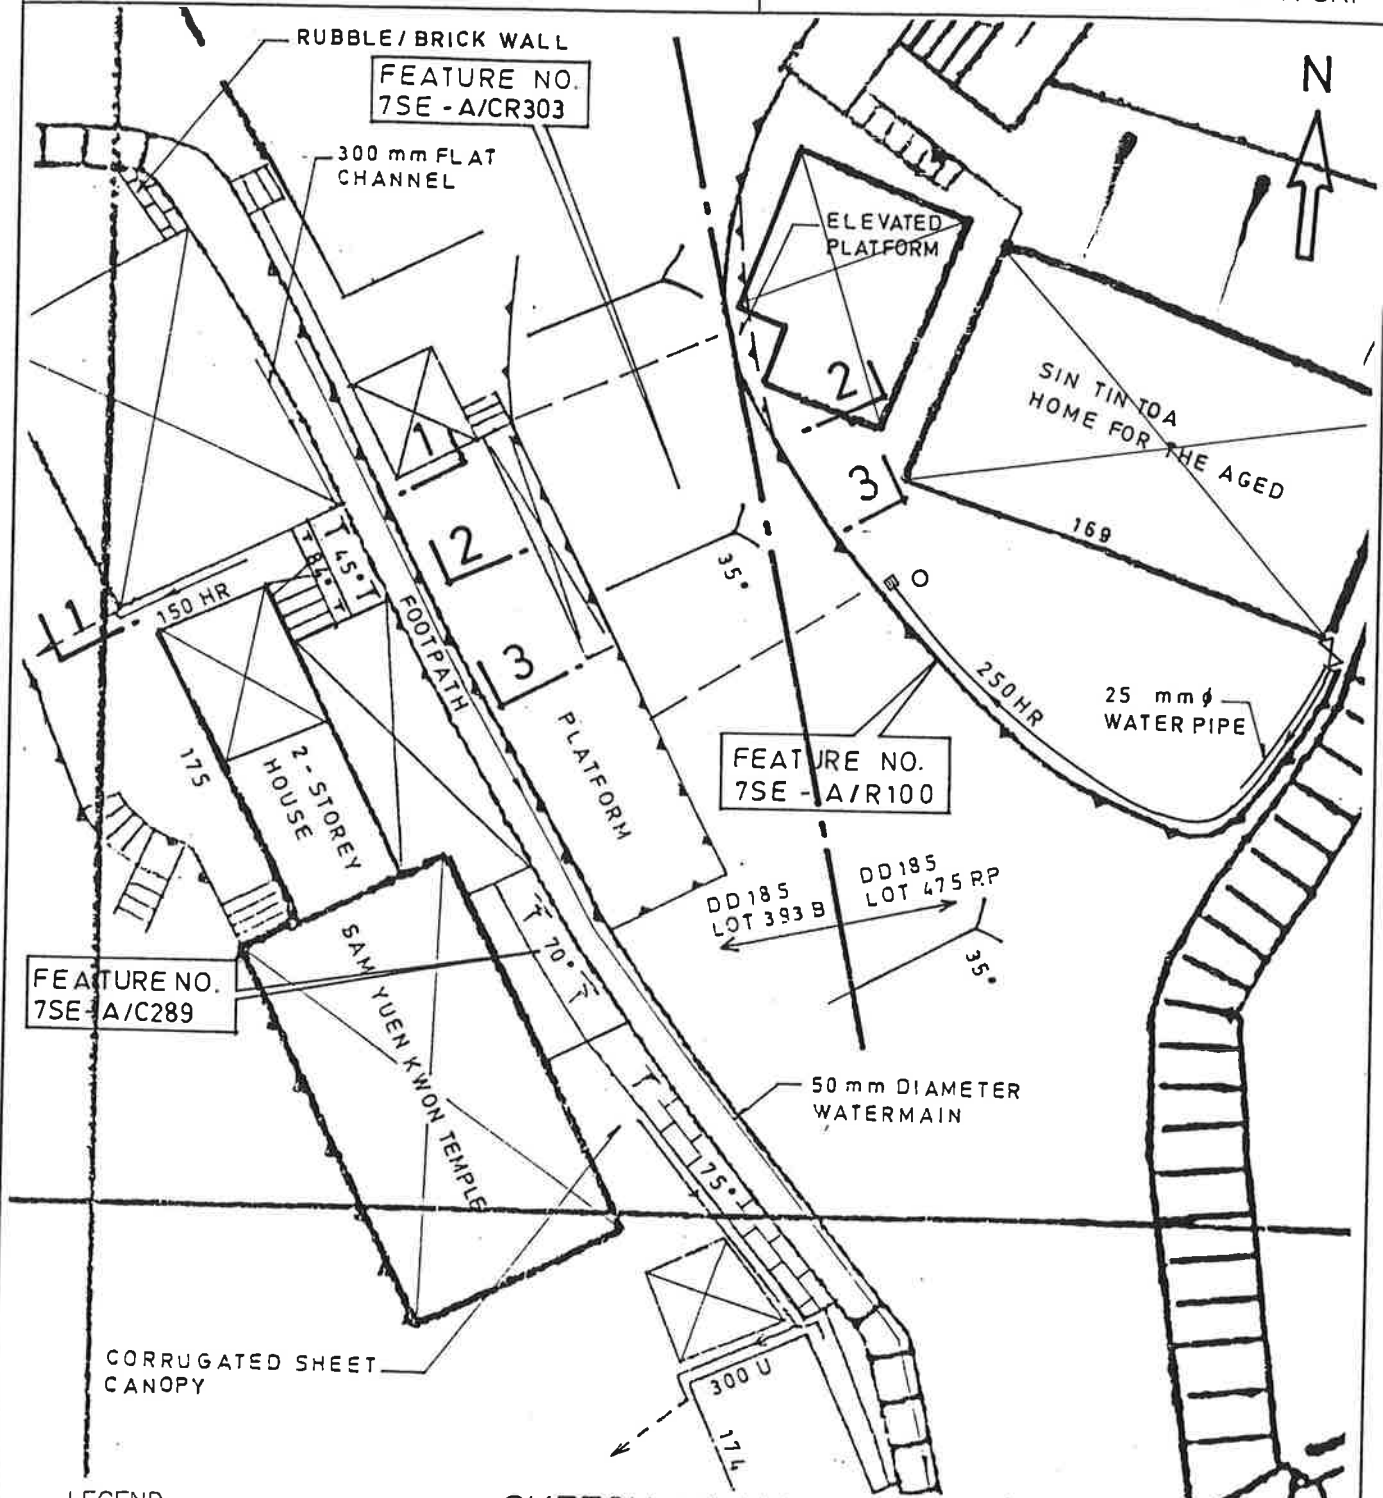
Drawn TW	Checked EC
Scale 1:250	Date AUG. 2000
Drg No.	Figure No. 2
MAA ENGINEERING CONSULTANTS (HK) LIMITED

Site inspections for the Features were carried out in September 1999 and August 2000. Observations made are outlined below. Salient features noted are shown on Sketch Plan in Figure 2. Views of the Features are shown on Plates 1 to 9.

Feature. One row of weepholes made of 75 mm diameter ceramic pipes are installed into the wall at horizontal spacing varied from 1.5 m to 2.0 m center-to-centre. Minor seepage was visible from one weephole and also from joints between the rubble blocks and the horizontal concrete beam at the central part of the wall at the time of inspection in August 2000. Weepholes were probed to depth between 0.5 m and 1.16 m. The results of weephole probing survey are presented in Figure 3. An elevated platform protrudes from the northern part of the wall. Part of concrete at the underside of the elevated platform has spalled exposing the steel reinforcements. A sub-vertical crack with crack width of maximum 15 mm extends to about 1 m above the toe of the wall underneath the elevated platform. Vegetations including trees grow and protrude from joints between rubble blocks at three locations. Behind the crest of the wall is a concrete paved platform. A single-storey house is situated at a horizontal distance of 0.7 m from the crest of the wall. A 250 mm half-round surface channel is constructed and a 25 mm diameter water pipe is laid along the crest of the southern part of the wall. A 160 mm diameter PVC downpipe is mounted on the wall face near the southern end of the wall.

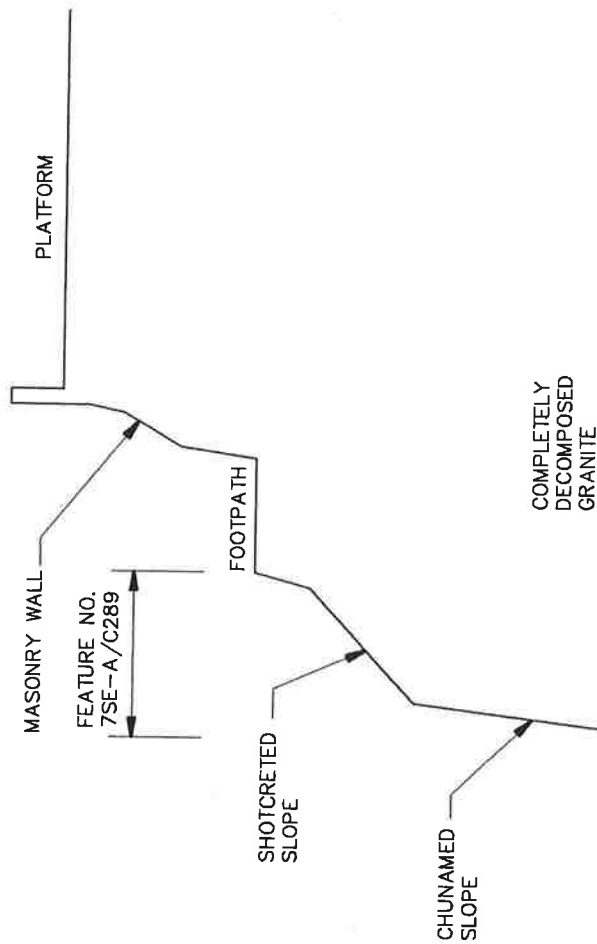
GEOLOGICAL MODEL AT SECTION 1-1

The geological model adopted for stability assessment of the Feature is depicted in Figure 4.

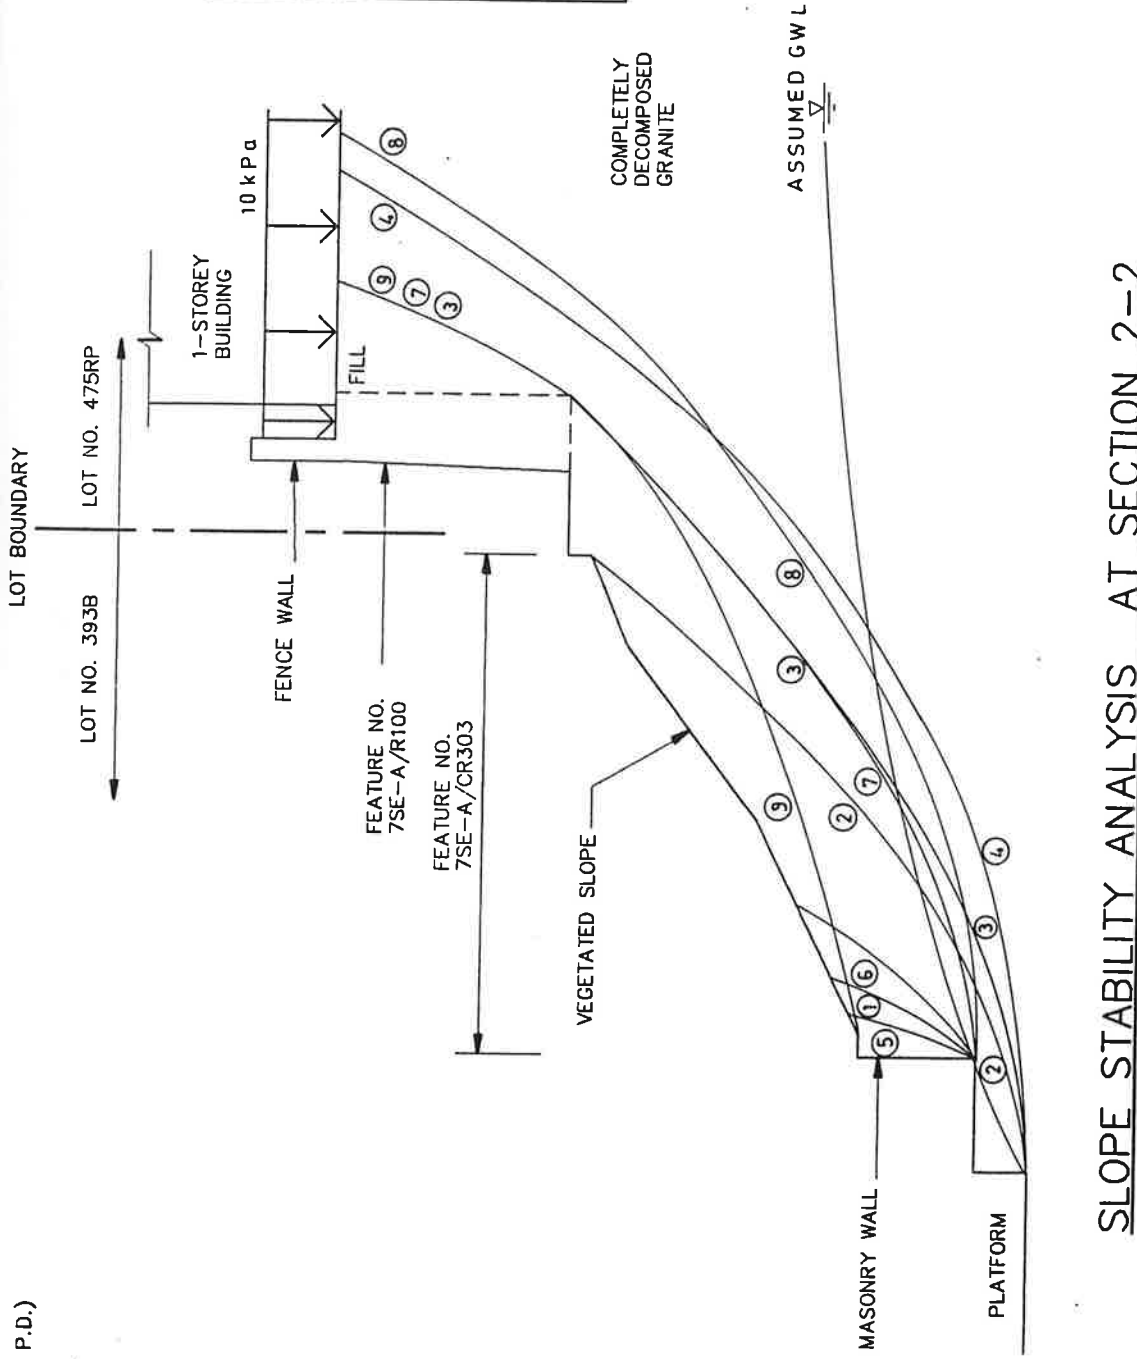
SLIP	CALCULATED FACTOR OF SAFETY			
	$c' = 5 \text{ kPa}$		$\phi' = 35^\circ$	
	DRY	ASSUMED G.W.L.	DRY	ASSUMED G.W.L.
1	1.19	1.19	2.01	2.01
2	1.59	1.52	2.25	2.16
3	1.21	1.17	1.61	1.57
4	1.32	1.25	1.75	1.67
5	1.26	1.26	2.28	2.28
6	1.32	1.32	2.13	2.13
7	1.21	1.20	1.60	1.60
8	1.33	1.31	1.76	1.73
9	1.25	1.25	1.72	1.72

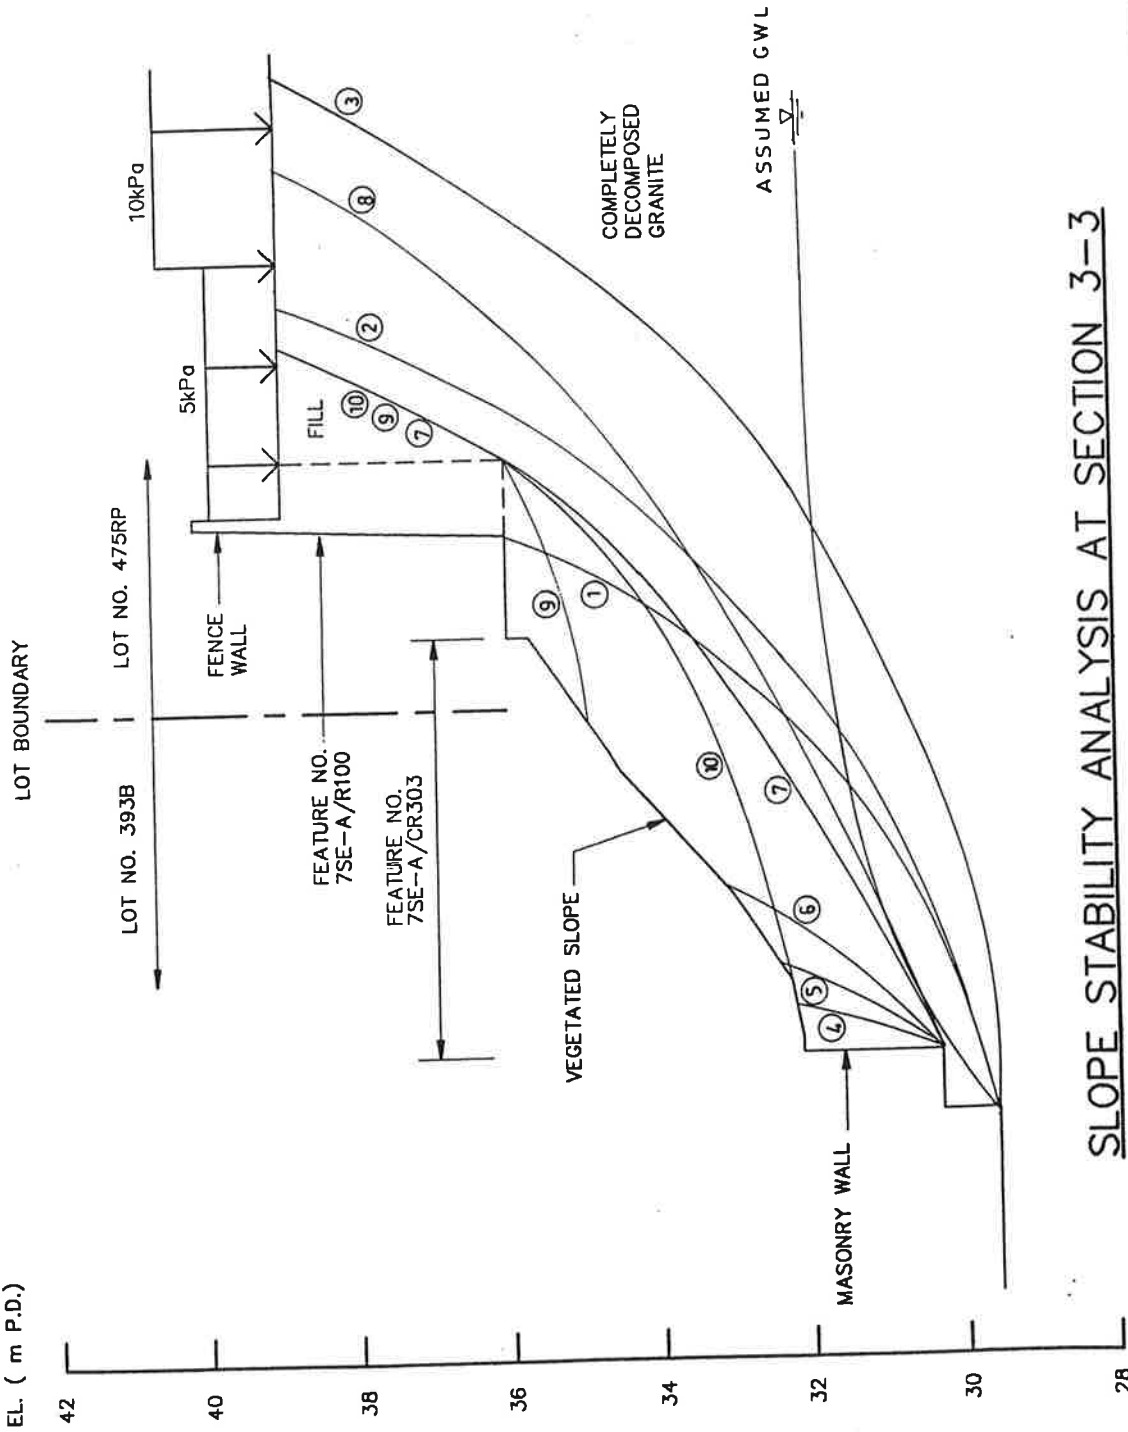
SLIP	CALCULATED FACTOR OF SAFETY			
	$c' = 5kPa$ $\phi' = 35^\circ$		$c' = 10kPa$ $\phi' = 40^\circ$	
	DRY	ASSUMED G.W.L.	DRY	ASSUMED G.W.L.
1	1.39	1.33	1.90	1.83
2	1.20	1.16	1.60	1.55
3	1.41	1.33	1.82	1.73
4	1.52	1.52	2.90	2.90
5	1.11	1.11	1.94	1.94
6	1.23	1.23	2.00	2.00
7	1.08	1.08	1.44	1.44
8	1.29	1.29	1.70	1.70
9	1.40	1.40	1.82	1.82
10	1.22	1.22	1.67	1.67
