**Geotechnical Planning Review Report**

**Section 16 Application –  
Layout Plan Submission and Proposed Minor  
Relaxation of Building Height Restriction for  
Permitted Flat Use**

**131 Pok Fu Lam Road, Hong Kong**

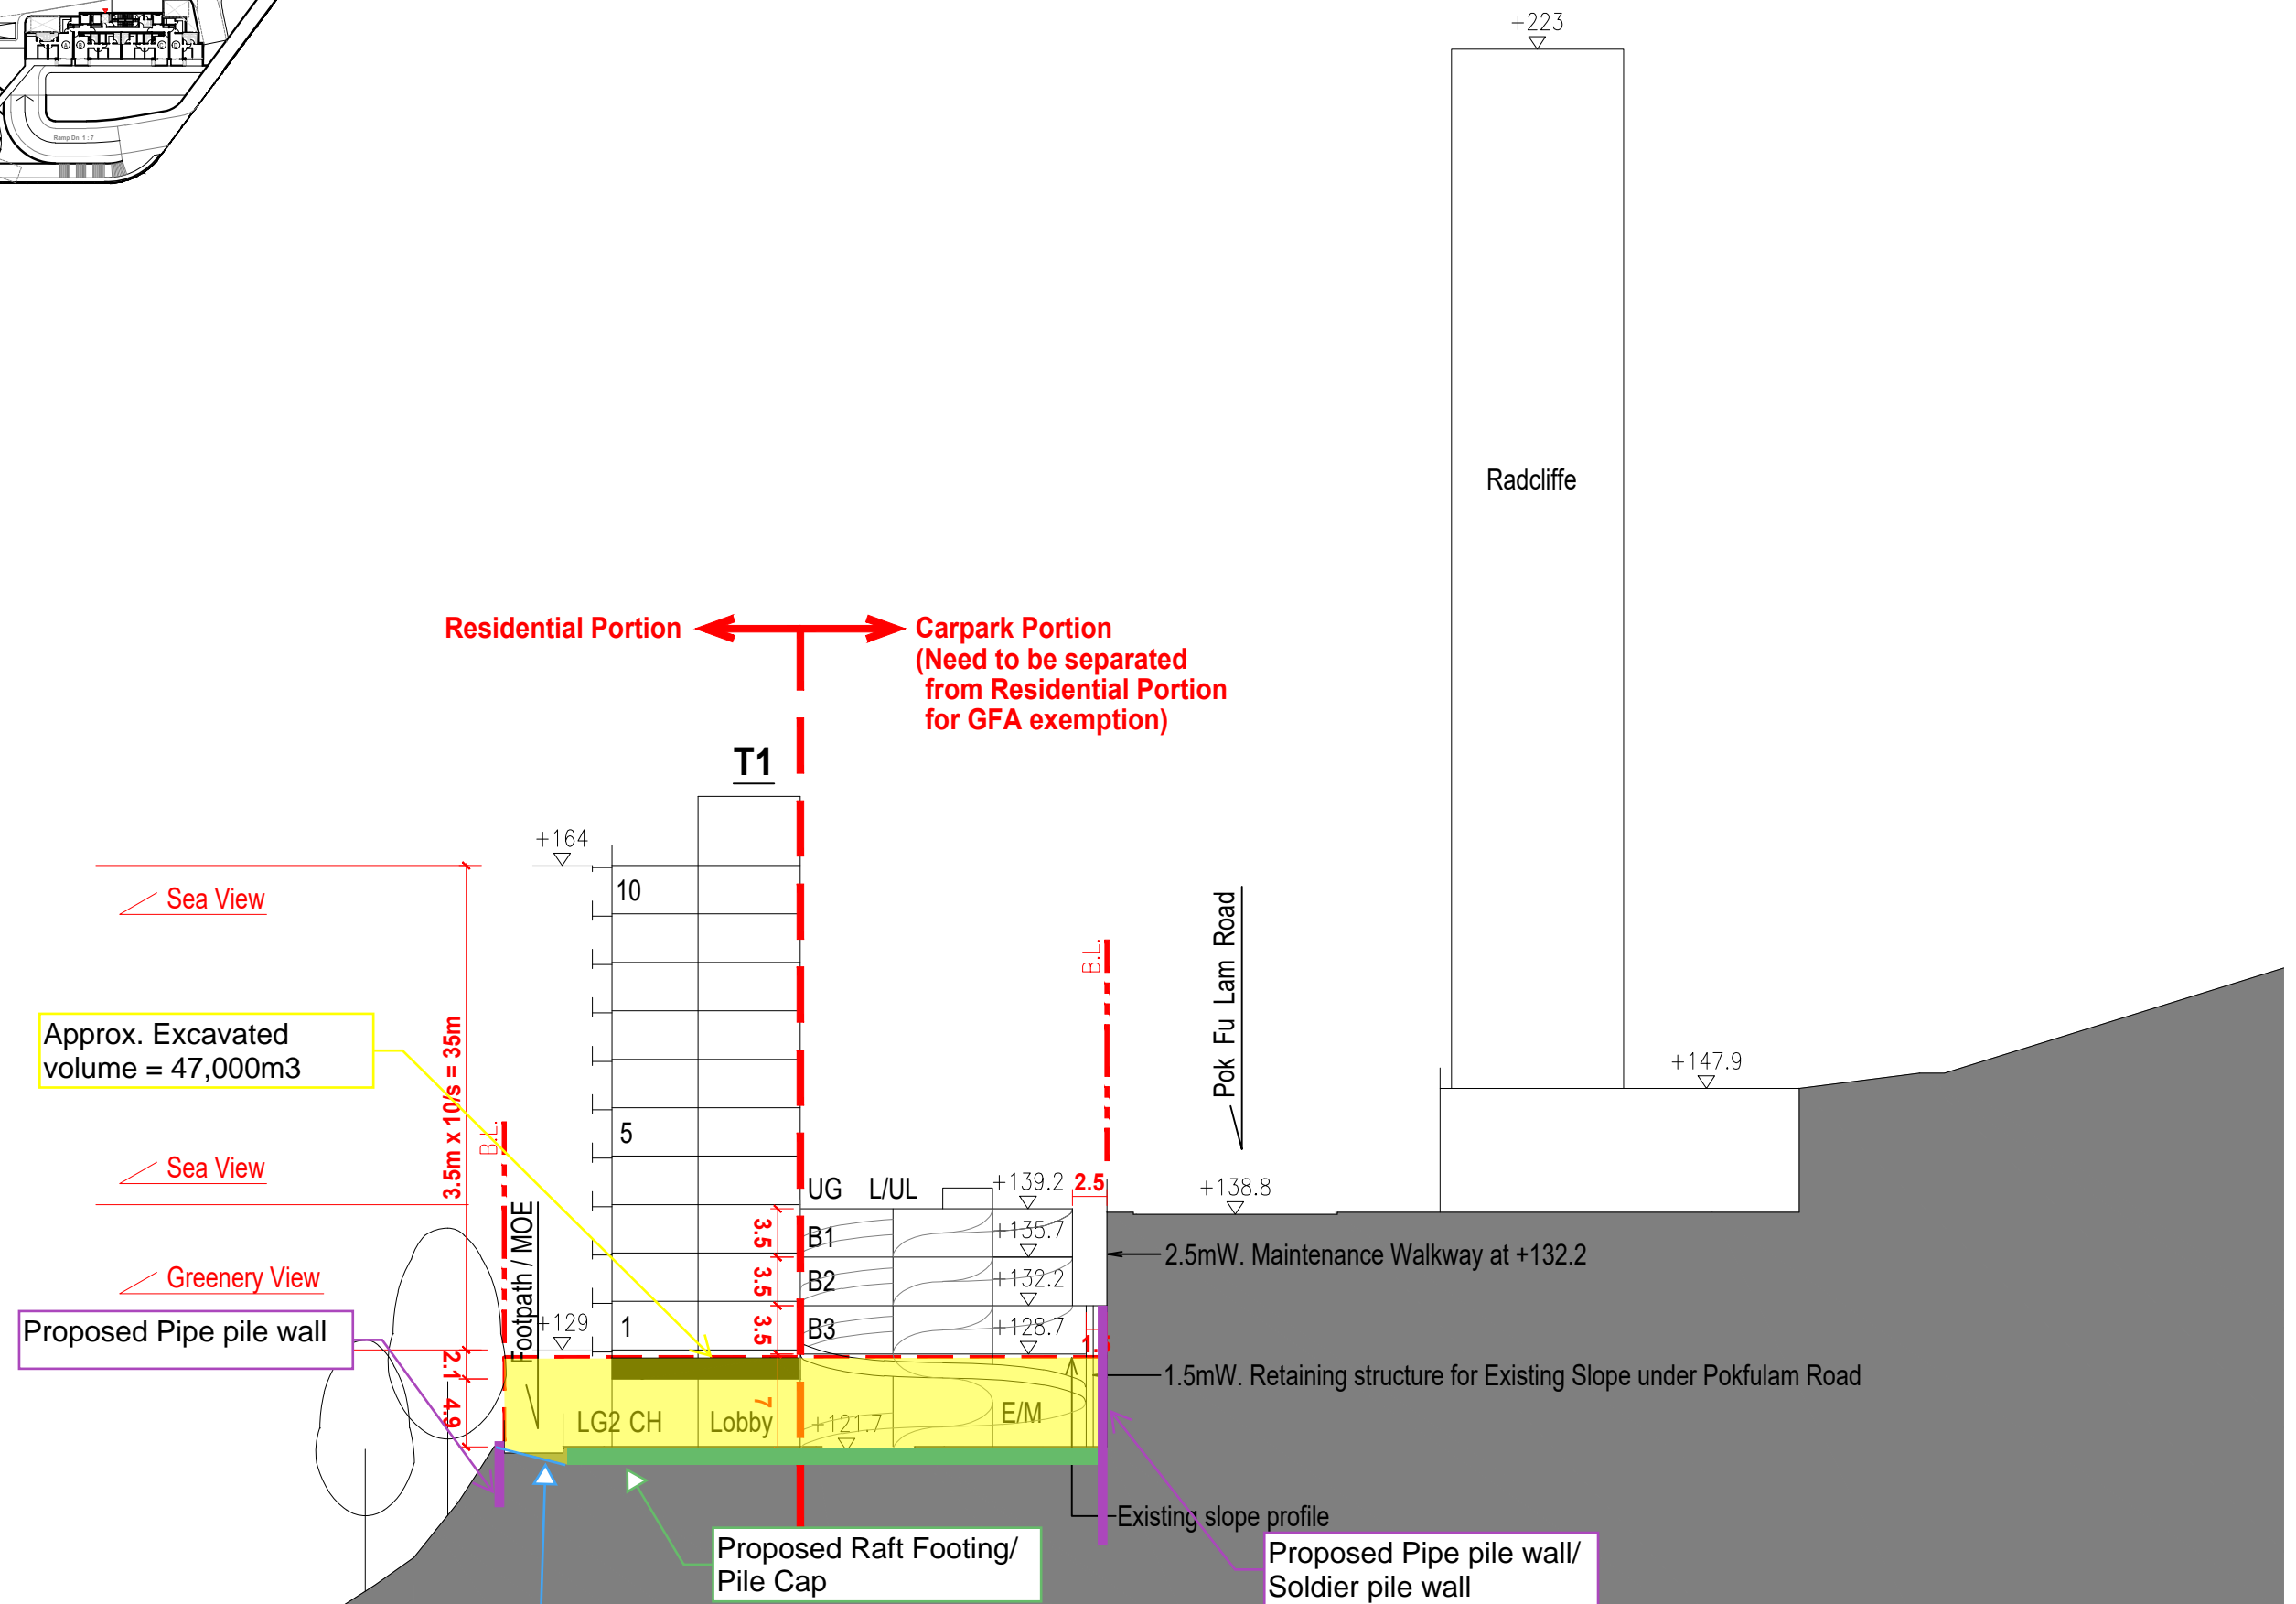
## **Appendix D**

Preliminary section showing  
ELS and Foundation works

- Appendix A Master Layout Plan
- Appendix B SIS Data Sheets, SIS Plans and SIMAR Reports
- Appendix C Existing ground investigation Record
- Appendix D Preliminary section showing ELS and Foundation works
