### **Geotechnical Planning Review Report**

**Geotechnical Planning Review Report**  
**for**  
**Application for Permission under Section 16 of The Town**  
**Planning Ordinance (Cap.131)**  
**For Minor Relaxation of Building Height Restriction from**  
**2 Storeys to 4 Storeys for Proposed 4-Storey**  
**Columbarium at Part of Inland Lot No. 7755 RP and**  
**Government Land sandwiched between Inland Lot No.**  
**7755 RP and Inland Lot No. 7713**  
**Cape Collinson Road, Chai Wan**

**March 2024**

***Philip So & Associates Consulting Civil & Geotechnical Engineers Ltd.***

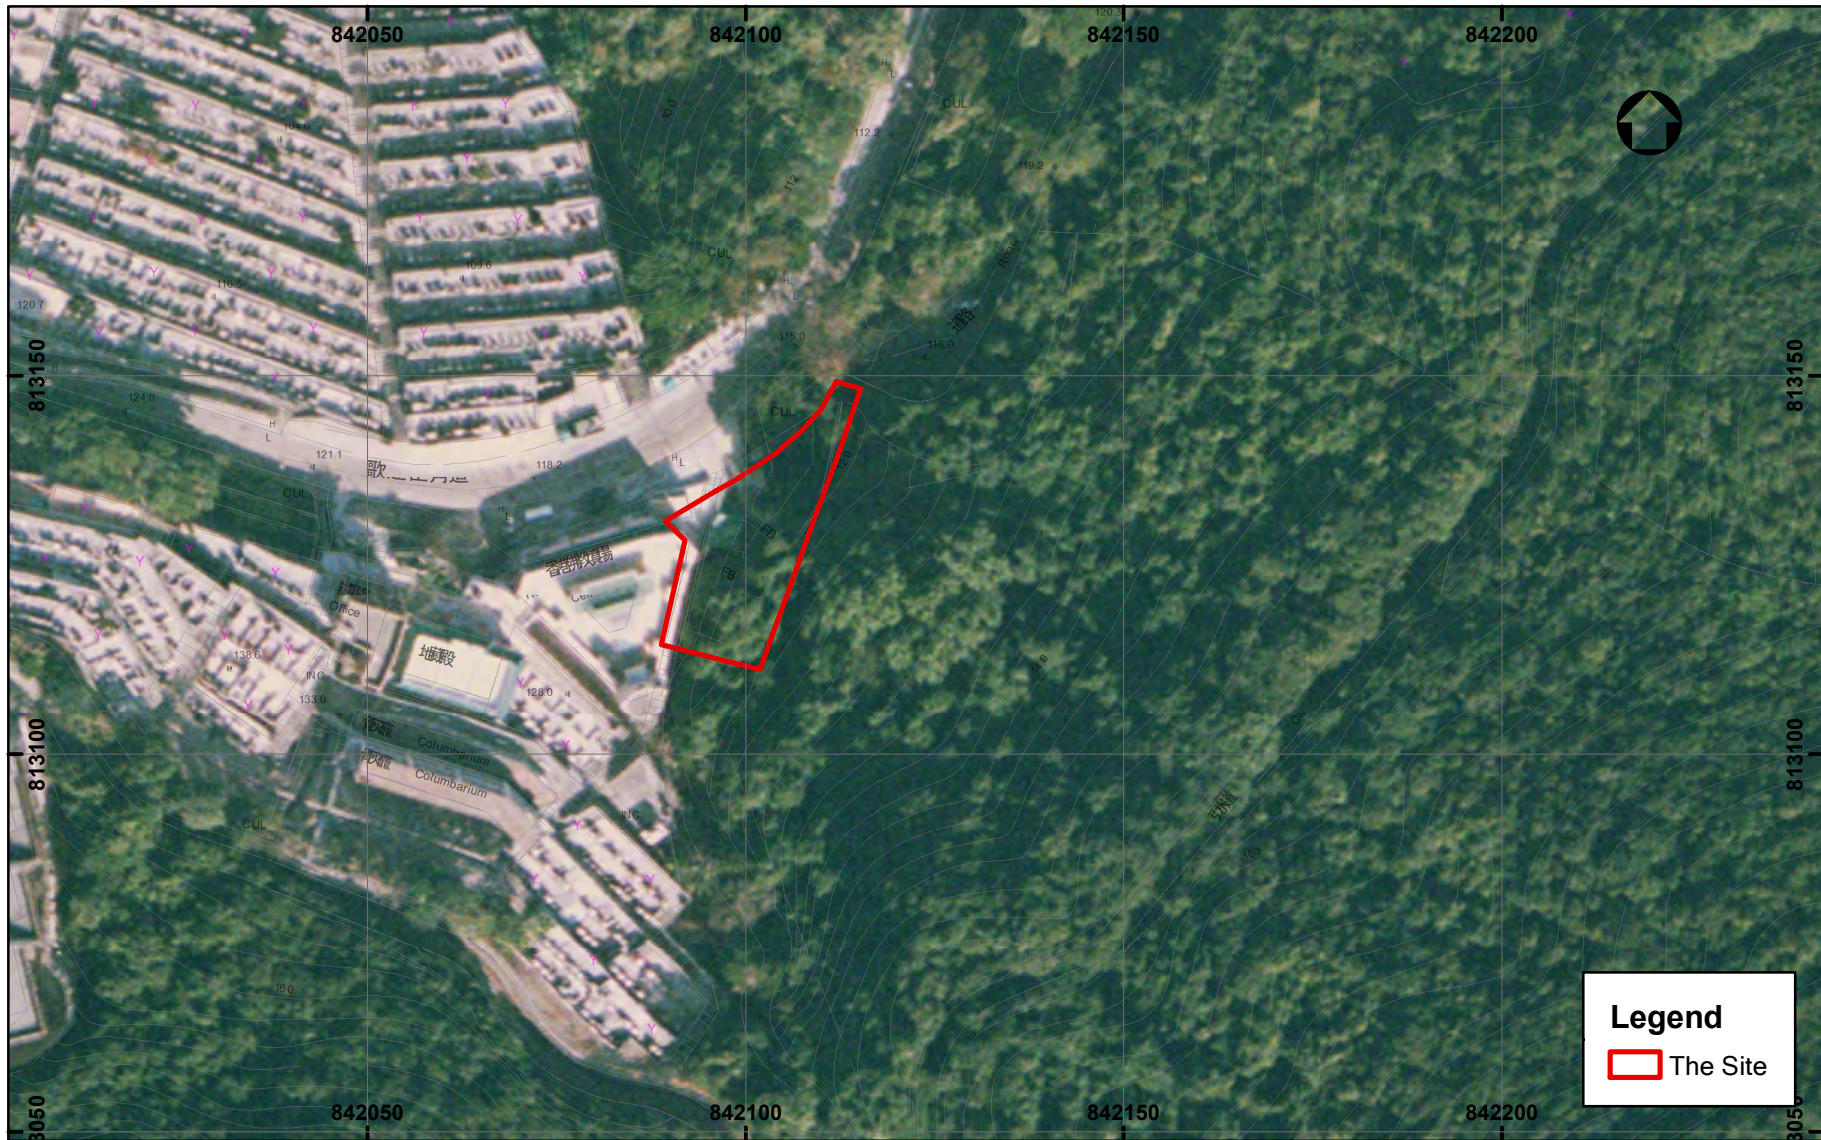
**FIGURE NO :**  
**FIGURE 2**

**TITLE:** Aerial View of the Proposed Development Site

The site is at a relatively flat ground at Cape Collinson Road, Chai Wan. Site photos taken in February 2024 are presented in Appendix A (see Photos A to D). General view and close up view of the Site is shown on Photo A, B, C and D. The location plan and the aerial view of the Site is presented in Figures 1 and 2, respectively.

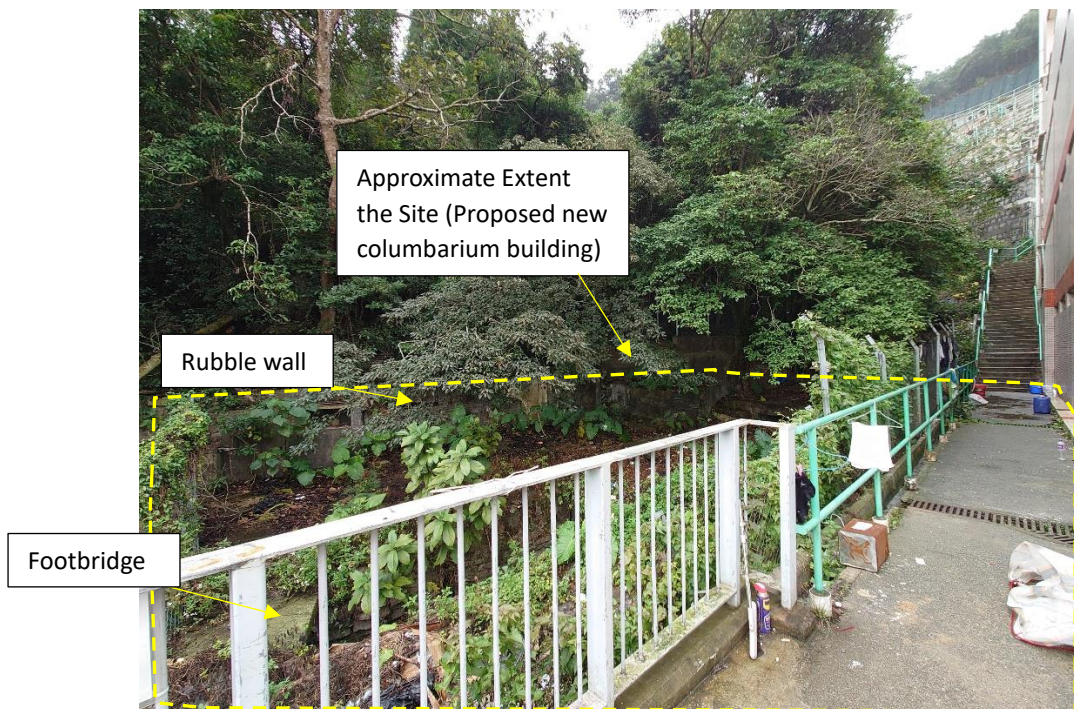
**Photo B – Close up view of the Southern Portion of the Site (looking south)**

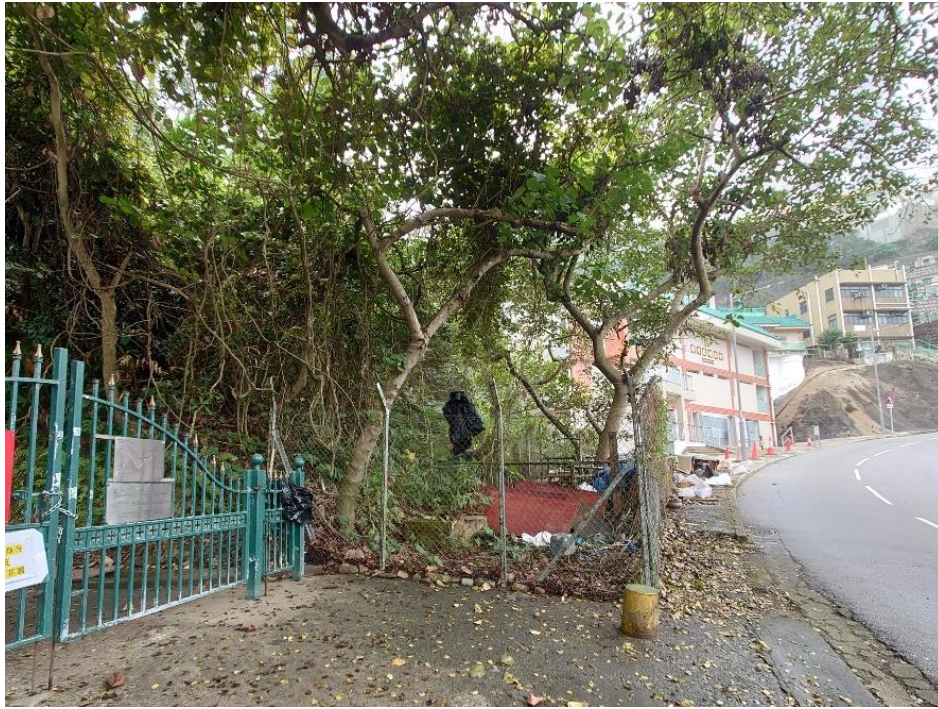
**Photo C – Close up view of the Northern Portion of the Site (looking west)**

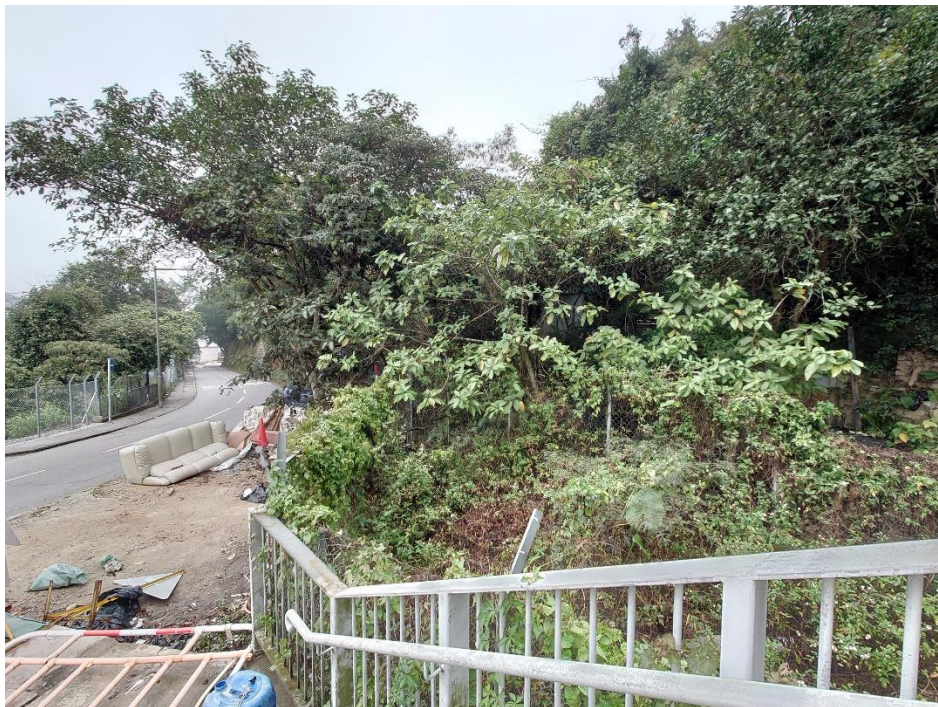
**Photo D – Close up view of the Northern Portion of the Site (looking east)**

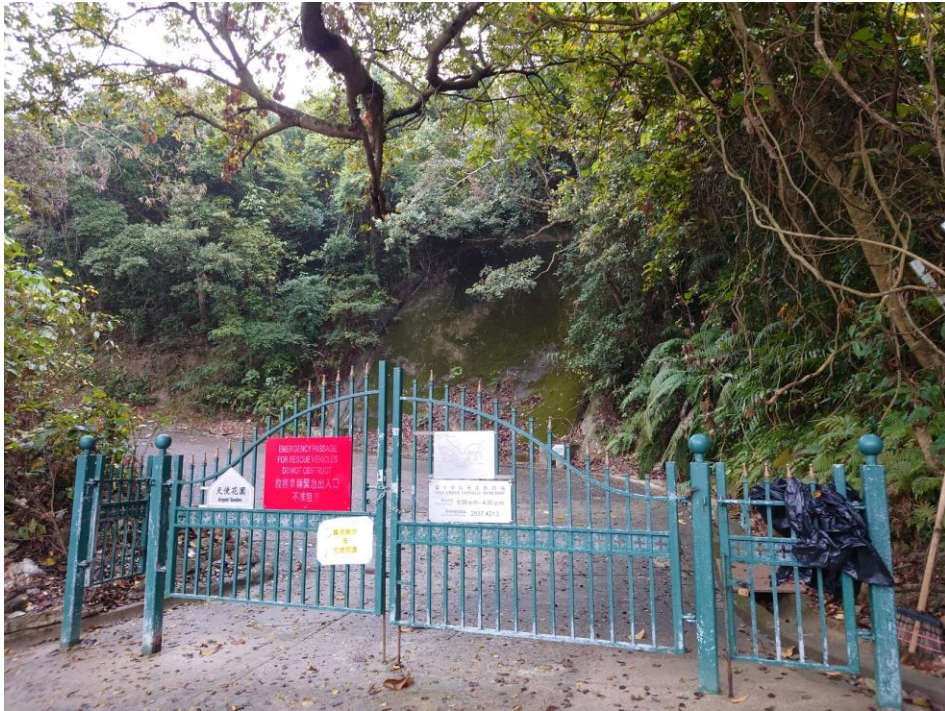
**Photo E – General View of the Feature No. 11SE-D/C69**

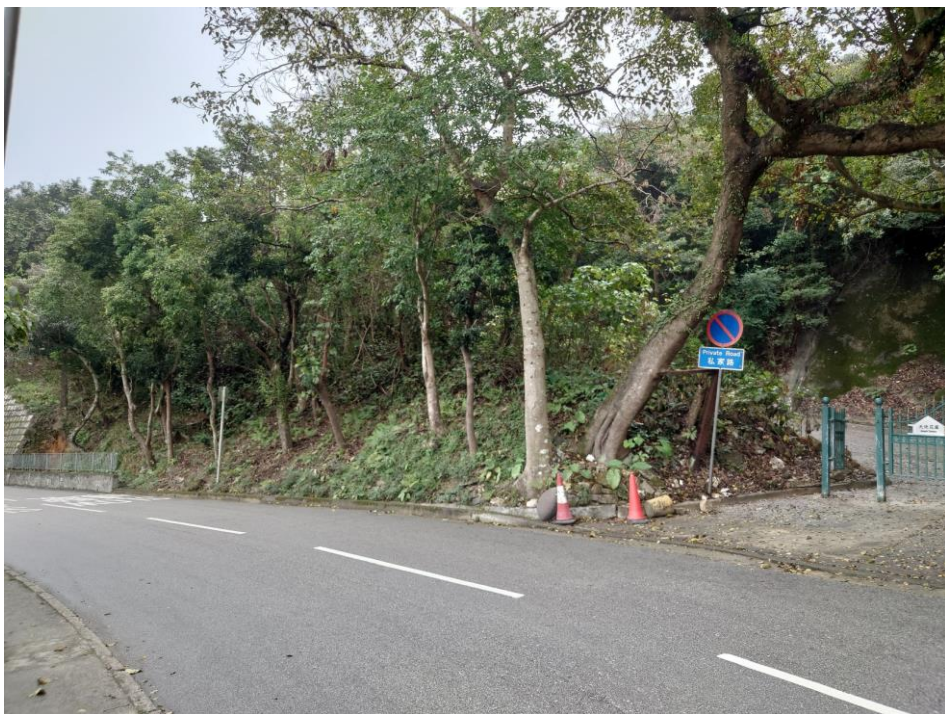
**Photo F – General View of the Feature No. 11SE-D/C123**

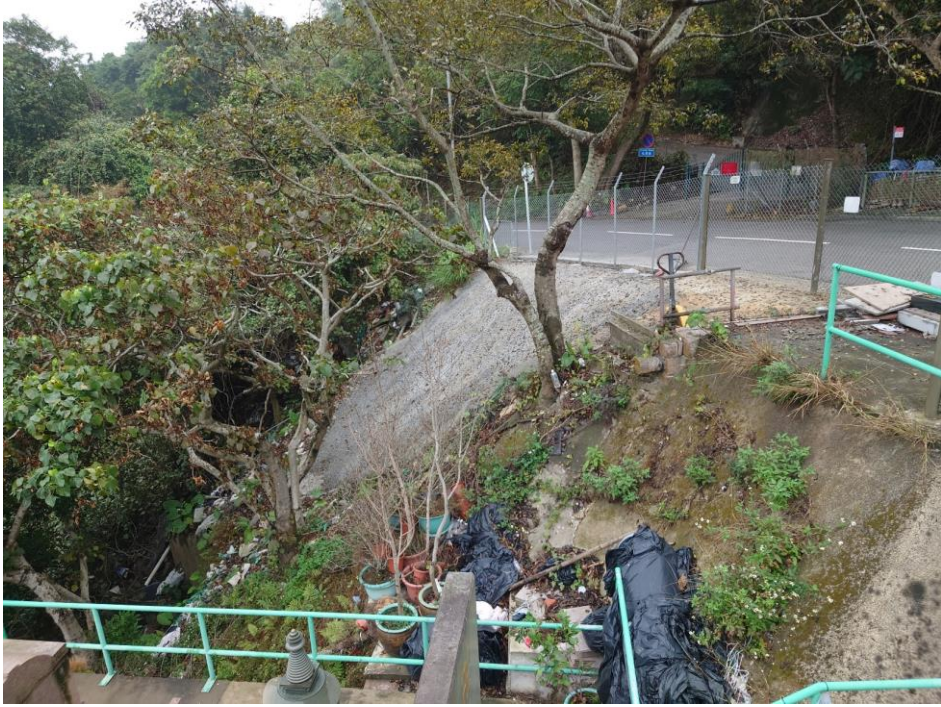
**Photo G – General View of the Feature No. 11SE-D/FR111**

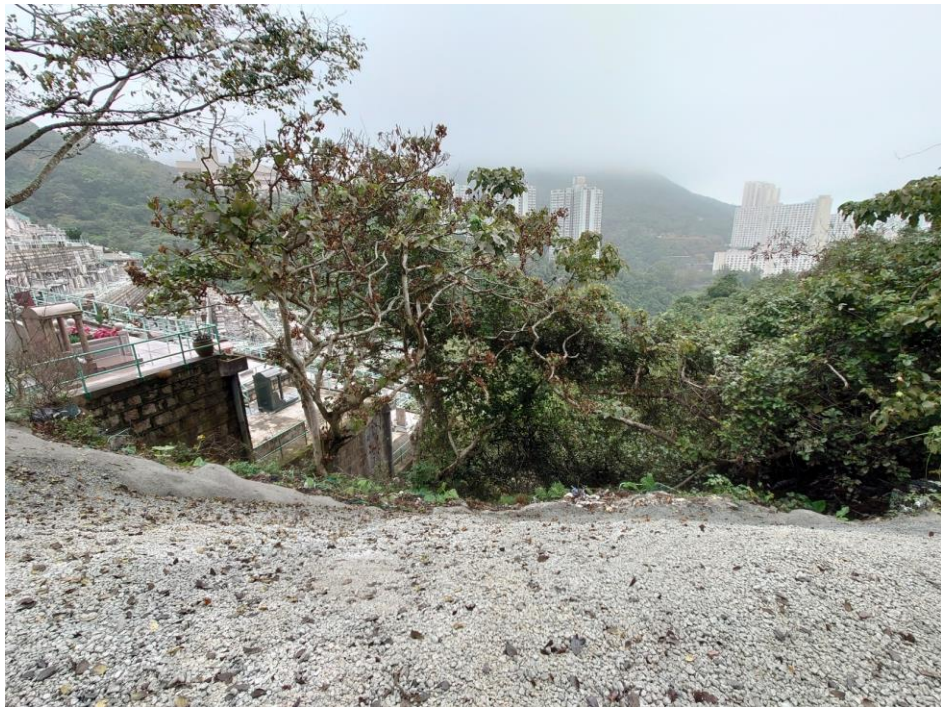
**Photo H – General View of the Feature No. 11SE-D/R64**

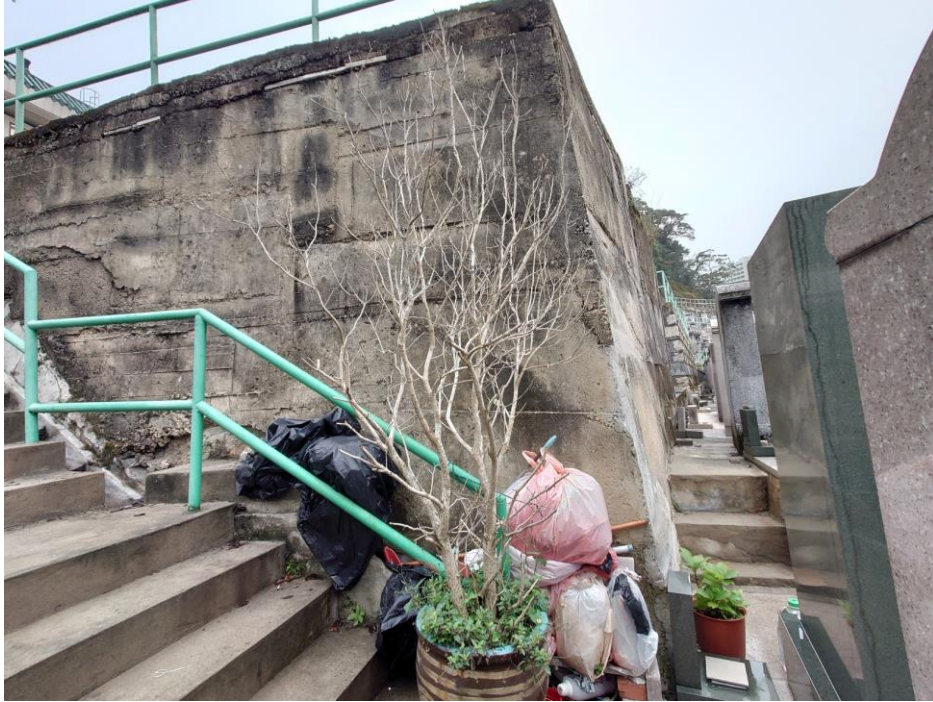
**Photo I – General View of the Feature No. 11SE-D/R65**

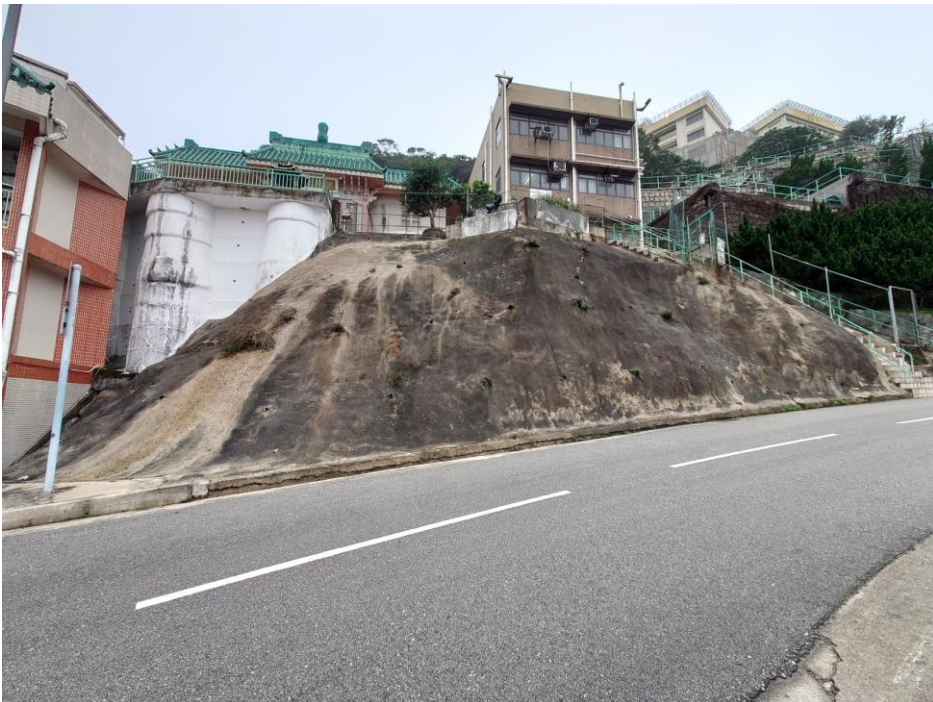
**Photo J – General View of the Feature No. 11SE-D/C345**

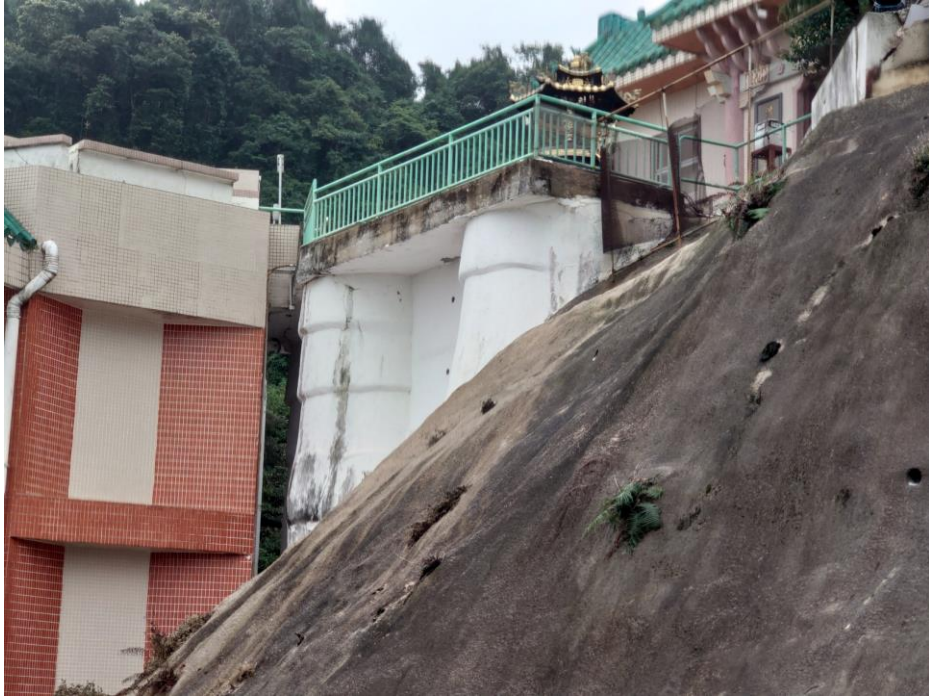
**Photo K – General View of the Feature No. 11SE-D/R63**

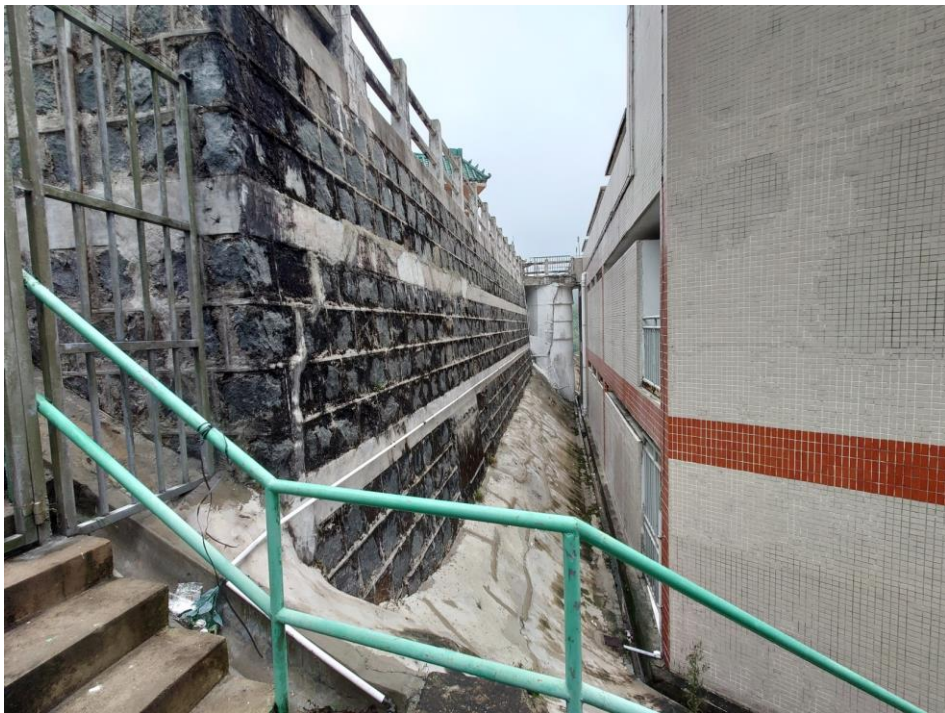
**Photo L – General View of the Feature No. 11SE-D/CR341**

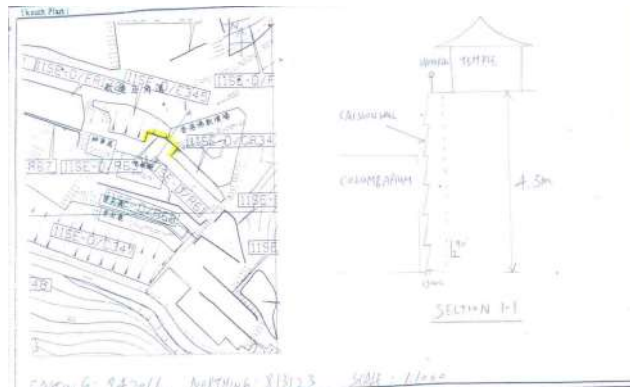
Section No: 1-1  
 Height(m): H1 : 5 , H2 : 5  
 Type of Toe Facility: Columbarium  
 Distance from Toe(m): 0  
 Type of Crest Facility: Temple  
 Distance from Crest(m): 0  
 Consequence Category: 1  
 Engineering Judgement: P  
 Section No: 2-2  
 Type of Toe Facility:  
 Distance from Toe(m):  
 Type of Crest Facility:  
 Distance from Crest(m):  
 Consequence Category: 1  
 Engineering Judgement: P  
 Sign of Seepage: Slope : N/A  
 Wall : No sign of seepage  
 Criterion A satisfied: N  
 Sign of Distress: Slope : N/A  
 Wall : N/A
