**GEOTECHNICAL PLANNING REVIEW REPORT  
FOR S16 APPLICATION**

**FOR PROPOSED ACCESS ROAD ADJOINING  
58 TAI HANG ROAD,  
HONG KONG**

**TSW Consulting Engineers Ltd.**

**February 2025**

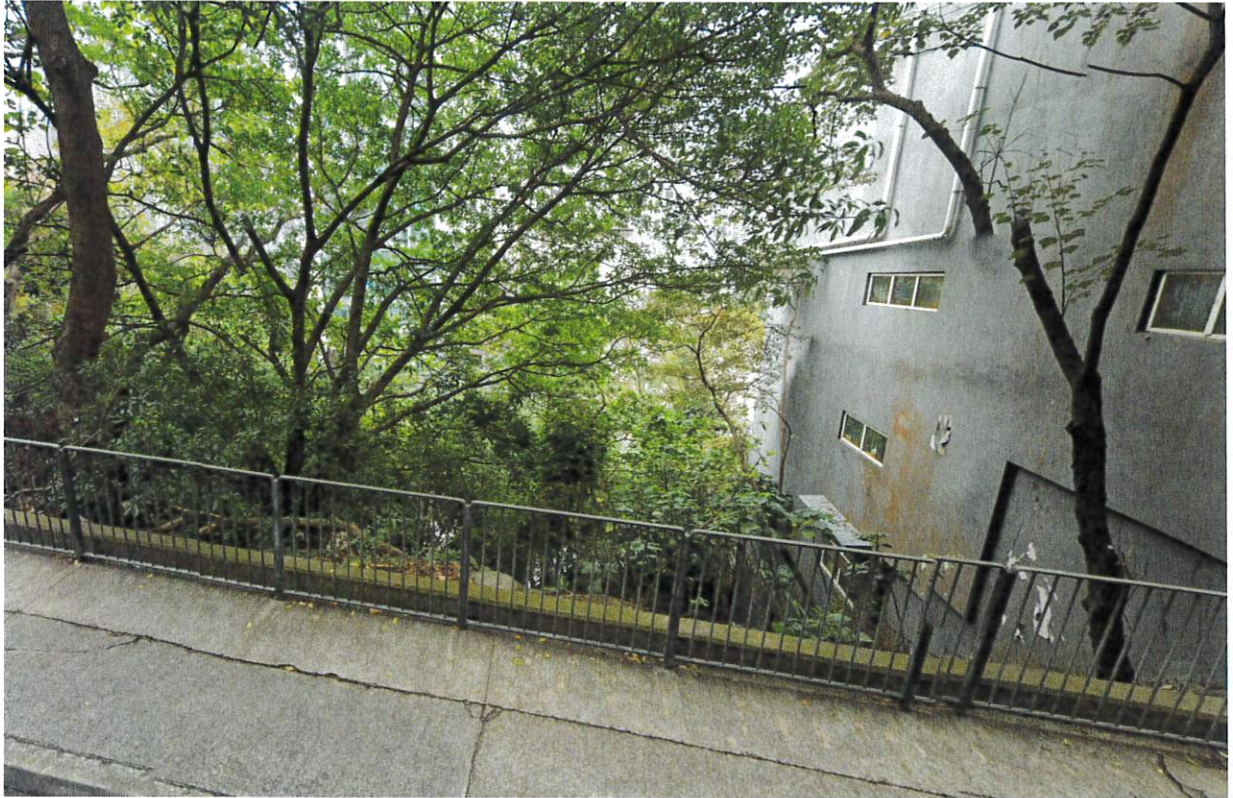
Front View of Area adjoining 60 Tai Hang Road
