## Annex I

## Approved Conservation Management Plan

MASONRY WALLS AND ASSOCIATED EARTHENWARE PIPES AT CAROLINE HILL, H.K  
CONSERVATION MANAGEMENT PLAN  
FOR PATCHWAY HOLDINGS (HK) LIMITED  
JULY 2022

# CAROLINE HILL, HK: CONSERVATION MANAGEMENT PLAN

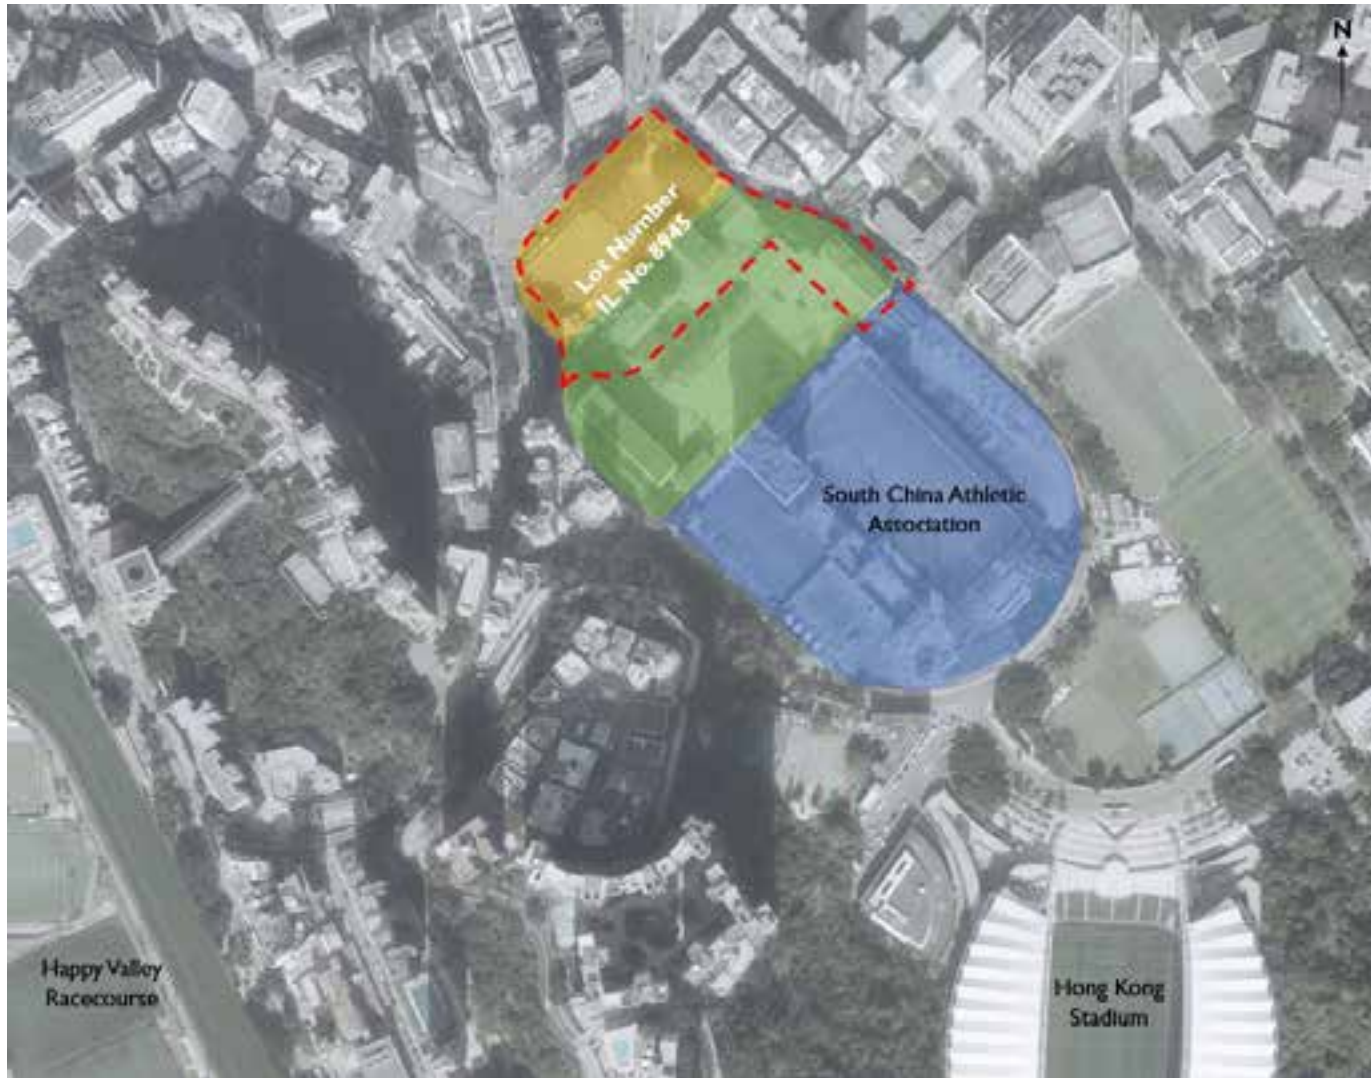
- Indicative Site Boundary
- Lower Platform
- Middle Platform
- Higher Platform

Fig. 2.1.2. Indicative site boundary of I.L. 8945 with existing Site context and indication of low, middle and high platform, 2019, E056756C  
 Source: Survey and Mapping Office, Lands Department, The Government of Hong Kong and Hong Kong Geodata Store, modified by Purcell.

The CMP study area (shown on Fig. 2.1.2) focuses on the graded historic building boundary, with considerations given to the immediate setting where this is necessary to inform the management of the Site.

By 1925, slopes of different levels were formed within the Site, which is largely in align with the existing site topology with three platforms (Fig. 2.1.2 and 3.2.2.8). The area at 50.00 A.O.D. (equal to approximately 15 mPD) was planned for the Navy's recreational use.<sup>72</sup> In relation to this, more retaining walls were needed to be built at the Queen's College Site. Tenders were received in April 1928. The works included the erection of a length of concrete backed walling in rubble facework together with any necessary piling to foundations and contingent drainage work.<sup>73</sup>

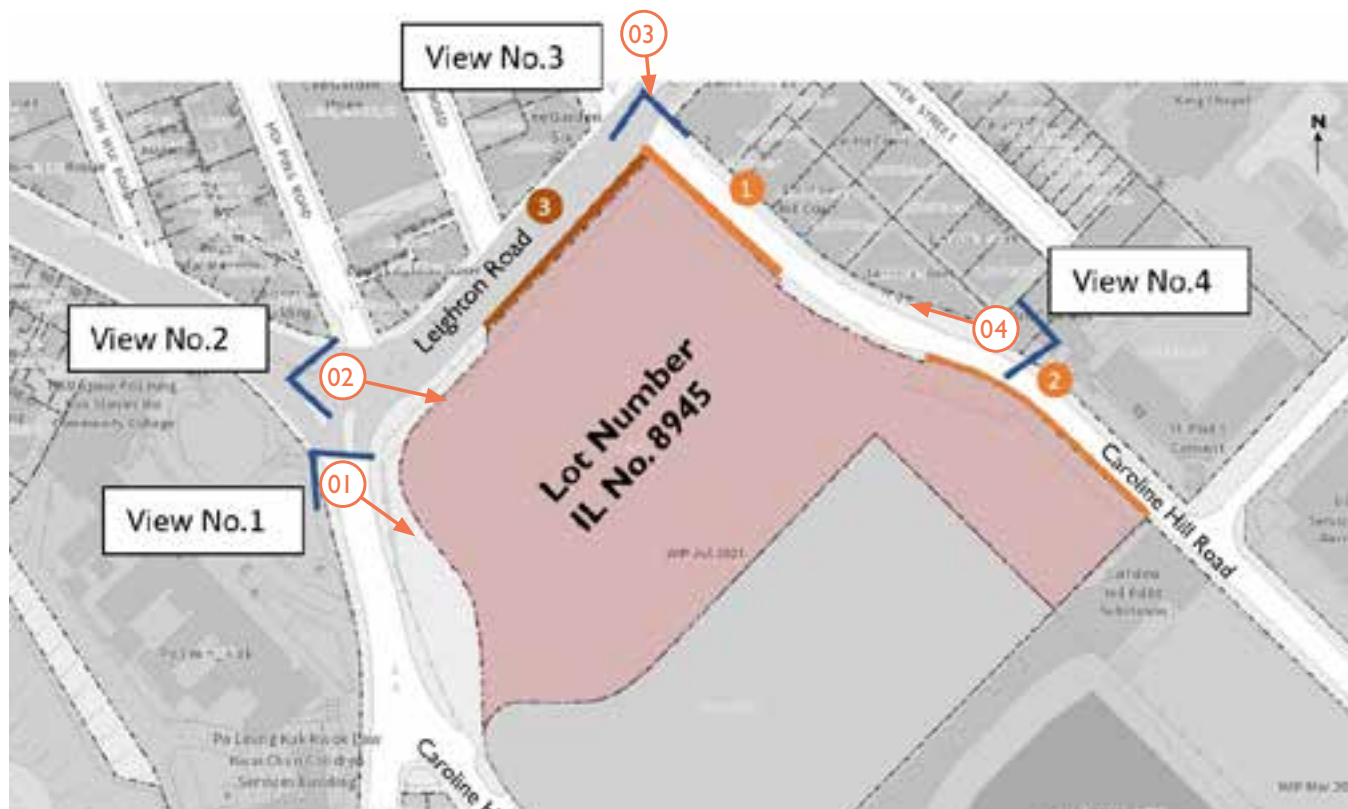
Fig. 2.2.1. Indicative Site boundary of I.L. 8945 with adjacent lot numbers. Source: Base map from Hong Kong Map Service 2.0, attributed by the Government and Hong Kong Geodata Store. Modified by Purcell.

<p>① View Point ➔ View Direction</p> <p><i>This plan is not to scale</i></p>	<p>① Grade 3 Masonry Wall (slope no.: IISW-B/FR 193) is approximately 52 m in length with one earthenware pipe</p> <p>② Grade 3 Masonry Wall (slope no.: IISW-B/FR 32) is approximately 76 m in length with one earthenware pipe and one replacement cast iron pipe</p> <p>③ Non-graded Masonry Wall (slope no.: IISW-B/FR 190) is approximately 38 m in length</p>
--	---

The east, north and west sides of the site have masonry retaining / boundary walls in place with three slope numbers assigned, IISW-B/FR 193, IISW-B/FR 32 and IISW-B/FR 190 (see Fig. 2.2.1).

The two masonry walls (IISW-B/FRI93 and IISW-B/FR32) and associated earthenware pipes were confirmed as Grade 3 Historic Buildings in December 2019 (N339) in recognition of the site's historical links with the Sookunpoo (now Causeway Bay) district. The extent of the masonry wall covered by this designation is shown on Fig. 2.2.1.

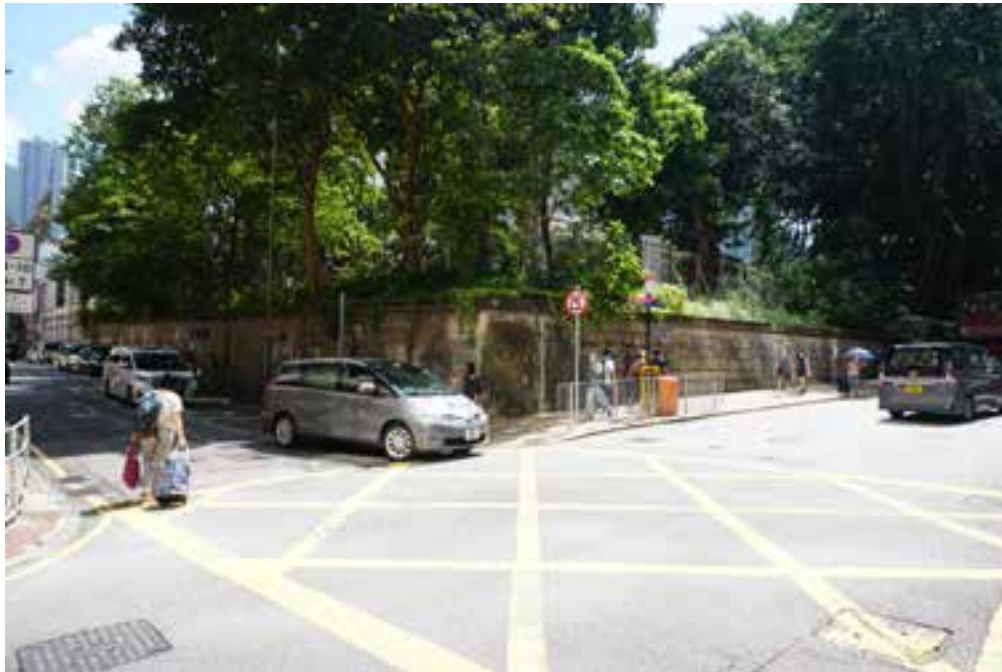
Fig. 2.2.4. View No.3: At the junction of Leighton Road, Yun Ping Road, Pennington Street and Caroline Hill Road looking towards the intersection between IISW-B/FR 193 and IISW-B/FR 190. Source: Purcell, 2021.

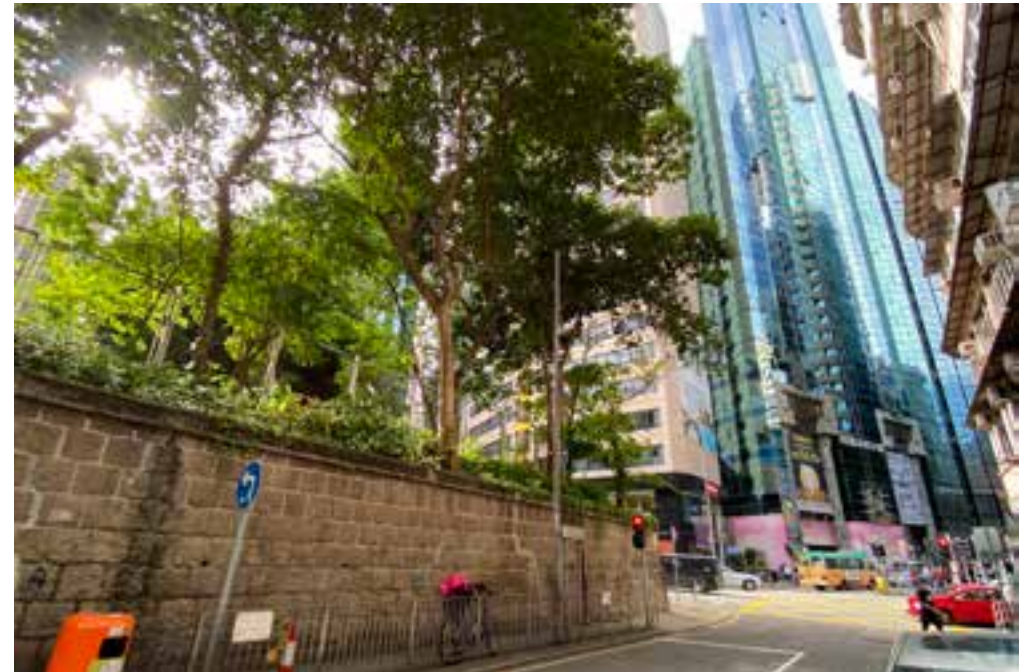
Fig. 2.2.5. View No.4: East side of the Site, looking north, featuring wall IISW-B/FR 193. Source: Purcell, 2021.

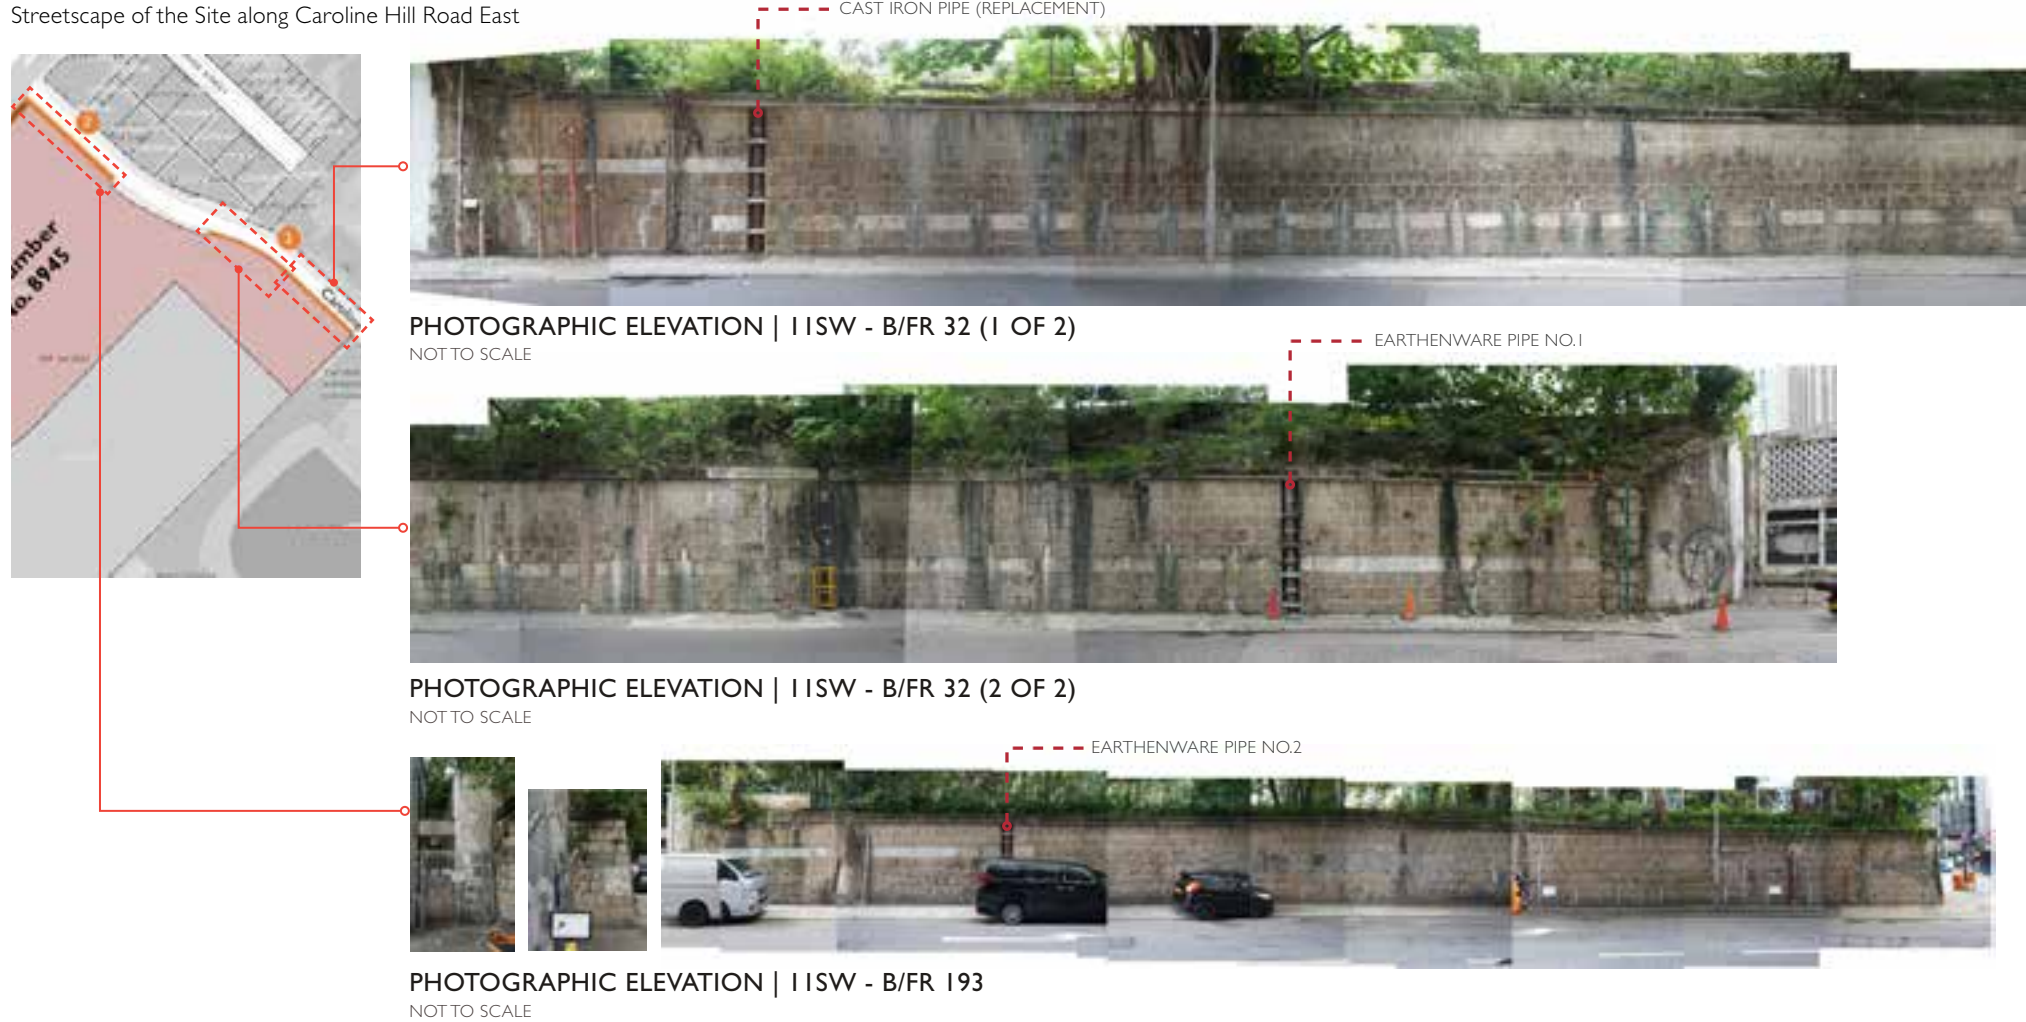
Fig. 2.2.8 Streetscape of I ISW - B/FR 32 and I ISW - B/FR 193 from Caroline Hill Road. (Source: Purcell, 2021)

The photographic elevations of the existing masonry retaining/ boundary walls are shown on the next three pages.

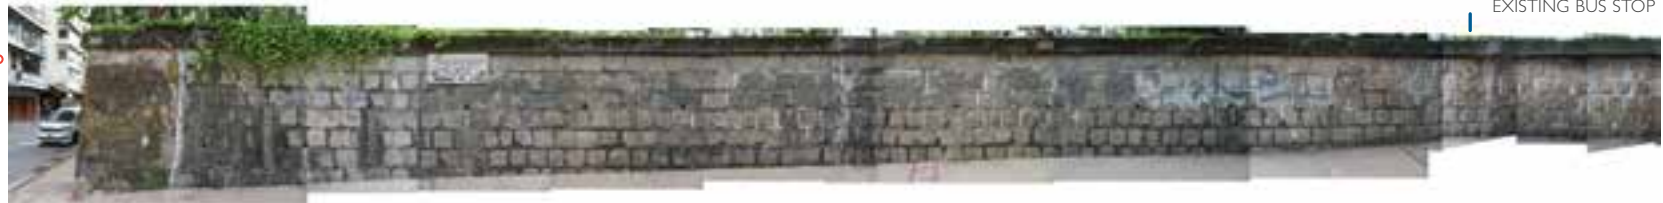
PHOTOGRAPHIC ELEVATION | I ISW - B/FR 190 (1 OF 2)  
NOT TO SCALE

Fig. 2.2.9 Streetscape of I ISW - B/FR 190 from Leighton Road. (Source: Purcell, 2021)

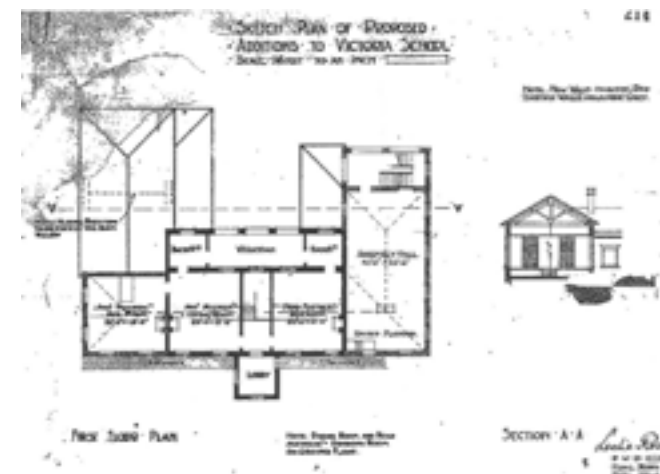
Fig. 3.2.2.2. Sketch plans of the Victoria British School. (Source: Hong Kong Public Record Office. CO-129-414p214-221 Sketch plans for - Proposed additions to Victoria School.)

Earliest record plans of the school date to 1914 (Fig. 3.2.2.2). The two storey school building had brick facades, but it is unclear whether these were red or grey bricks. The dining room and head mistress drawing room were on the ground floor while an assembly hall, the head mistress’ and assistant headmistress’ bedroom were on the first floor.<sup>55</sup>

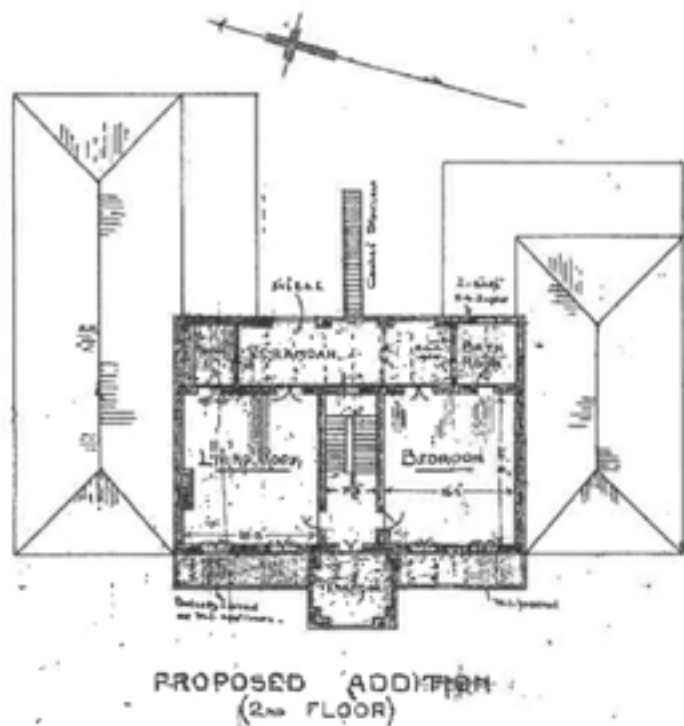
Fig. 3.2.2.3. Plans of Victoria British School. (Source: Hong Kong Public Record Office. CO-129-341p579-586 Plans of Victoria British School.)

Proposals (Fig. 3.2.2.3) were made later in 1918 to construct an additional storey to accommodate a living, bed and bathroom.<sup>56</sup> The proposed 1918 alteration and addition (A&A) plans show the school occupying the same site as the Sookunpoo School but the orientation and layout of the building was different. The A&A plans however correspond to the 1924 aerial photos which illustrate the school had been designed with a C-shape plan, facing northeast.

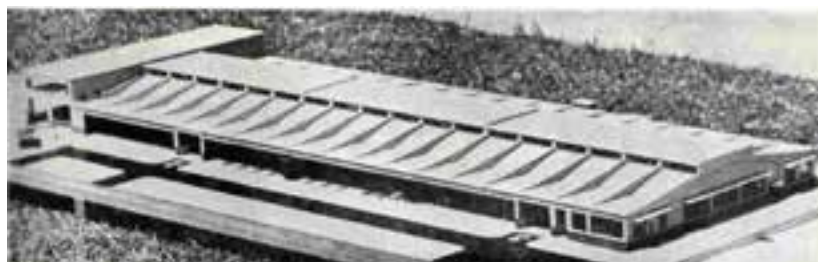
Fig. 3.2.3.2 Work in progress and the physical models of the workshops. (Source: Hong Kong and Far East Builder 1955 vol. 11, no. 2, p. 35)

The first stage of the construction was completed by the end of September 1955. One of the most significant elements of the design was the expressed reinforced concrete framework that enabled a large clear floor space for the workshops (Fig. 3.2.3.2, 3.2.3.3 and 3.2.3.4).<sup>87</sup> They were designed in the Architectural Office of the Public Works Department in close consultation with the engineers of the Electrical and Mechanical Office.

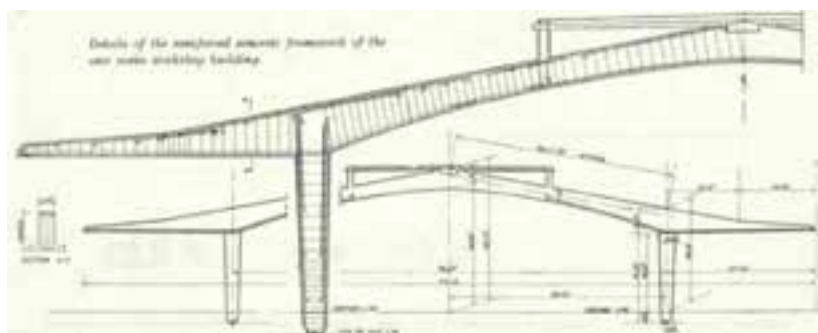
Fig. 3.2.3.3 Details of the reinforced concrete framework of the new main workshop building. (Source: Hong Kong and Far East Builder 1955, vol. 11, no. 2, p. 35)

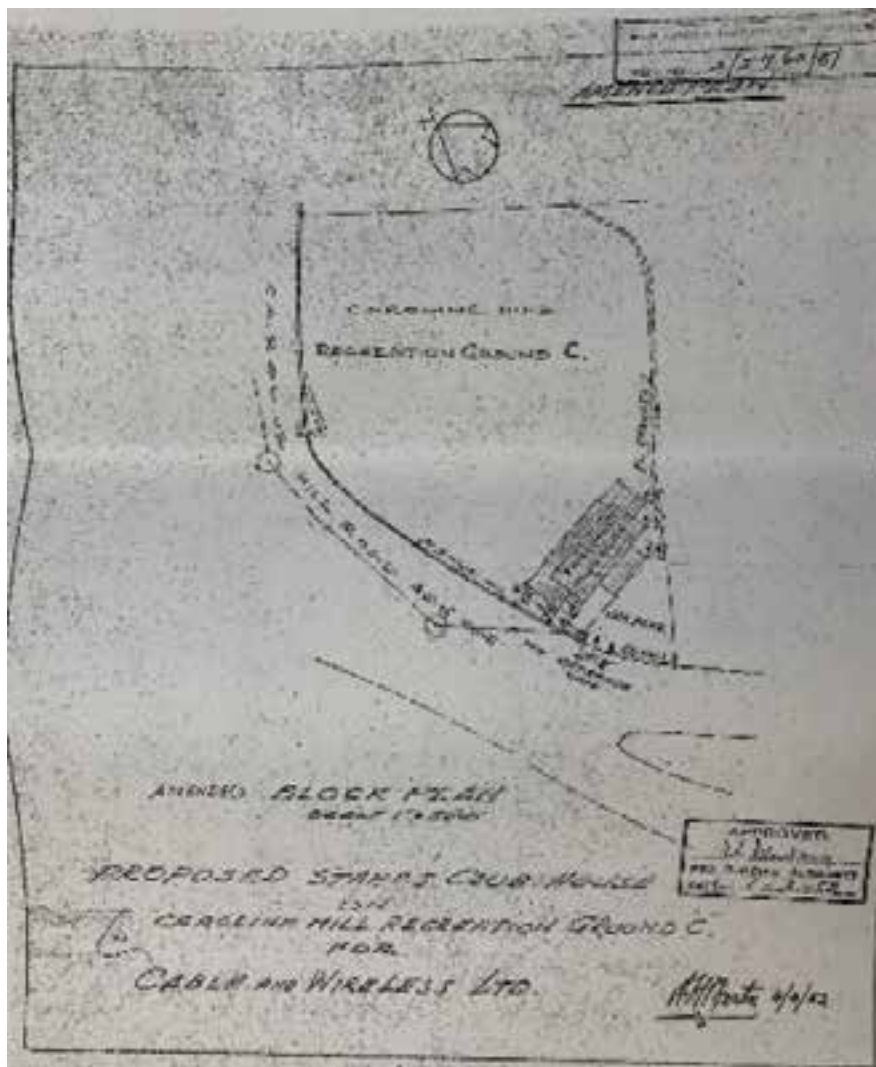
Fig. 3.2.3.5 Amended Block Plan for the proposed Cable and Wireless Clubhouse on Caroline Hill Recreation Ground C in 1952. (Source: Record Drawings DLO File\_004)

The Cable and Wireless Club (“CWC”) was opened in July 1952 by Mrs. H.C. Baker<sup>88</sup>. The clubhouse was located on the west of the Electrical and Mechanical Office, opposite to Po Leung Kuk. According to the approved record drawings by the Building Authority in 1952, the building was single storey with a hall, library, verandah, cloak, lavatories, Ino. boys’ room, store, bar and kitchen. The site was named as Caroline Hill Recreation Ground “C”, and was later renamed as I.L. 8597 (Fig. 3.2.3.5).<sup>89</sup>

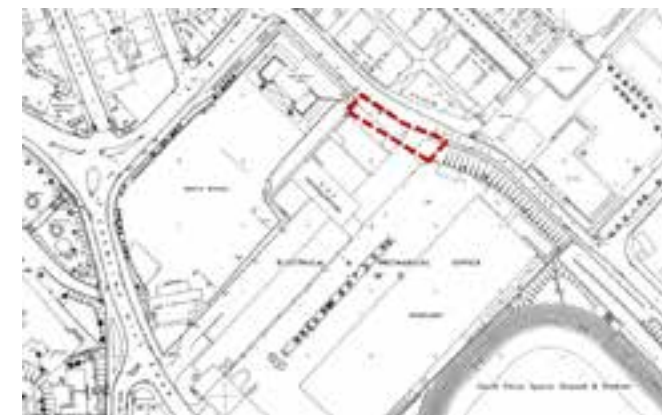
Fig. 3.2.3.9 Part of the masonry walls are demolished for the construction of EMSD offices. (Source: Survey and Mapping Office, Lands Department, The Government of Hong Kong and Hong Kong Geodata Store, 196-SE-16, 1968)

There were major changes to the Site in mid 1960s. To facilitate constructing the second stage of the Electrical and Mechanical Offices, part of the retaining walls to the southeast of the PORC (see Fig. 3.2.3.9 and 3.2.3.10, the missing section between the currently graded walls) were demolished during 1960 to 1967. The old offices were demolished, and new electrical and mechanical office accommodation expanded across Caroline Hill. A new opening was made to the south the Cable and Wireless Club for vehicles' entry.

The first Civil Aid Services Headquarters was also built as part of the second stage of the Electrical and Mechanical Offices in 1966.<sup>94</sup> This can be observed from the survey plan dated 1968 (Fig. 3.2.3.9) and aerial photo dated 1967 (Fig. 3.2.3.10). The 7-storey building was built in a Modernist style, with panels on the northeast façade being painted in light blue. The Apprentice Training Centre was also set up in EMSD offices later in 1975<sup>95</sup>.

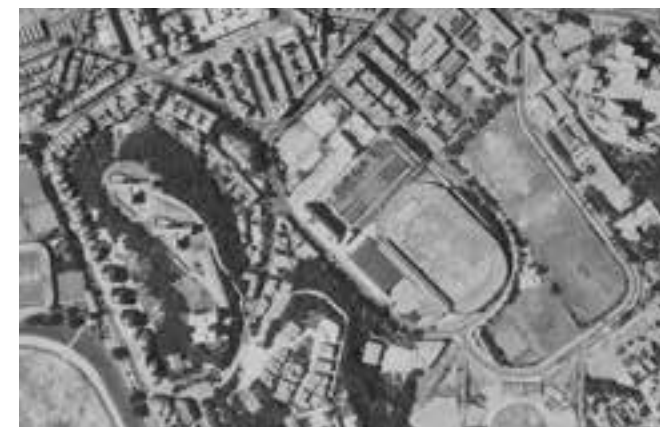
Fig. 3.2.3.10 Aerial photo showing the completed second stage of the Electrical and Mechanical Offices in 1967. (Source: Survey and Mapping Office, Lands Department, The Government of Hong Kong and Hong Kong Geodata Store, 1967)

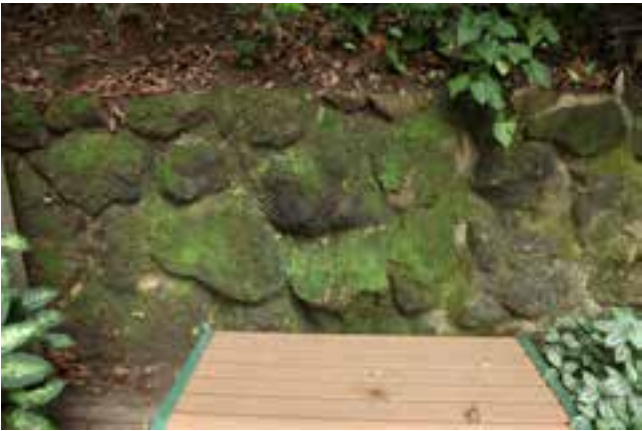
<p>IISW-B/CR 406</p> <p>Hong Kong Zoological and Botanical Gardens</p>

TYPE NO.	DESCRIPTION	REFERENCE PHOTO	EXAMPLE
I	Dry Packed Random Rubble Wall <sup>102</sup>

Fig. 3.3.1.1 Photo of retaining wall IISW-B/CR 406 in Hong Kong Zoological and Botanical Gardens

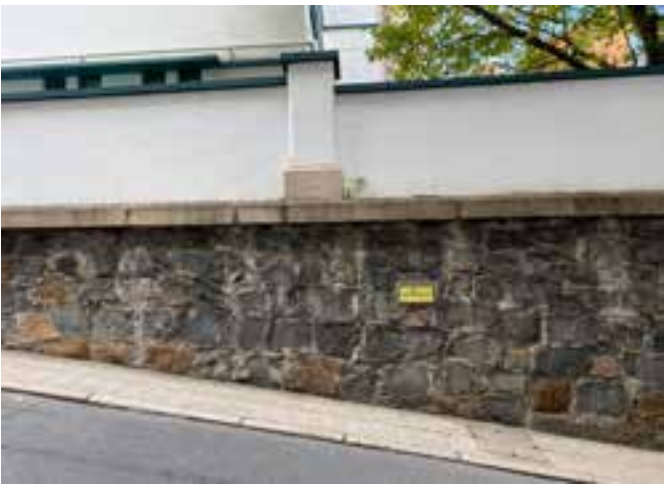
TYPE NO.	DESCRIPTION	REFERENCE PHOTO	EXAMPLE
2	Pointed Random Rubble Wall

Fig. 3.3.1.2 Photo of retaining wall IISW-A/R 962  
Former Hollywood Road Police Quarters

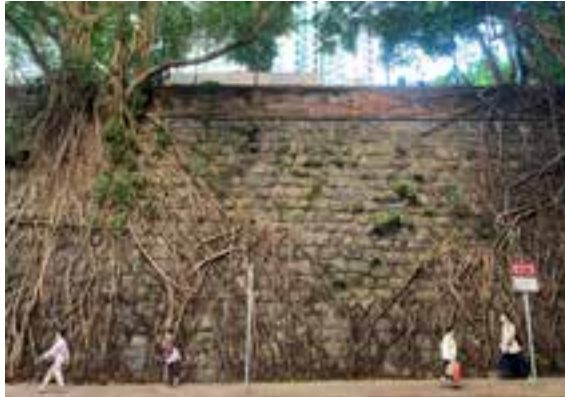
TYPE NO.	DESCRIPTION	REFERENCE PHOTO	EXAMPLE
5	Pointed Squared Rubble Wall

<p data-bbox="804 805 1366 829"><i>Fig. 3.3.1.3 Photo of retaining wall IISW-A/R 838 Forbes Street, Kennedy Town</i></p>	<p data-bbox="1500 383 1792 438">IISW-A/R838 Forbes Street, Kennedy Town</p>
6	Pointed Squared Rubble Wall with Horizontal Beams

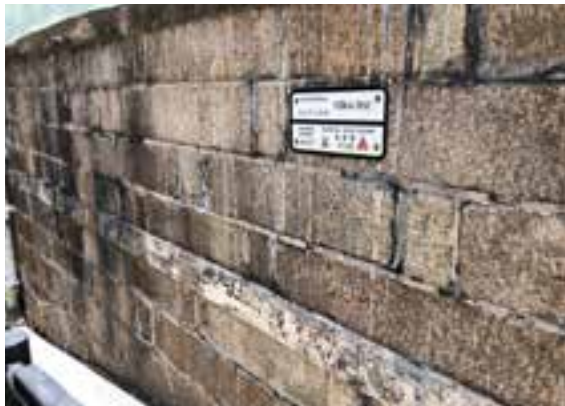
<p data-bbox="804 1300 1366 1324"><i>Fig. 3.3.1.4 Photo of retaining wall IISW-A/R141</i></p>	<p data-bbox="1500 861 2060 917">IISW-A/R141 Aberdeen Street, Behind Ming Hing House, Sheung Wan</p>

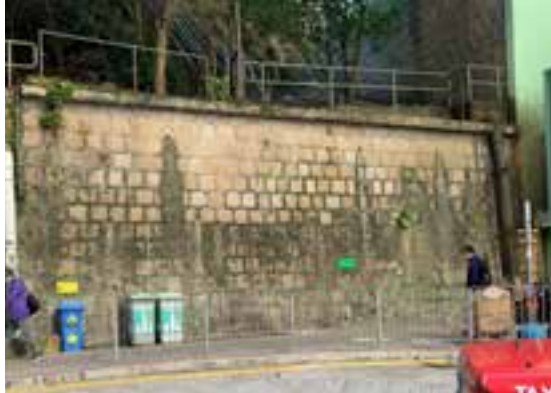
TYPE NO.	DESCRIPTION	REFERENCE PHOTO	EXAMPLE
7	Dressed Block Wall

<p data-bbox="804 804 1384 826"><i>Fig. 3.3.1.5 Photo of retaining wall IISW-A/CR 566 Forbes Street, Kennedy Town</i></p>	<p data-bbox="1503 384 1794 443">IISW-A/CR566 Forbes Street, Kennedy Town</p>
8	Dressed Block Wall with Horizontal Beams

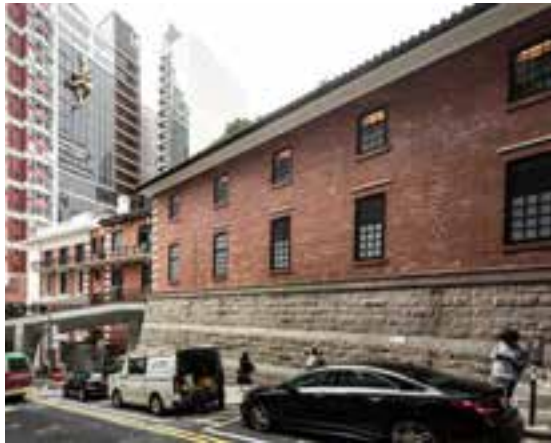
<p data-bbox="804 1318 1151 1362"><i>Fig. 3.3.1.6 Photo of retaining wall IISW-B/R 55 10 Hollywood Road, Central Police Station</i></p>	<p data-bbox="1503 863 1921 922">IISW-B/R 55 10 Hollywood Road, Central Police Station</p>

When considering the definitions and due to the walls various heights, the masonry walls at Caroline Hill would be categorized under “Dressed Block Wall with Horizontal Beams” and “Dressed Block Wall”. The extents of each type of masonry walls are indicated in Fig. 3.3.1.13. There are two types of coping details found on the existing masonry walls. One is with vermiculated rustication in framed panels (Fig. 3.3.1.11) and the other is plainly rendered (Fig. 3.3.1.12). The extents of each type of coping design are indicated in Fig. 3.3.1.14. Both coping designs project outwards with the incorporation of drip details. The top surface of the coping falls inward to a drainage channel.

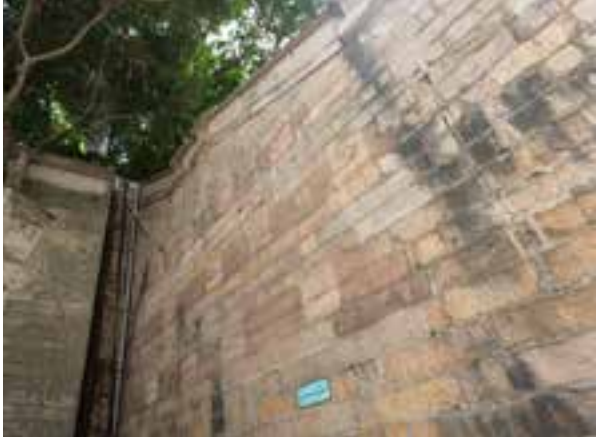
<p data-bbox="801 853 1153 893"><i>Fig. 3.3.1.7 Photo of retaining wall IISW-B/R 80 Battery Path</i></p>	IISW-B/R 80 Battery Path
10	Tied Face Wall with Horizontal Beams

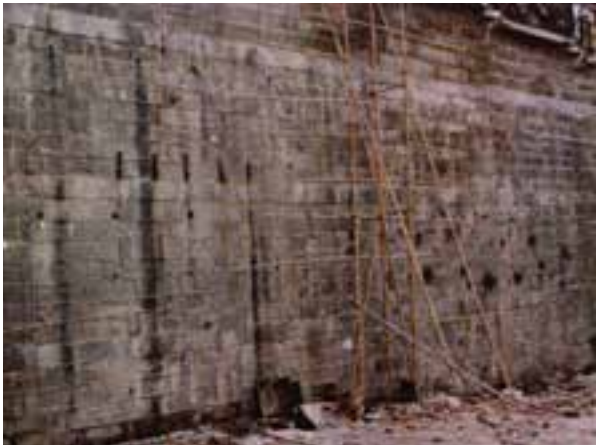
<p data-bbox="801 1396 1198 1428"><i>Fig. 3.3.1.8 Photo of former retaining wall IISW-A/R45</i></p>	Former IISW-A/R45, now demolished

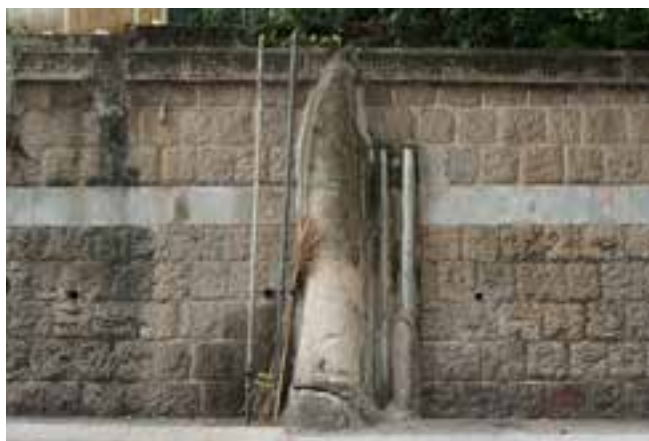
Fig. 3.3.1.11 Existing coping with vermiculated rustication, 2021. (Source: Purcell, 2021)

Although archival records are limited, based on site inspection, there is a high degree of intactness in the current coping, especially the one with vermiculated rustication set within a framed panel. Whilst changes in the coping design can be observed through historic photographs, it is not known why or exactly when the current detail was constructed. Based on the existing available information, it can only be suspected that the coping was added in the late 1940s as a response to the upgrade of Building Ordinance in 1935.

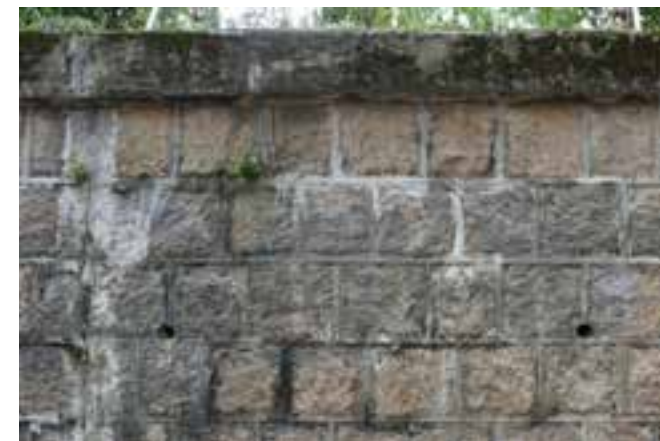
Fig. 3.3.1.12 Existing coping with plain rendered finish, 2021. (Source: Purcell, 2021)

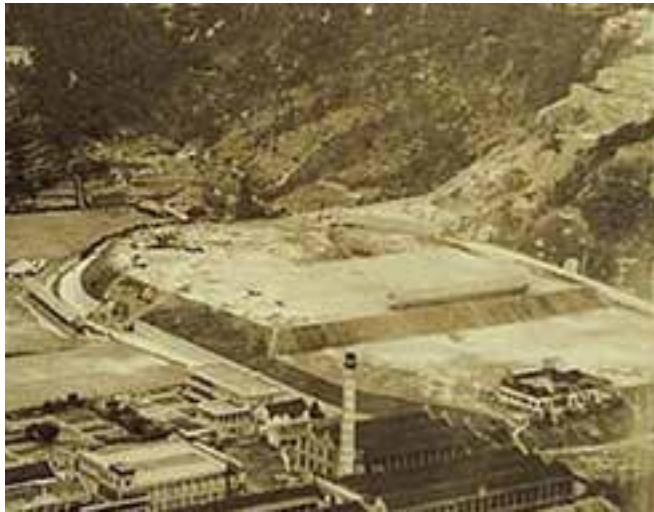
Fig. 3.3.1.15. Aerial photo dated late 1920s or early 1930s showing the largely completed site formation works at Caroline Hill. (Source: H Wong, digitalized by flickr, <https://www.flickr.com/photos/35328107@N08/4257151205>)

The masonry walls were first shown in an aerial photo dated late 1920s or 1930s (Fig 3.3.1.15) when the site formation of Caroline Hill had largely been completed. In a later photo c.1945 (Fig 3.3.1.16) taken looking from Leighton Road towards the newly completed Po Leung Kuk, the coping detail is notably different from the detail today (Fig. 3.3.1.18). Judging from the deteriorated section shown in the photo, the original coping design seems to be a thin layer of concrete screeding applied on top of the granite blocks. The current vermiculated rustication coping design can probably be traced back to before the 1950s judging from a Public Works Department photo (Fig. 3.3.1.17) showing a Hong Kong Government Department Despatch Service Van parking in front of the masonry walls on the east of Caroline Hill Road as well as another photo dated mid-1950s (Fig. 3.3.1.19) showing same details on the west of Caroline Hill Road.

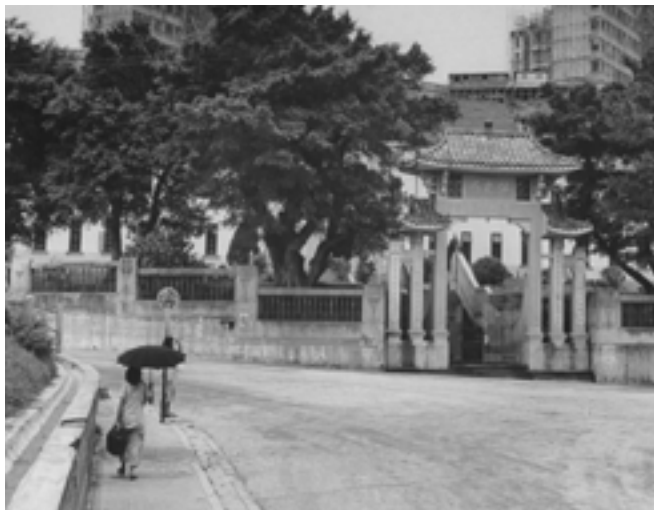
Fig. 3.3.1.16. Photo dated c.1945 showing the masonry wall opposite Po Leung Kuk with different coping detail. (Source: Life Magazine)

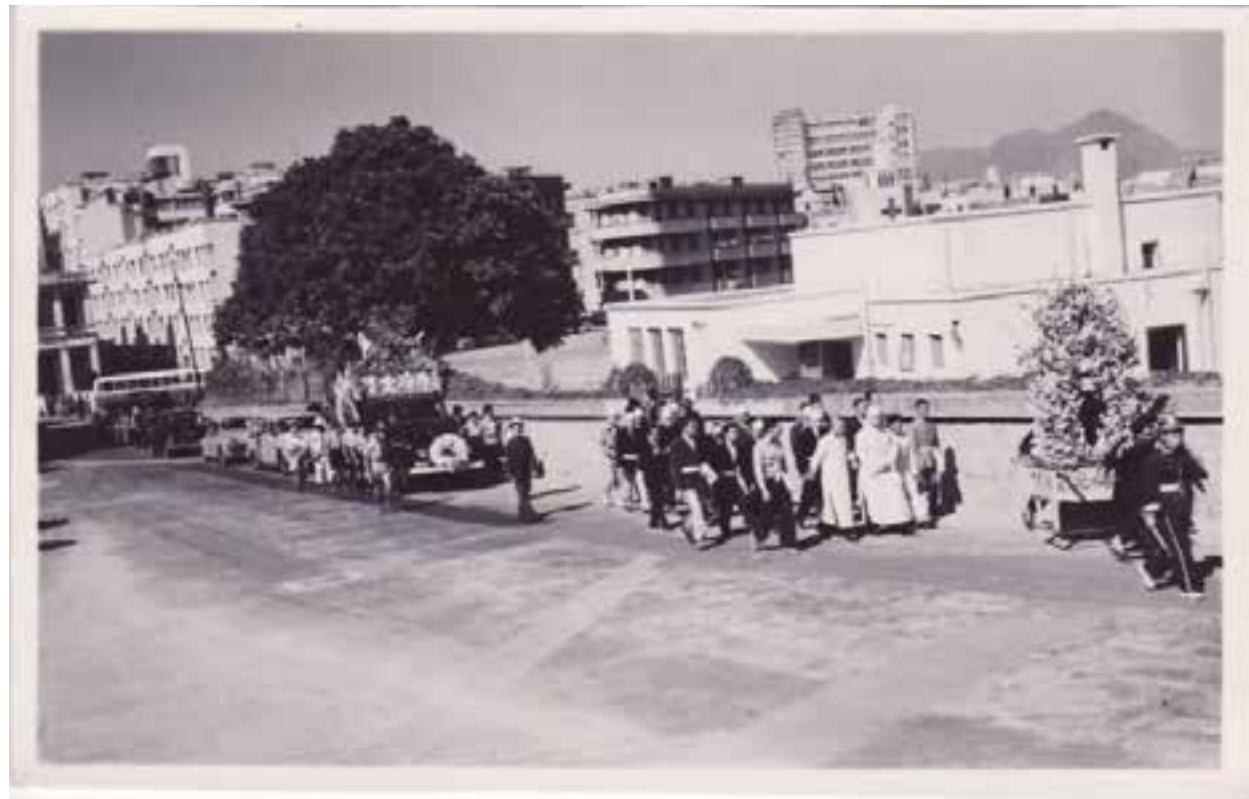
Fig. 3.3.1.19. The coping design with vermiculated rustication is also visible in a photo taken at the junction of Link Road and Caroline Hill Road looking north with the Cable and Wireless Club in the near background, dating to the mid-1950s. (Source: unknown author)

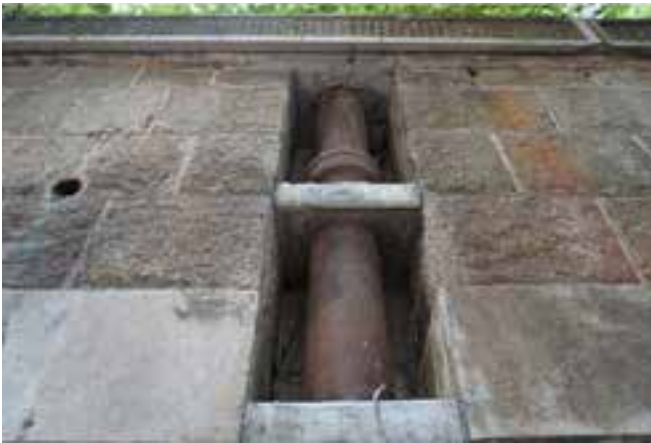
Fig. 3.3.2.1. Cast iron replacement pipe. (Source: Purcell, 2021)

There are a total of three exposed, built-in vertical pipes installed in the masonry walls IISW-B/FR 193 and IISW-B/FR 32. The one located in IISW-B/FR 193 and one of the two in IISW-B/FR 32 are earthenware pipes of similar design. The other one in IISW-B/FR 32 is a cast iron pipe (Fig. 3.3.2.3). According to ASD's 2013 maintenance records, the cast iron pipe was a recent replacement of an earlier earthenware pipe which was damaged by the growth of tree roots which had penetrated the pipe.

There is no evidence to suggest any major alterations to the two surviving earthenware pipes. Given their expected age, there is evidence of some wear and tear, which is evident in some areas of localised patch repairs. In general, these two pipes are in fair condition. According to ASD's maintenance record, in 2013, an earthenware pipe near Cotton Path was replaced by a cast iron pipe as it had been damaged beyond repair by tree roots penetrating the pipe.

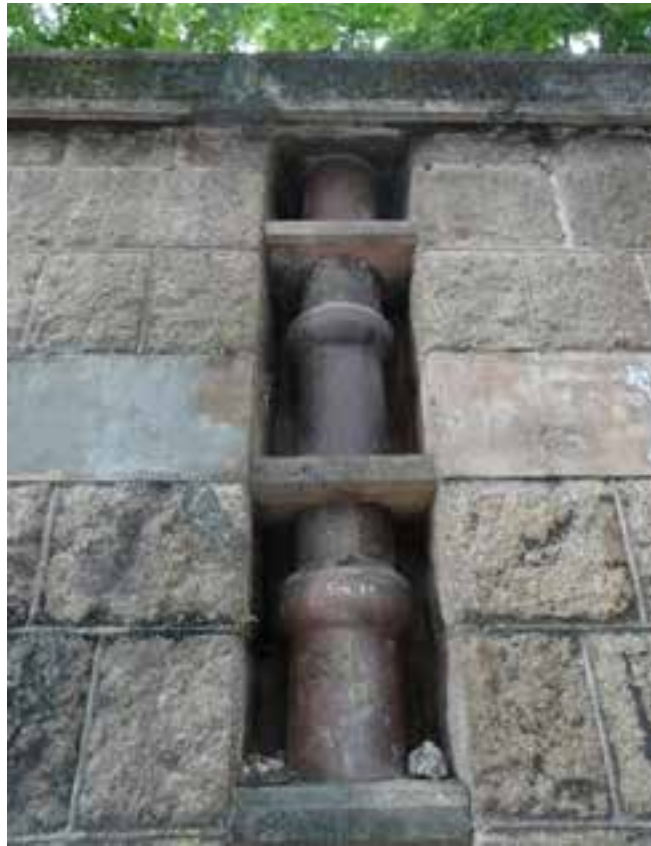
Fig. 3.3.2.2 Existing condition of earthenware pipe. (Source: Purcell, 2021)

The two existing earthenware pipes are generally in fair condition without major defects. Historical patch repairs were noted in ASD's maintenance records. No manufacturer's marks were found in the easily accessible areas around the pipes, nor on the original construction drawings and specifications. It is therefore unknown whether they are original to the 1920s construction of the masonry walls.

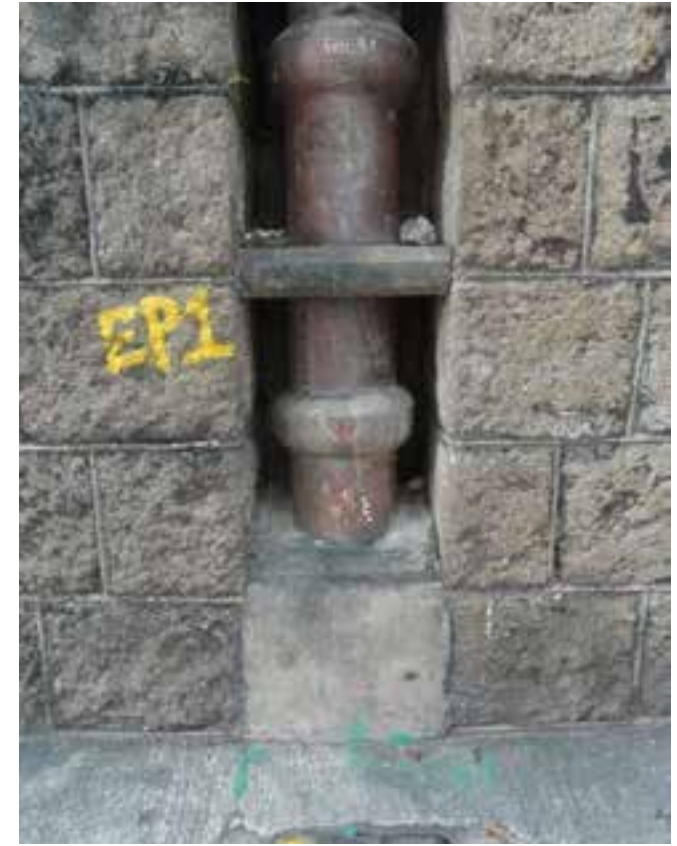
Fig. 3.3.2.3 Bottom part of the earthenware pipe with historical repairs. (Source: Purcell, 2021)

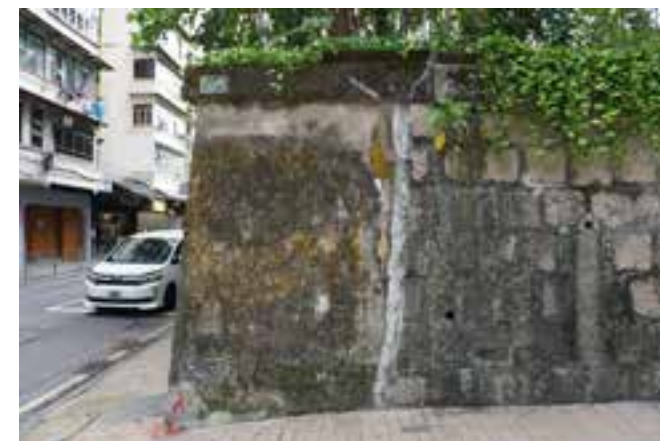
Fig. 4.3.1.1 Junction between the Leighton Road and the east Caroline Hill Road. (Source: Purcell)

Other physical changes to the walls appear minimal, although one change was observed during site inspections carried in September 2021. A section of missing dressed granite blocks is found at the junction between the Leighton Road and the east Caroline Hill Road. (Fig. 4.3.1.1)

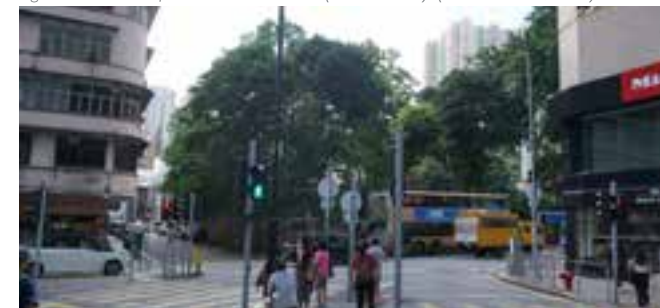
Fig. 4.3.3.2 View of Caroline Hill from the junction of Leighton Hill and Caroline Hill Road. (Source: Purcell, 2021)

The masonry walls which are topped by a distinctive band of vegetation, including existing trees, clearly define the Caroline Hill site and are the main features that the public observe (Fig. 4.3.3.2). Views towards the Site from street level is however limited due to the elevated levels. The walls, trees and elevated site level create an interesting relationship with the streets around the site, the character of which is extremely familiar to people who live, work and socialize in Causeway Bay.

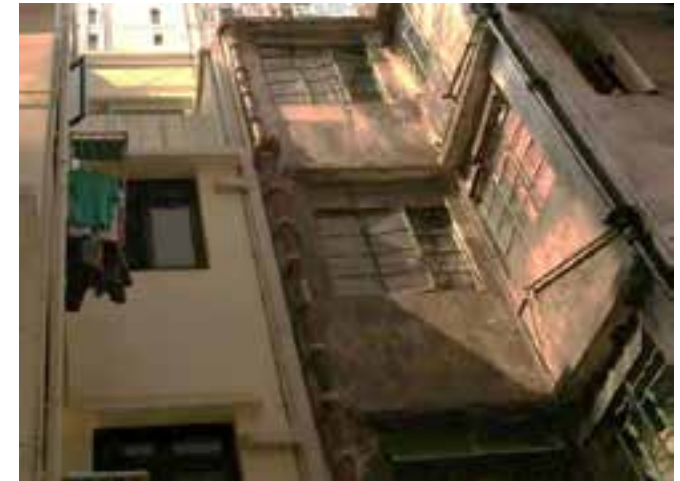
Fig. 4.3.6.1 Clay pipe in Wing Lee Street from around the 1950s. (Source: Purcell, 2021)

Since clay pipes were mainly used for underground sewage, surviving examples of clay pipes above ground drainage are rare. Due to the pipes weight, the logistics for installing them vertically by workers would have been challenging. Similar surviving glazed clay pipes are observed on Chinese tenement houses of the 1950s Wing Lee Street Building (Fig. 4.3.6.1), and on the west elevation of Li Hall, St. John's Cathedral (Fig. 4.3.6.2).

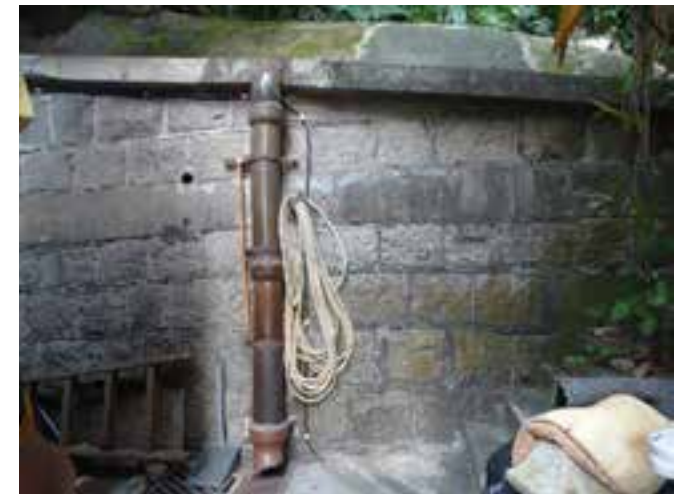
Fig. 4.3.6.2 Glazed clay pipe on masonry wall to the west of Li Hall, St John's Cathedral, possibly from the 1920s during the construction of former Li Hall. (Source: Purcell, 2021)

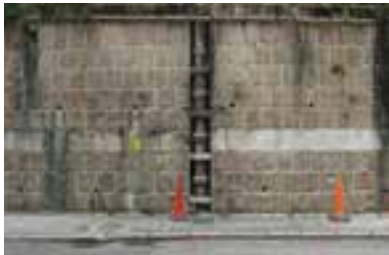
ELEMENT NO.	DESCRIPTION	PHOTO	SIGNIFICANCE	CONSERVATION RECOMMENDATION	LOCATION PLANS (INDICATIVE ONLY)
I.03	Glazed Clay (earthenware) Pipes

<p data-bbox="495 639 891 683"><i>Fig. 4.4.2.3 Glazed clay pipe on masonry wall I ISW-B/FR 193. (Source: Purcell, 2021)</i></p>	Moderate	<p>Although the earthenware pipe(s) may become redundant, they should still be conserved to prevent against deterioration.</p> <p>Poor past repairs shall be unpicked and made good properly.</p> <p>To be read in conjunction with Policy 6.6.1, 6.6.2, 6.6.3, 6.7.5, and 6.7.6</p>

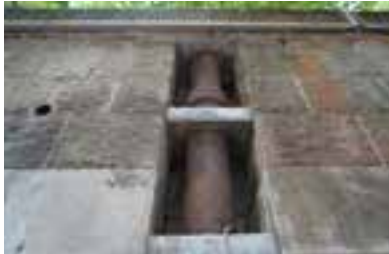
I.04	Cast iron pipe

<p data-bbox="495 983 891 1026"><i>Fig. 4.4.2.4 Cast iron pipe on masonry wall I ISW-B/FR 193. (Source: Purcell, 2021)</i></p>	Neutral/ Adverse	<p>Consideration shall be given to replace cast iron pipe by a replica earthenware pipe on a like-for-like basis to enhance the relevant heritage significance.</p> <p>To be read in conjunction with Policy 6.6.4.</p>

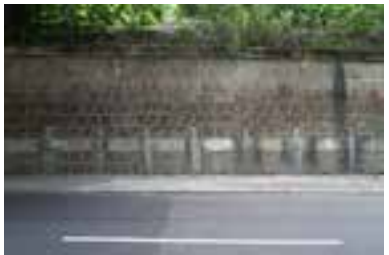
Moderate	<p>The dressed granite block walls with horizontal concrete banding should be repaired, conserved and maintained to keep its appearance as it is at present.</p> <p>To be read in conjunction with Policy 6.6.1, 6.6.2, 6.6.3, 6.6.4, 6.7.2, 6.7.5, and 6.7.6.</p>

Fig. 4.4.2.6 The well-dressed masonry walls. (Source: Purcell, 2021)

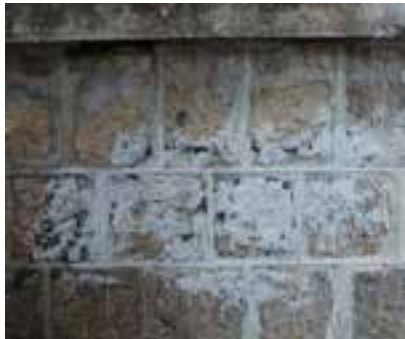
ELEMENT NO.	DESCRIPTION	PHOTO	SIGNIFICANCE	CONSERVATION RECOMMENDATION	LOCATION PLANS (INDICATIVE ONLY)
I.07	Graffiti paint and concrete cover-ups on masonry walls

Adverse	<p>Develop a cleaning and repair strategy to remove/unpick the undesired graffiti and poorly executed historic repairs.</p> <p>To be read in conjunction with Policy 6.6.2, 6.6.3 and 6.6.4</p>	N/A

*Fig. 4.4..2.7 A part of the painted masonry walls.  
(Source: Purcell, 2021)*

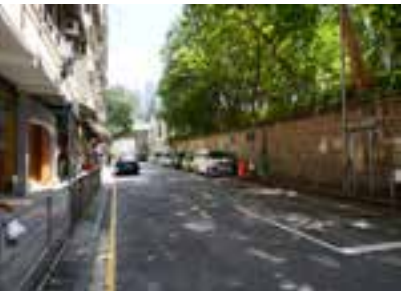
<p data-bbox="510 722 869 786"><i>Fig. 4.4.2.9 The view of Caroline Hill Road from a distant, showing how the walls make a significant impact to the streetscape. (Source: Purcell, 2021)</i></p>	High	<p data-bbox="1126 411 1626 627">By virtue of the Grade 3 listing, the graded walls are already recognised by the statutory authority as being historically and culturally significant and as having a positive contribution to the streetscape. These walls shall be retained in their entirety as much as possible, and should be conserved and repaired as appropriate.</p> <p data-bbox="1126 667 1608 722">To be read in conjunction with Policy 6.6.1, 6.6.6, 6.7.1, 6.7.2 and 6.8.2.</p>

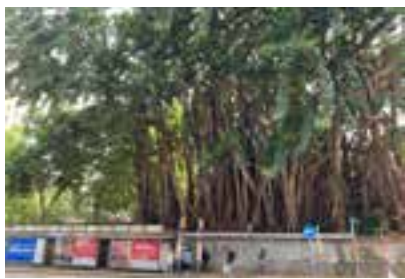
<p data-bbox="504 662 873 710"><i>Fig. 4.4.2.10 View of the walls along Leighton Road (Source: Purcell, 2021)</i></p>	High	<p data-bbox="1120 359 1624 646">This portion of masonry wall along Leighton Road is not graded. Part of the wall is to be retained while the rest is scheduled to be demolished to facilitate road widening works. It should be acknowledged that the non-graded wall also has similar historical and cultural significance as the graded masonry walls since they both define the original plot and were constructed as part of the sites original formation works.</p> <p data-bbox="1120 678 1624 837">The retained section in relation with slope no. IISW-B/FR 190 should be conserved and repaired as appropriate. Any necessary new interventions for access within this section of wall are acceptable subject to review of detailed proposal.</p> <p data-bbox="1120 869 1624 997">For the demolished portion, consideration shall be given to salvage the granite and reused for repairs elsewhere in the Site as far as necessary and practical.</p> <p data-bbox="1120 1029 1624 1093">To be read in conjunction with Policy 6.6.1, 6.6.5, 6.6.6 and 6.8.4.</p>

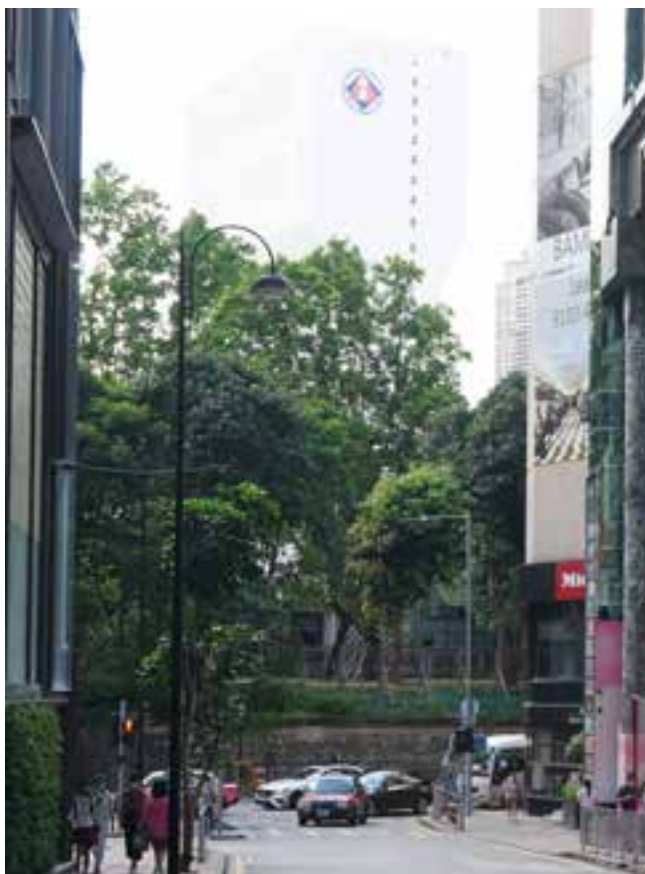
Fig. 5.2.1 View from Pennington Street showing the three distinguishable layers of masonry walls, buildings and greeneries. (Source: Purcell, 2021)

There are 3 distinguishable layers which can be observed at street level. This layering comprises the masonry walls, an elevated platform (slope) and green buffer formed by various species of trees. The trees provide a pleasant screening between the elevated site and its adjacent pedestrian streets.
