## Annex I

## Approved Conservation Management Plan

MASONRY WALLS AND ASSOCIATED EARTHENWARE PIPES AT CAROLINE HILL, H.K  
CONSERVATION MANAGEMENT PLAN  
FOR PATCHWAY HOLDINGS (HK) LIMITED  
JULY 2022

# CAROLINE HILL, HK: CONSERVATION MANAGEMENT PLAN

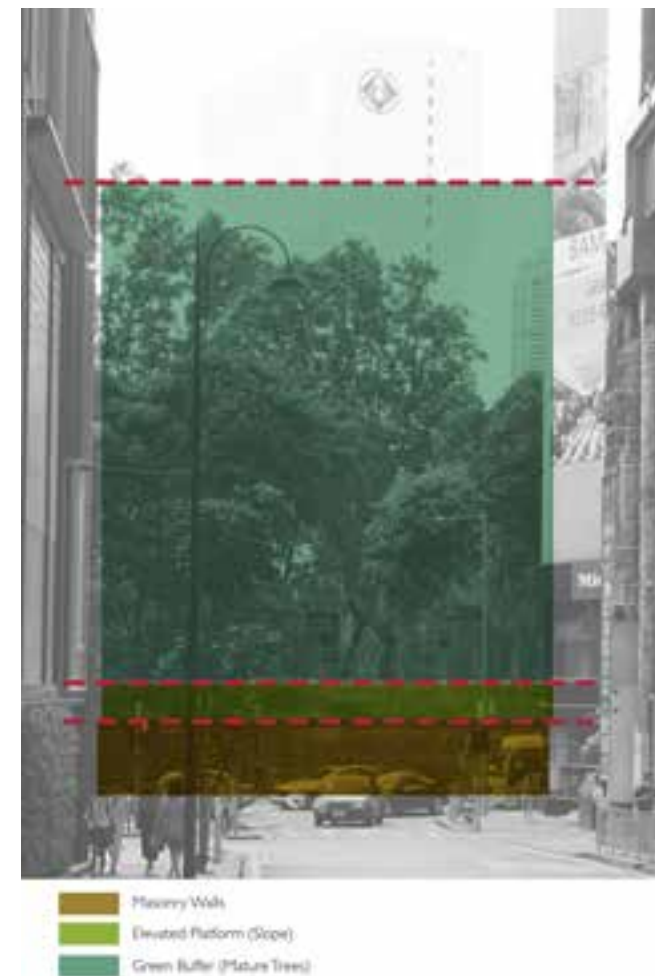
Fig. 5.2.2 Diagram showing three layers: walls, building and trees. (Source: Purcell, 2021)

There are 3 distinguishable layers which can be observed at street level. This layering comprises the masonry walls, an elevated platform (slope) and green buffer formed by various species of trees. The trees provide a pleasant screening between the elevated site and its adjacent pedestrian streets.
