Geotechnical Planning Review Report

**Geotechnical Planning**  
**Review Report for**  
**Application for Permission under Section 16**  
**of The Town Planning Ordinance (Cap.131)**  
**Proposed Temporary Place of Recreation, Sports or**  
**Culture (Hobby Farm) with Ancillary Facilities for a**  
**Period of 3 Years and Associated Filling of Land at**  
**Lots 1275 (Part), 1279 (Part), 1280, 1281 (Part), 1282**  
**and 1284 (Part) in D.D. 96, Ma Tso Lung, New**  
**Territories**

**January 2025**

**W.K.Poon**

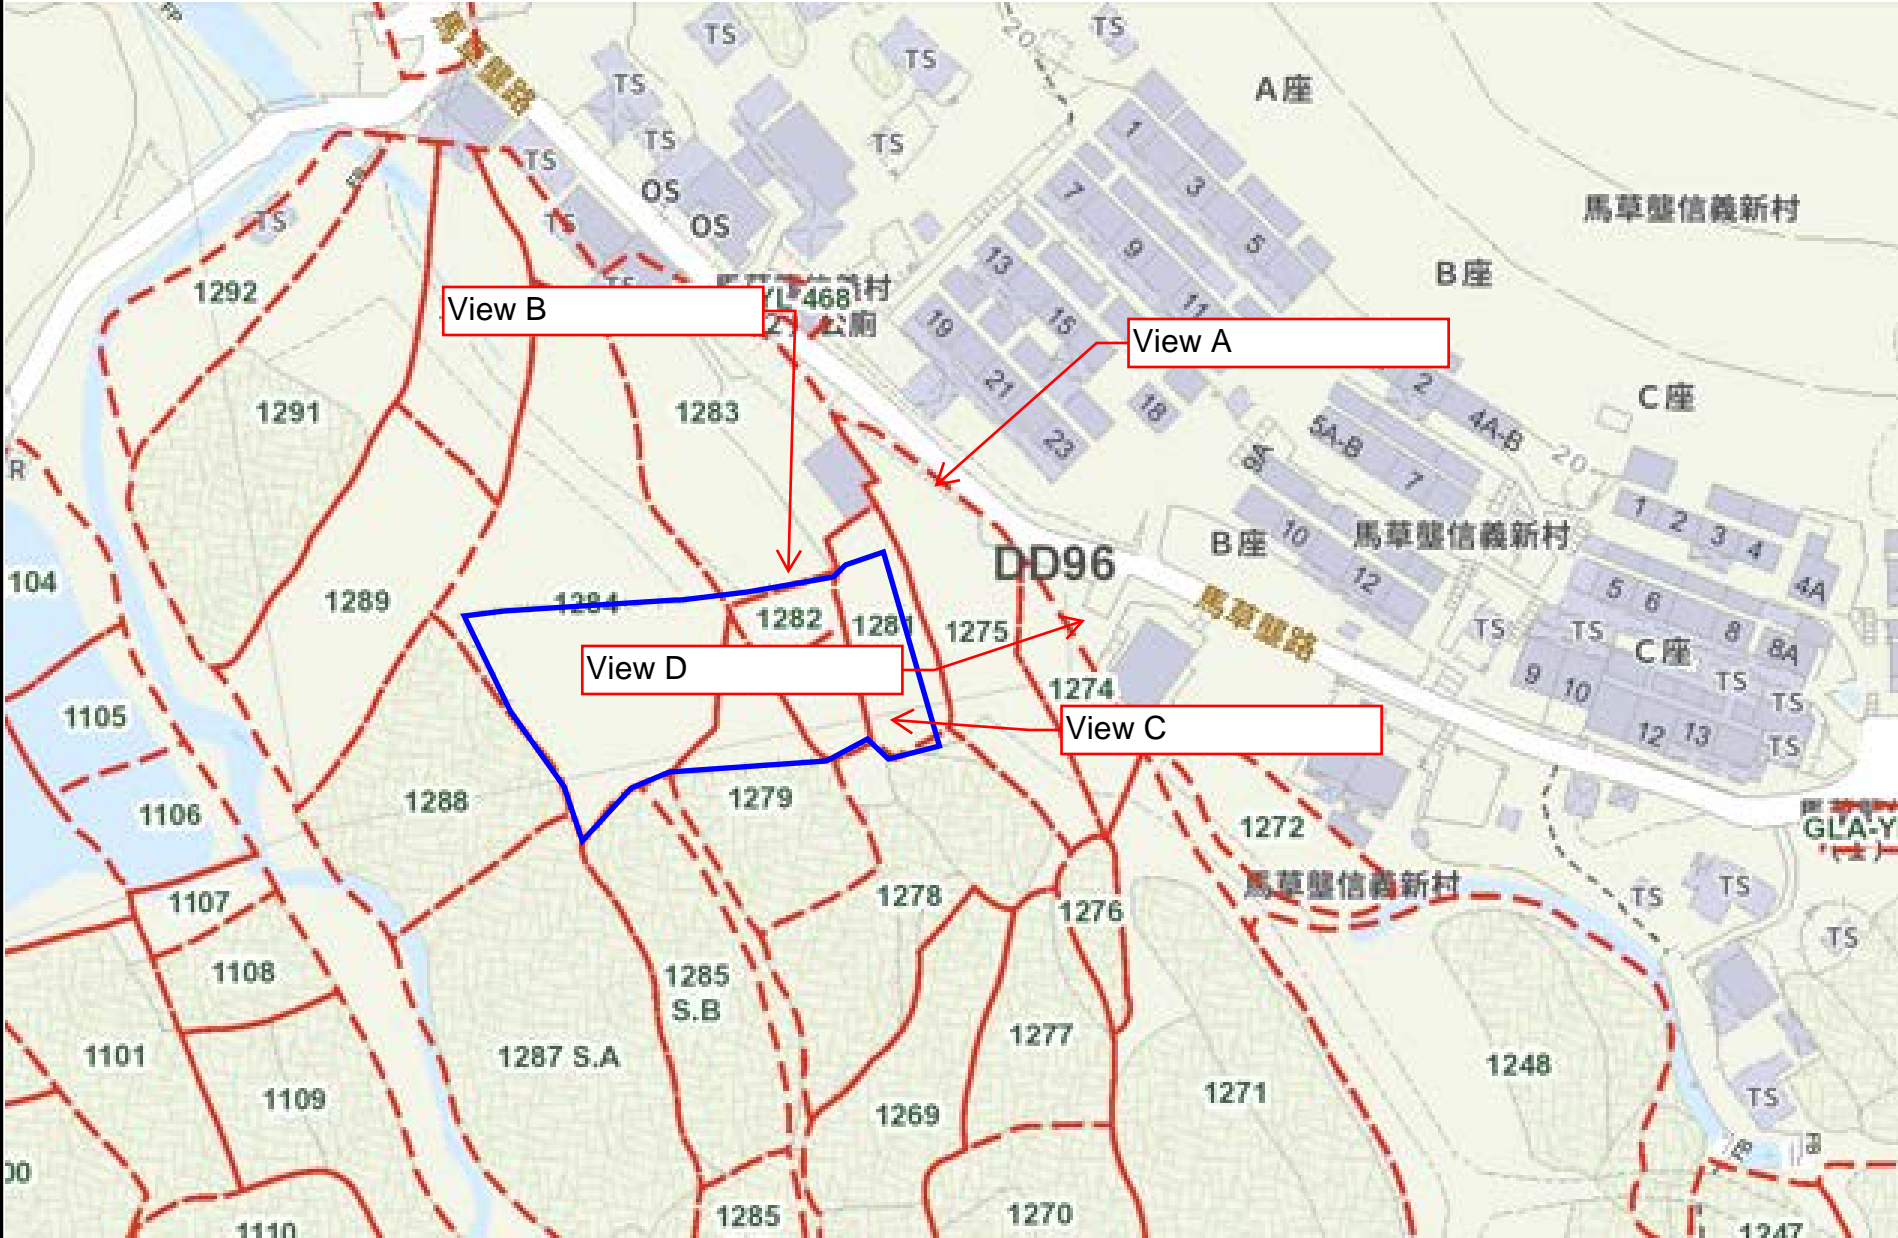
Fig.4

According to the available SIMAR reports retrieved from Lands Department and SIS records obtained from Geotechnical Engineering Office (GEO), there are 9 nos. of registered geotechnical features lies within or in the vicinity of the site (see Figure 4).

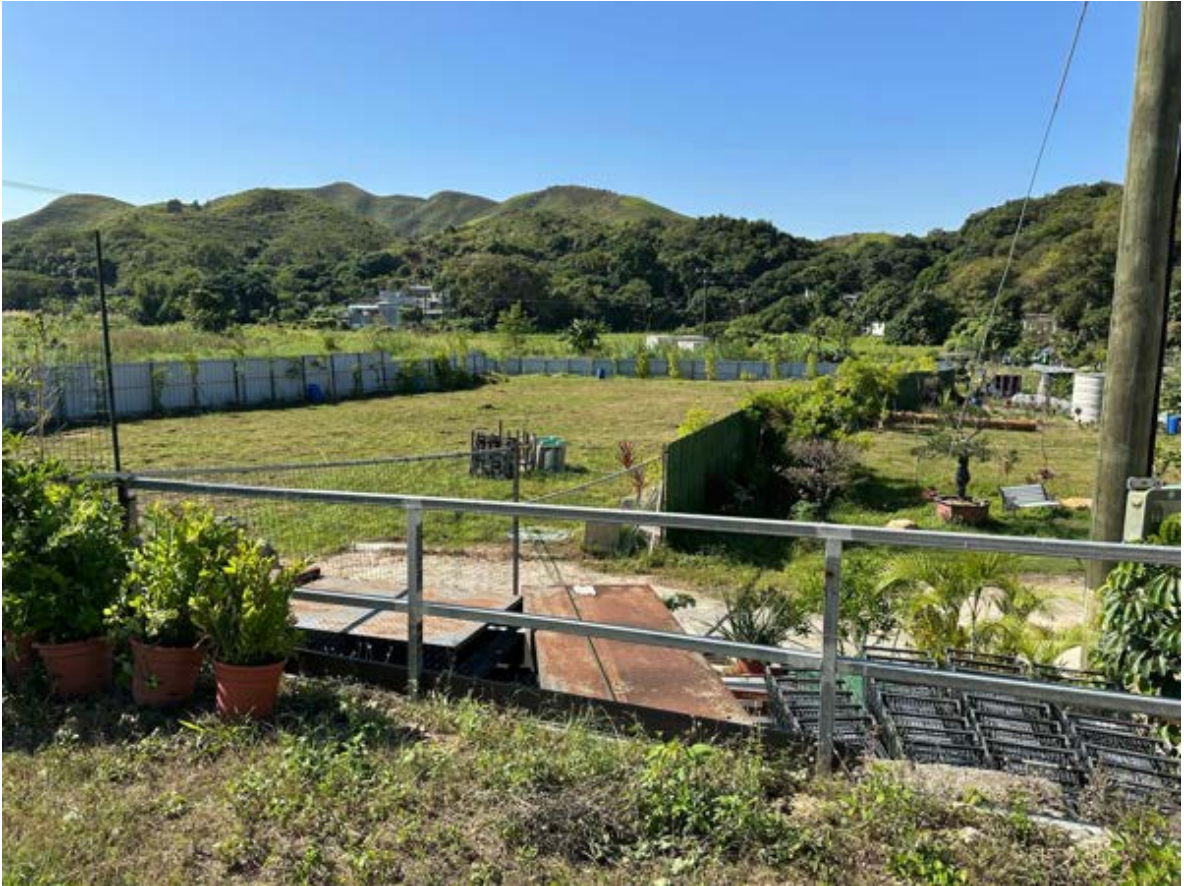
VIEW A SITE VIEW

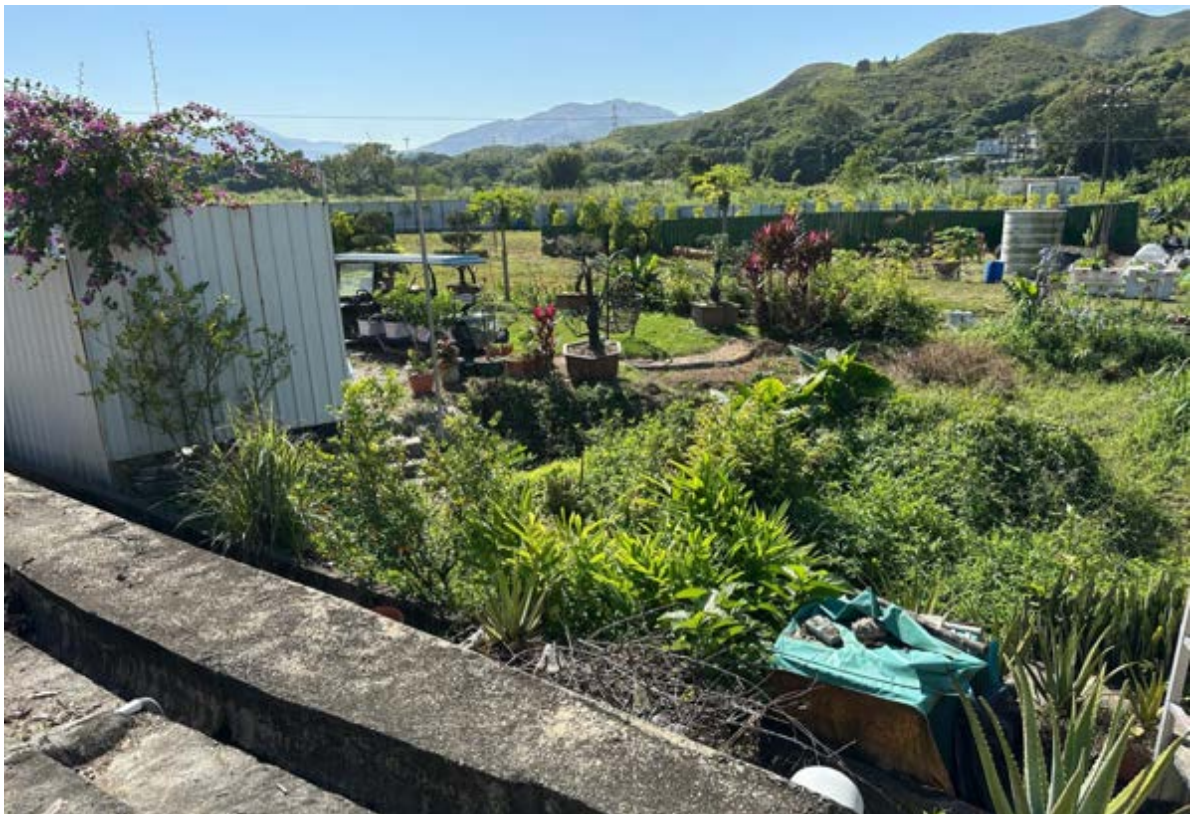
VIEW B SITE VIEW

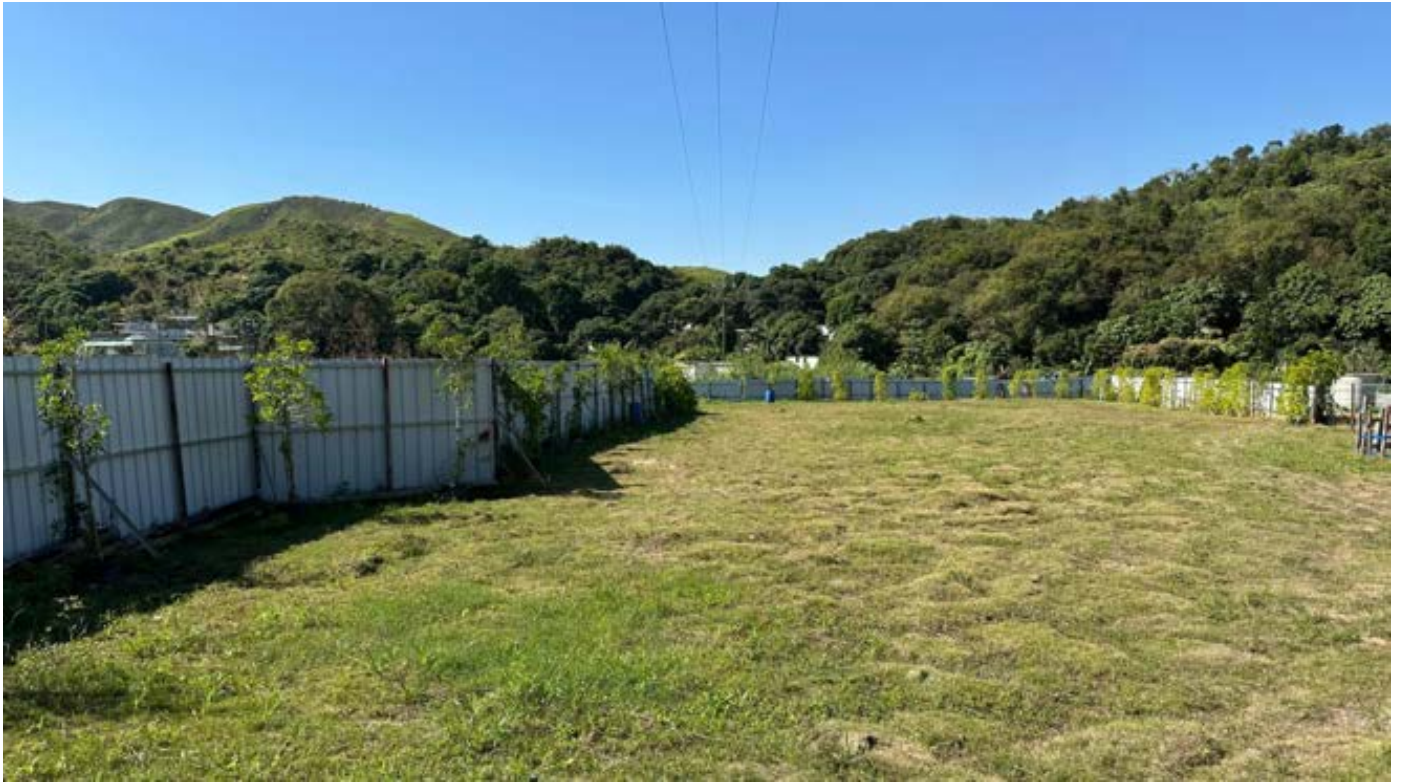
VIEW C SITE VIEW

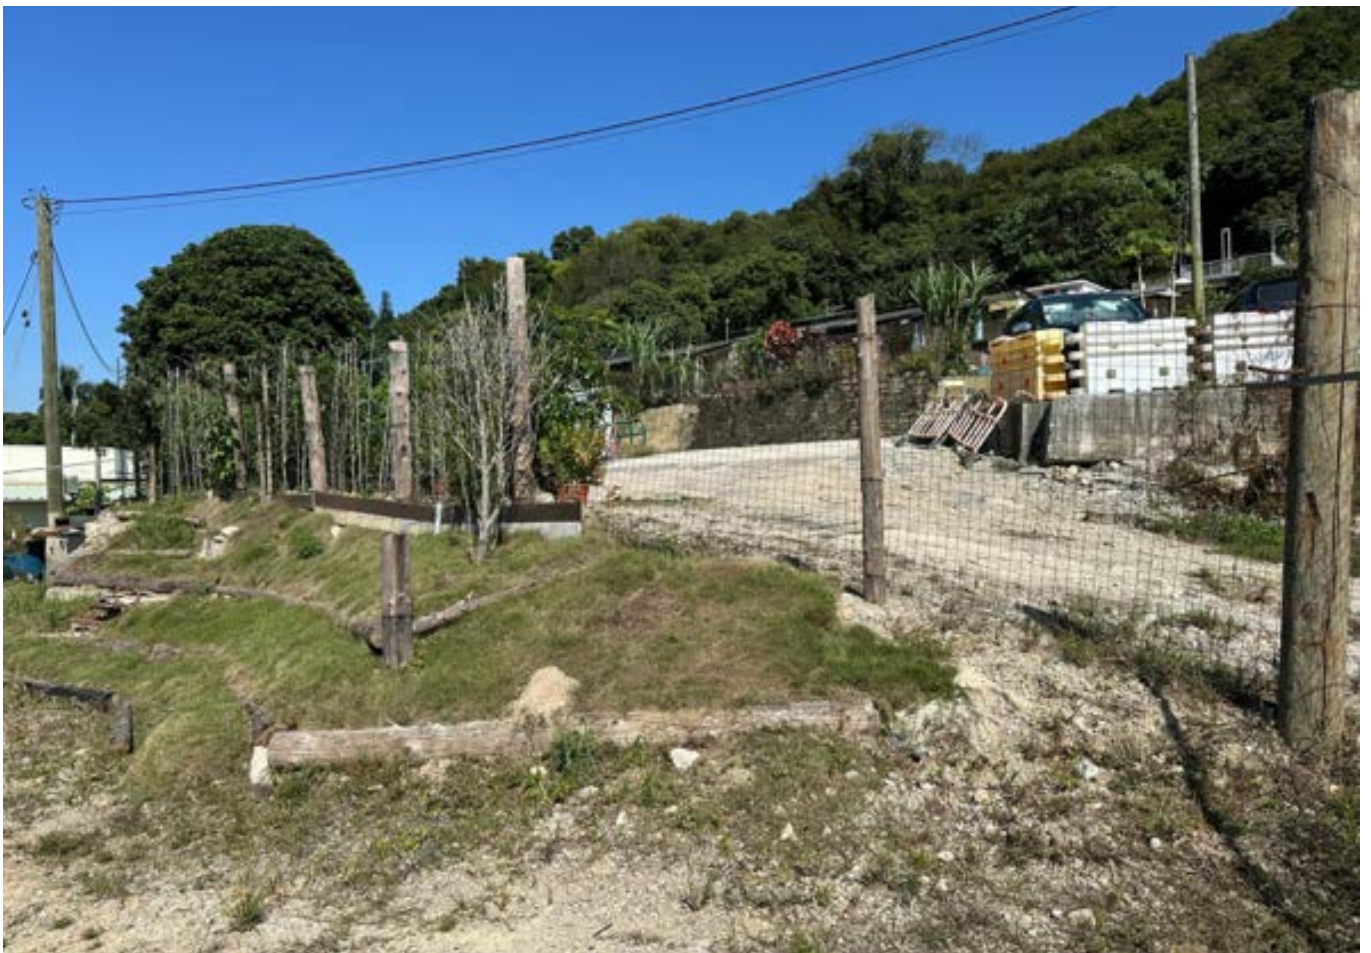
VIEW D Entrance of Site

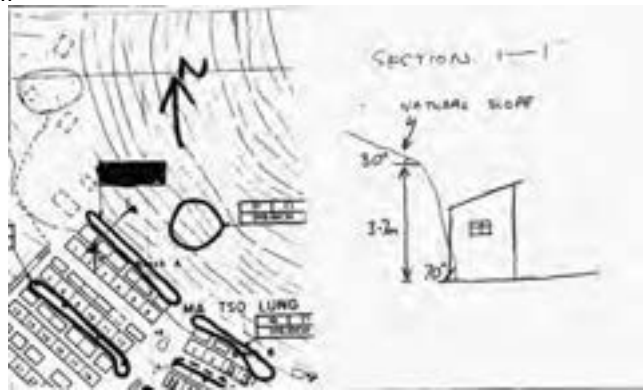
Section No: 1-1  
 Height (m): N/A  
 Type of Toe Facility: Cottage, licensed and squatter area  
 Distance from Toe (m): 0  
 Type of Crest Facility: Undeveloped green belt  
 Distance from Crest (m): 0  
 Consequence Category: 1  
 Engineering Judgement: P

Section No: 2-2  
 Type of Toe Facility: N/A  
 Distance from Toe (m): 0  
 Type of Crest Facility: N/A  
 Distance from Crest (m): 0  
 Consequence Category: 1  
 Engineering Judgement: P

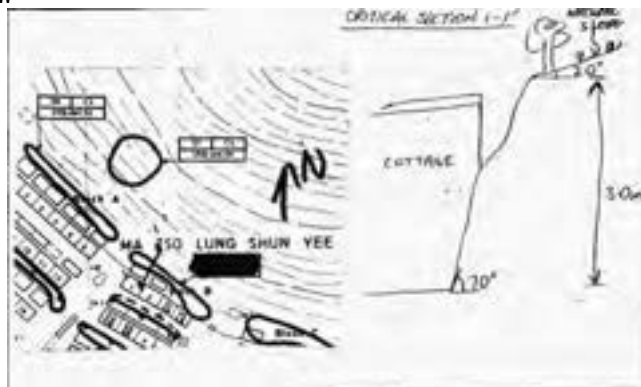
Section No: 1-1  
 Height (m): N/A  
 Type of Toe Facility: Cottage, licensed and squatter area  
 Distance from Toe (m): 0  
 Type of Crest Facility: Undeveloped green belt  
 Distance from Crest (m): 0  
 Consequence Category: 1  
 Engineering Judgement: P  
 Section No: 2-2  
 Type of Toe Facility: N/A  
 Distance from Toe (m): 0  
 Type of Crest Facility: N/A  
 Distance from Crest (m): 0  
 Consequence Category: 1  
 Engineering Judgement: P  
 Sign of Seepage: Slope : Signs of seepage  
 Wall : N/A  
 Criterion A satisfied: N  
 Sign of Distress: Slope : Minor (near crest, mid-portion, at toe)  
 Wall : N/A  
 Criterion D satisfied: N  
 Non-routine maintenance required: N  
 Note: N/A  
 Masonry wall / Masonry facing: N

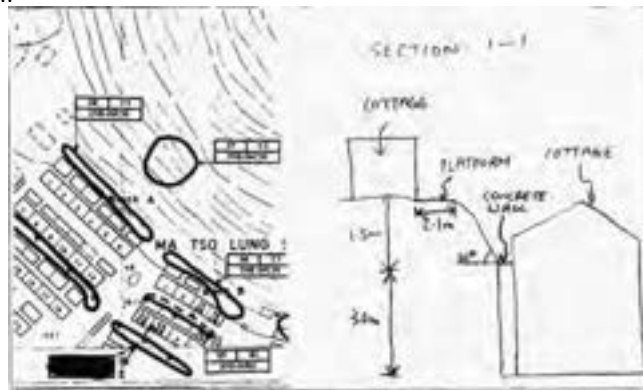
Section No: 1-1  
 Height (m): H1 : 5 , H2 : 3  
 Type of Toe Facility: Cottage, licensed and squatter area  
 Distance from Toe (m): 0  
 Type of Crest Facility: Cottage, licensed and squatter area  
 Distance from Crest (m): 3.5  
 Consequence Category: 1  
 Engineering Judgement: P  
 Section No: 2-2  
 Type of Toe Facility: N/A  
 Distance from Toe (m): N/A  
 Type of Crest Facility: N/A  
 Distance from Crest (m): N/A  
 Consequence Category: 1  
 Engineering Judgement: P  
 Sign of Seepage: Slope : No signs of seepage  
 Wall : Signs of seepage  
 Criterion A satisfied: N  
 Sign of Distress: Slope : N/A  
 Wall : N/A  
 Criterion D satisfied: N

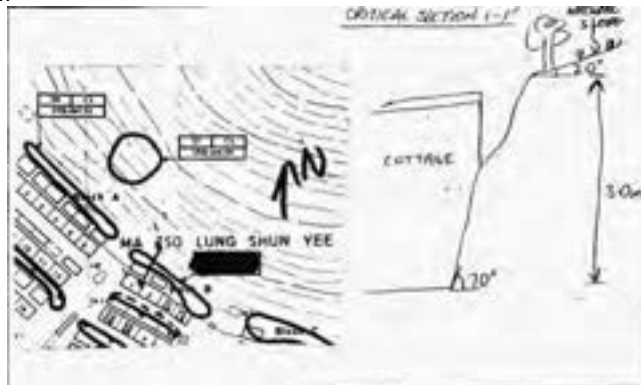
**STAGE 1 STUDY REPORT**

Inspected On: 27-10-1997  
 Weather: Mainly Fine  
 District: MW

Section No: 1-1  
 Height (m): N/A  
 Type of Toe Facility: Cottage, licensed and squatter area  
 Distance from Toe (m): 0  
 Type of Crest Facility: Undeveloped green belt  
 Distance from Crest (m): 0  
 Consequence Category: 1  
 Engineering Judgement: P  
 Section No: 2-2  
 Type of Toe Facility: N/A  
 Distance from Toe (m): 0  
 Type of Crest Facility: N/A  
 Distance from Crest (m): 0  
 Consequence Category: 1  
 Engineering Judgement: P  
 Sign of Seepage: Slope : Signs of seepage  
 Wall : N/A  
 Criterion A satisfied: N  
 Sign of Distress: Slope : Minor (near crest, mid-portion, at toe)  
 Wall : N/A  
 Criterion D satisfied: N  
 Non-routine maintenance required: N  
 Note: N/A  
 Masonry wall / Masonry facing: N

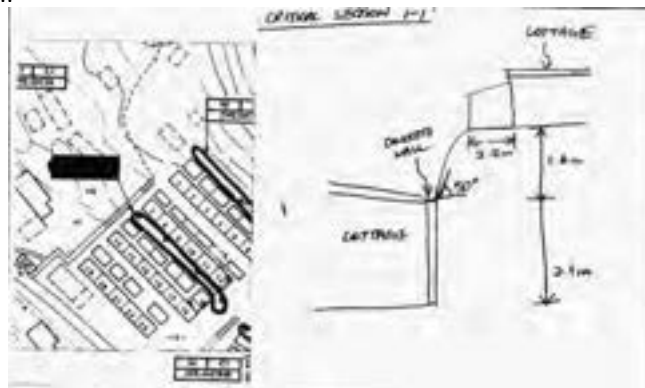
**STAGE 1 STUDY REPORT**

Inspected On: 27-10-1997  
 Weather: Mainly Fine  
 District: MW

Section No: 1-1  
 Height (m): H1 : 2 , H2 : 2  
 Type of Toe Facility: Cottage, licensed and squatter area  
 Distance from Toe (m): 0  
 Type of Crest Facility: Cottage, licensed and squatter area  
 Distance from Crest (m): 2  
 Consequence Category: 1  
 Engineering Judgement: P  
 Section No: 2-2  
 Type of Toe Facility: N/A

Distance from Toe (m):	N/A
Type of Crest Facility:	N/A
Distance from Crest (m):	N/A
Consequence Category:	1
Engineering Judgement:	P
Sign of Seepage:	Slope : No signs of seepage Wall : No sign of seepage
Criterion A satisfied:	N
Sign of Distress:	Slope : N/A Wall : N/A
Criterion D satisfied:	N
Non-routine maintenance required:	N
Note:	N/A
Masonry wall / Masonry facing:	N
Note:	N/A
Consequence category (for critical section):	1
Observations:	N/A
Emergency Action Required:	N
Action By:	N/A

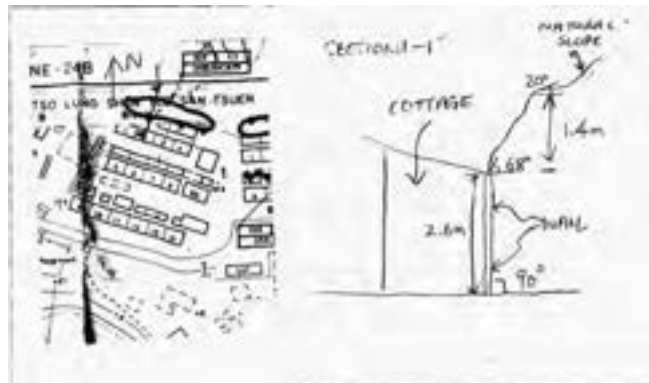
## STAGE 1 STUDY REPORT

Inspected On: 06-11-1997  
 Weather: Mainly Fine  
 District: MW

Section No: 1-1  
 Height (m): N/A  
 Type of Toe Facility: Cottage, licensed and squatter area  
 Distance from Toe (m): 0  
 Type of Crest Facility: Undeveloped green belt  
 Distance from Crest (m): 0  
 Consequence Category: 1  
 Engineering Judgement: HP

Section No: 2-2  
 Type of Toe Facility: Cottage  
 Distance from Toe (m): 0  
 Type of Crest Facility: Undeveloped green belt  
 Distance from Crest (m): 0  
 Consequence Category: 1  
 Engineering Judgement: HP

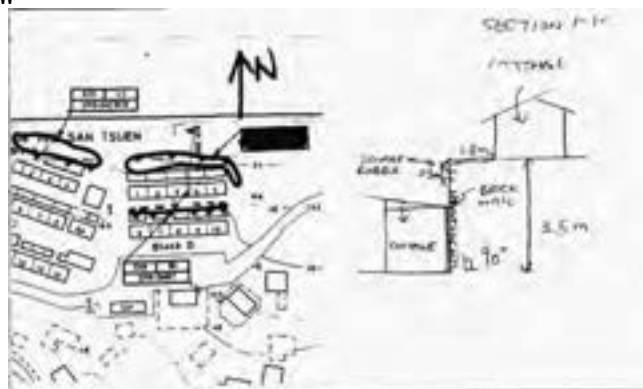
**STAGE 1 STUDY REPORT**

Inspected On: 27-10-1997  
 Weather: Mainly Fine  
 District: MW

Section No: 1-1  
 Height (m): N/A  
 Type of Toe Facility: Cottage, licensed and squatter area  
 Distance from Toe (m): 0  
 Type of Crest Facility: Non-dangerous goods storage site  
 Distance from Crest (m): 1  
 Consequence Category: 1  
 Engineering Judgement: P  
 Section No: 2-2  
 Type of Toe Facility: Cottage  
 Distance from Toe (m): 0  
 Type of Crest Facility: Other lightly-used open space  
 Distance from Crest (m): 0  
 Consequence Category: 1  
 Engineering Judgement: P  
 Sign of Seepage: Slope : No signs of seepage  
 Wall : No sign of seepage  
 Criterion A satisfied: N  
 Sign of Distress: Slope : N/A  
 Wall : N/A  
 Criterion D satisfied: N

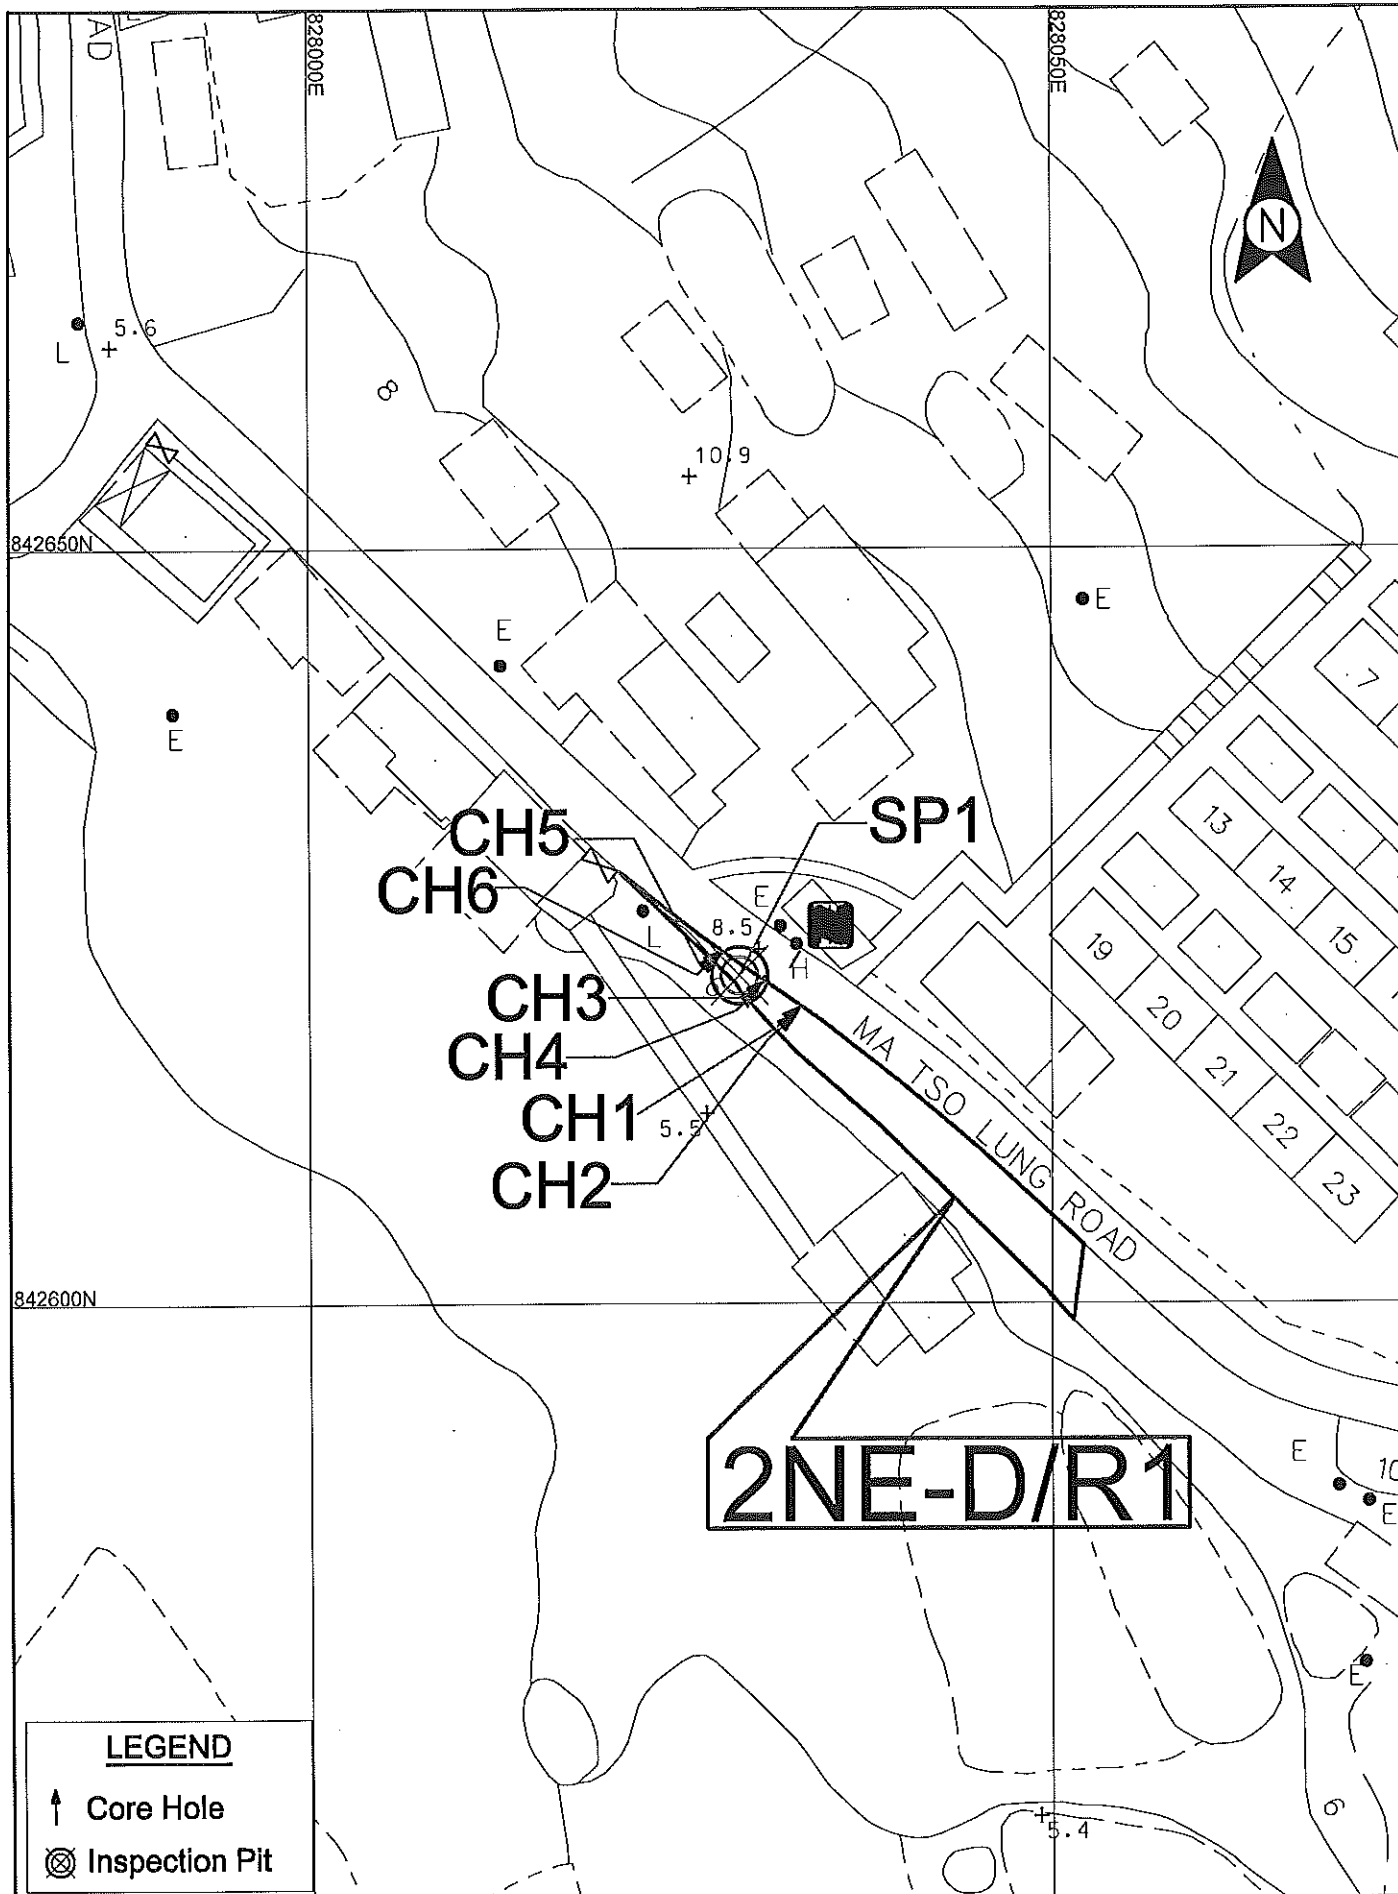
**FIGURE**

<b>LEGEND</b>	
↑	Core Hole
⊗	Inspection Pit

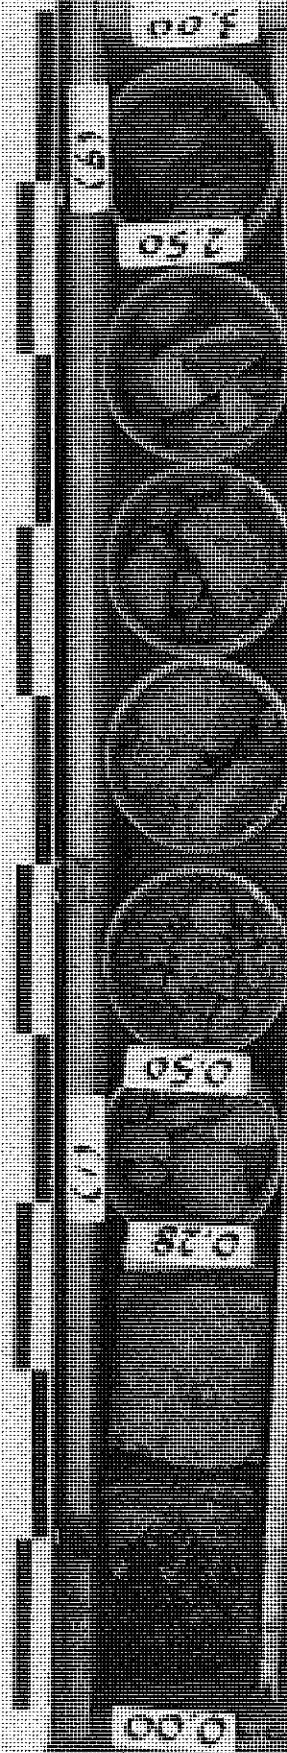
**Date of Photograph:** 5/3/2010

**Job Title:** Agreement No. BA012005  
 Consultancy for the Investigation, Design & Supervision of Slope & Retaining Wall Upgrading Works at Ma Tso Lung Sun Tsuen, Yuen Long, N.T. on Lot No. 1263 in D.D.96 for Portion of Feature No. 2NE-D/R1

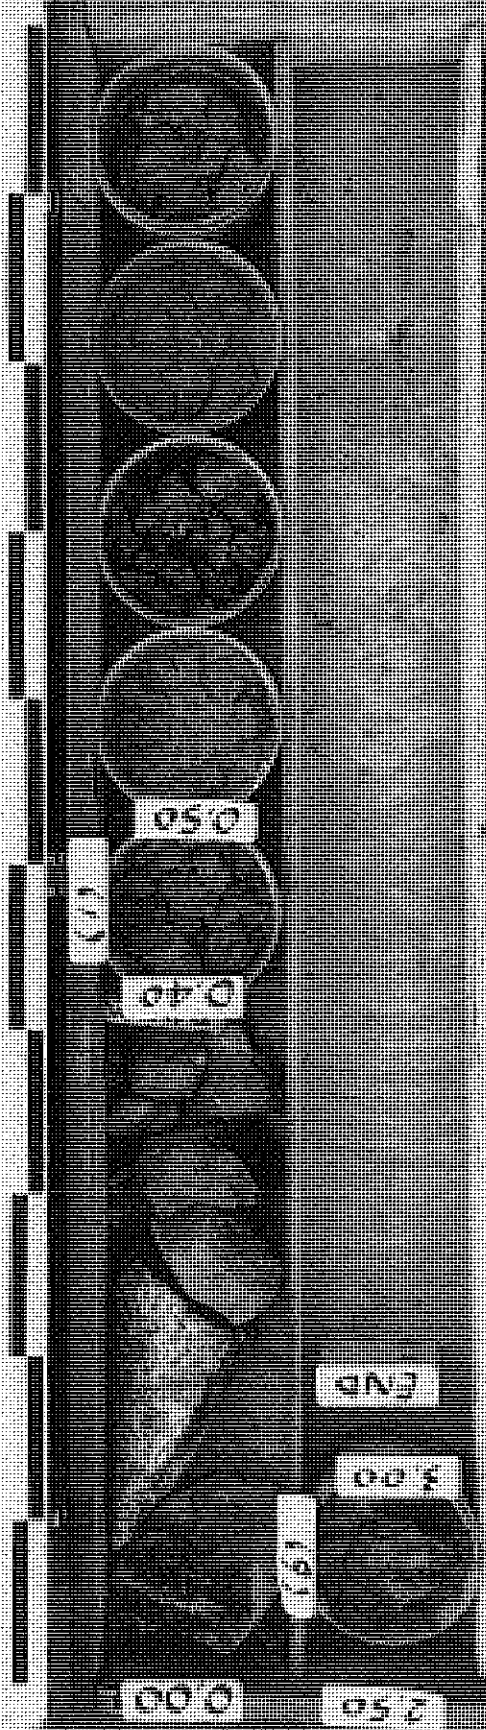
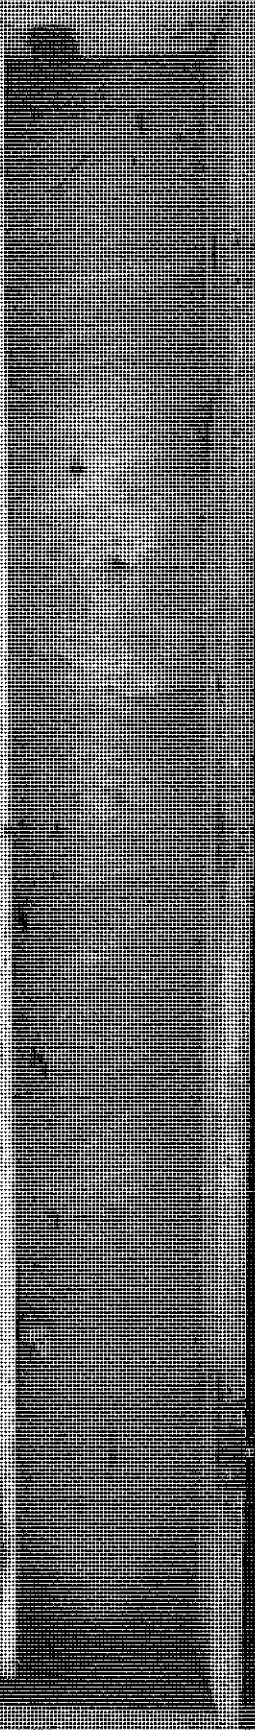
Job Title: Agreement No. BA/01/2006  
 Consultancy for the Investigation, Design  
 & Supervision of Slope & Retaining Wall  
 Upgrading Works at Ma Tso Lung Sun  
 Tsuen, Yuen Long, N.T. on Lot No. 1283 in  
 D.D.96 for Portion of Feature No. 2NE-D/R1

Date of Photograph: 5/3/2010

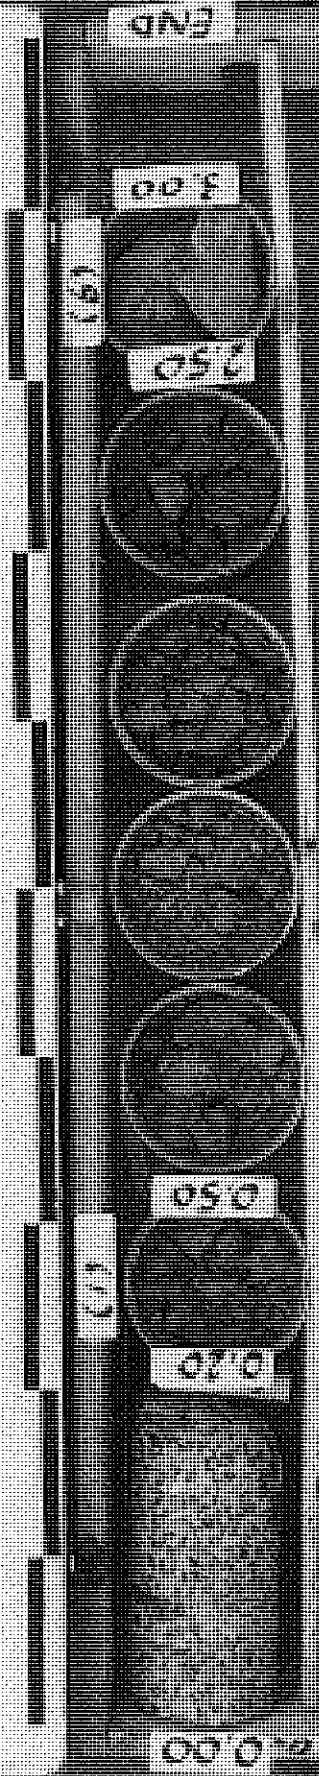
Date of Photograph: 5/3/2010

Job Title: Agreement No. BA/01/2008  
 Consultancy for the Investigation, Design  
 & Supervision of Slope & Retaining Wall  
 Upgrading Works at Ma Tso Lung Sun  
 Tsuen, Yuen Long, N.T. on Lot No. 1283 in  
 D.D.96 for Portion of Feature No. 2NE-D/R1

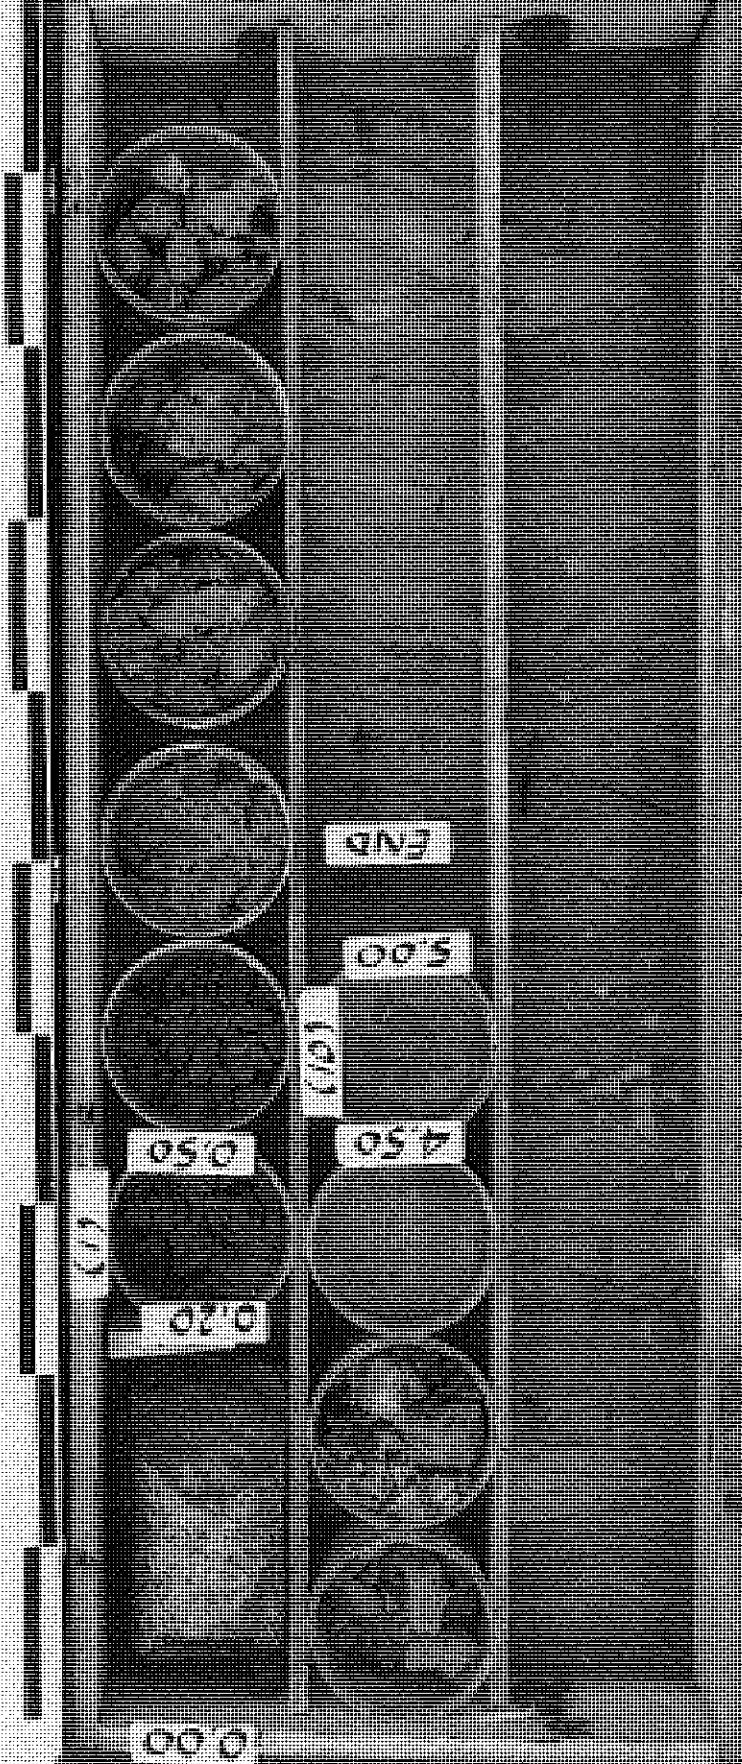
Date of Photograph: 5/3/2010

Job Title: Agreement No. BA/01/2006  
 Consultancy for the Investigation, Design  
 & Supervision of Slope & Retaining Wall  
 Upgrading Works at Ma Tso Lung Sun  
 Tsuen, Yuen Long, N.T. on Lot No. 1283 in  
 D.D.96 for Portion of Feature No. 2NE-D/R1

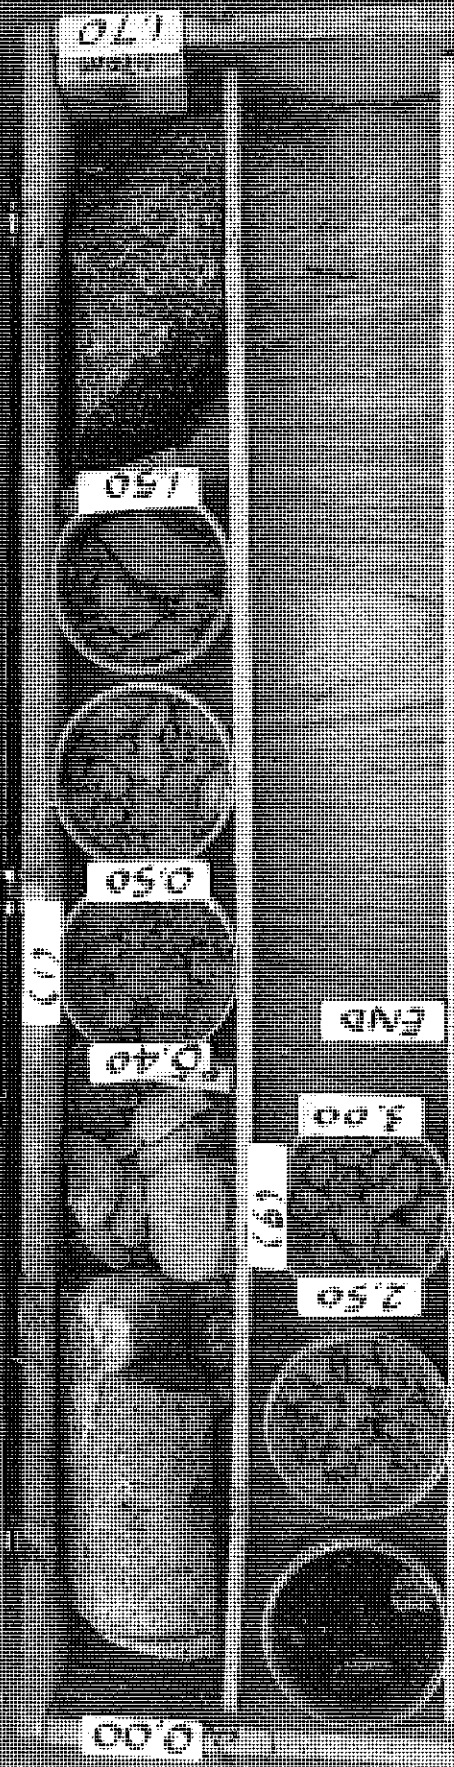
Date of Photograph: 5/3/2010

Consultancy for the Investigation, Design  
 & Supervision of Slope & Retaining Wall  
 Upgrading Works at Ma Tso Lung Sun  
 Tsuen, Yuen Long, N.T. on Lot No. 1283 in  
 D.D.96 for Portion of Feature No. 2NE-D/R1

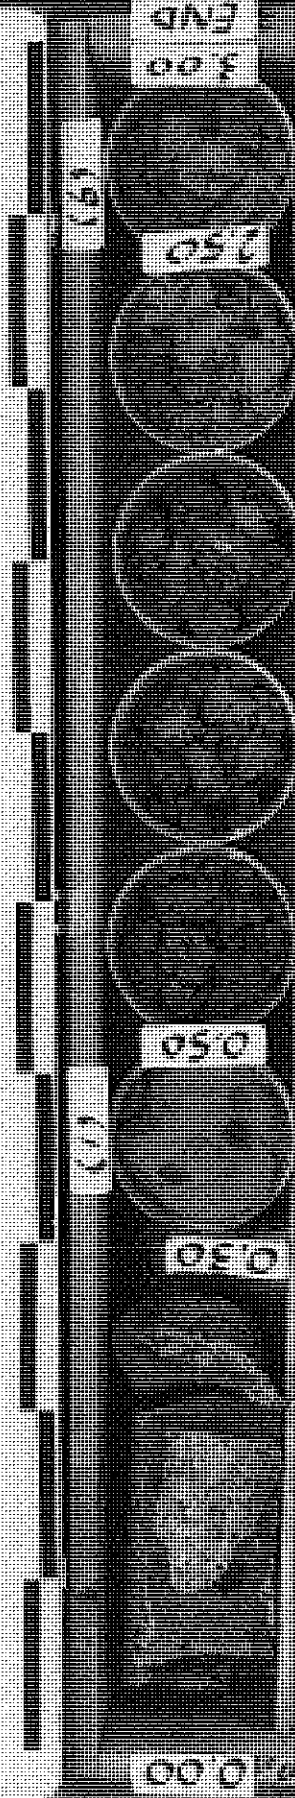
Job Title: Agreement No. BA/012008  
 Consultancy for the Investigation, Design  
 & Supervision of Slope & Retaining Wall  
 Upgrading Works at Ma Tso Lung Sun  
 Tsuen, Yuen Long, N.T. on Lot No. 1283 in  
 D.D. 96 for Portion of Feature No. 2NE-D/R1

Date of Photograph: 5/3/2010
