**GEOTECHNICAL PLANNING REVIEW REPORT (GPRR)
FOR
A COMMERCIAL DEVELOPMENT
AT
LOT 325 RP & 505 IN D.D. 210 and
ADJOINING GOVERNMENT LAND,
HO CHUNG, SAI KUNG**

**附件f , Geotechnical
Planning Review Report**

Client: Kin Hing Door Engineering Limited
Registered Geotechnical Engineer: SLN And Associates Ltd.

July 2024

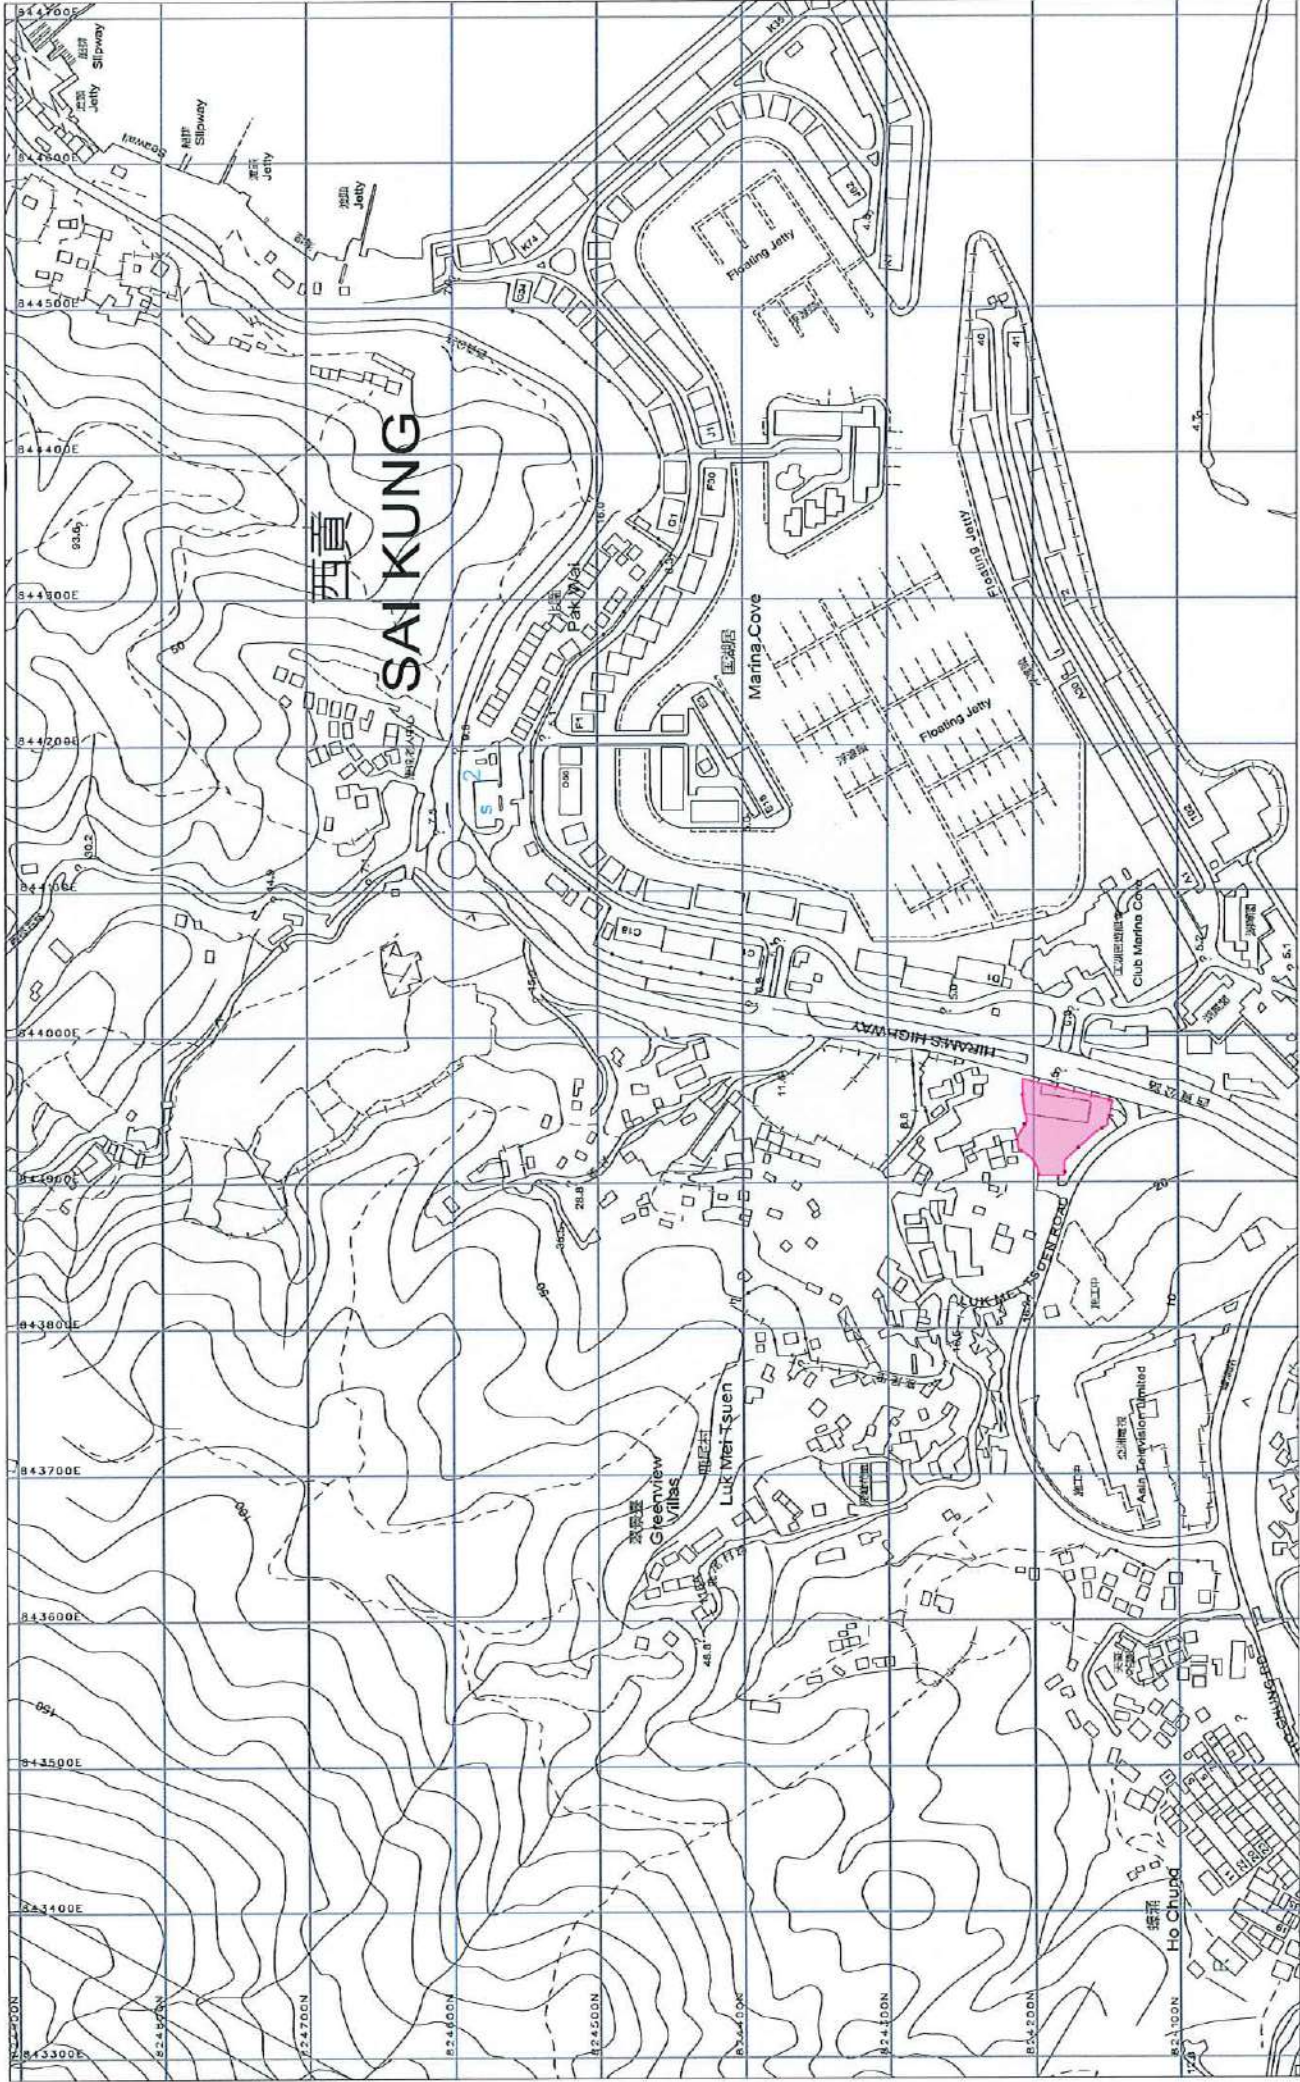
Figure 1

FIGURE 1 – SITE PLAN (1:5000)

SITE PLAN (1:5000)

The application site is located at Lot 325 RP & 505 in D.D.210 and adjoining government land, Ho Chung, Sai Kung (the Site). A site plan (1:5000) is shown in *Figures 1*.

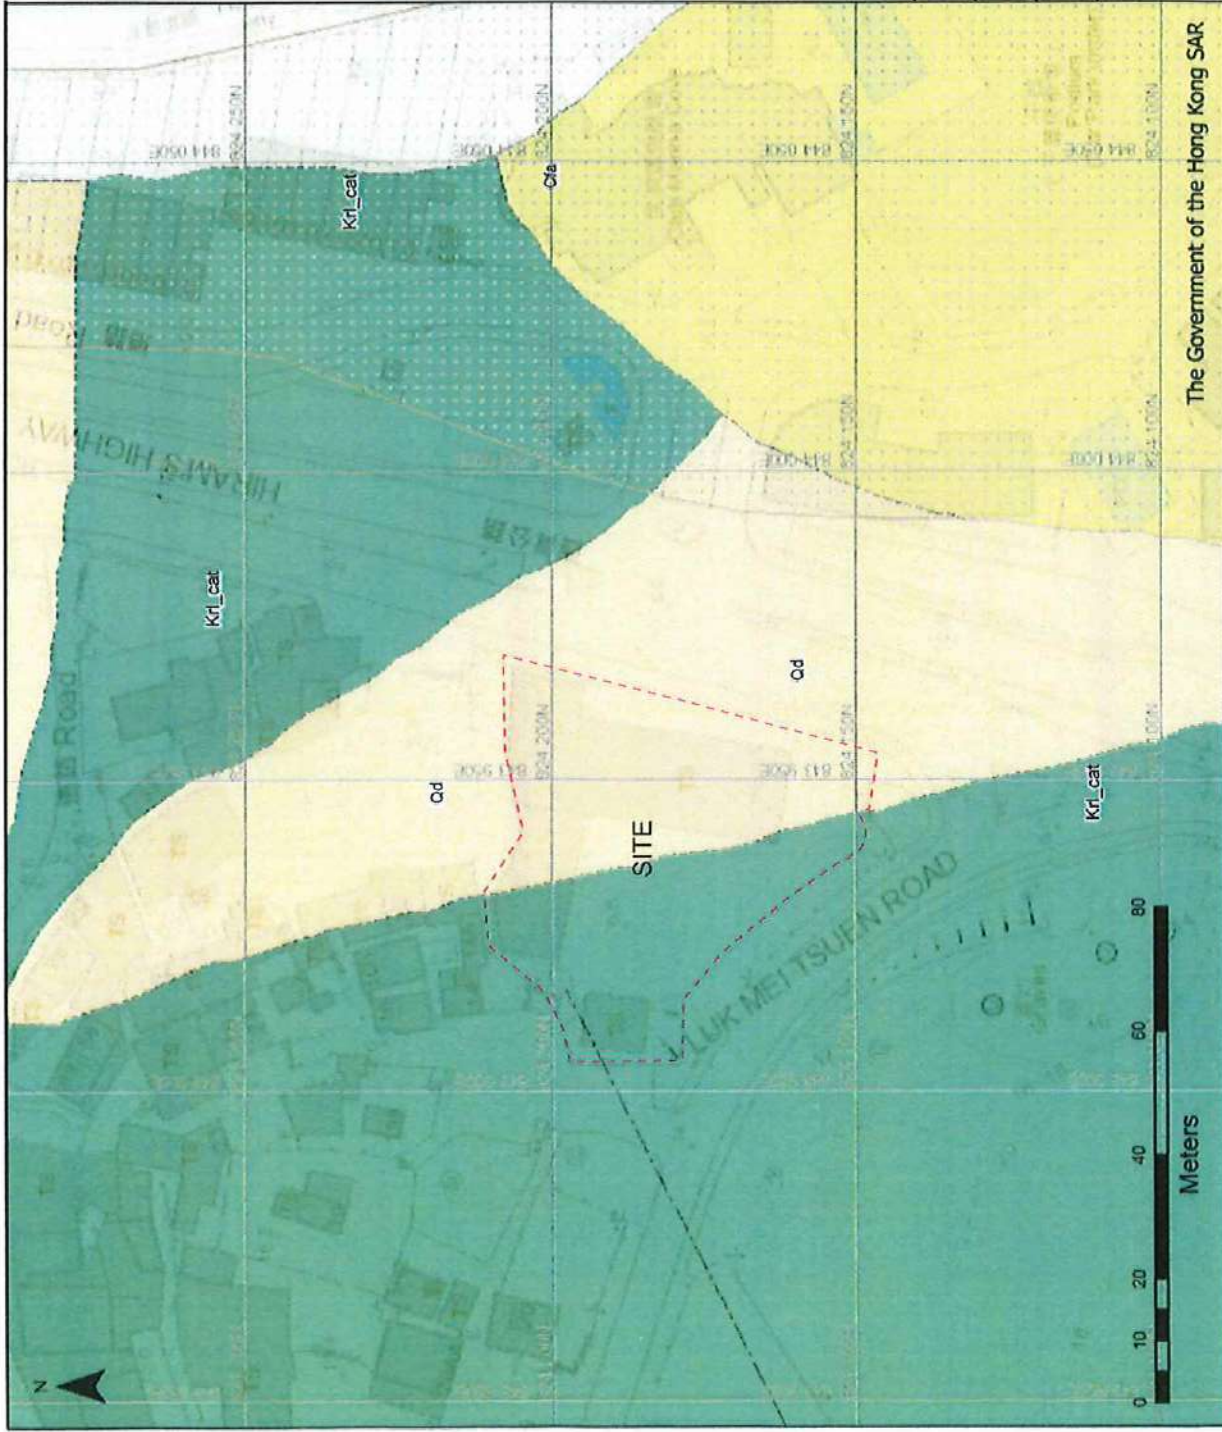
Figure 3

FIGURE 3 – EXTRACT OF GEOLOGICAL MAP

The geology of the Study Area is shown on the Hong Kong Geological Survey Map (HKGS) Sheet 7 (scale 1:20,000). An extract of the published geological map showing the Site and its vicinity is produced in *Figure 3* and described below.

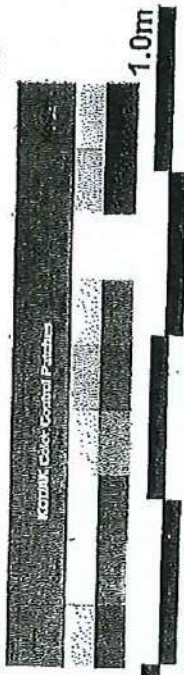
HOLE NO.: BH 18
BOX NO.: 4 OF 6

DEPTH: 9.93 m TO 12.93 m
DATE OF PHOTOGRAPH: 30/ 4 /2013

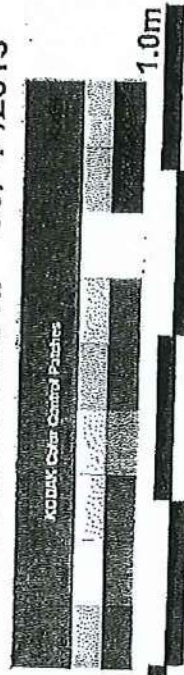
DEPTH: (15.63) m TO 17.23 m

DATE OF PHOTOGRAPH: 30/4/2013
