We are instructed by the Applicant, Yuba Company Limited to prepare this **Geotechnical Planning Review Report (GPRR)** in support of the Proposed Amendments to the Approved Wan Chai Outline Zoning Plan No. S/H5/31 from Comprehensive Development Area", "Residential (Group C)", "Open Space" and "Government, Institution or Community" zones and Areas shown as "Road" to "Other Specified Uses (Residential Development with Historic Building Conserved)" and "Other Specified Uses (Elevated Walkway)" at Nos. 1, 1A, 2 and 3 Hill Side Terrace, No. 55 Ship Street (a.k.a. Nam Koo Terrace), Nos. 1-5 Schooner Street, No. 53 Ship Street, No. 18 Sau Wa Fong, Inland Lot No. 9048 and adjoining Government Land, Wan Chai (collectively referred to as the "**Rezoning Site**" / the "**Site**").

The geotechnical feasibility of the Indicative Development Scheme in relation to the stability of man-made slopes/retaining walls and to address any potential natural terrain landslide hazards that may affect or be affected by the Site is assessed in the report. Please refer to Appendix 1 of supplementary planning statement for the architectural plans.

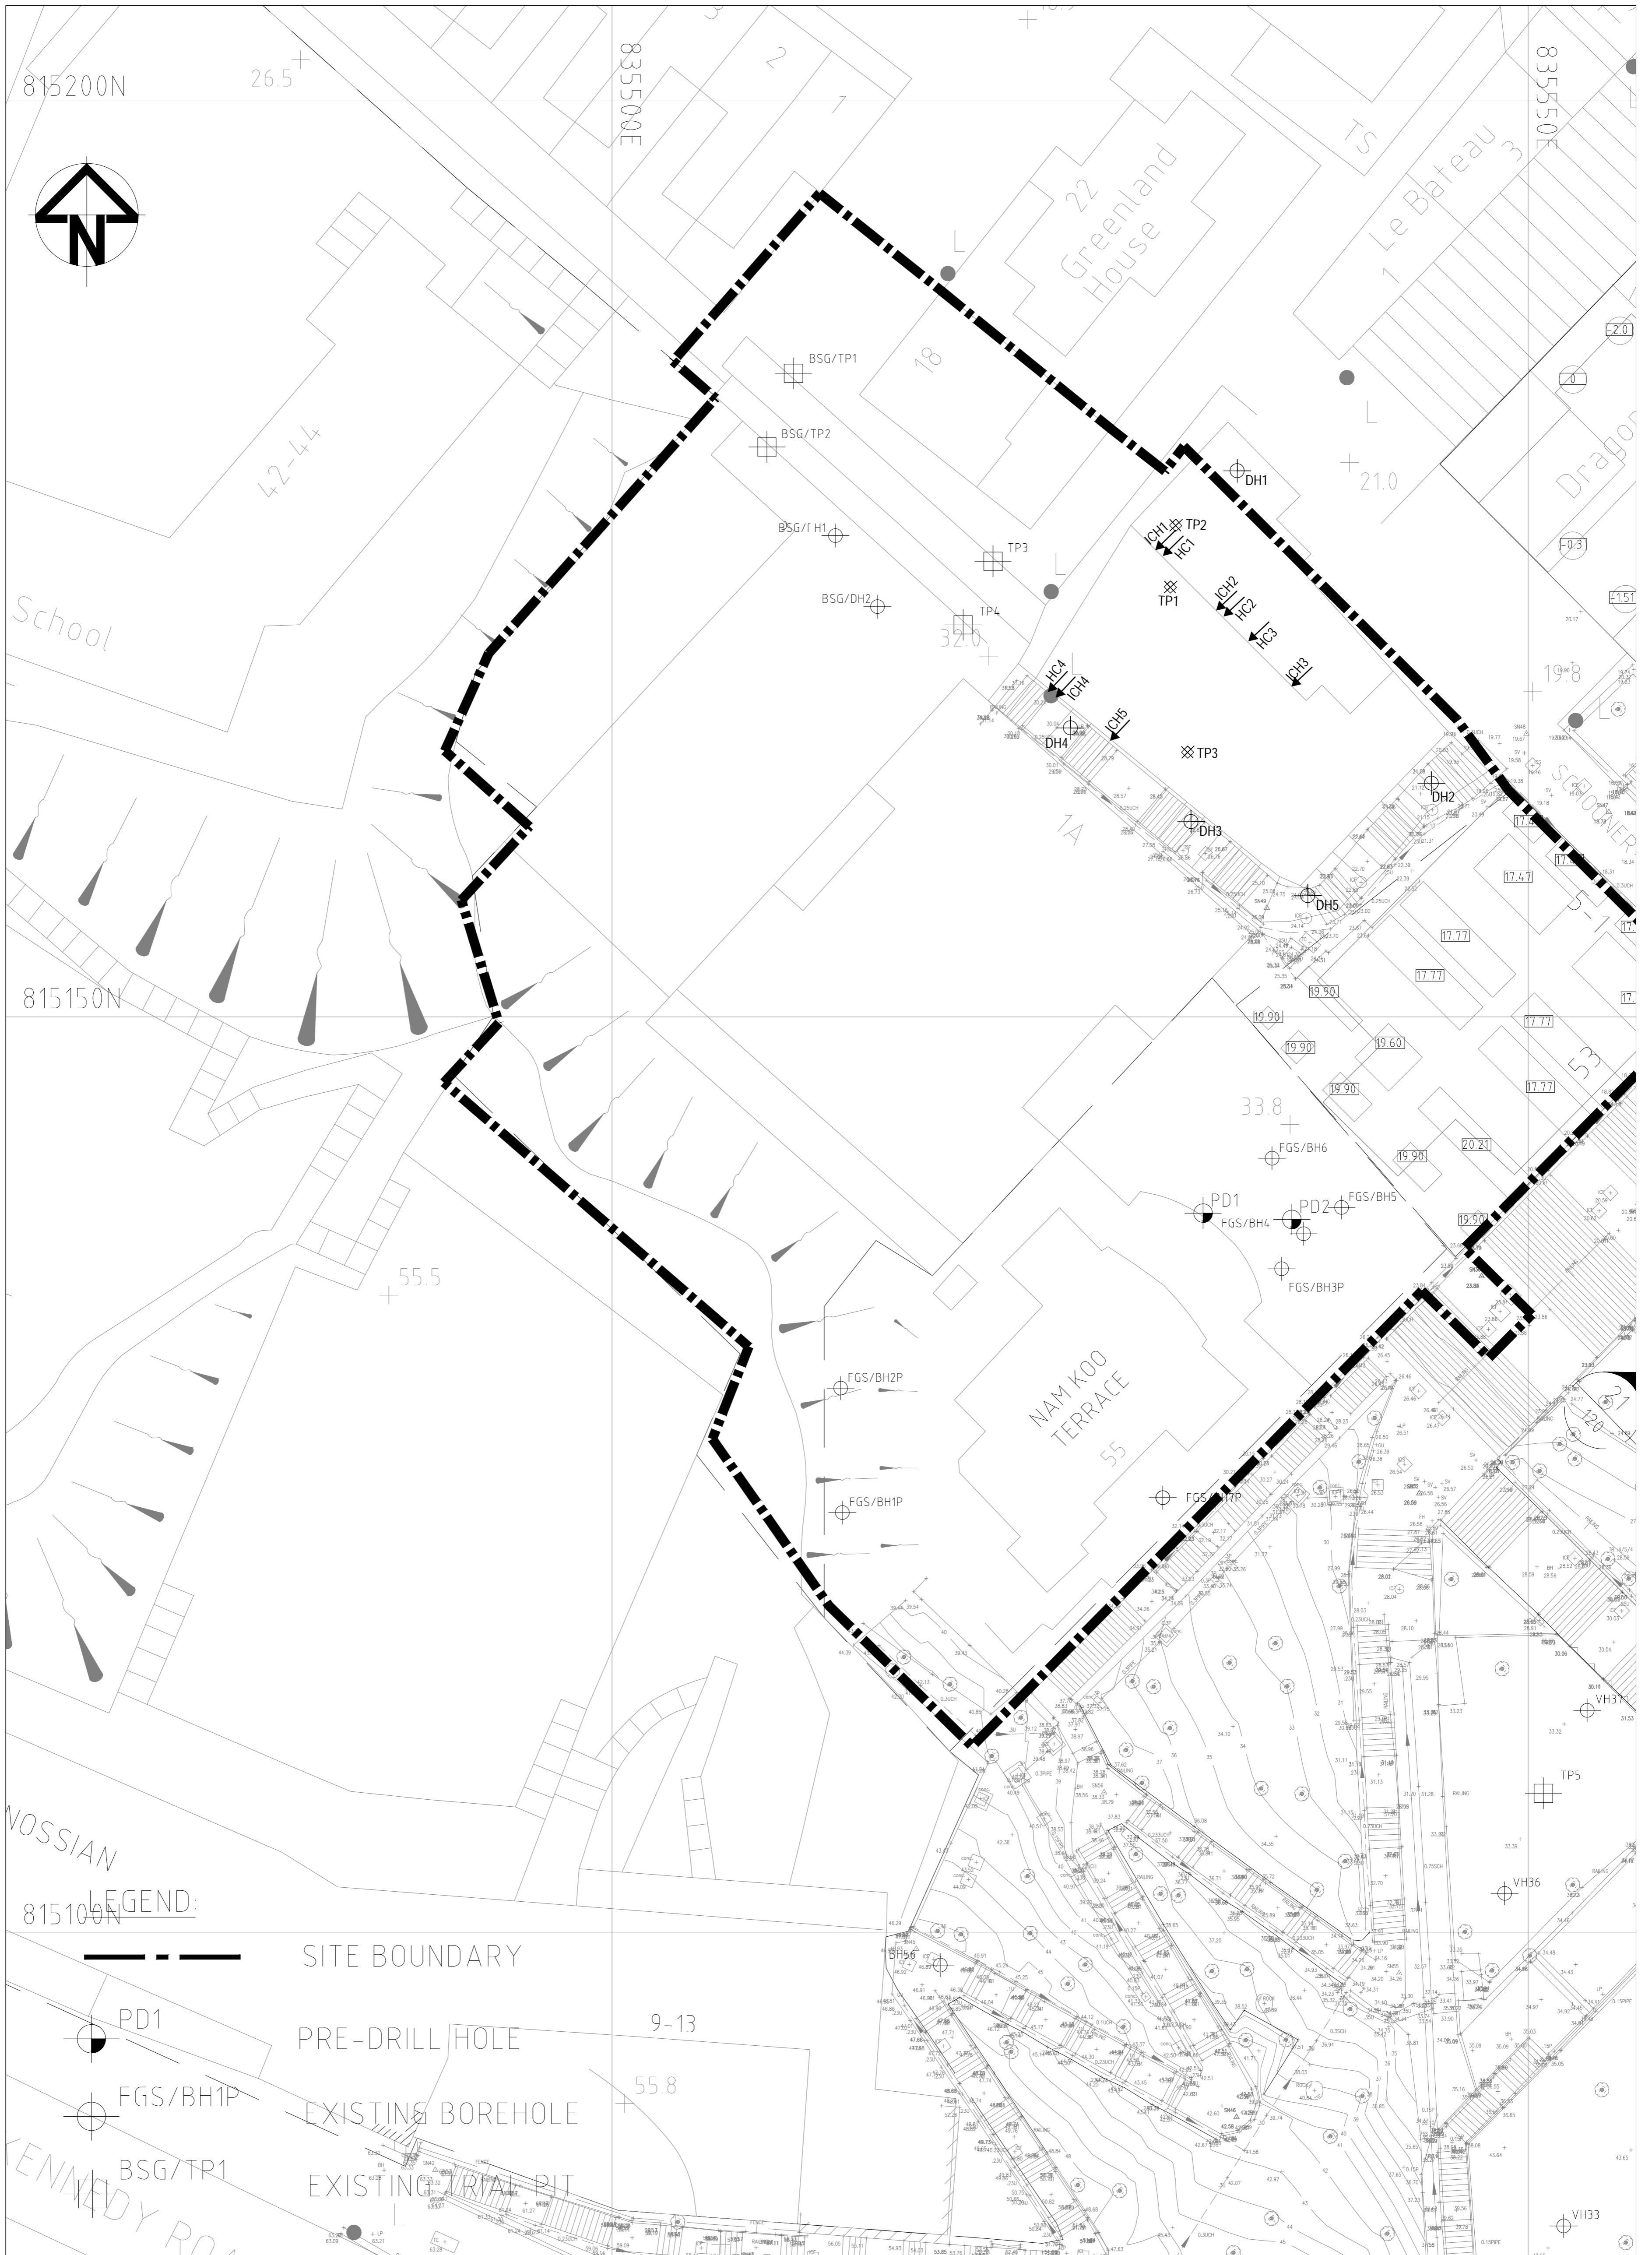
Drawing No. **FIGURE 2**

- SITE BOUNDARY
- PD1 PRE-DRILL HOLE
- FGS/BH1P EXISTING BOREHOLE
- BSG/TR1 EXISTING TRIAL PIT

Status		Project	
Scale	1 : 500	Original Size	A4
Height Datum	-	Grid	-
Filename: FIGURE 2D.dwg		Title: EXISTING GROUND INVESTIGATION PLAN	
© Copyright reserved
