Geotechnical Planning Review Report

Application for Amendment of Plan under Section 12A of the
Town Planning Ordinance (Cap. 131) to Rezone the
Application Site from “Green Belt” to “Residential (Group C)
1” for Proposed House Development

Various Lots in D.D. 244 and Adjoining Government
Land,
Nam Pin Wai, Sai Kung

JMK Consulting Engineers Limited
May 2023

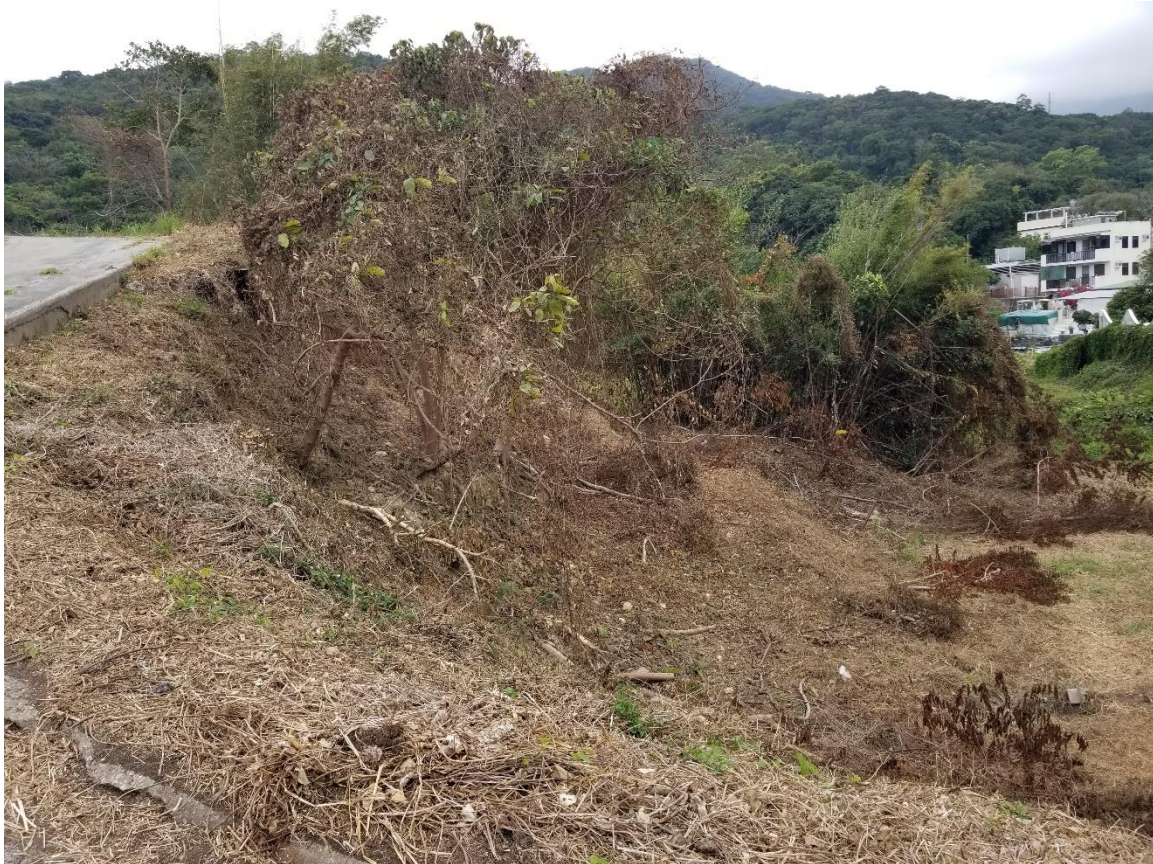
Photo E

General View of the Northern End of Feature No. 11NE-B/F186, Looking South

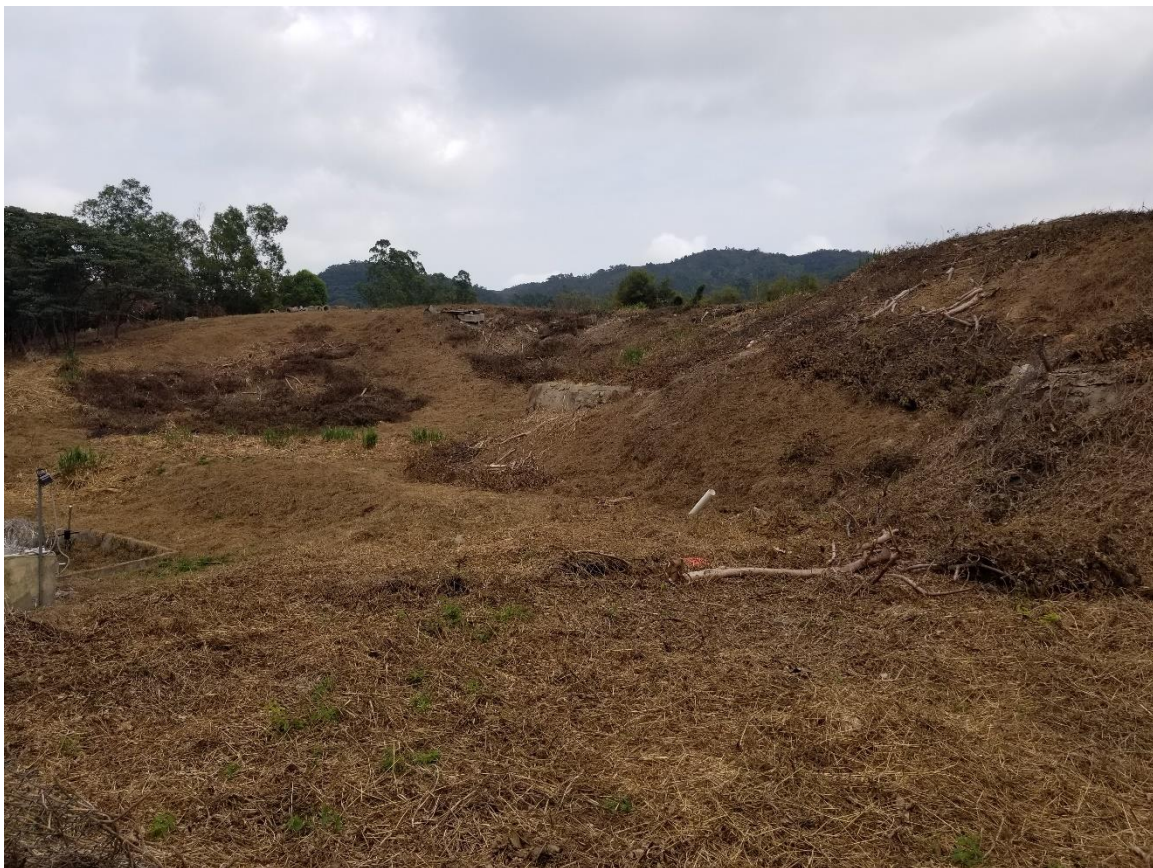
Photo F

General View of the Mid Portion of Feature No. 11NE-B/F186, Looking Northeast

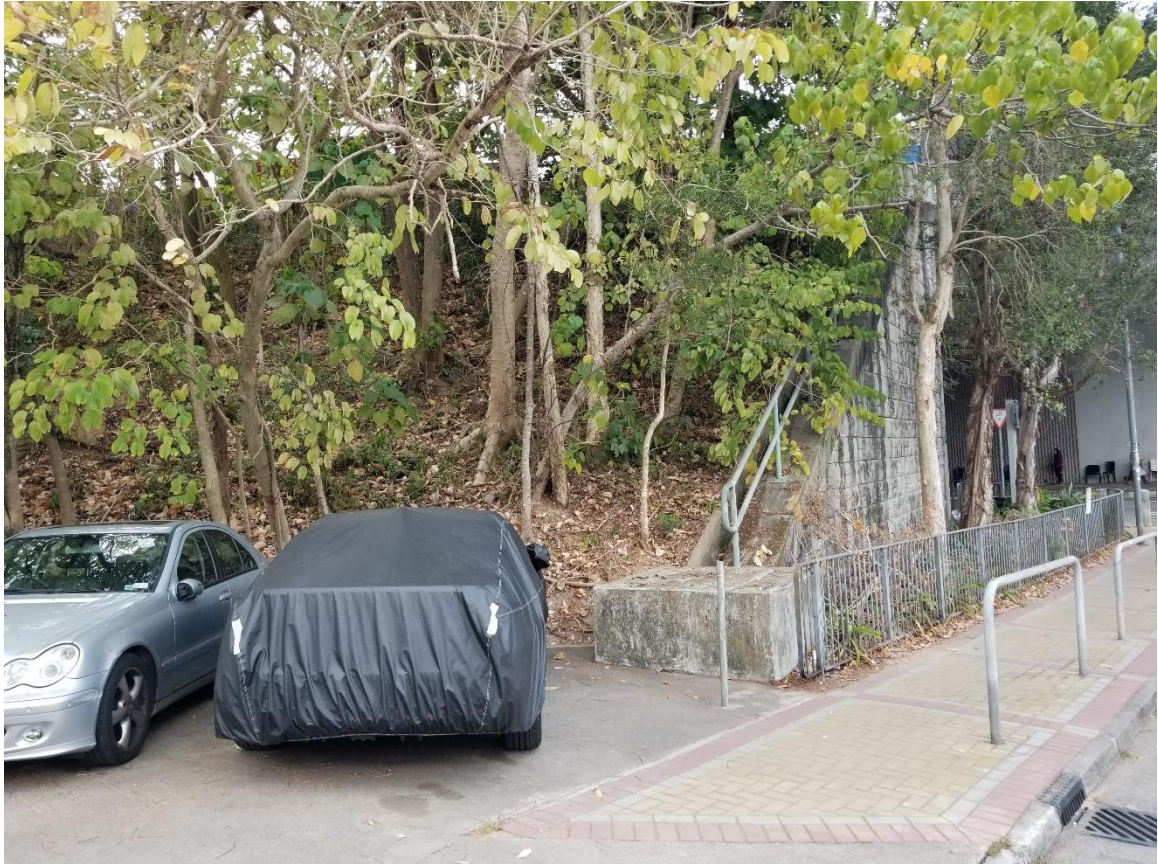
Photo G

General View of the Feature No. 11NE-B/FR 295, Looking North

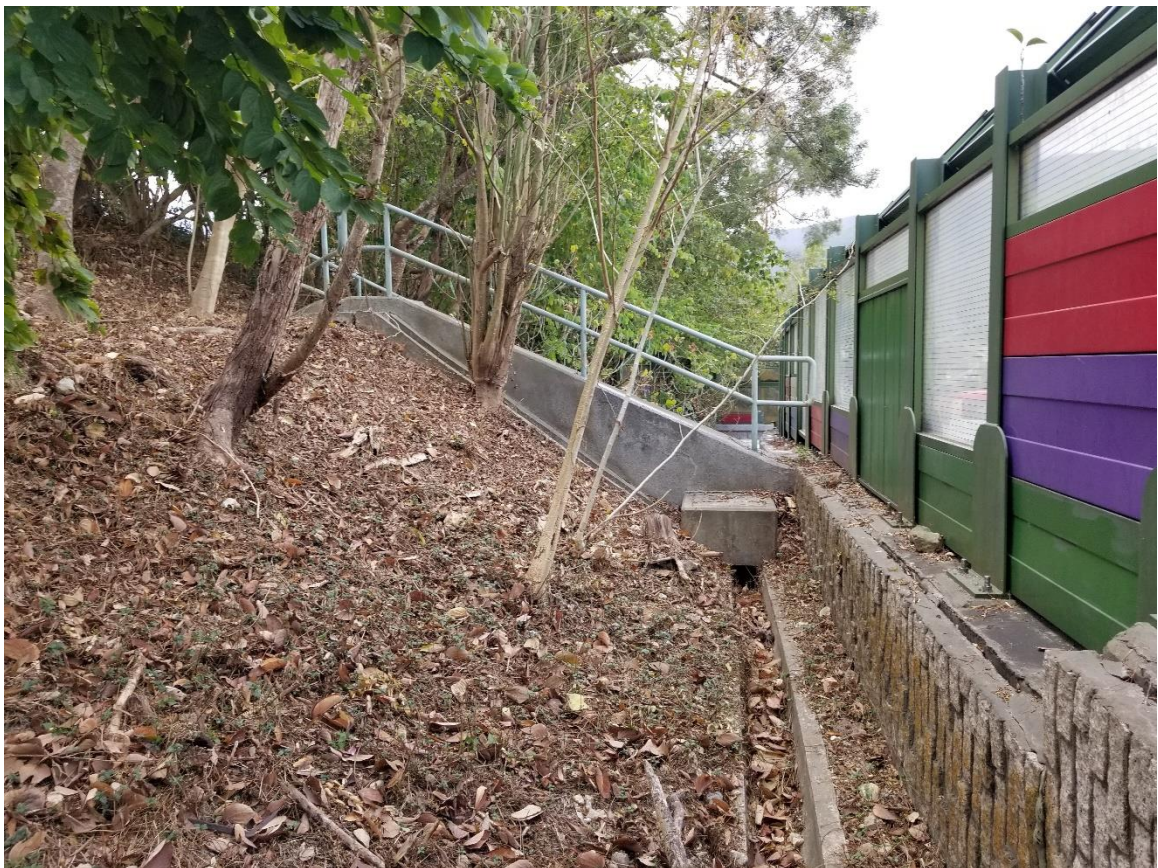
Photo H

General View of the Feature No. 11NE-B/FR 295, Looking Southeast

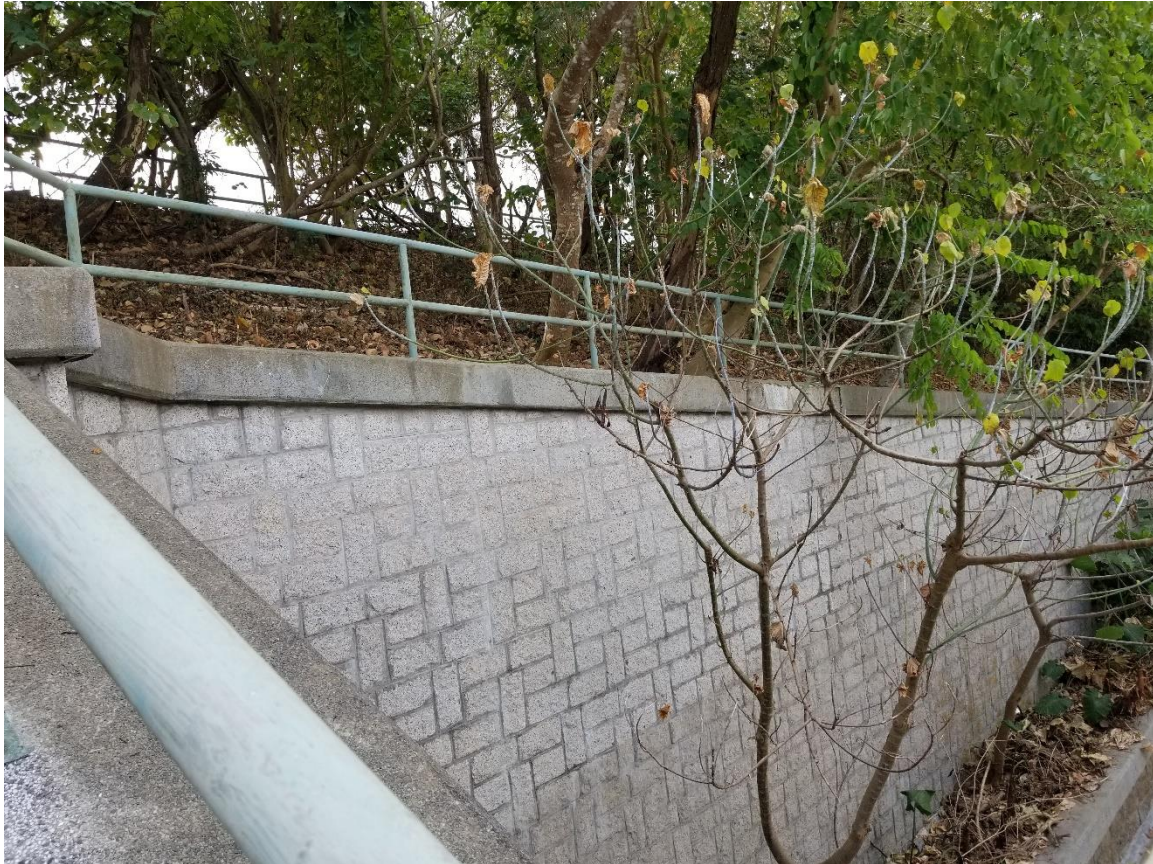
Photo I

General View of the Feature No. 11NE-B/CR924, Looking southwest

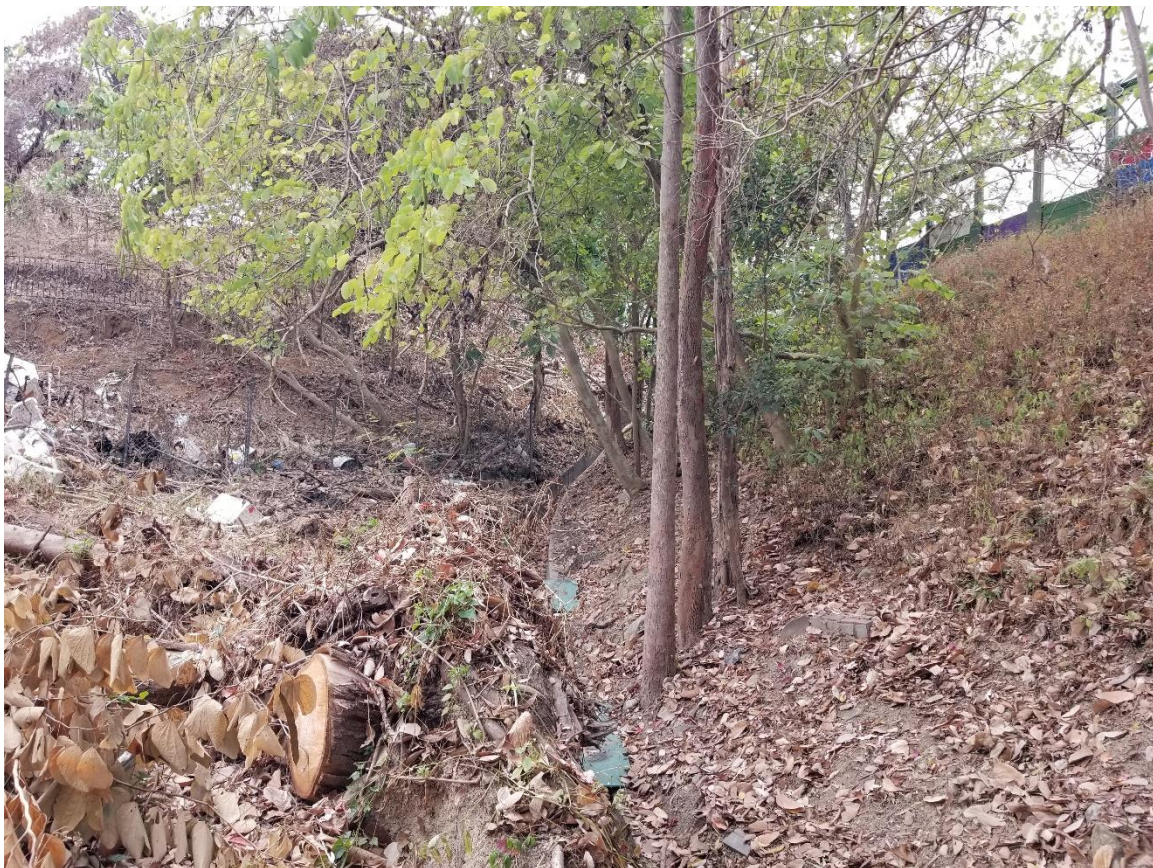
Photo J

General View of the Feature No. 11NE-B/CR924, Looking Northwest
