**Section 12A Rezoning Application
From “V” To “G/IC (3)” for
Pre-Cut Off Columbariums at Buddhist Cheung Ha Temple,
Lot Nos. 1087 and 1130 in D.D.6,
and adjoining Government Land,
Tai Po, New Territories**

GEOTECHNICAL PLANNING REVIEW REPORT

JUNE 2024

Project No.: J1926/B

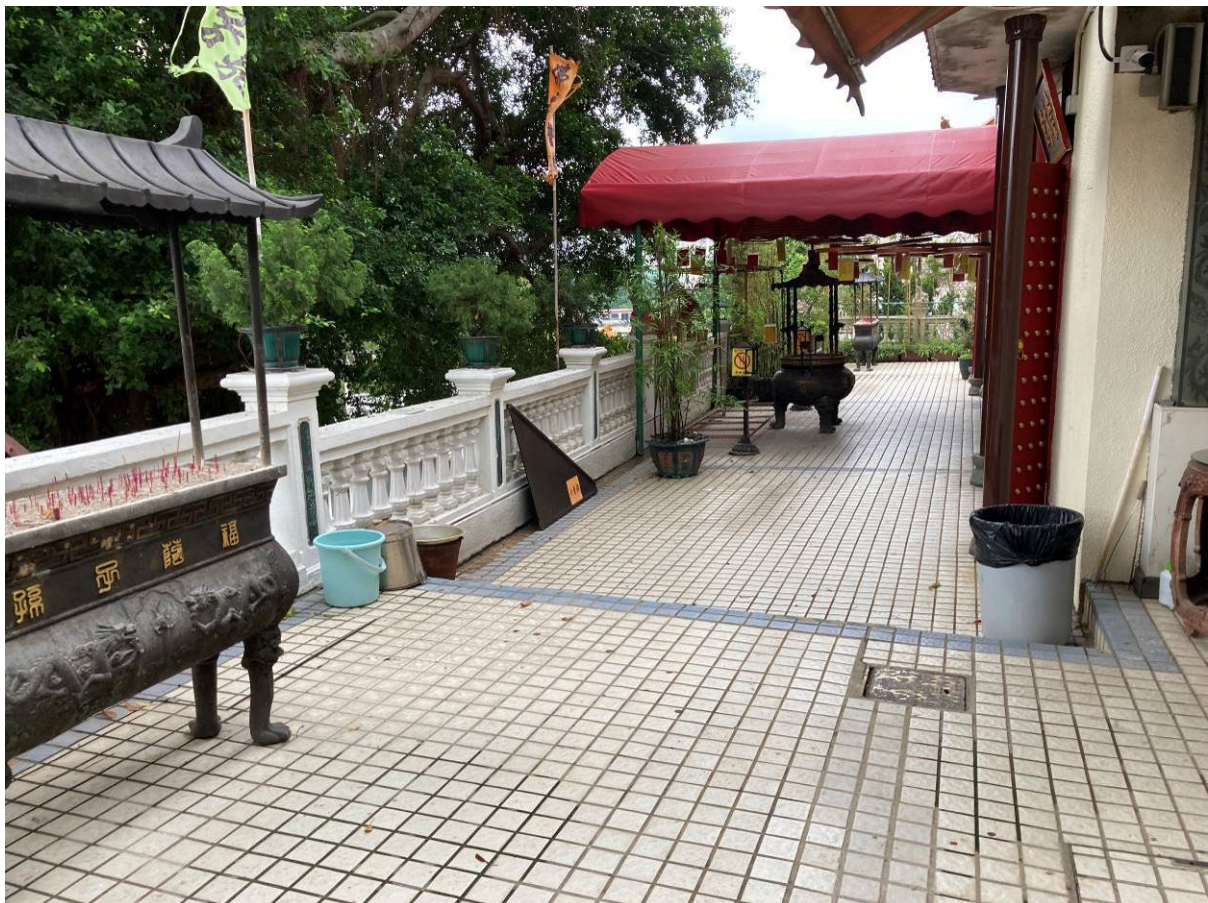
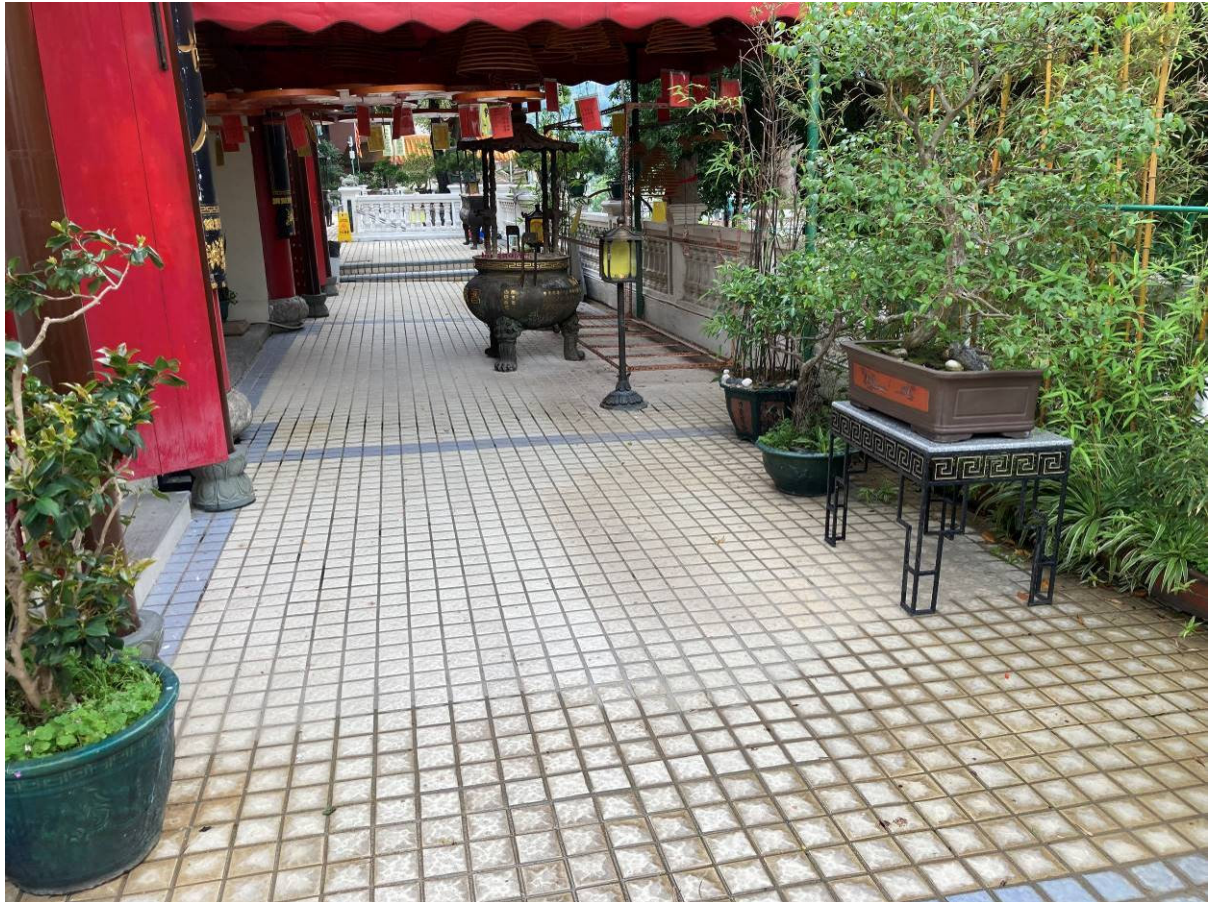
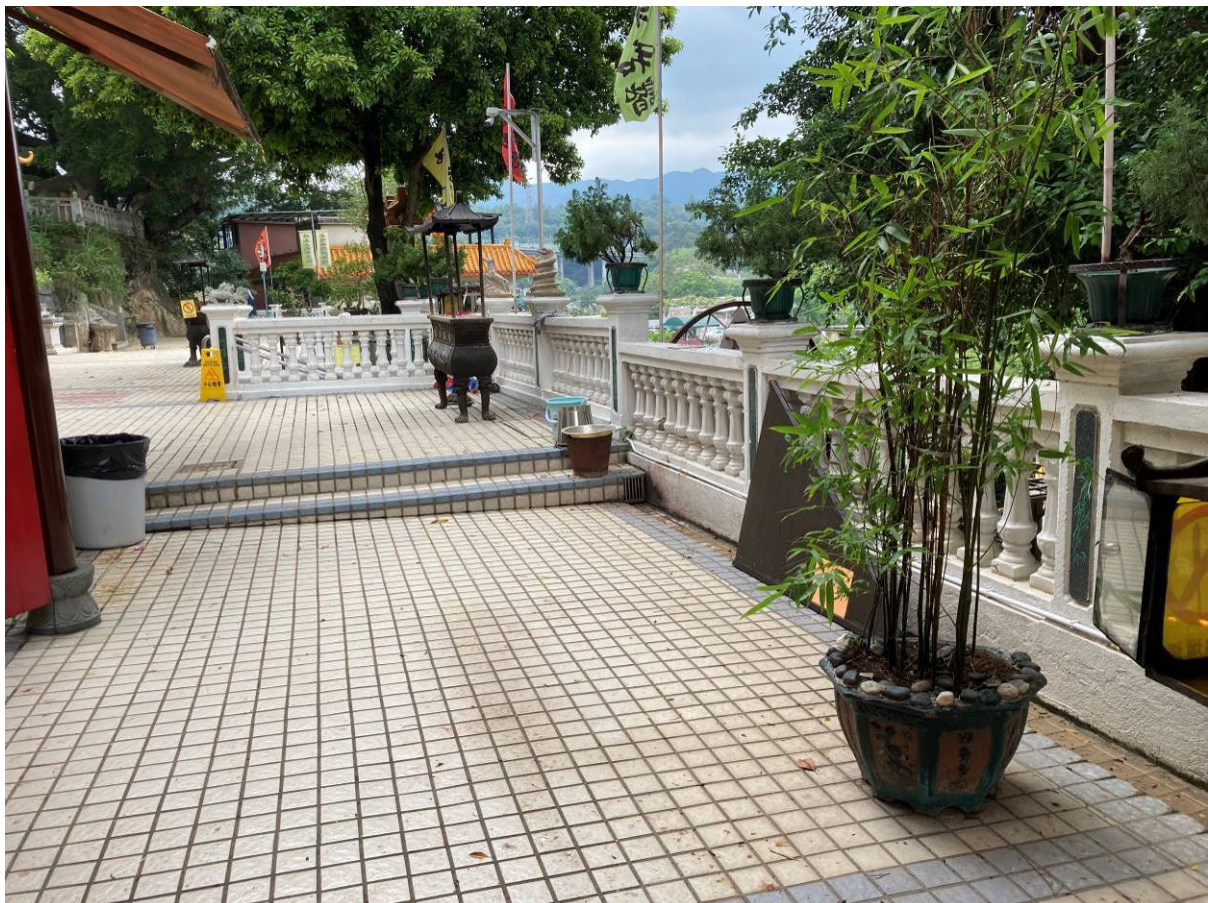
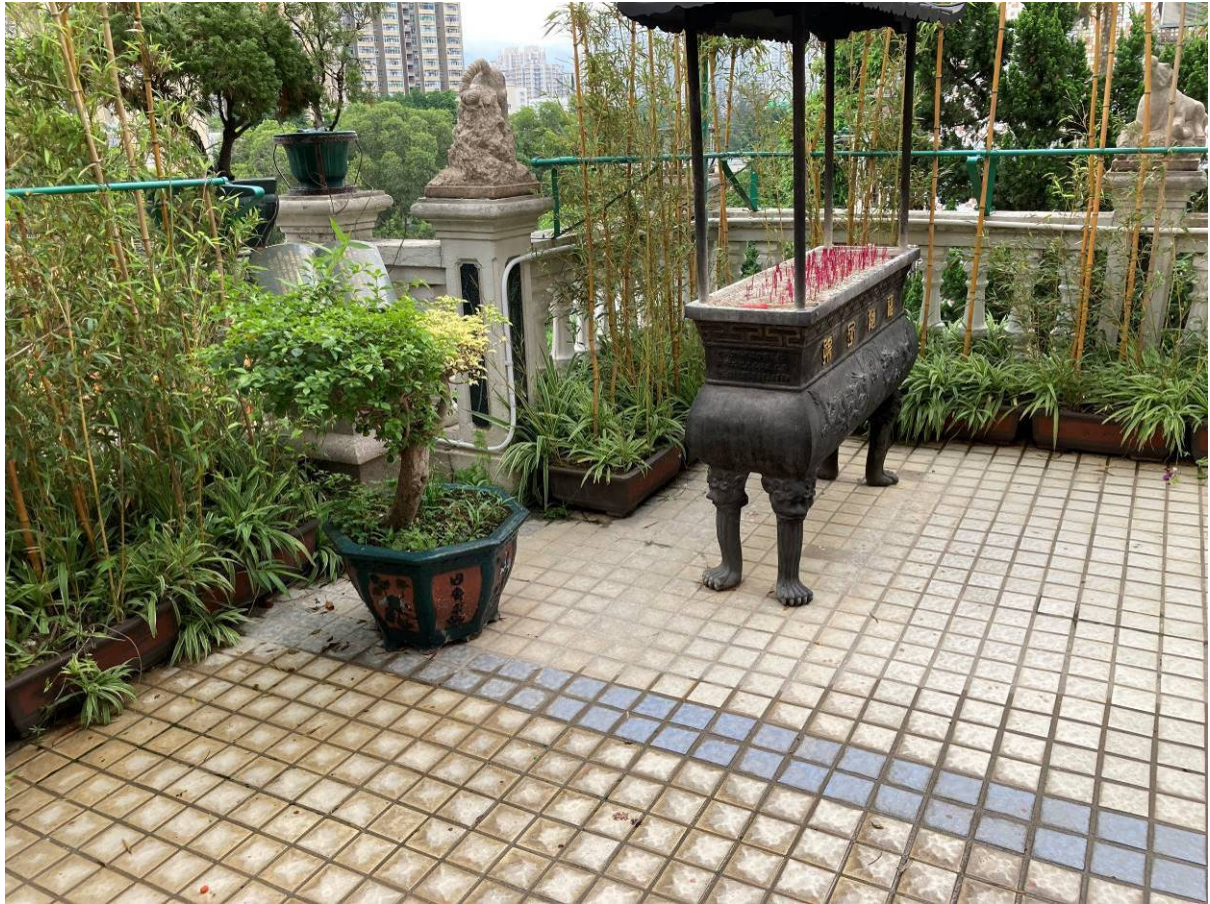
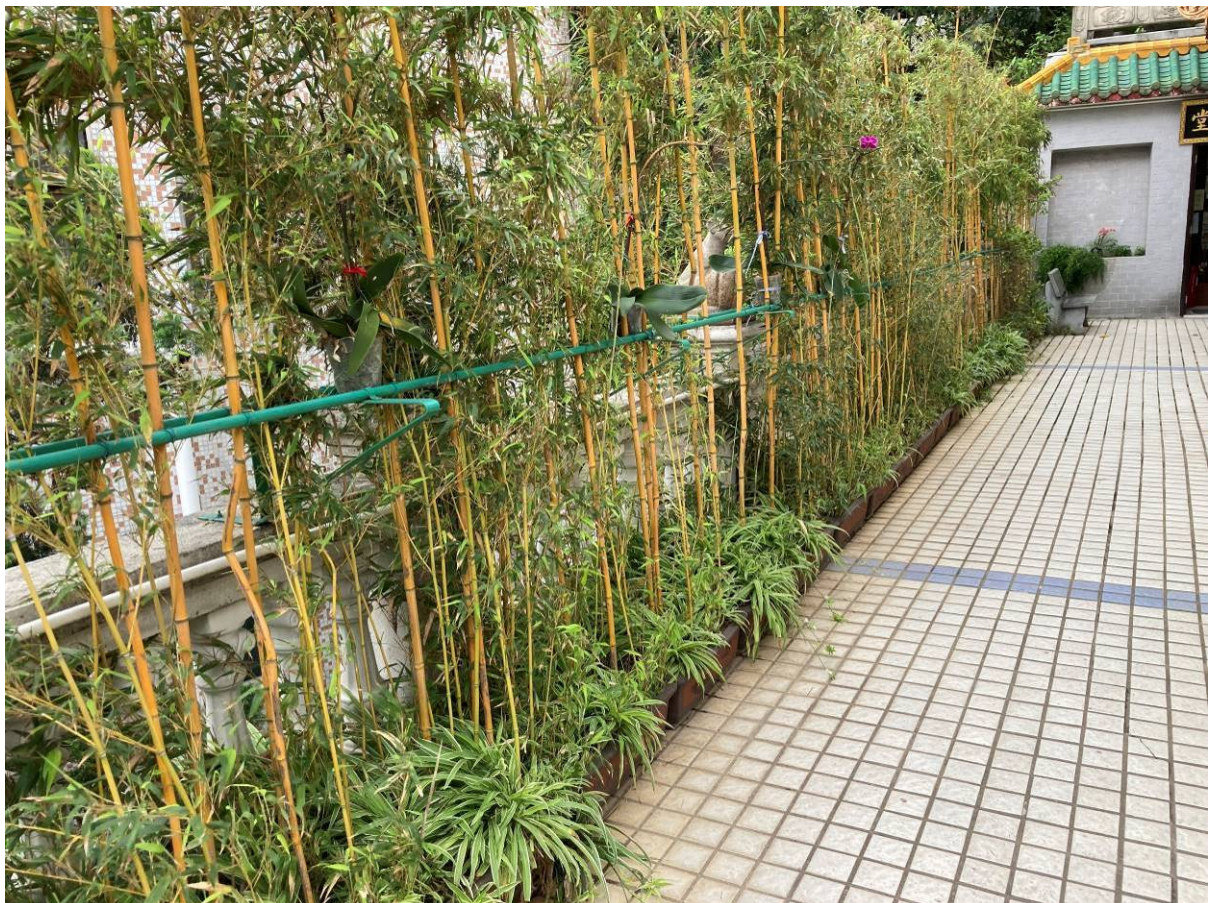
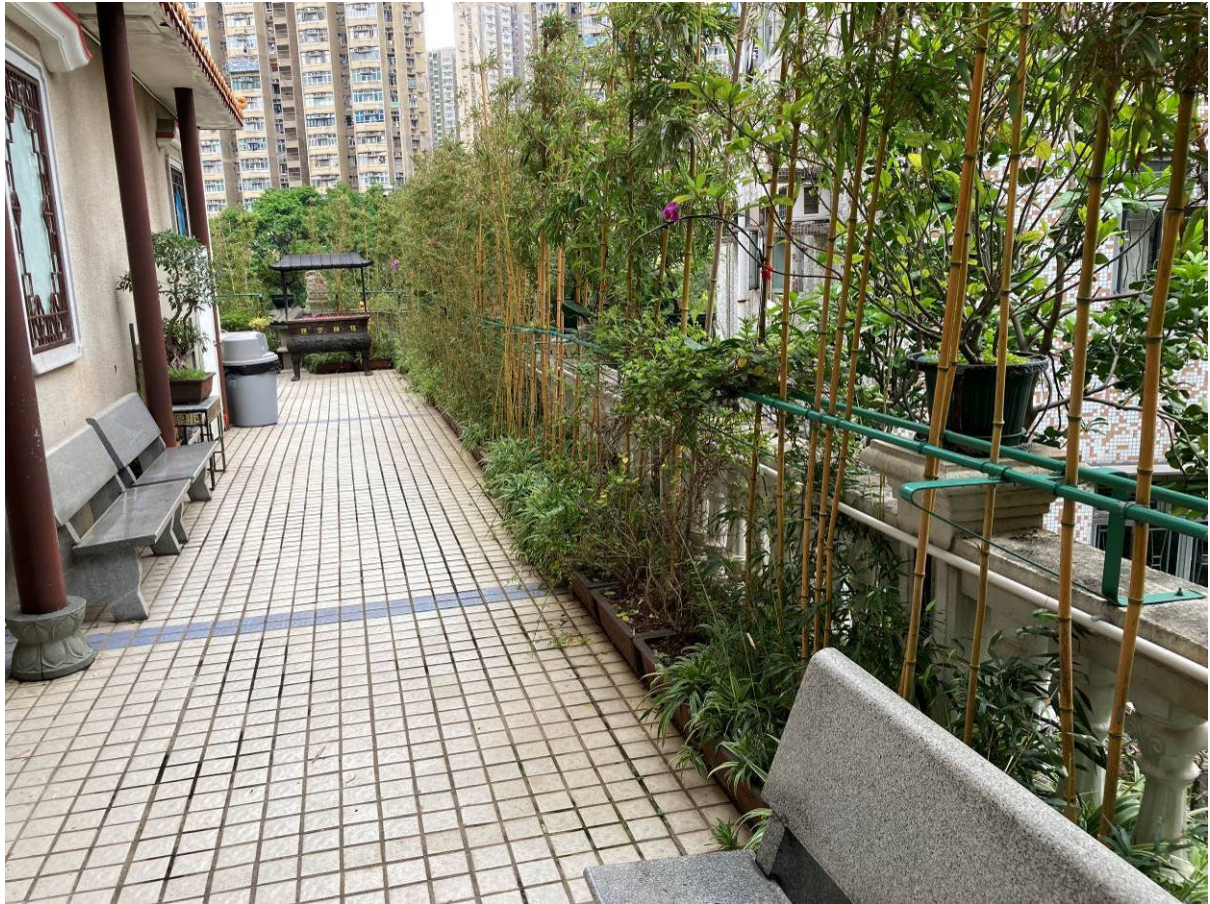
- 2.14.7 Plate Nos. 18 to 23 shown Existing Platform behind Feature No. 7NW-B/R90;
- 2.14.8 Plate No. 24 shown Feature No. 7NW-B/R90;
- 2.14.9 Plate Nos. 25 to 28 shown Wall No. 3;

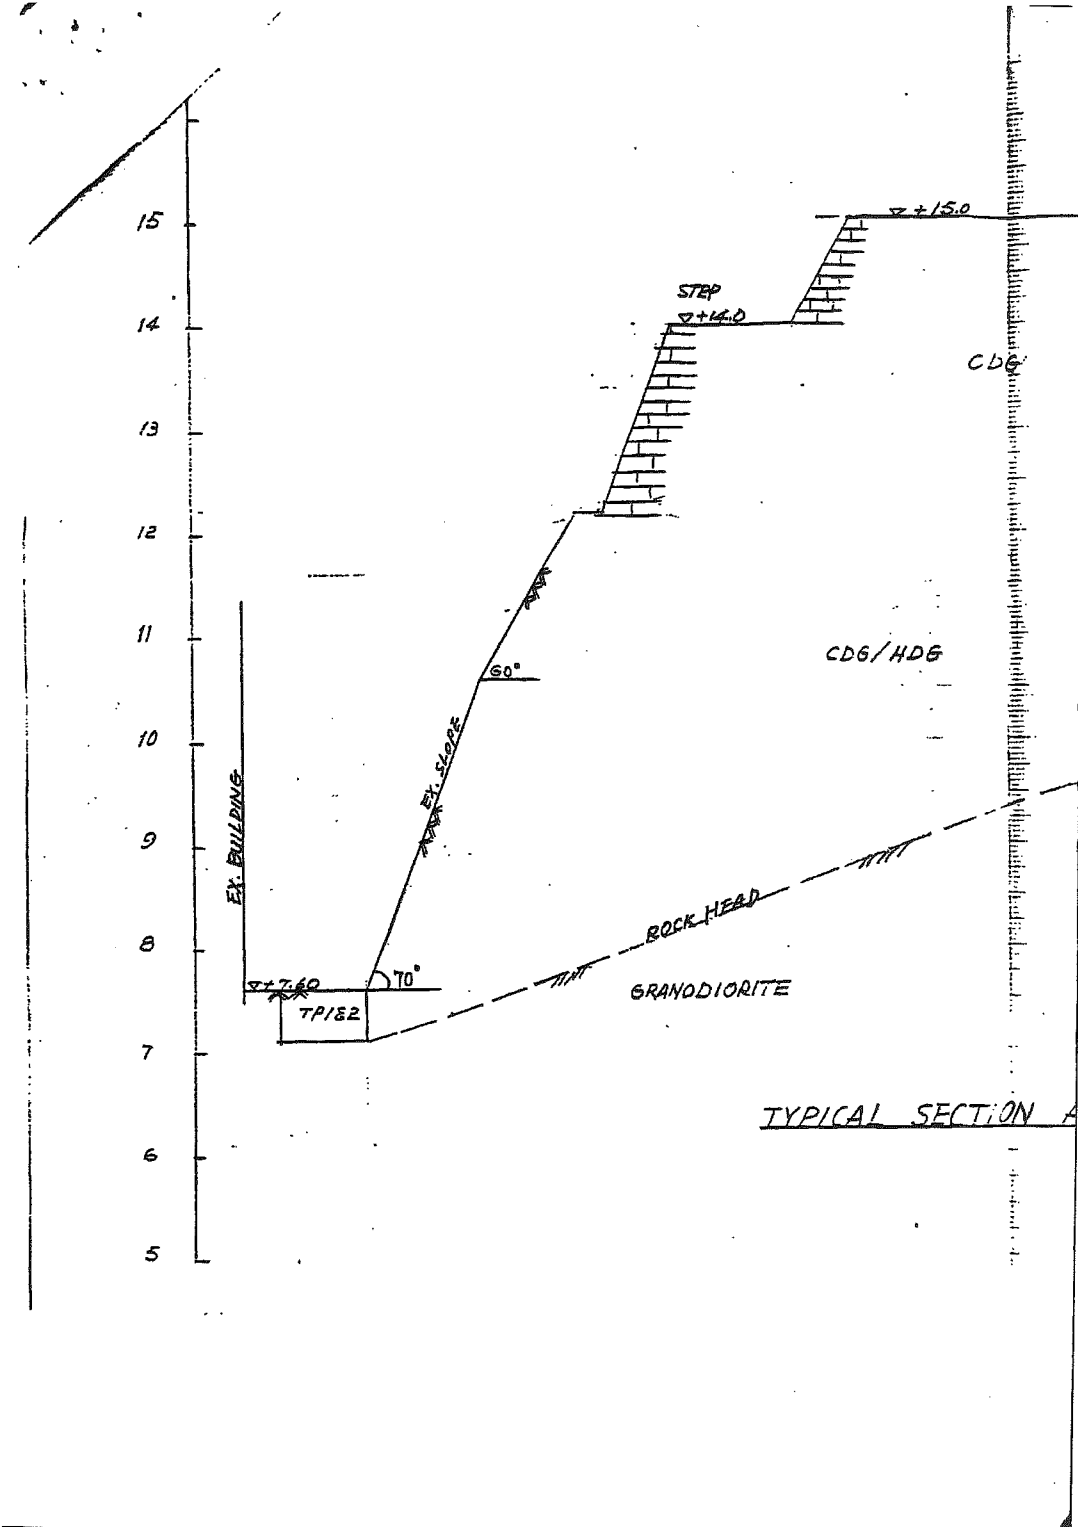
PROPOSED SITE PLAN
(1 : 100)

Site Plan and Typical Section

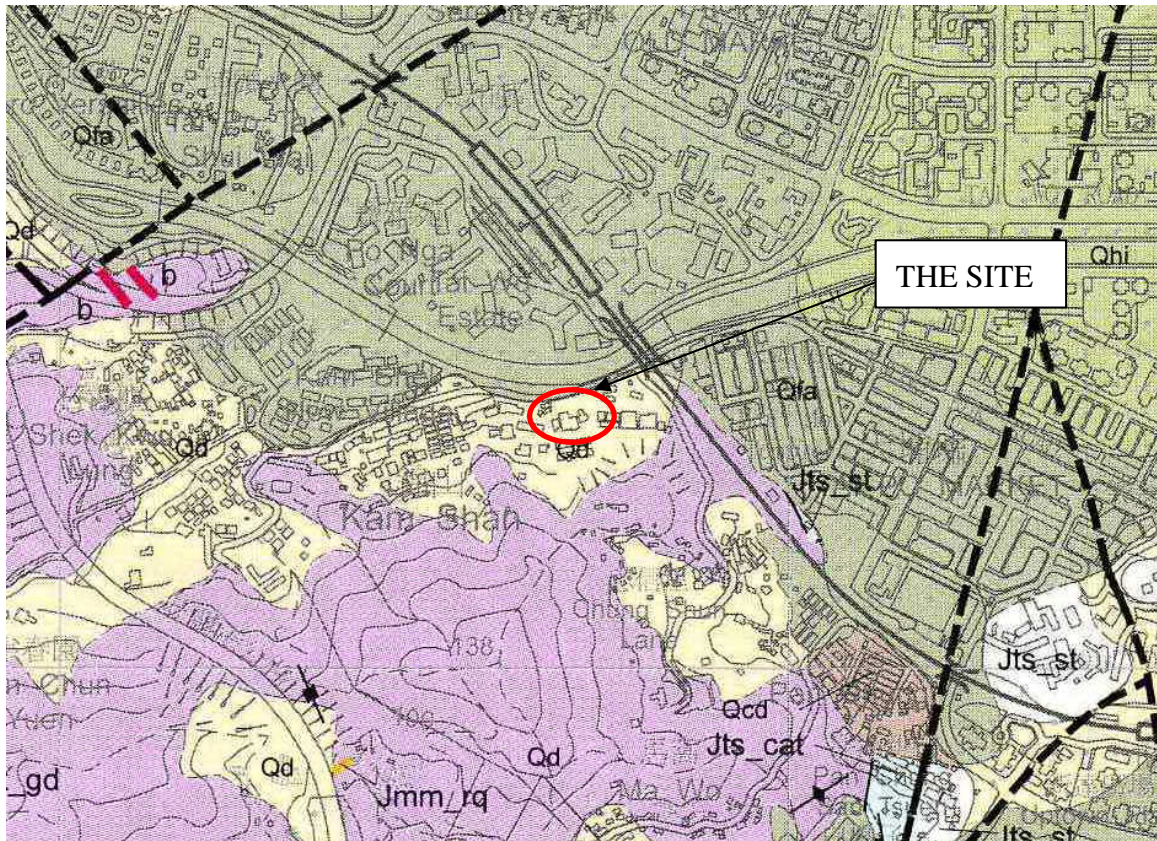
**Geology Map Extracted from
Sheet No.7 (Sha Tin) 1:20000 HGM 20-Series Hong Kong Geological Survey Map**

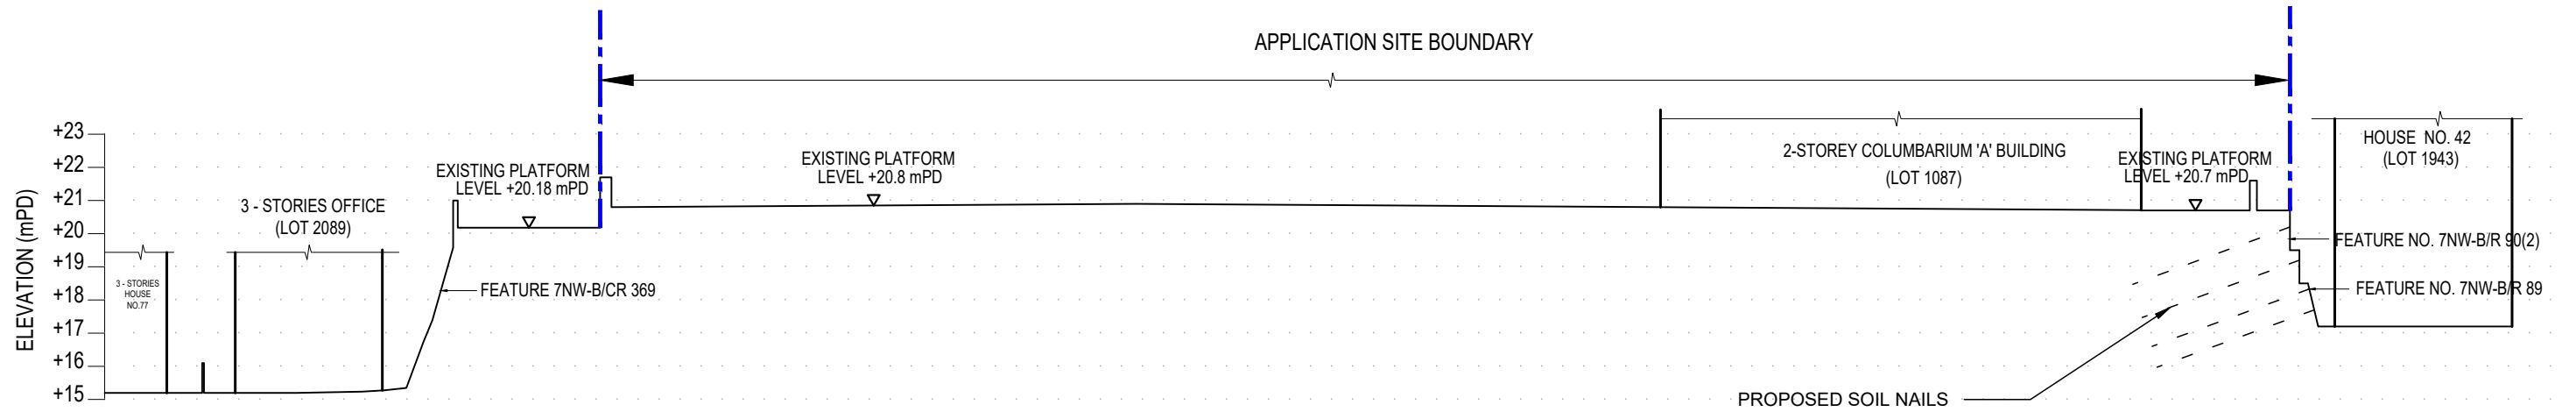
SECTION A - A
1 : 100

CLIENT :
BUDDHIST CHEUNG HA TEMPLE
DRAWING TITLE :
SECTION A-A & B-B
DRAWING NO.: SF-02
