**GEOTECHNICAL PLANNING REVIEW REPORT
FOR S16 APPLICATION**

**FOR PROPOSED RESIDENTIAL DEVELOPMENT
AT 152 – 164 WELLINGTON STREET,
HONG KONG**

February 2024

TSW Consulting Engineers Ltd.

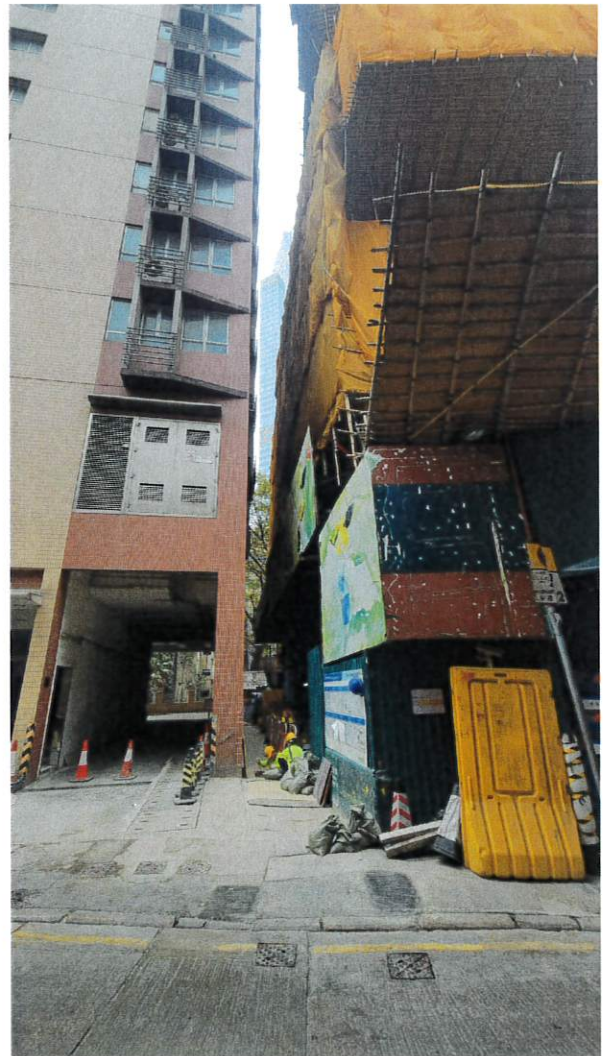
#G07 View at Gage Street (It is suspected that part of the Wall Feature should have been removed or replaced by the New Development at 10 – 14 Staveley Street.)

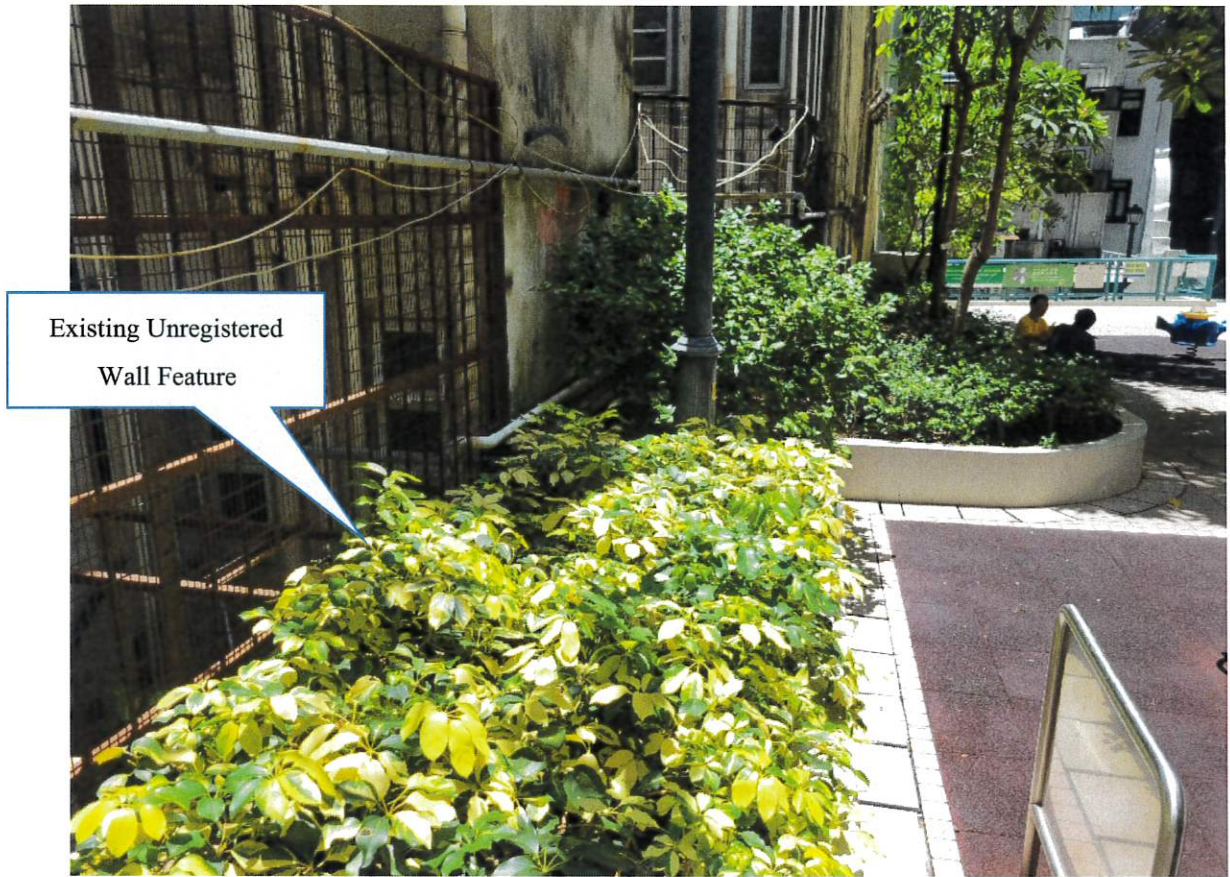
#G08 Crest of an Unregistered Wall Feature at Rear of 156 – 158 Wellington Street

An unregistered wall feature abutting Wa On Lane at or behind the site is also noted. Retained height is 3.0m / 5.7m. Site reconnaissance reveals that this wall extends towards Staveley Street and ends at 142 Wellington Street, where retaining height is around 3.0m. Its layout is incorporated in Figure 3 as well.

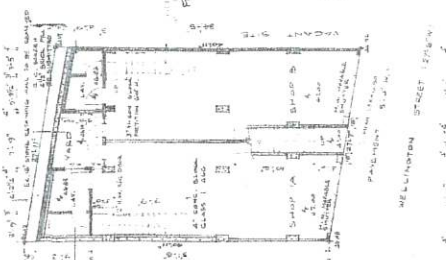
G/FEL PLAN
NO. 152
(ADJACENT WELINGTON STREET)

FOUNDATION AND STRUCTURE BELOW G/FEL LEVEL TO BE DEMOLISHED
 THROUGHOUT AND REINFORCED WITH 10# REINFORCEMENT
 (NO-FINE CONCRETE WILL BE TO BE FINISHED WITH TO CORRECT APPLICATION
 OF DEMOLITION WORKS)

Demolition Plans were submitted to Buildings Department on 31-5-2023 and were approved on 26-7-2023. 30° no-fine concrete fill berms are provided at G/F & 1/F to support existing wall features exposed and remained to ensure their continual stability. The approval letter and extracts of relevant approved plans are included as Appendix D for reference.
